INITIAL ABATEMENT ACTION REPORT FOR CLOSED ORPHAN UNDERGROUND STORAGE TANK

**92 Park Street, Town of Canton Property
Parcel #7
Canton, North Carolina
TIP # B-3656, WBS Element # 33202.1.2
Haywood County**

**Gasoline UST (UST #002)
Parcel #7
Town of Canton Property
92 Park Street
Canton, NC**

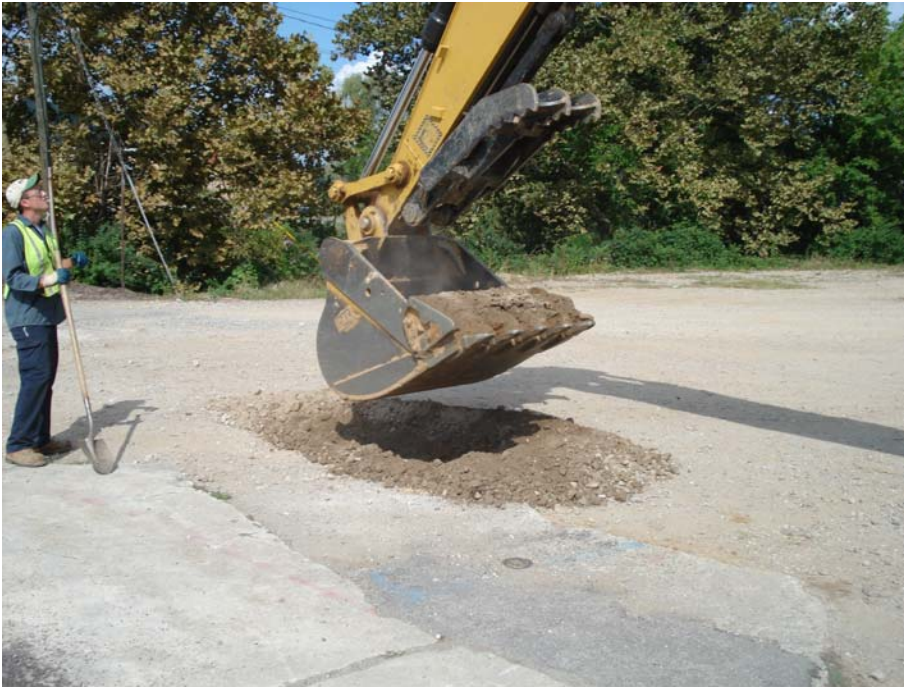
Photograph 1: View looking northwest at initial excavation of USTs at Parcel #7. Fill pipe cover for UST #003 is shown in center foreground.

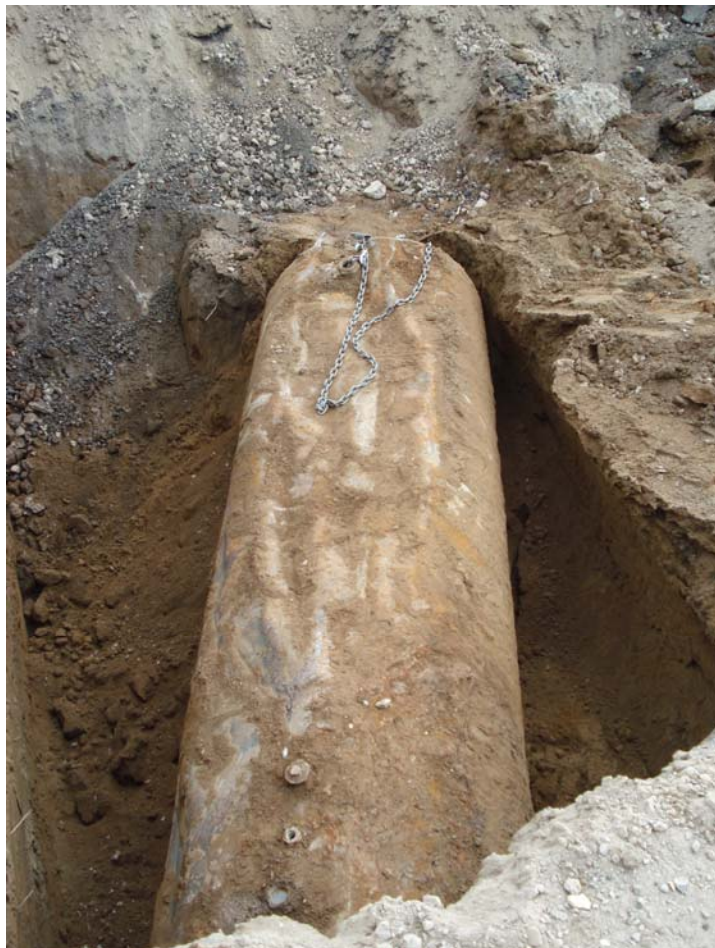
Photograph 2: View looking east at removal of UST #003.

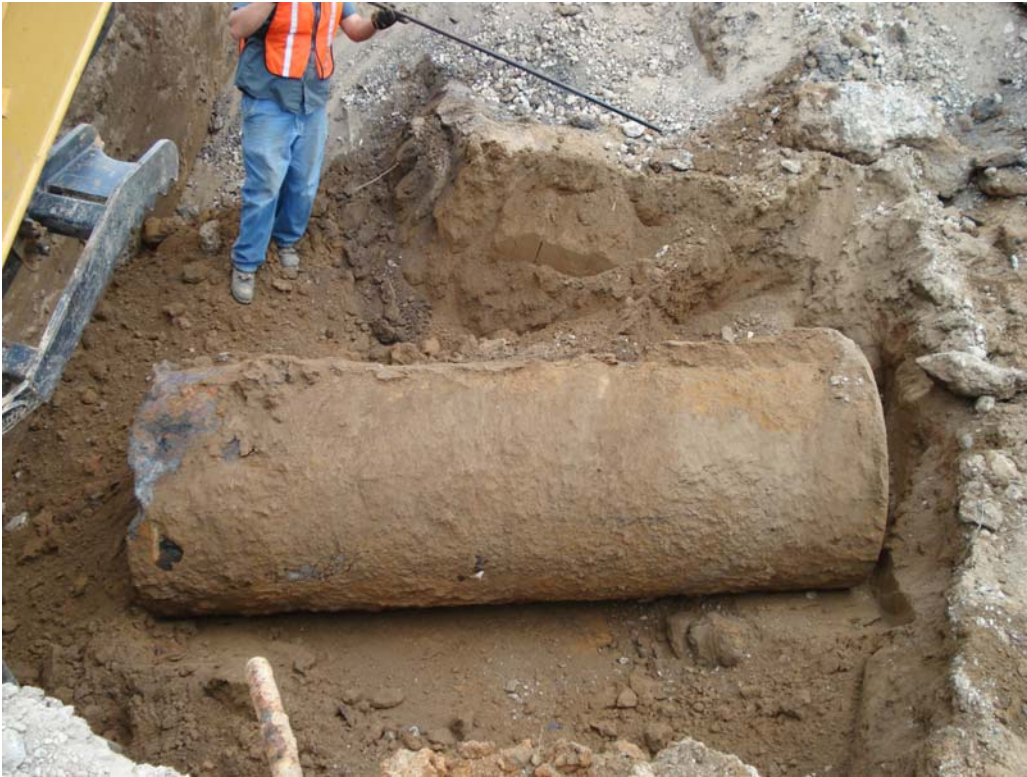
Photograph 3: View looking east at removal of UST #002. UST #001 product piping is shown in lower left.

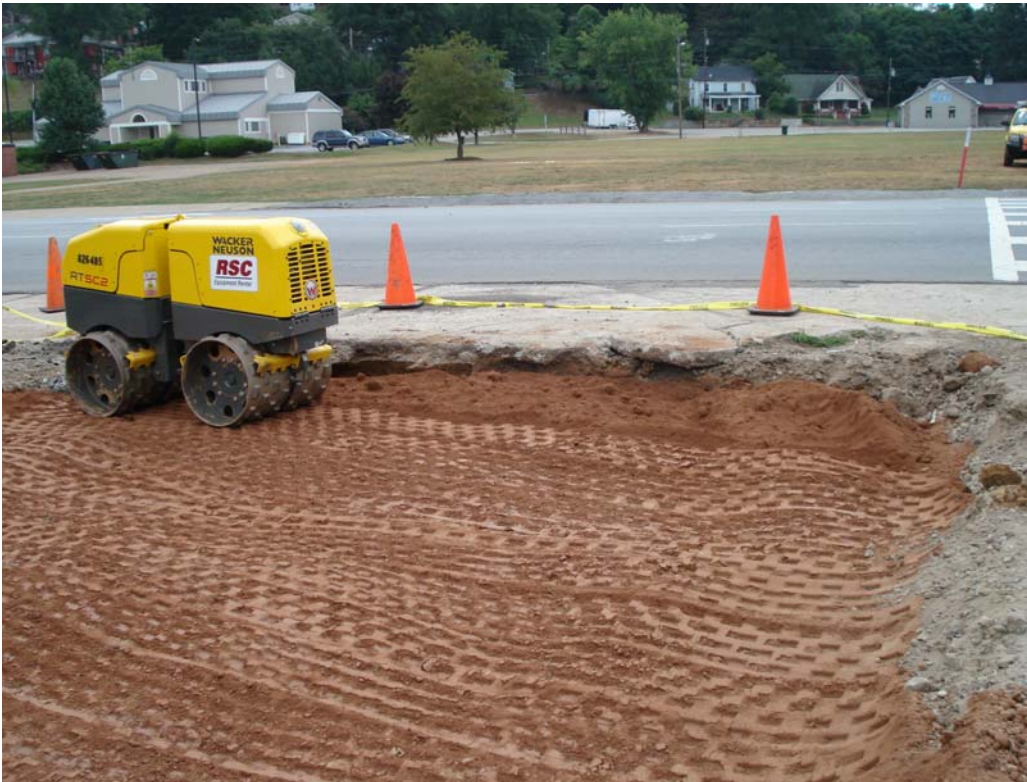
Photograph 4: View looking south at compaction of backfill material in UST pit using remote-controlled vibratory roller.

A trackhoe was used to remove the USTs and backfill the UST excavation. A remote-controlled vibratory roller was used to compact the backfilled material in the excavation to 95% Proctor. The backfill compaction report is provided in Appendix X. Photographs of the UST removals and compaction are provided in Appendix IX.

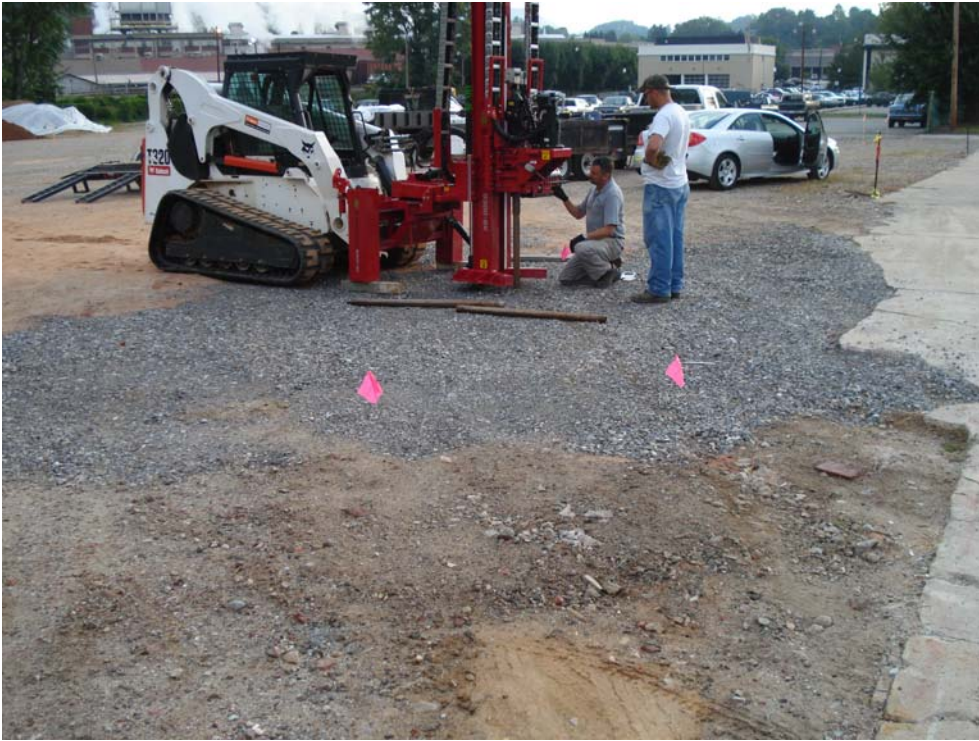
Photograph 5: View looking east at collection of confirmation soil sample SB7-4A. Confirmation soil sample locations SB7-7A and SB7-8 are marked by pink flags in foreground.

Following the collection of closure soil samples, the UST excavation was backfilled with clean fill material and compacted to 95% Proctor to a depth of 0.5 feet below ground surface (see Photograph 4 in Appendix IX, and compaction report in Appendix X), then capped with 6 inches of ABC stone, which was compacted by the trackhoe to ground surface (see Photographs 5 in Appendix IX).

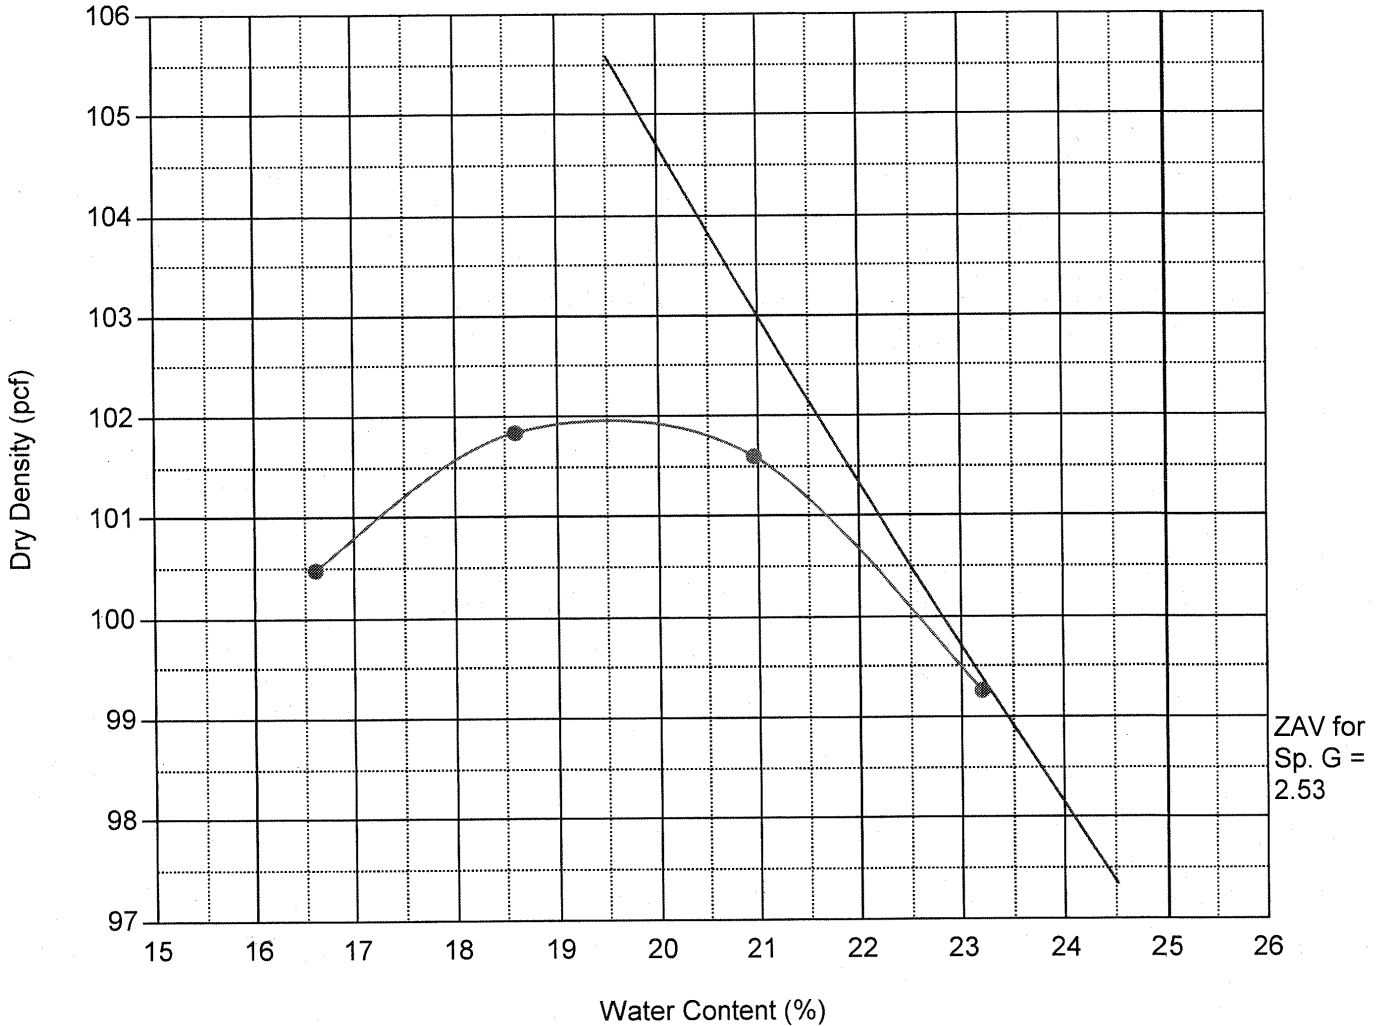
Compaction Test Report

Test Results	Material Description
Test Specification: ASTM D698 Standard Proctor Method A Maximum Dry Density: 102.0 pcf Optimum Moisture: 19.5 %	Brn/Red sl. micaceous, sl. silty SAND
Client: GEL Engineering of NC, Inc. Project: Canton DOT UST Project No. 6685101891.01 Test No: 1 ID: Date: 8/17/2010 Source: Borrow Site 150 Sunset Heights Road	Remarks: Natural Field Moisture: 16.5%
