**PRELIMINARY SITE ASSESSMENT
PARCEL #16
LAURENCE WATSON, JR. & KENNETH TICKLE PROPERTY
9400 WEST MARKET STREET
COLFAX, GUILFORD COUNTY, NORTH CAROLINA
STATE PROJECT: R-2611
WBS ELEMENT: 34482.1.1**

Solutions-IES Project No. 3948.11A3.NDOT

May 26, 2011

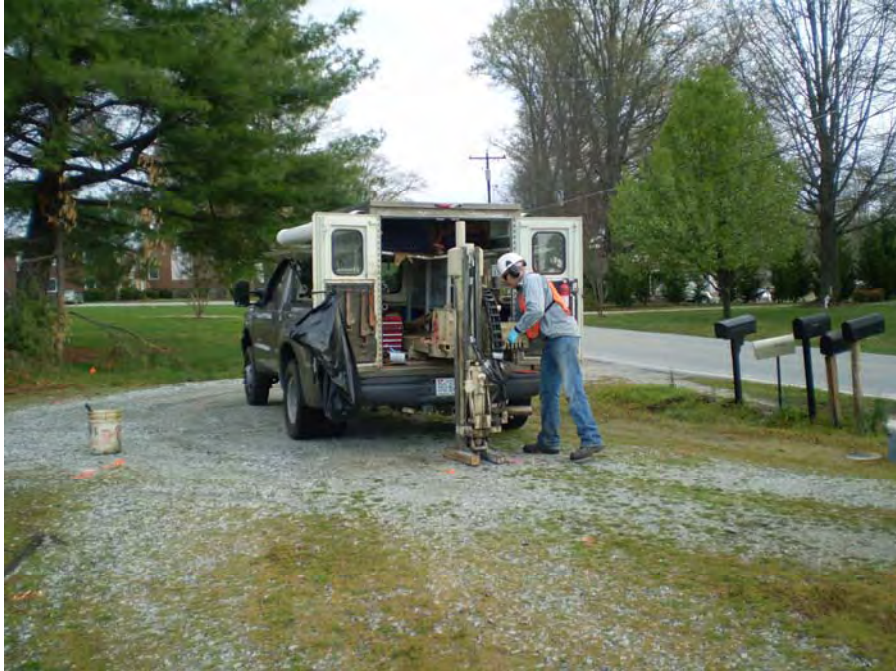
Photograph 5 – View of Geoprobe and boring location 16-11 on the north side of Parcel #16 along North Bunker Hill Road.

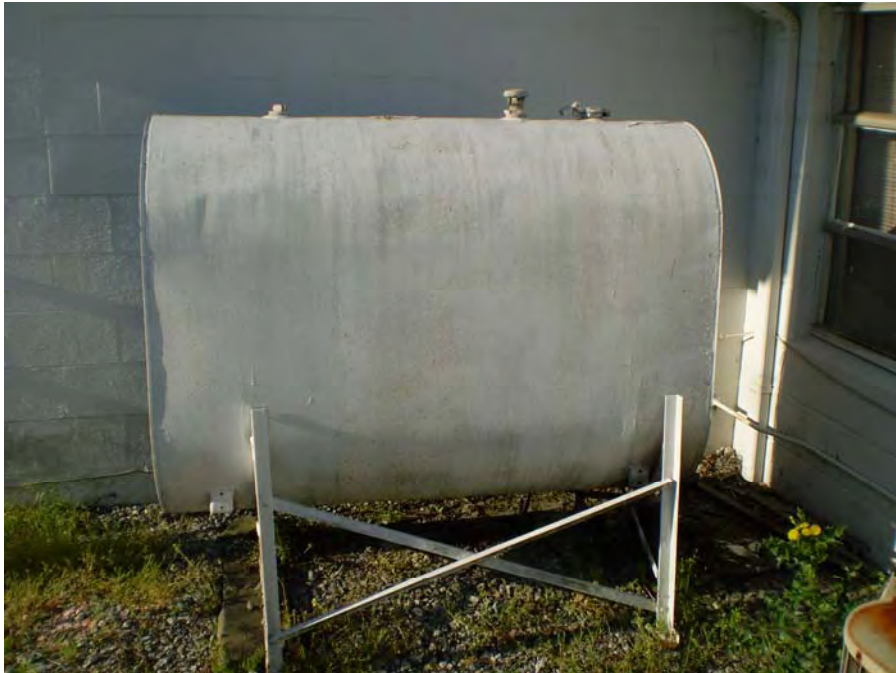
Photograph 6 – View of AST located on the east side of the commercial building at Parcel #16.

During the initial site visit, Solutions-IES personnel observed an above ground storage tank (AST) on the northeast side of the commercial building at the site. The AST was labeled for fuel oil and surface staining was observed beneath the filter and supply line connecting the AST to the building. Solutions-IES remobilized to the site on April 29, 2011, to collect two soil samples near the AST. The first boring was advanced to 8 ft bgs at the location of the surface staining and the second was advanced to 4 ft bgs on the opposite side of the tank. Both borings were advanced using a hand auger. FID measurements were recorded in 2-foot intervals and screening results did not suggest the presence of volatile vapors. As a result of courier delays, the two AST soil samples arrived at the laboratory above the recommended sample preservation temperature and were not analyzed. Solutions-IES returned to the site on May 5, 2011, to collect two additional samples from the vicinity of the AST. These borings were advanced to 2 ft bgs at the location of the surface staining and on the opposite side of the AST using a hand auger. Boring logs were not prepared for these borings. However, FID measurements were recorded and presented in Table 1 as Borings 16-12 and 16-13.

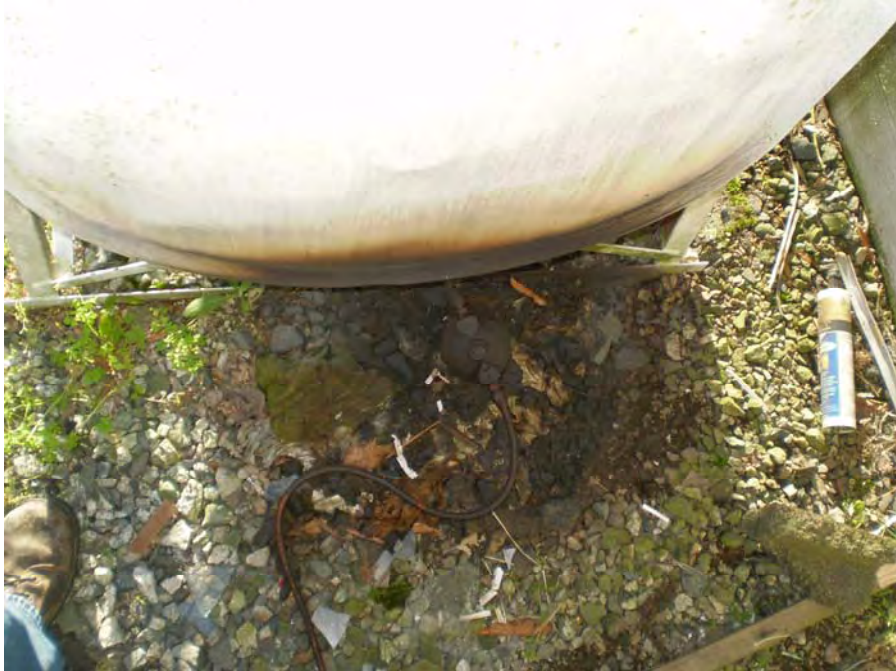
Photograph 7 – View of surface staining beneath AST supply line and filter adjacent to commercial building.

The laboratory analytical results from boring 16-12 collected from the area of observed staining beneath the AST indicate the presence of TPH DRO above the laboratory reporting limit but below the action level of 40 mg/kg specified in the *UST Section Guidelines for the Investigation and Remediation of Contamination from Non-UST Petroleum Releases* ([NCDENR, Division of Waste Management [DWM], *UST Section, Effective July 1, 2007*). TPH was not detected above the laboratory reporting limits in the other samples collected from the site. Further assessment at this site is not necessary at this time.

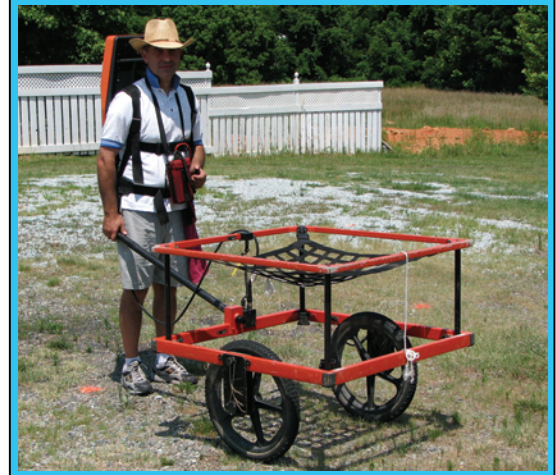
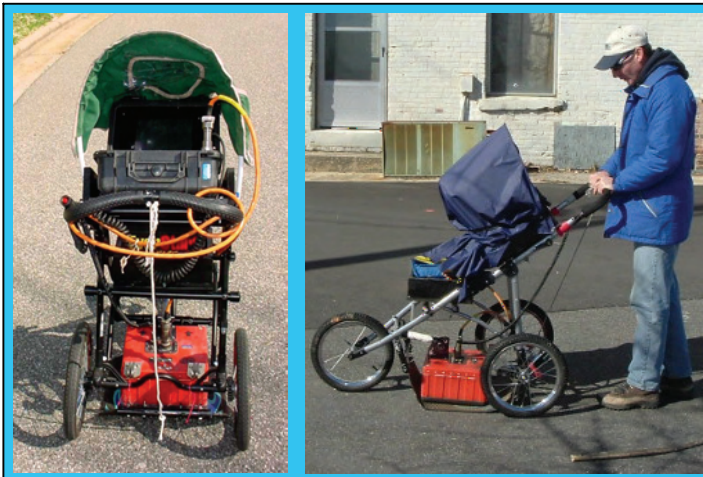
The photographs show the SIR-2000 GPR system equipped with a 400 MHz antenna that were used to conduct the ground penetrating radar investigation at Parcel 16 on March 8, 2011.

GPR surveys were conducted on March 8, 2011 across selected areas recording EM61 differential anomalies using a GSSI SIR-2000 unit equipped with a 400 MHz antenna. Data were digitally collected in a continuous mode along X-axis and/or Y-axis survey lines, spaced 2.5 to 5.0 feet apart using a vertical scan of 512 samples, at a rate of 48 scans per second. A 70 MHz high pass filter and an 800 MHz low pass filter were used during data acquisition with the 400 MHz antenna. GPR data were collected down to a maximum depth of approximately 5 feet, based on an estimated two-way travel time of 8 nanoseconds per foot. All of the GPR data were downloaded to a field computer and reviewed in the field and office using Radprint software.

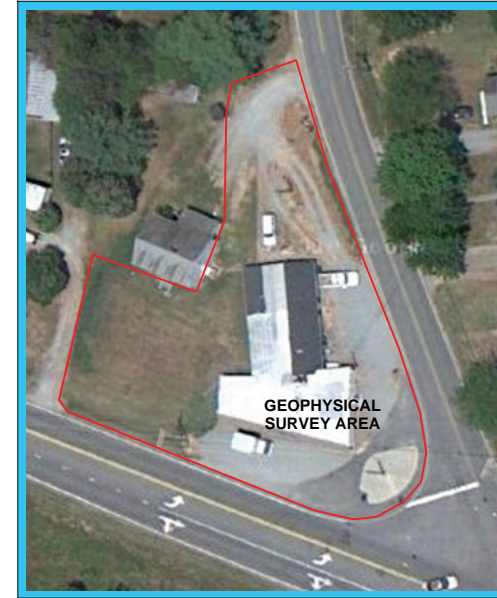
FIGURE 2

Note: The map shows the geophysical survey area at the Laurence Watson property located at 9400 West Market Street. The red dots represent the EM61 metal detection survey lines that were acquired on February 28, 2011 using a Geonics EM61 metal detection instrument. Each dot represents an EM61 data point.

The solid purple lines represent the GPR survey lines. The GPR investigation was conducted on March 8, 2011 using a Geophysical Survey Systems SIR-2000 unit with a 400 MHz antenna.

Locations of the EM61 metal detection survey lines and the GPR survey lines acquired across the geophysical survey area are shown as red dots and purple lines, respectively in **Figure 2**. Each red dot represents an EM61 data point.

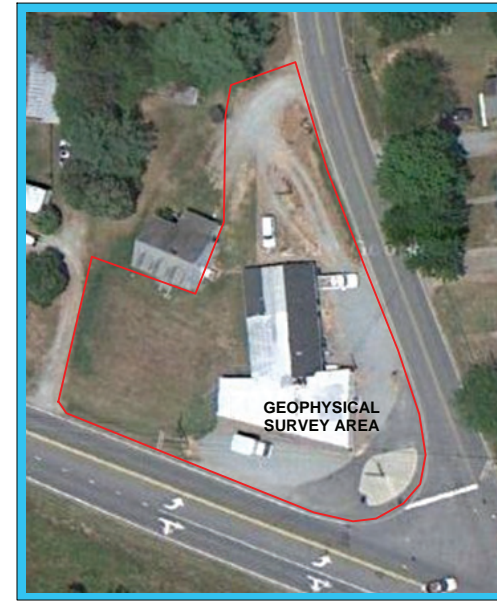
FIGURE 3

The contour plot shows the bottom coil (most sensitive) response of the EM61 instrument in millivolts (mV). The bottom coil response shows buried metallic objects regardless of size. The EM metal detection data were collected on February 28, 2011 using a Geonics EM61 instrument. Ground penetrating radar (GPR) data were acquired on March 8, 2011 across selected EM61 differential anomalies using a Geophysical Survey Systems SIR 2000 instrument with a 400 MHz antenna.

The geophysical investigation suggests that the surveyed portion of Parcel 16 does not contain metallic USTs.

Contour plots of the EM61 bottom coil and differential results are presented in **Figures 3 and 4**, respectively. The bottom coil results represent the most sensitive component of the EM61 instrument and detect metal objects regardless of size. The bottom coil response can be used to delineate metal conduits or utility lines, small, isolated metal objects, and areas containing insignificant metal debris. The differential results are obtained from the difference between the top and bottom coils of the EM61 instrument. The differential results focus on the larger metal objects such as drum and UST-size objects and ignore the smaller insignificant metal objects.

The two linear EM61 bottom coil anomalies running along the edge of West Market Street and intersecting grid coordinates X=100 Y=40 are probably in response to several buried utility lines. GPR data suggest the EM anomalies centered near grid coordinates X=108 Y=100, X=120 Y=53, X=144 Y=100, and X=155 Y=56 are in response to the commercial building and other known surface objects. Similarly, GPR data suggest that the EM61 differential anomalies centered near grid coordinates X=85 Y=128 and 90 Y=123 are in response to the home, satellite dish, gas meter, and the air conditioning unit. The dashed magenta line shown in the figures and intersecting grid coordinates X=50 Y=130 represents the approximate location of a probable gas line, as suggested by the GPR data. The probable line appears to run from the gas meter, to the east edge of the drive way and then to the ditch area.

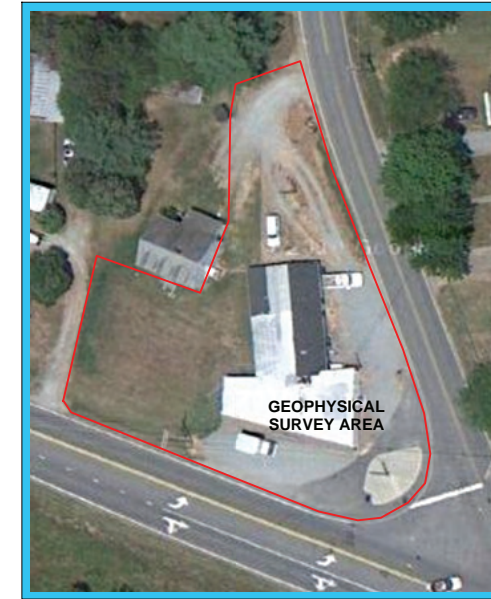
FIGURE 4

Note: The contour plot shows the differential response between the bottom and top coils of the EM61 instrument in millivolts (mV). The differential response focuses on larger, buried metallic objects such as drums and USTs and ignores smaller miscellaneous, buried, metal debris. The EM61 data were collected on February 28, 2011 using a Geonics EM61 instrument. Ground penetrating radar (GPR) data were acquired on March 08, 2011 using a Geophysical Survey Systems SIR 2000 instrument with a 400 MHz antenna.

The geophysical investigation suggests that the surveyed portion of Parcel 16 does not contain metallic USTs.

GPR data suggest the EM61 anomalies centered near grid coordinates X=105 Y=160 are in response to buried miscellaneous debris or objects. The remaining EM61 anomalies are probably in response to known surface objects or to buried miscellaneous debris. The geophysical investigation suggests that the surveyed portion of Parcel 16 does not contain metallic USTs.
