STRUCTURE
SUBSURFACE INVESTIGATION

PROJ. REFERENCE NO 33783.1.1 F.A. PROJ. BRZ-1323 (1)
 COUNTY MONTGOMERY
 PROJECT DESCRIPTION BRIDGE #121 OVER DENSONS CREEK
ON S.R. 1323 (TROY RD./OKEEWEMEE RD.)

PROJECT : 33783.1.1 ID : B-4582

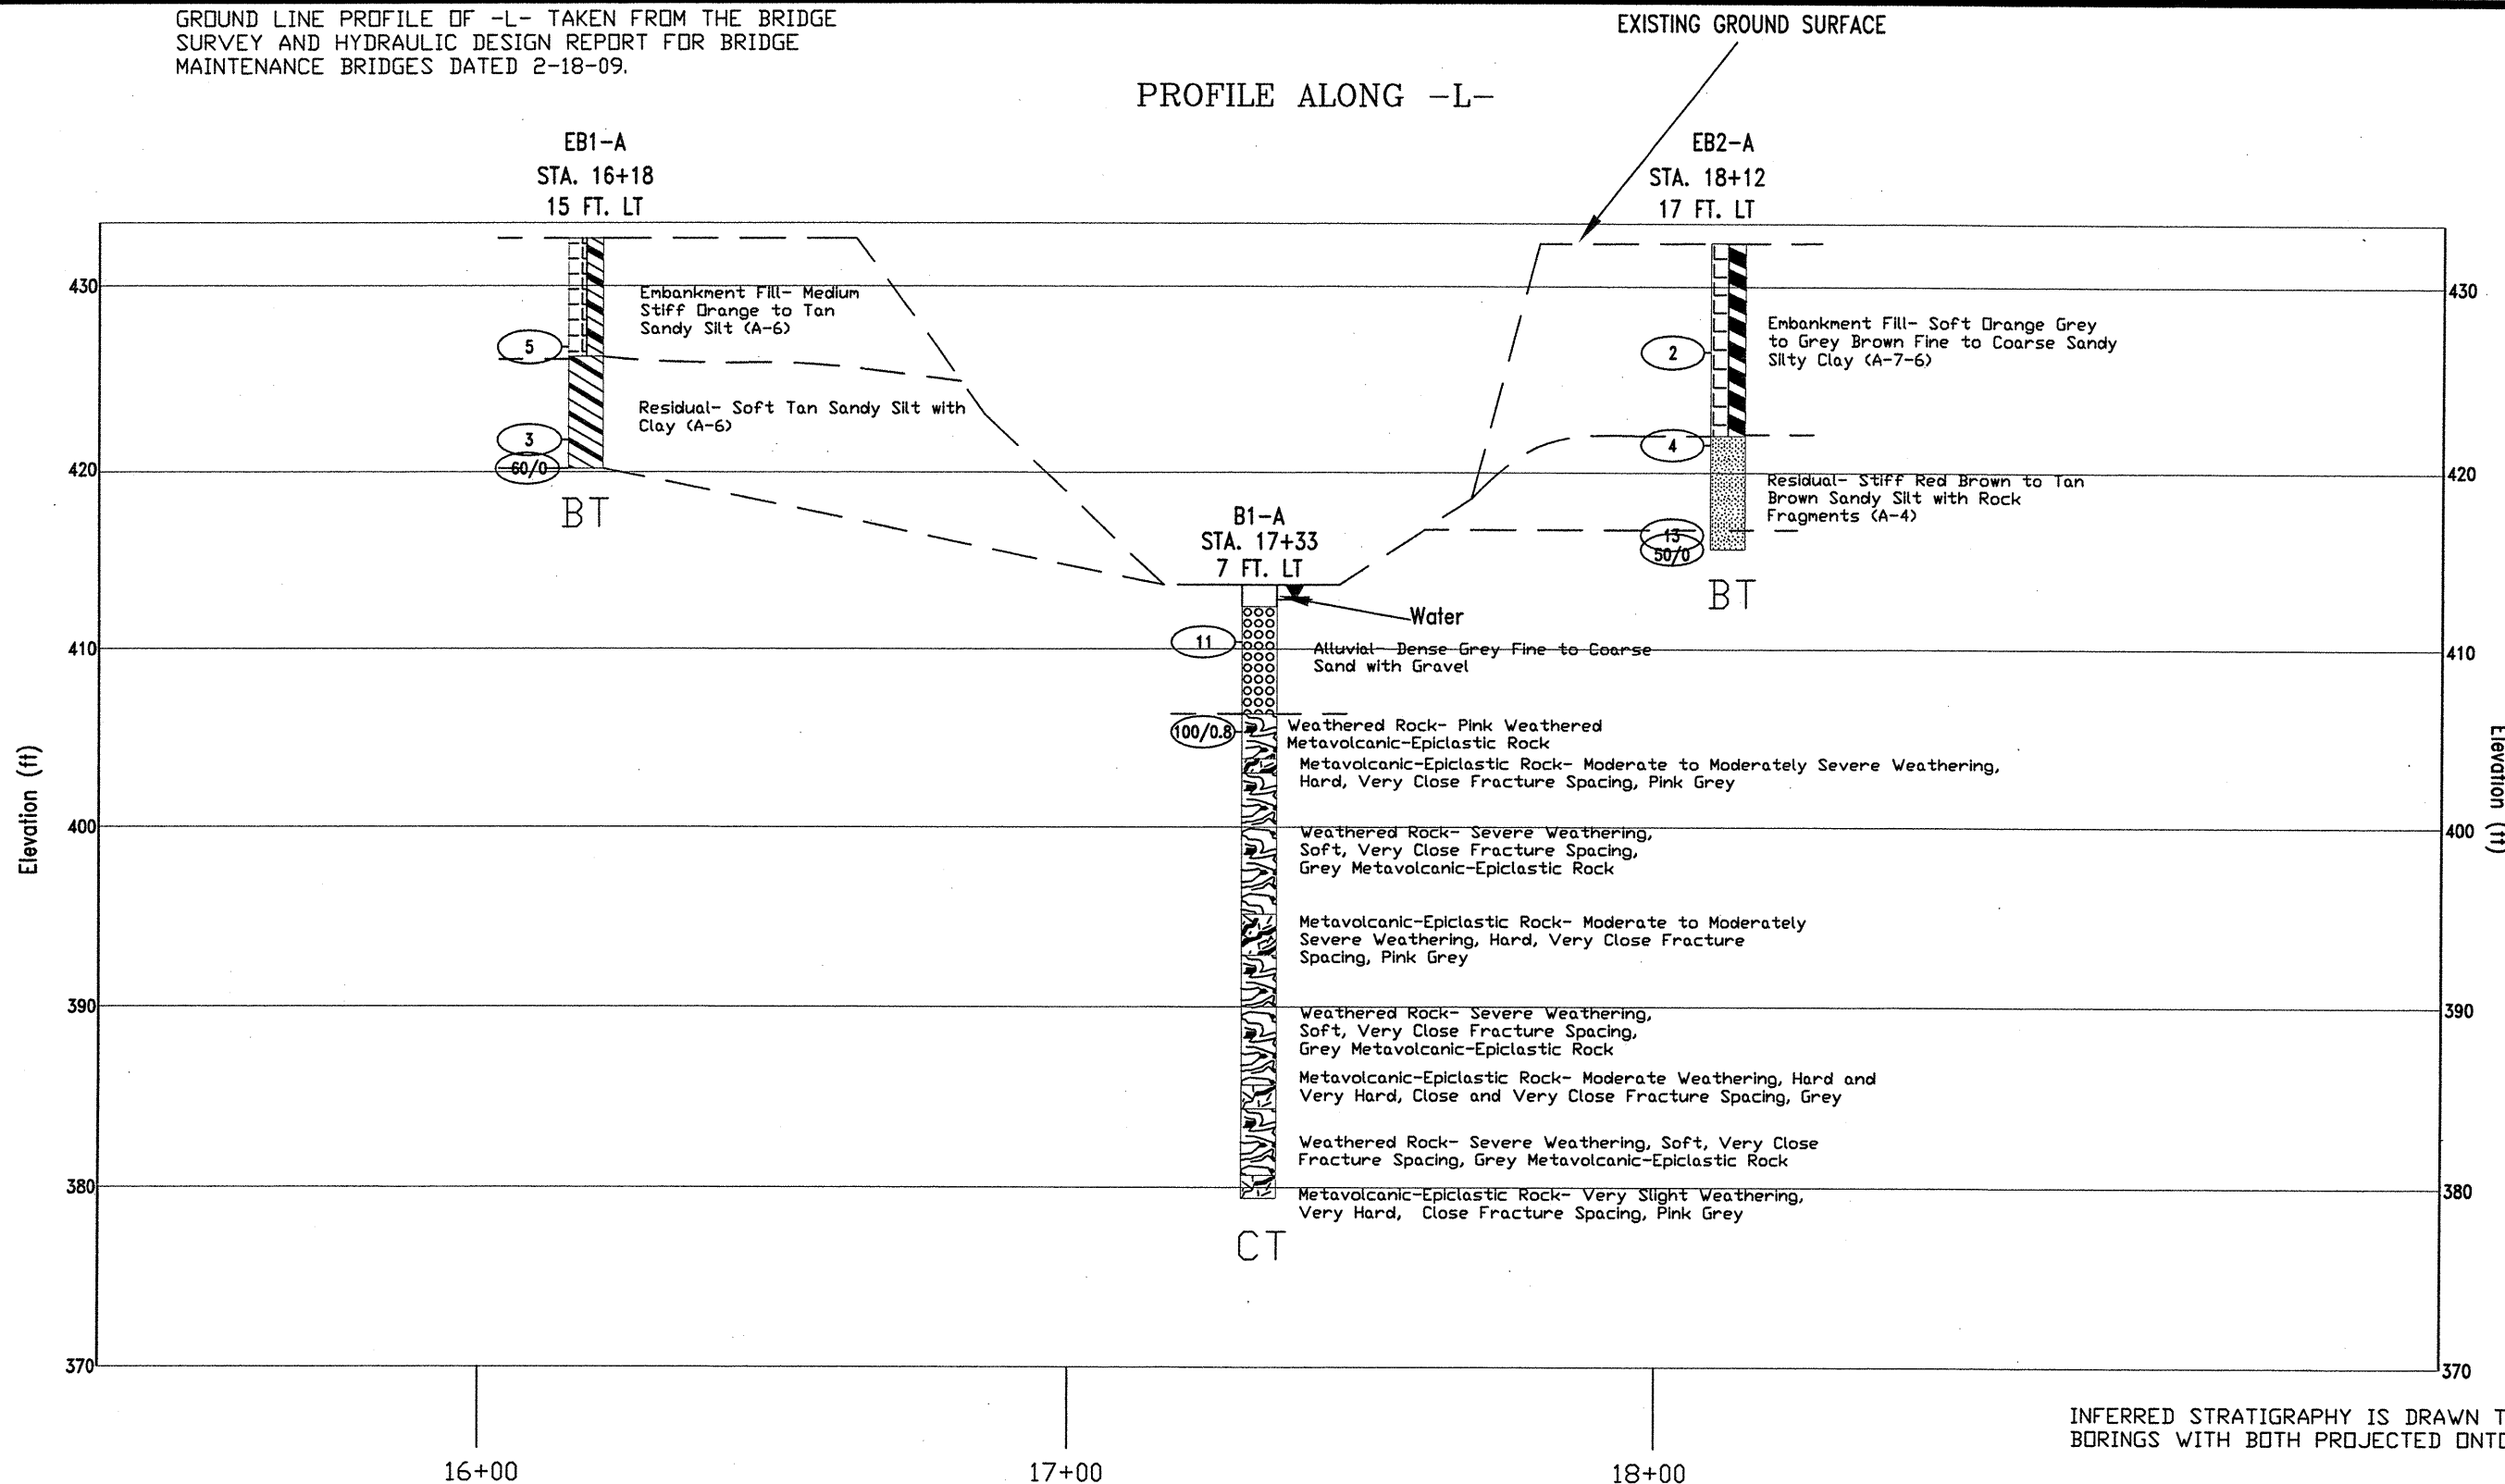
PROFILE ALONG -L-

GROUND LINE PROFILE OF -L- TAKEN FROM THE BRIDGE SURVEY AND HYDRAULIC DESIGN REPORT FOR BRIDGE MAINTENANCE BRIDGES DATED 2-18-09.

INFERRED STRATIGRAPHY IS DRAWN THROUGH THE BORINGS WITH BOTH PROJECTED ONTO THE PROFILE.

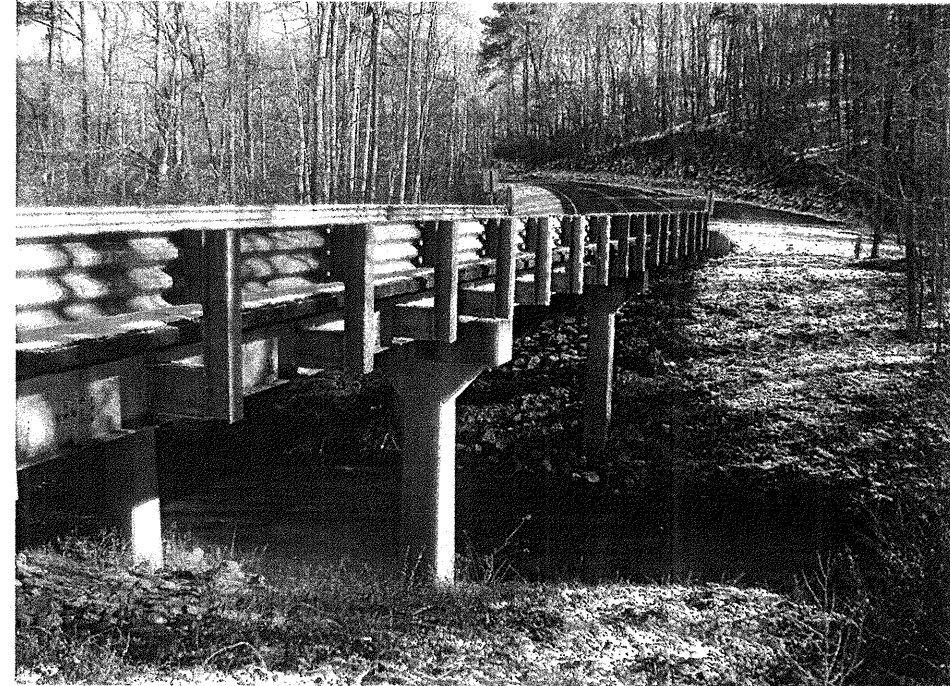
View of Bridge from Downstream side at existing End Bent 1

Abutments or End Bent Slopes: Minimal, Existing rip-rap effective
