June 25, 2010

Reference: Preliminary Site Assessment  
Donald and Maxine Joyce Property (Parcel #148)  
1400 Union Cross Road  
Kernersville, Forsyth County, North Carolina  
NCDOT Tip No. U-4909  
WBS Element 40278.1.1  
AECOM Project No. 60155373

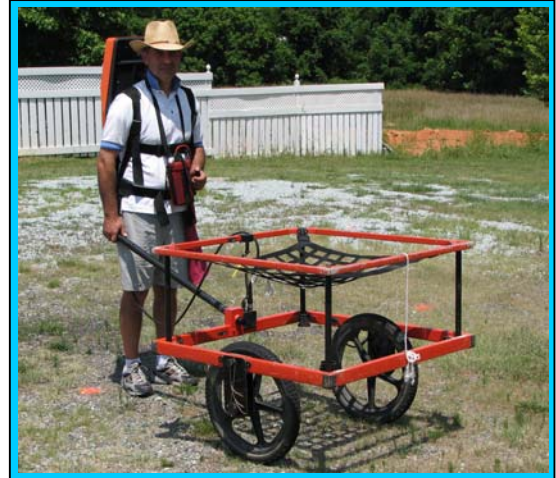
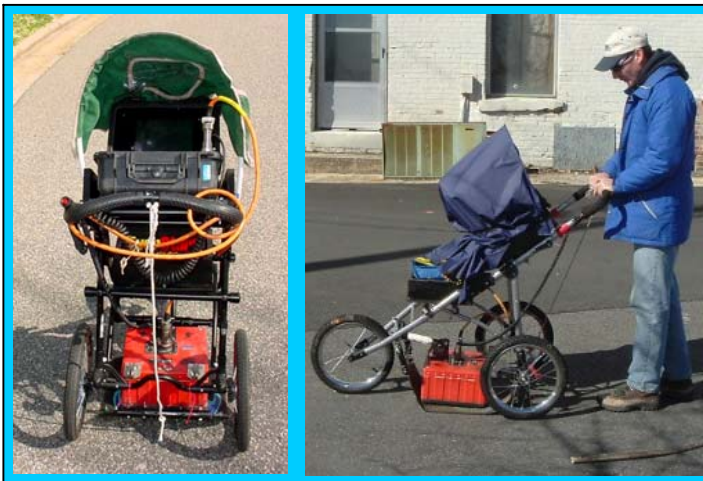
The photographs show the SIR-2000 GPR system equipped with a 400 MHz antenna that were used to conduct the ground penetrating radar investigation at Parcel 148 on May 19, 2010.

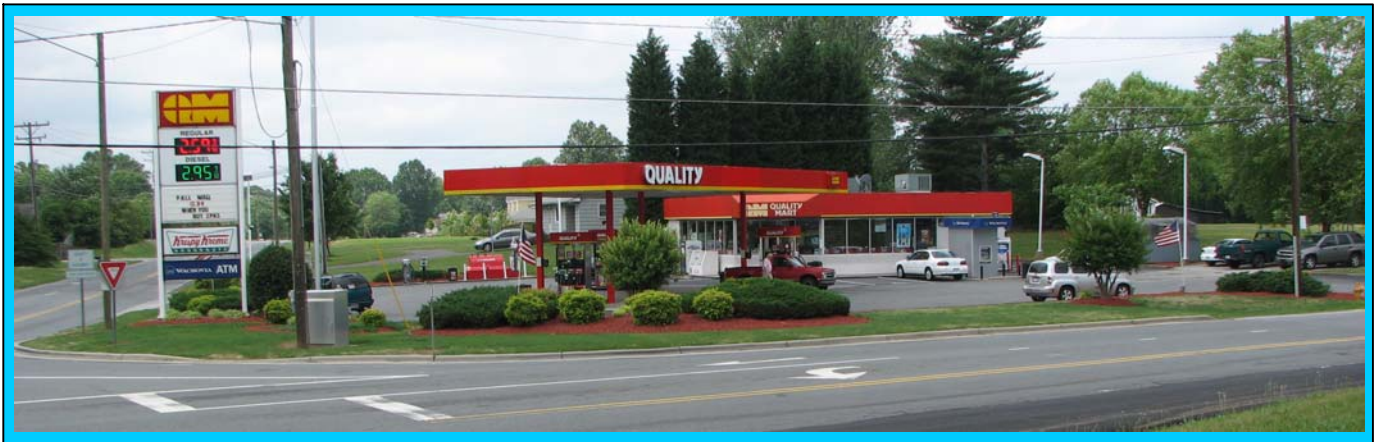
The photograph shows the Quality Mart station at the Donald and Maxine Joyce property (Parcel 148) located at the intersection of Union Cross Road and Sedge Garden Road in Forsyth County, North Carolina. The photograph is viewed in a southerly direction.
