PRELIMINARY SITE ASSESSMENT

**PARCEL #22, LEGION ROAD AUTO
3911 LEGION ROAD, HOPE MILLS, NORTH CAROLINA**

**FAYETTEVILLE – SR 1132 (LEGION ROAD) FROM SR 1363 (ELK ROAD)
TO SR 1007 (OWEN ROAD)
CUMBERLAND COUNTY, NORTH CAROLINA**

**NCDOT WBS ELEMENT 34865.2.3
STATE PROJECT U-2809B**

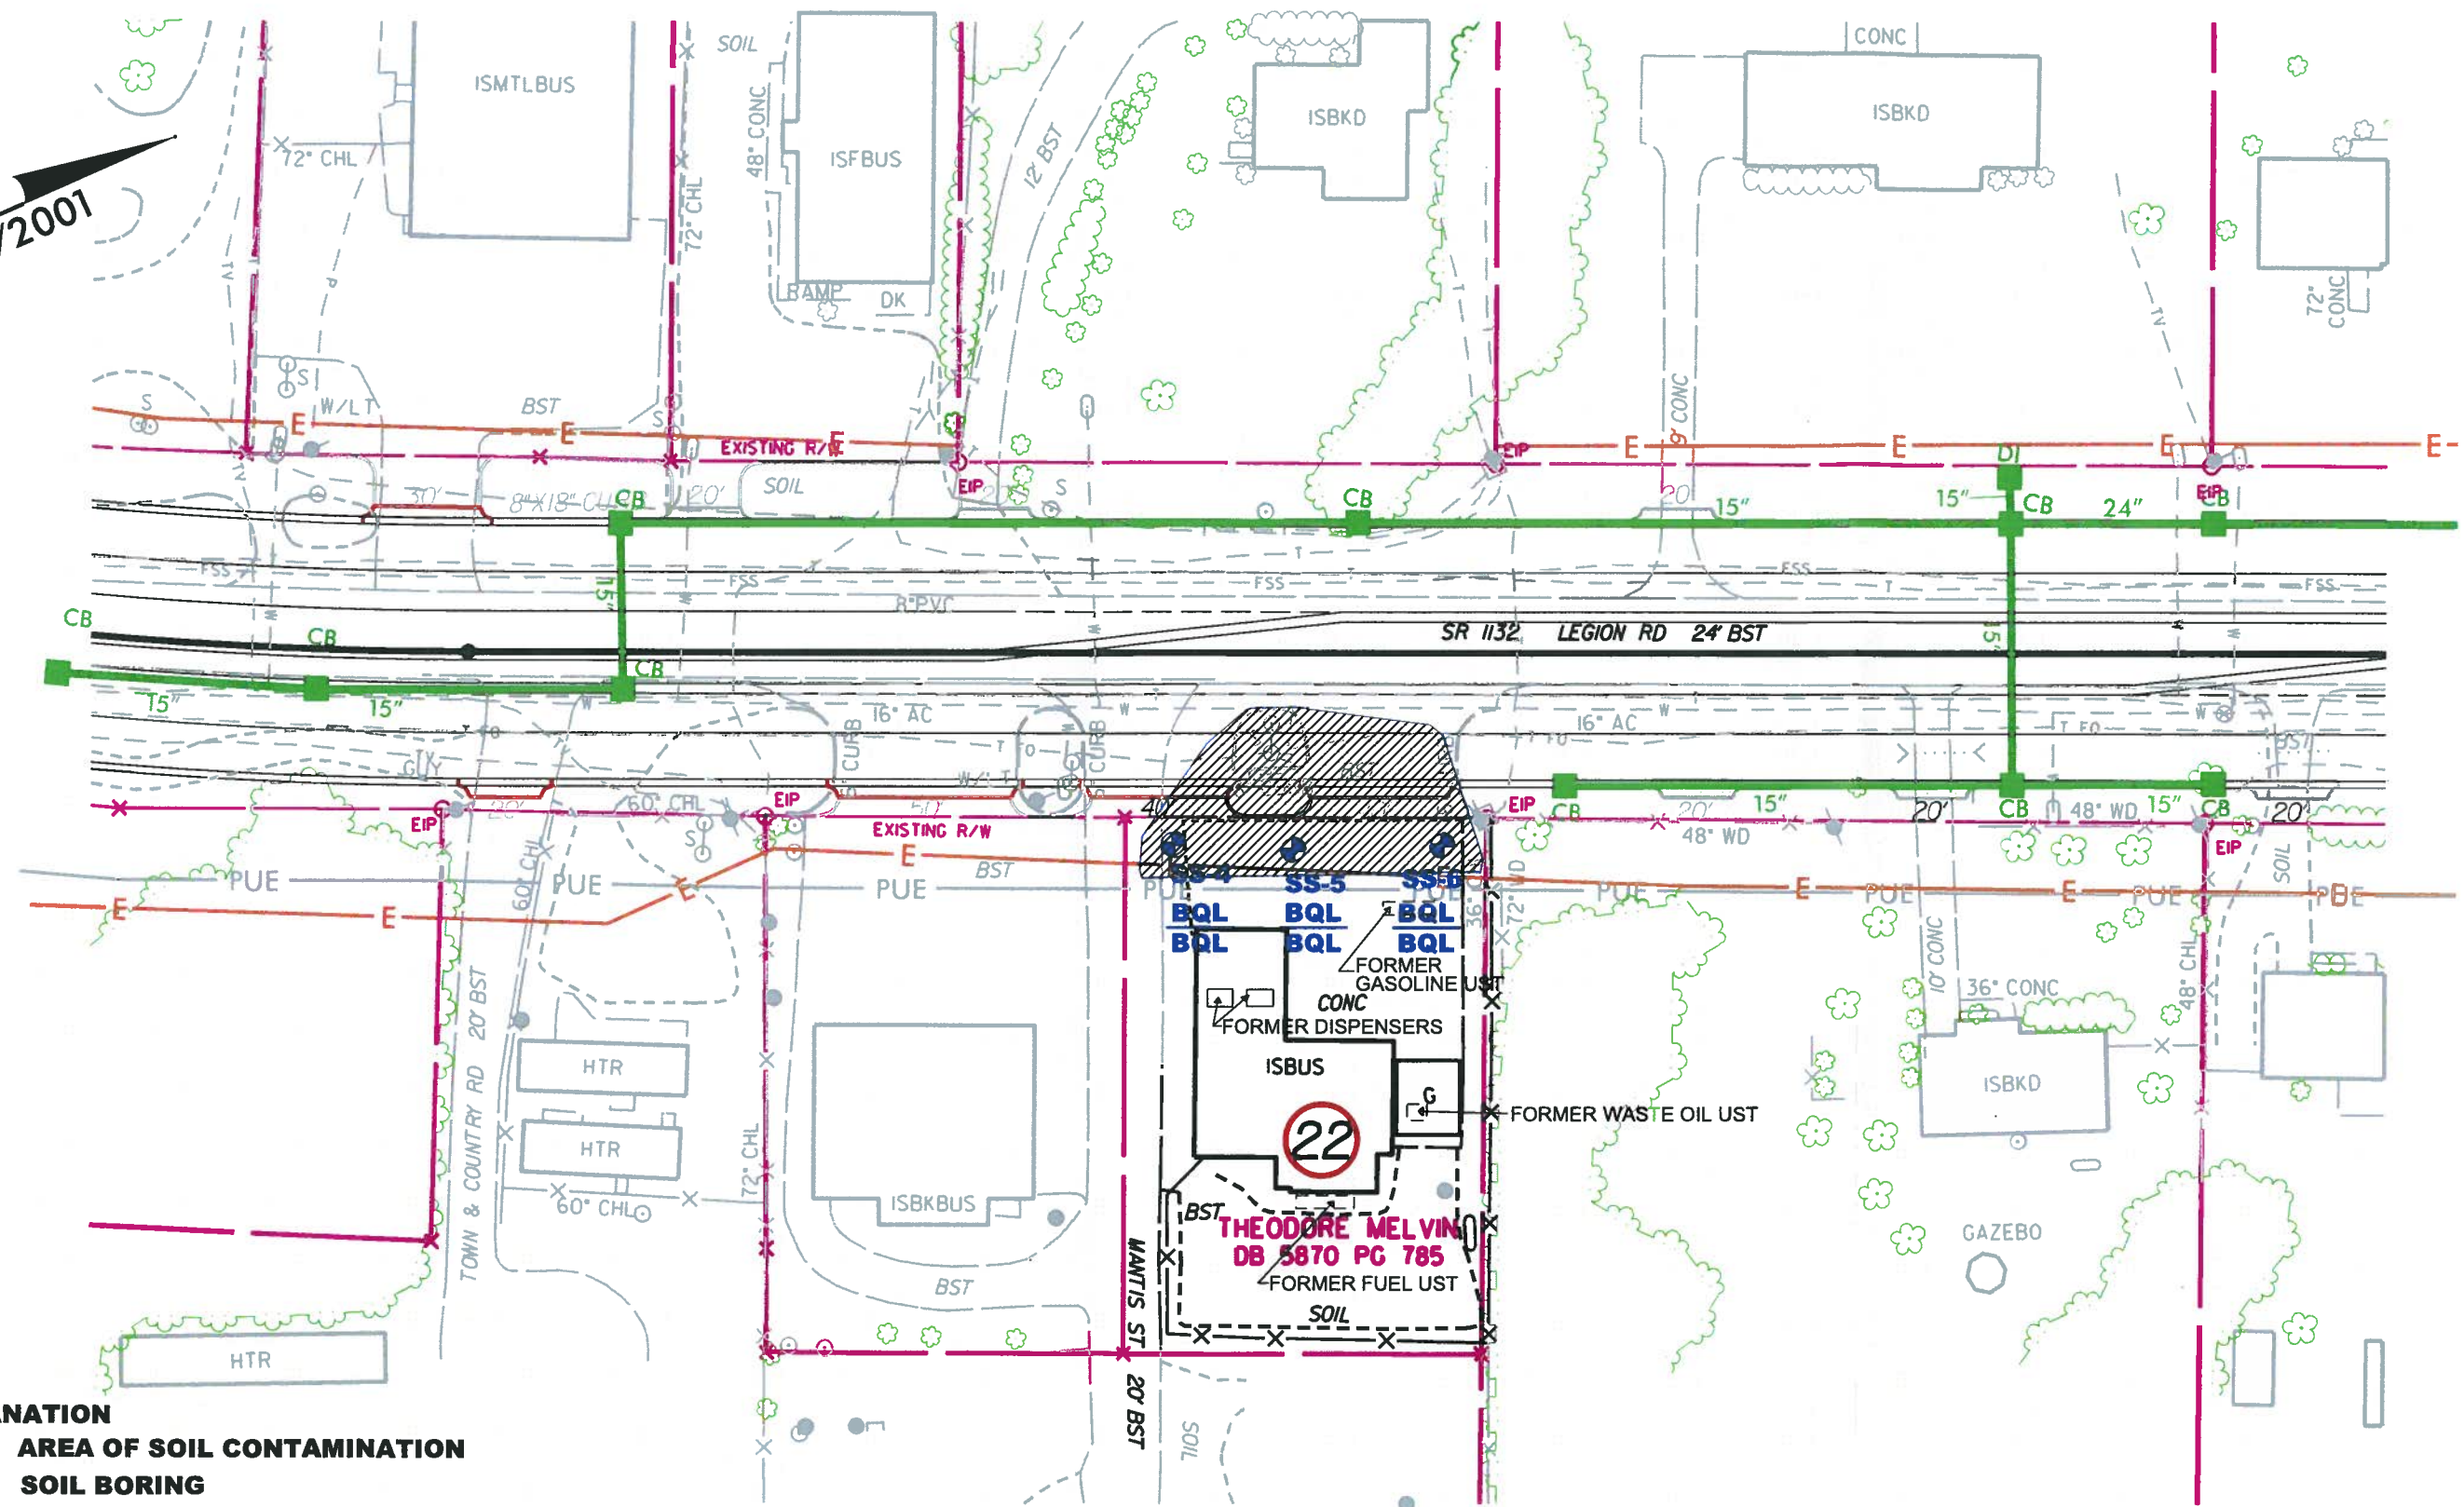
PROJECT NO.	113754	EXTENT OF SOIL CONTAMINATION		FIGURE: 4	
DRAWN:	11/24/2010	PARCEL #22			
DRAWN BY:	DJH	THEODORE MELVIN			
CHECKED BY:	JMS	3911 LEGION ROAD			
SCALE:	1" = 50'	TIP NO.	U-2809B	WBS ELEMENT NO.	34865.2.3
		CUMBERLAND COUNTY NORTH CAROLINA

Diesel range organics (DRO), gasoline range organics (GRO), and volatile organic hydrocarbons were not detected at concentrations above the method detection limits in the soil samples. The laboratory results are summarized in Table 2 and on Figure 3. The laboratory report and associated chain-of-custody document are included in Appendix E.

- ◆ Groundwater was encountered at a depth of six feet; and
- ◆ TPH and VOCs were not detected in the soil samples at concentrations above the method detection limits.

Groundwater samples were not collected from borings drilled along the proposed right-of way/easement; however, analysis of samples collected from monitoring wells installed in this area in the late 1990s and early 2000s, detected low concentrations of chlorinated hydrocarbons. The source of the chlorinated hydrocarbons is unknown, but possibly from releases from the used oil tank. Should construction activities extend down more than 2.13 feet (shallowest depth to groundwater measured), impacted soil will likely be encountered. The area of potential contamination extends approximately 100 feet along the frontage of the property by 40 feet wide (Figure 4). The volume of soil which could be encountered below a depth of 2 feet is approximately 600 cubic yards (100 feet long by 40 feet wide by 4 feet thick). Impacted soil will need to be stockpiled and sampled prior to offsite disposal.

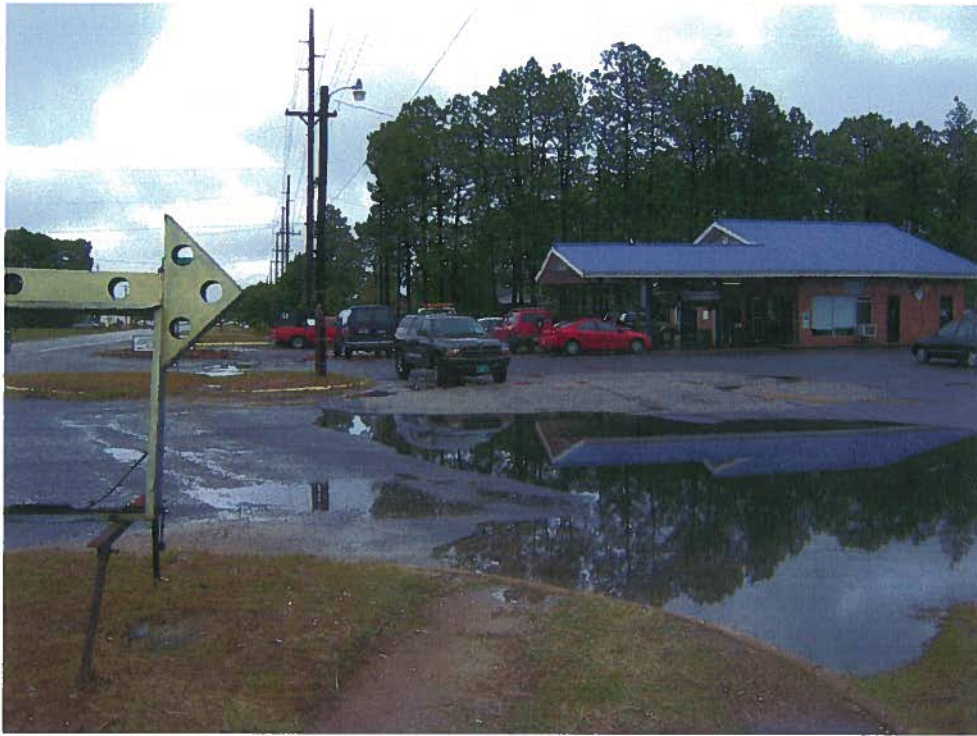
Photograph 1 – View looking north from parcel #19

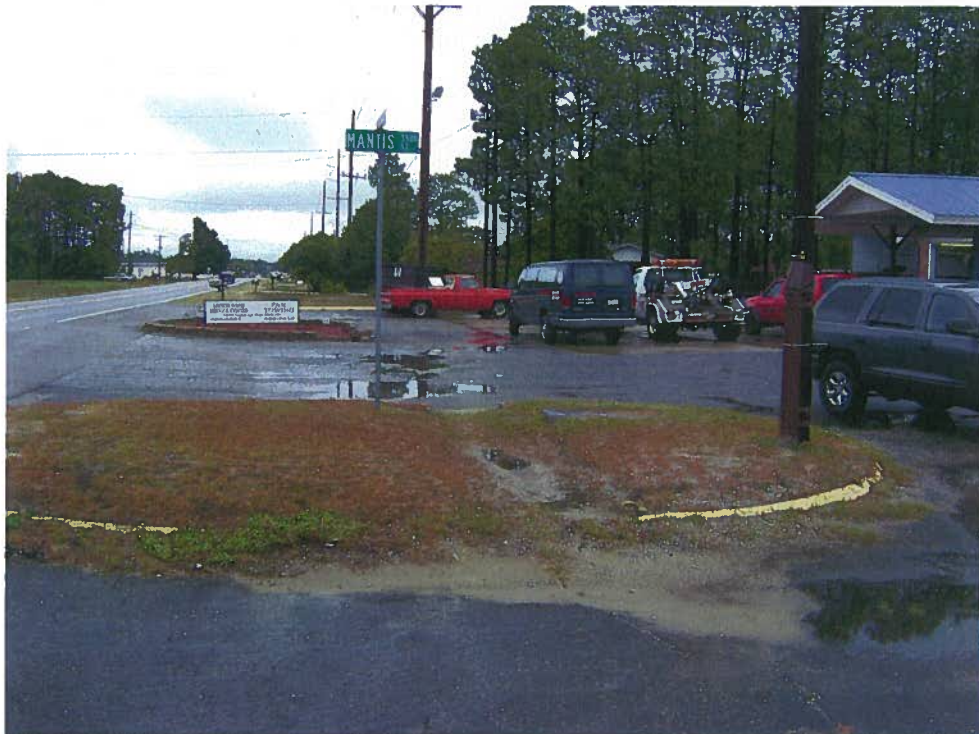
Photograph 2 – View looking north. Two soil samples were collected from below the concrete pad and one was collected south of the concrete pad below the asphalt.

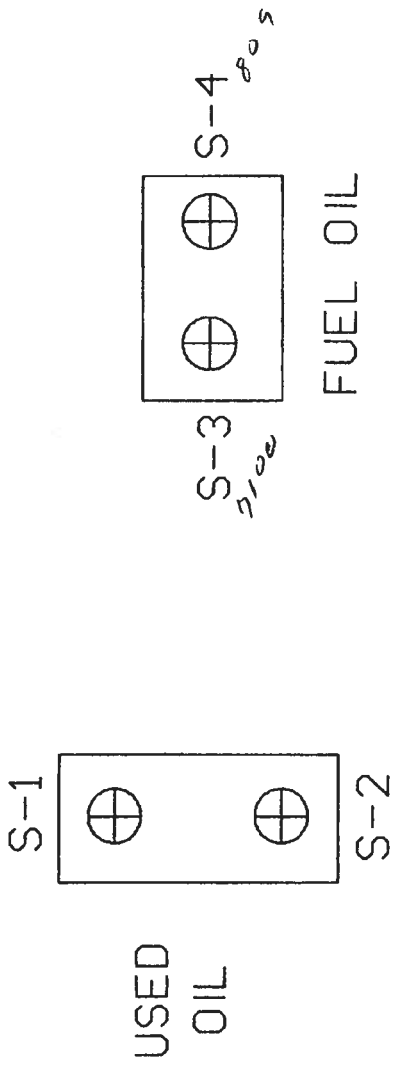
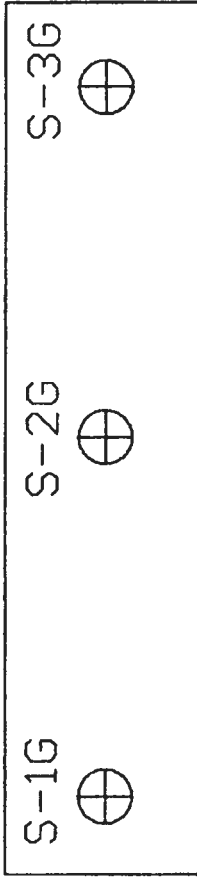
SAMPLING MAP		JOB NUMBER GESOHMPL	
LEGION ROAD SUNOCO		DRAWN: WRB CHECKED: WWC	FIGURE NUMBER 3
3220 LEGION ROAD HOPE MILLS, NC		DATE: 8/25/93

Upon completion of the field scanning, soil samples were taken from two (2) feet below the USTs, in native soil, per NC DEM protocol. A groundwater sample was also taken from the Used oil UST excavation per NC DEM protocol. All of the samples were placed into separate glass jars, with Teflon-lined screw-on lids, using a clean sampling spoon. These jars were then placed on ice in an insulated cooler and shipped to REIC Laboratory, in Beaver, West Virginia, on May 10 and May 17, 1993.

The soil samples were tested using EPA methods 5030, 3550, 9071, and 8021, while the water sample was tested using EPA methods 502.2, 625, and 3030C. The results of the laboratory analyses are shown in Tables 2 and 3, while the exact sampling locations are shown in Figure 3.

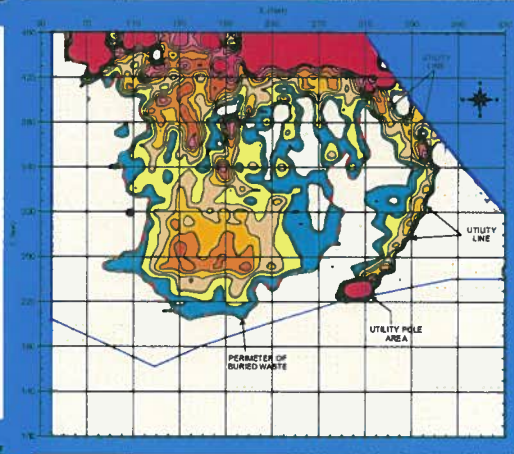
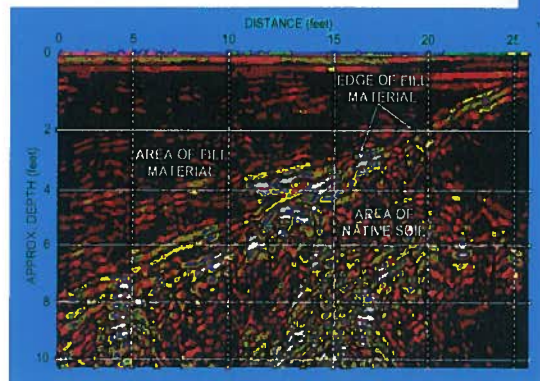
The photograph shows the Geonics EM61 metal detector that was used to conduct the metal detection survey at Parcel 22 on October 22, 2010.

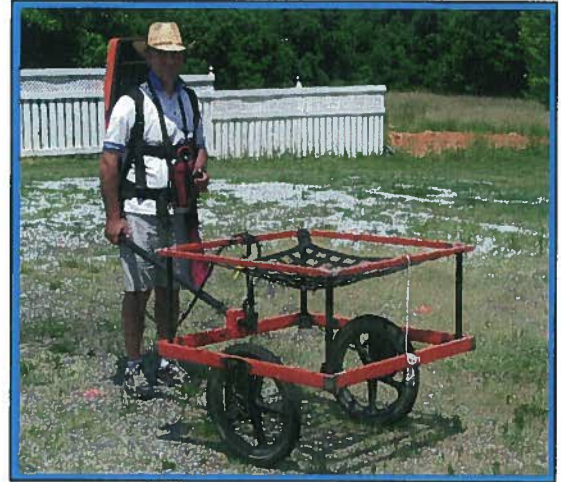
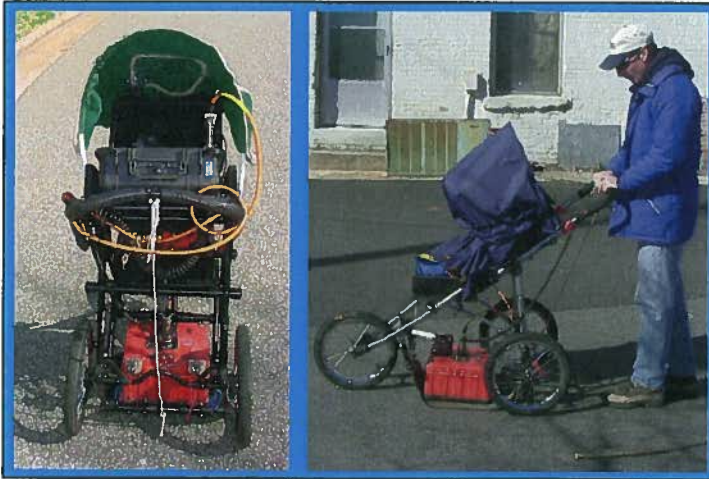
The photographs show the SIR-2000 GPR system equipped with a 400 MHz antenna that were used to conduct the ground penetrating radar investigation at Parcel 22 on October 29, 2010.

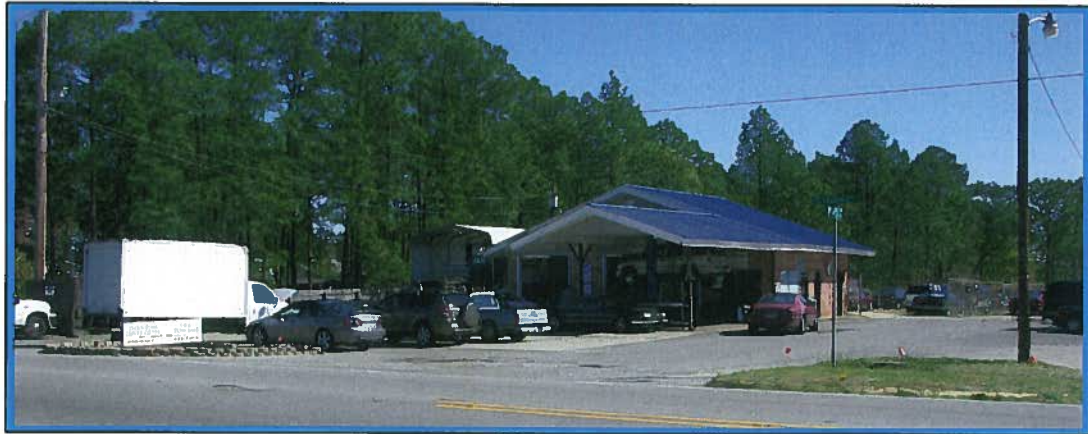
The photograph shows the front (western) portion of the Theodore Melvin property (Parcel 22) located at the intersection of Legion Road and Mantis Drive in Fayetteville, North Carolina. The photograph is viewed in a northeasterly direction.

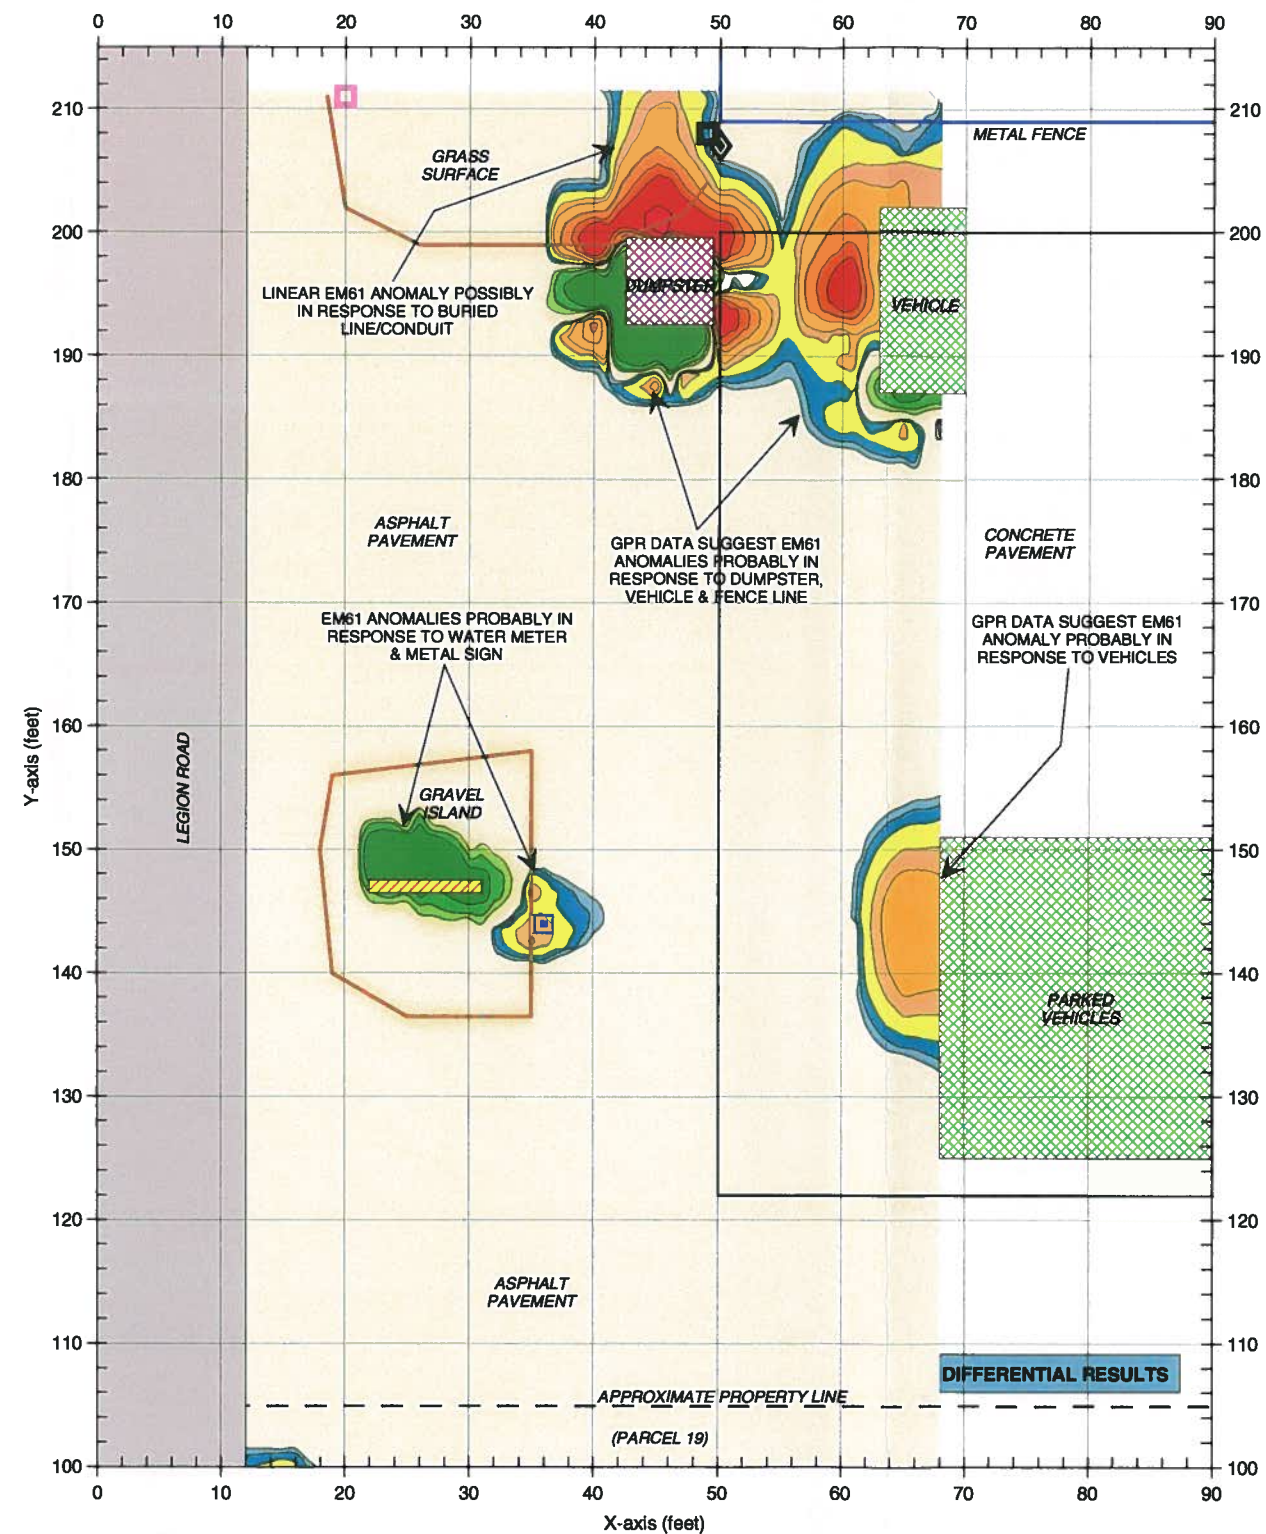
Pyramid's results indicate that the GPR and EM investigation did not detect unknown metallic USTs within the survey area. Pyramid's report is included in Appendix C.
