Re: Attempted Closure of Two Suspected Underground Storage Tanks
Parcel 335, 2774 Piney Green Road
Jacksonville, Onslow County, North Carolina
TIP: U-3810, WBS No. 35801.1.1

GEL Engineering of NC, Inc. (GEL) is submitting this letter report for the referenced UST closure task, which was completed following issuance of the Notice to Proceed for TIP No. U-3810 on October 20, 2011. The purpose of this report is to provide documentation of GEL's findings for the attempted closure of two suspected petroleum underground storage tanks (USTs) in November 2011.

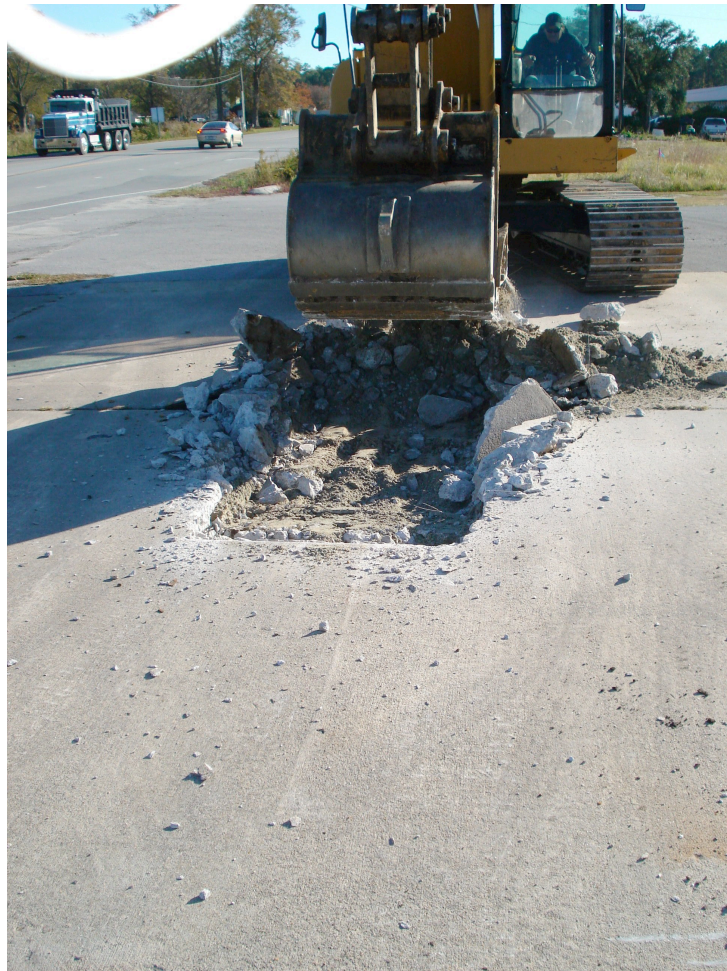
Photograph 1: View looking south at beginning of excavation across "Possible USTs" area.

GEL and its subcontractor, A&D Environmental Services, Inc. (A&D), arrived at the site on November 8, 2011, and initiated an excavation in the center of the two identified anomaly locations, as shown in Figure 3 and in Photograph 1 of Attachment A. A&D removed the concrete paving over an area approximately 12 feet long and 3 feet wide, and excavated the underlying soil to a total depth of approximately 5 feet below land surface (bls). Sections of 1-inch and 2-inch diameter steel piping (suspected product lines or vent piping) were encountered in the excavation, as shown in Photograph 2, but no USTs (or indications of a petroleum release) were encountered.

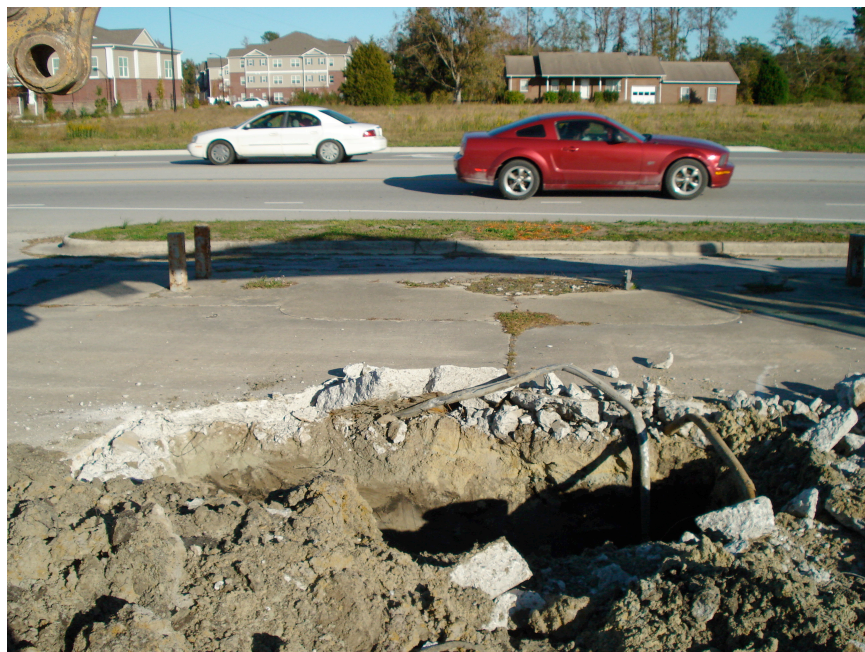
Photograph 2: View looking east at excavation, showing some of piping encountered beneath concrete.

1. Underground steel piping that was encountered during excavation;
2. Concrete overlying the “Possible USTs” area; and
3. Changes in the bulk characteristics of the soil where the two anomalies were identified.

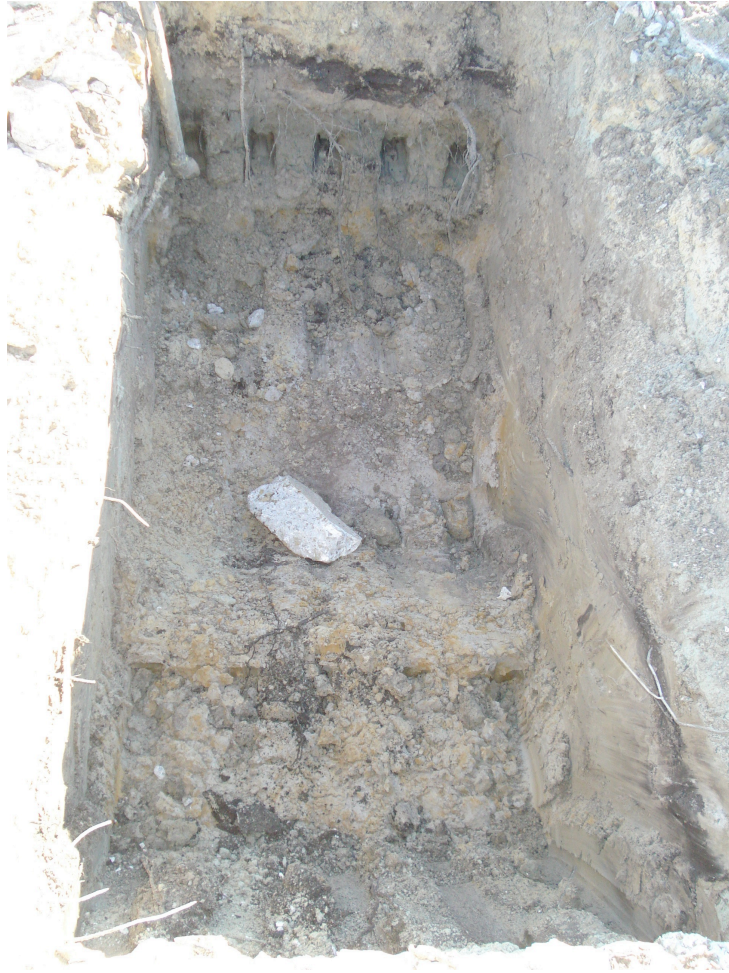
The soil encountered beneath the concrete paving was orange/tan fine-grained sand to depth of approximately 3 feet bls, and was underlain by undisturbed plastic gray/tan sandy/silty clay, as shown in Photograph 3. A photoionization detector (PID) was used to measure organic vapors in three soil grab samples collected from the excavation during soil removal. The three PID measurements ranged from 0 to 2 parts per million (ppm).

Photograph 3: View looking south at completed excavation.

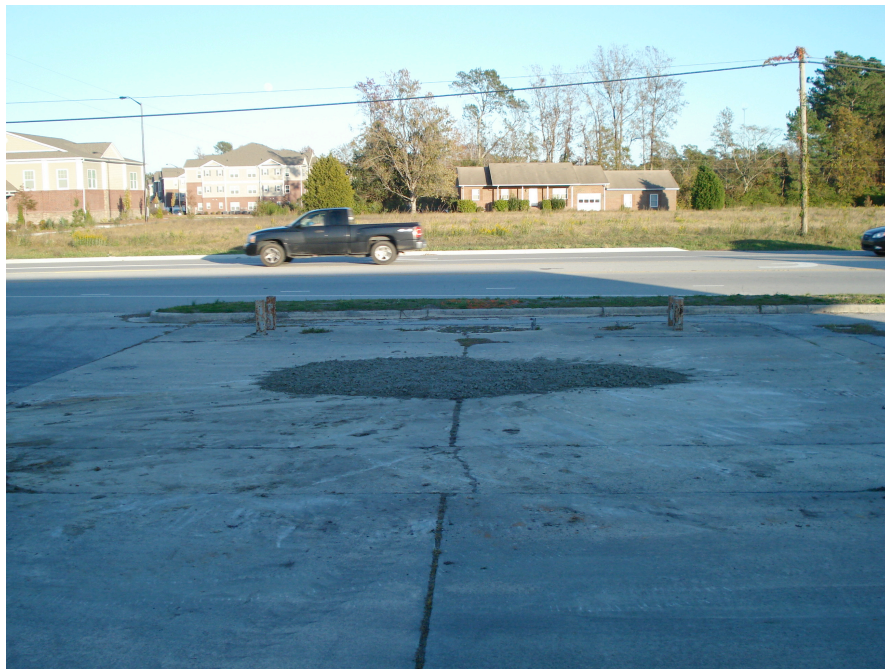
Photograph 4: View looking east at backfilled and compacted excavation.

No groundwater was encountered during the excavation. No soil samples were collected for analysis. The excavated area was backfilled with the stockpiled soil and concrete that had been excavated, then compacted by A&D using a trackhoe, and topped with compacted ABC stone. Photograph 4 shows the backfilled excavation.
