HYDRAULIC LIFT AND HYDRAULIC FLUID UNDERGROUND STORAGE TANK CLOSURE REPORT

**1381 Piney Green Road, Parcel #149
TIP # U-3810, WBS Element #35801.1.1
Onslow County**

February 24, 2012

GEL ENGINEERING OF NC, INC.
an Affiliate of The GEL Group, Inc.

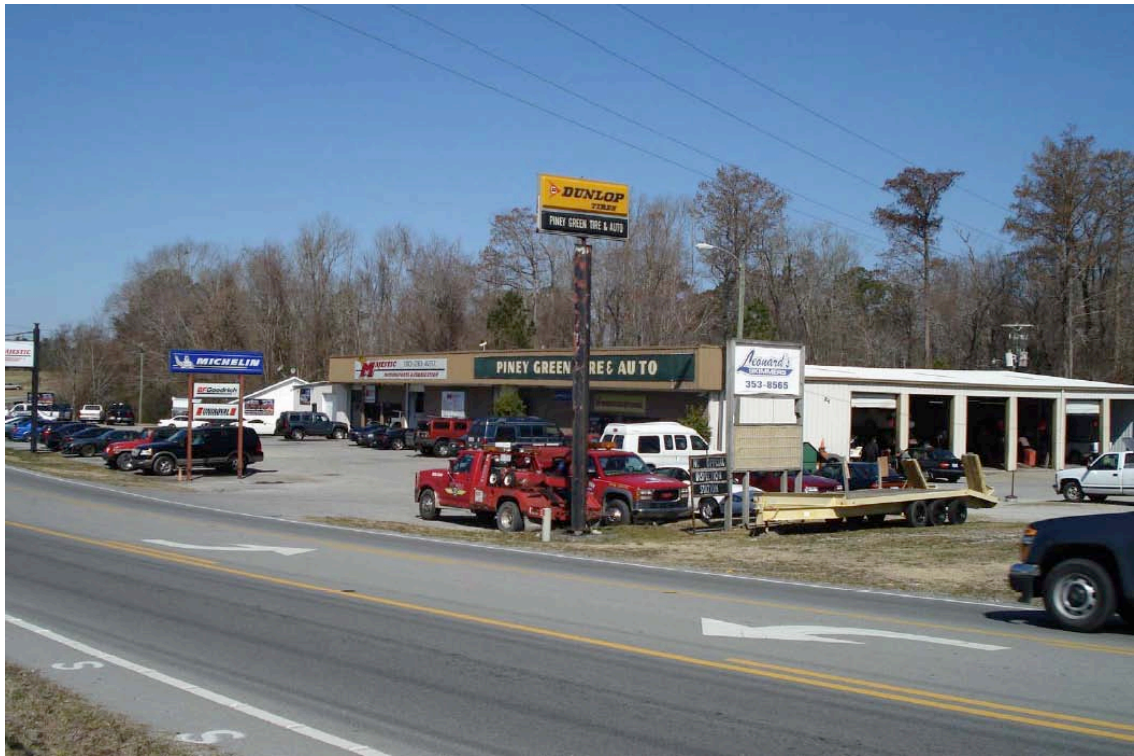
Photograph 1: View looking northwest at Parcel 149 in November 2010 when facility was in operation.

An abandoned structure located on the property at 1381 Piney Green Road (Parcel 149) in Onslow County, North Carolina (formerly Piney Green Tire & Auto, as shown in Photograph 1 in Appendix I) was being demolished by the North Carolina Department of Transportation's (NCDOT's) contractor in November 2011 as part of NCDOT's planned widening of Piney Green Road. The contractor encountered three in-ground hydraulic lifts during the demolition. Two of the lifts (Lift 1 and Lift 2) appeared to have been used when the facility was in operation, and the third lift (Lift 3) was an older, single cylinder lift that had apparently been abandoned and plugged. The three lifts are shown in Photograph 2. Following the removal of the structure, GEL Engineering of NC, Inc. (GEL) was requested by NCDOT to remove the three hydraulic lifts and a hydraulic fluid underground storage (UST) that was suspected to be present near the lifts.

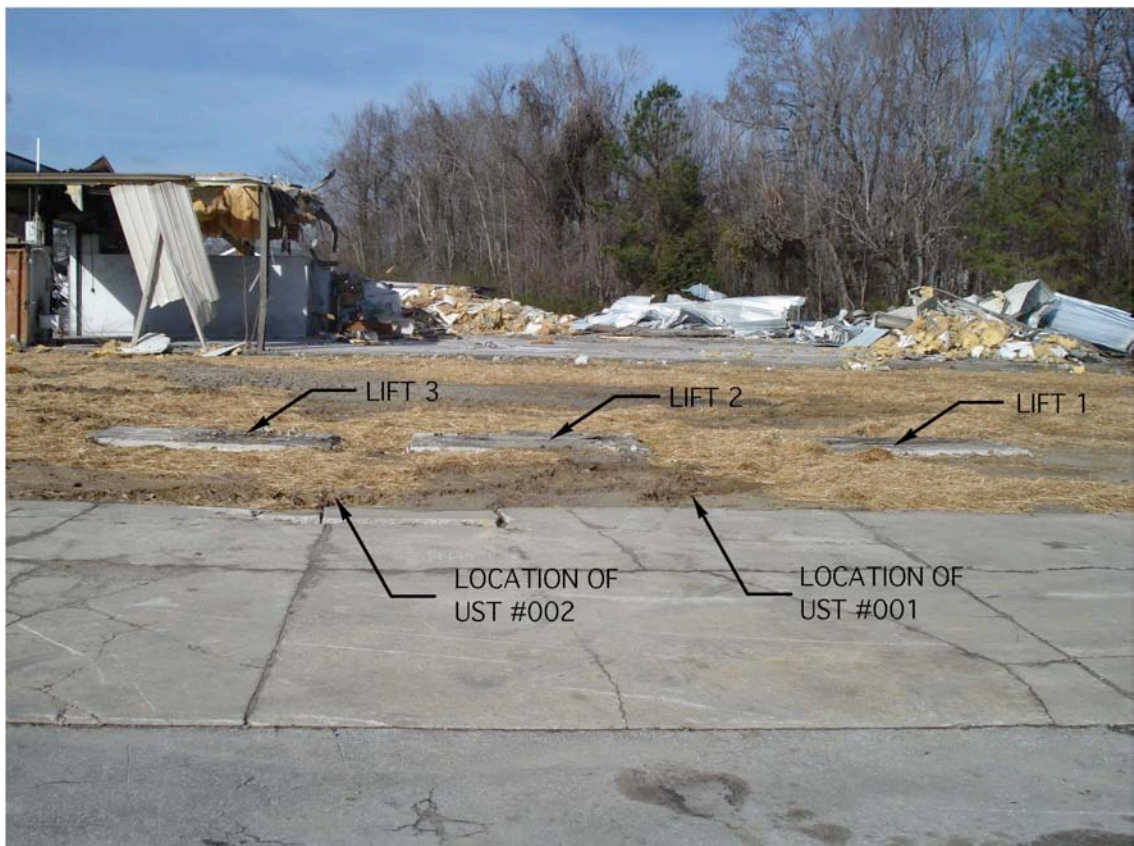
Photograph 2: View looking west at hydraulic Lift 1, Lift 2, and Lift 3, and locations of hydraulic fluid USTs #001 and #002 prior to removal and after demolition of Piney Green Tire & Auto building.

Hydraulic fluid USTs #001 and #002 were removed from the locations shown in Figure 2 and in Photograph 2 on January 12, 2012. The exposed tops of both tanks were identified during GEL's reconnaissance of the area in the vicinity of Lifts 1, 2, and 3 (see Photograph 3). Each UST was approximately 5 feet long and 1.2 feet in diameter (40-gallon capacity), and constructed of metal encased with fiberglass, as shown in Photograph 4. Prior to removal of the USTs, approximately 15 gallons of a hydraulic fluid/water mixture was removed from each tank using a vacuum truck. No indications of a release or damage to either UST were noted when they were removed. Therefore, no soil samples were collected for analysis.

Lift 1 and Lift 2 were removed from the locations shown in Figure 2 and Photograph 2 on January 12, 2012. Each lift consisted of two in-ground, enclosed steel telescoping cylinders, approximately 8 feet long (collapsed) and 1 foot in diameter (see Photograph 5). Prior to removal of Lift 1 and Lift 2, a total of approximately 140 gallons of a hydraulic fluid/water mixture was removed from the four cylinders using a vacuum truck, as shown in Photograph 5. No indications of a release or damage to the cylinders for either hydraulic lift were noted when they were removed. Therefore, no soil samples were collected for analysis.

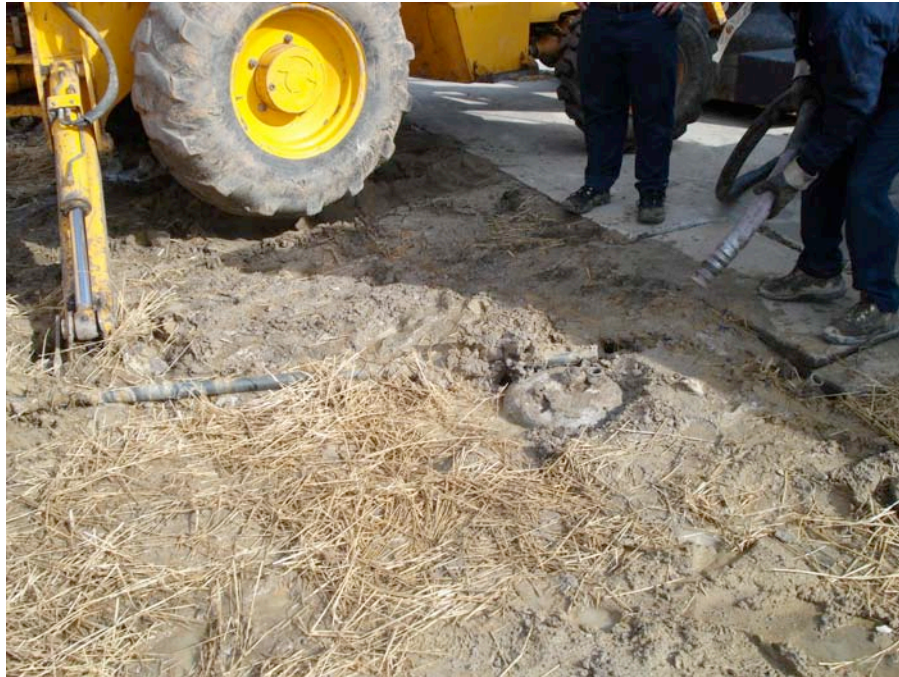
Photograph 3: View looking northeast at UST #001 prior to removal.

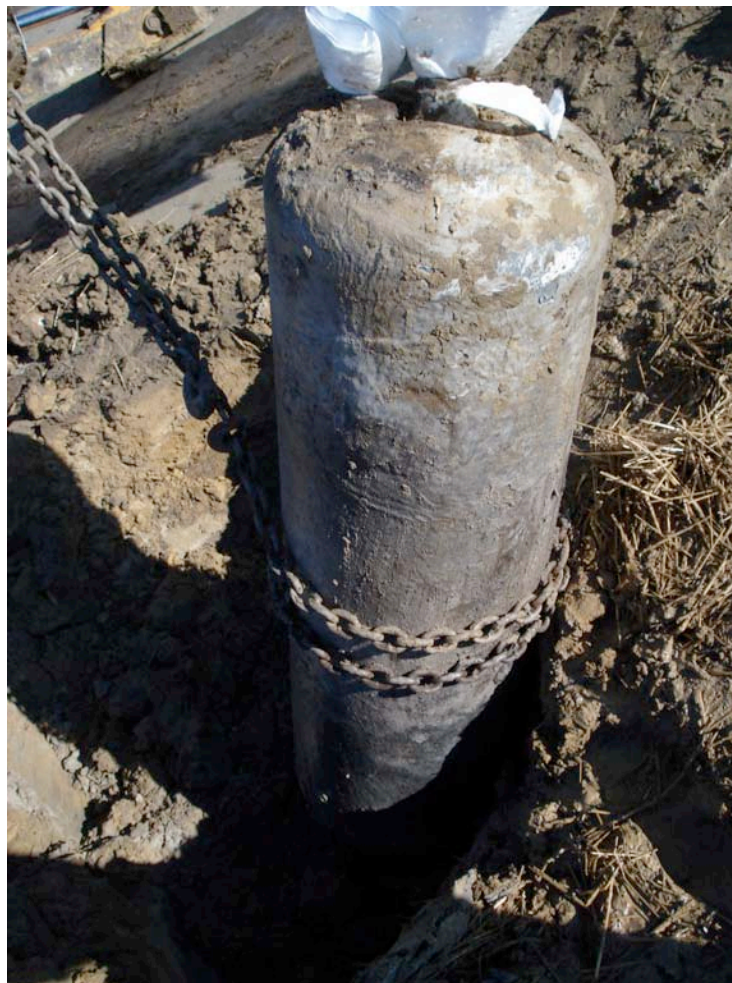
Photograph 4: View looking northwest at UST #002 during removal.

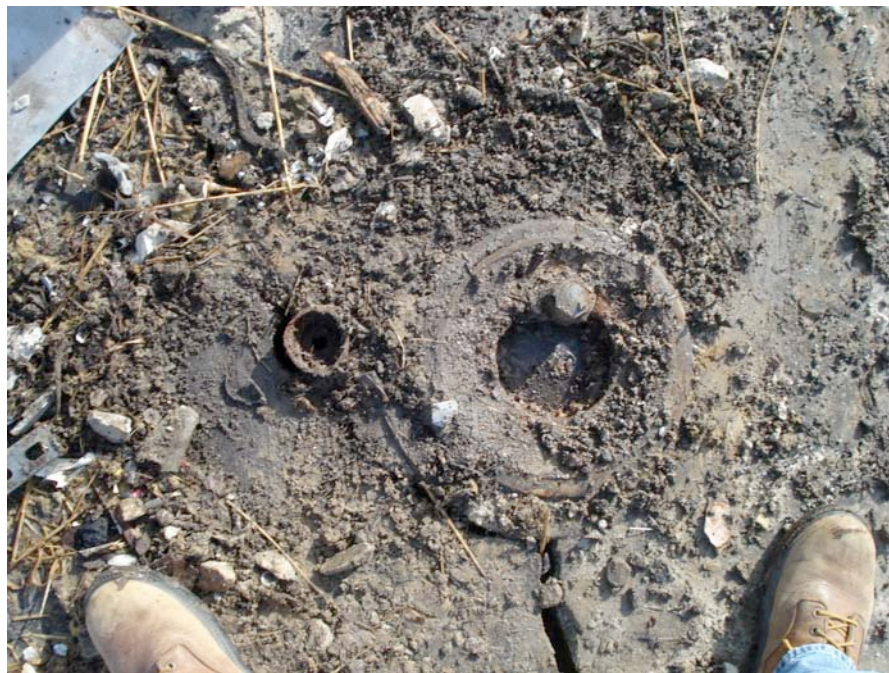
Photograph 6: View looking down at Lift 3 prior to removal.

Lift 3 (see Photographs 6 and 7) was an in-ground, enclosed steel, single telescoping cylinder that was plugged at the surface of the cylinder and probably no longer in use when the facility was operating prior to demolition. It was approximately 8 feet long and 1 foot in diameter. Prior to removal of Lift 3, approximately 20 gallons of hydraulic fluid was removed from the cylinder using a vacuum truck. Stained soil was

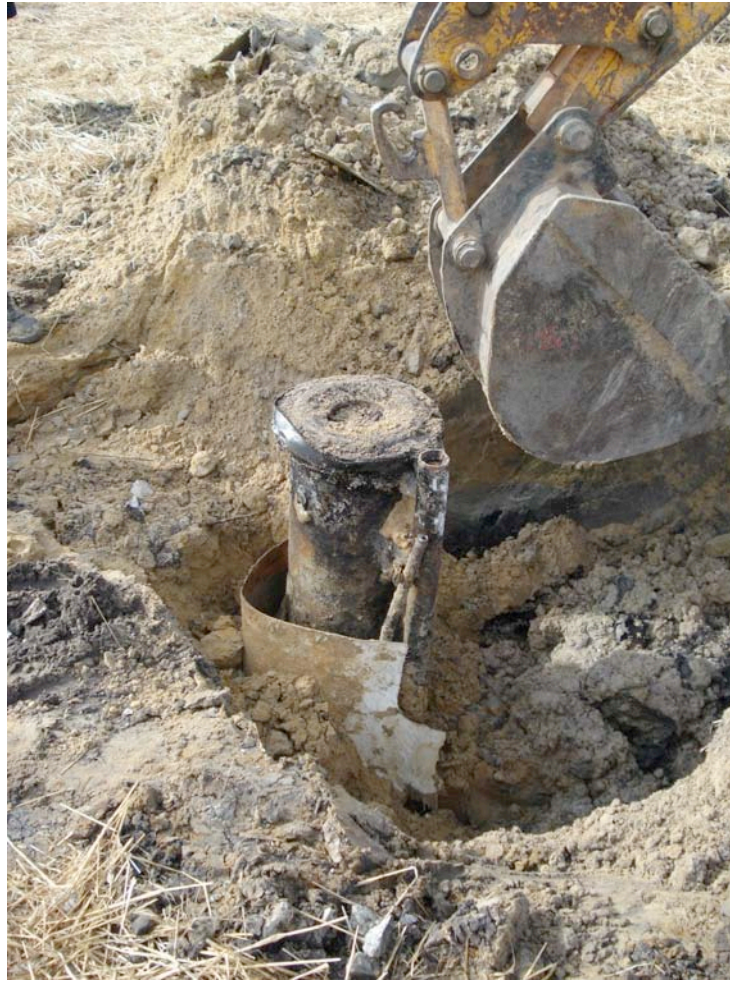
observed near the top of the cylinder as it was being excavated, as shown in Photograph 7. However, there were no indications of damage or leaks from the cylinder. All visibly stained soil was excavated to a depth of approximately 4 feet below land surface and loaded onto a dump truck for offsite disposal.

Photograph 7: View looking northwest at Lift 3 during removal. Sidewalls show stained soil.

A sample of the stained soil excavated during the removal of Lift 3 was collected on January 12, 2012, and analyzed by SGS Laboratories in Wilmington, North Carolina for diesel range organics (DRO) using EPA Method 3550. In addition, soil samples were collected from each sidewall and the bottom of the excavation on January 13, 2012, following the removal of all visibly stained soil. All five samples were analyzed for DRO by EPA Method 3550.

The analytical results for the analyzed soil samples are provided in Appendix III. DRO was detected at a concentration of 25,400 milligrams per kilogram (mg/kg) in the sample of stained soil ("Stockpile") collected from excavated soil removed from Lift 3.

DRO was detected in the post-excavation soil samples collected from the Lift 3 excavation at the following concentrations:

<u>Soil Sample ID</u>	<u>Concentration (mg/kg)</u>
S-1 (bottom of excavation)	129
S-2 (north sidewall)	102
S-3 (east sidewall)	135
S-4 (south sidewall)	66.3
S-5 (west sidewall)	141

The detected DRO concentrations in all five confirmation soil samples exceed the NCDENR action level of 10 mg/kg. Therefore, impacted soil remains in the former location of Lift 3, based on the detected DRO concentrations. It is our understanding that this area will undergo construction as part of NCDOT's planned right-of-way expansion (see Figure 2). GEL recommends that remaining impacted soil in the vicinity of the former location of Lift 3 be removed at that time, and that confirmation samples be collected for analysis of DRO to confirm removal of the impacted soil.

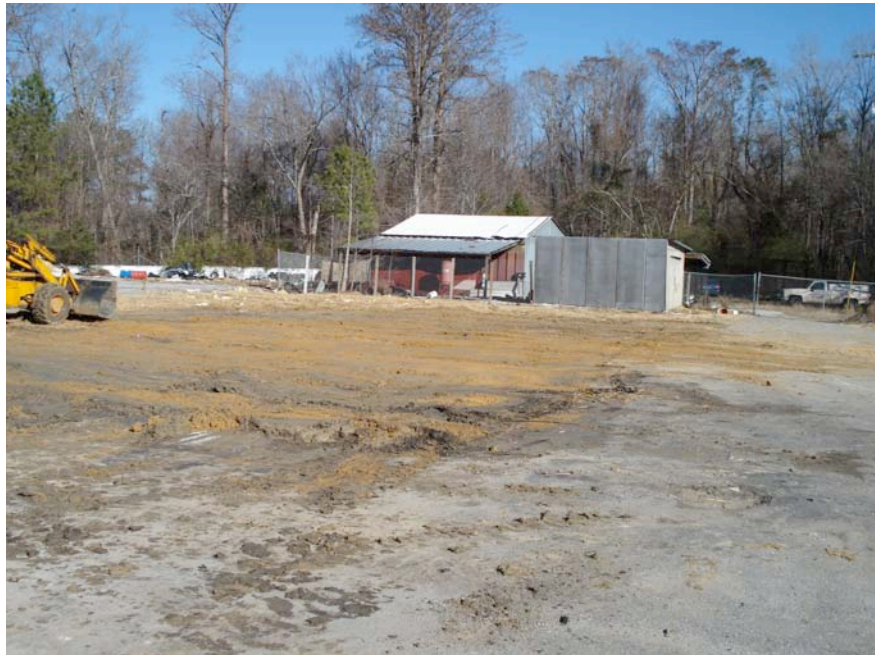
Photograph 8: View looking north at backfilled and compacted hydraulic lift and hydraulic fluid UST removal area.
