Reference: Preliminary Site Assessment
Lisa Darden Property
102 N. Bragg Blvd.
Spring Lake, Cumberland County, North Carolina
NCDOT Tip No. U-4444B
WBS Element 36492.1.2
AECOM Project No. 60158550

GEOPHYSICAL INVESTIGATION REPORT

**LISA DARDEN PROPERTY
Lillington Highway
Spring Lake, North Carolina**

AECOM Environment
GEOPHYSICAL INVESTIGATION REPORT
LISA DARDEN PROPERTY
Spring Lake, North Carolina

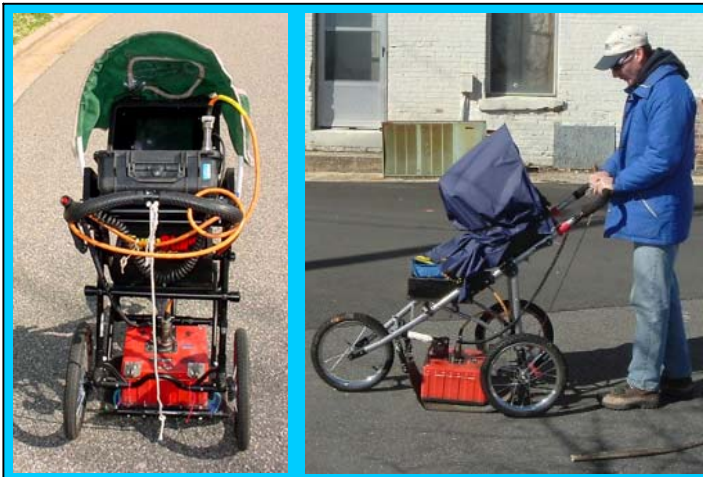
The photographs show the SIR-2000 GPR system equipped with a 400 MHz antenna that were used to conduct the ground penetrating radar investigation at the Lisa Darden property on August 3, 2010.

GPR surveys were conducted on August 3, 2010 across selected EM61 differential anomalies using a GSSI SIR-2000 unit equipped with a 400 MHz antenna. Data were digitally collected in a continuous mode along X-axis and/or Y-axis survey lines, spaced 2.5 to 5.0 feet apart using a vertical scan of 512 samples, at a rate of 48 scans per second. A 70 MHz high pass filter and an 800 MHz low pass filter were used during data acquisition with the 400 MHz antenna. GPR data were collected down to a maximum depth of approximately 5 feet, based on an estimated two-way travel time of 8 nanoseconds per foot. All of the GPR data were downloaded to a field computer and reviewed in the field and office using Radprint software.

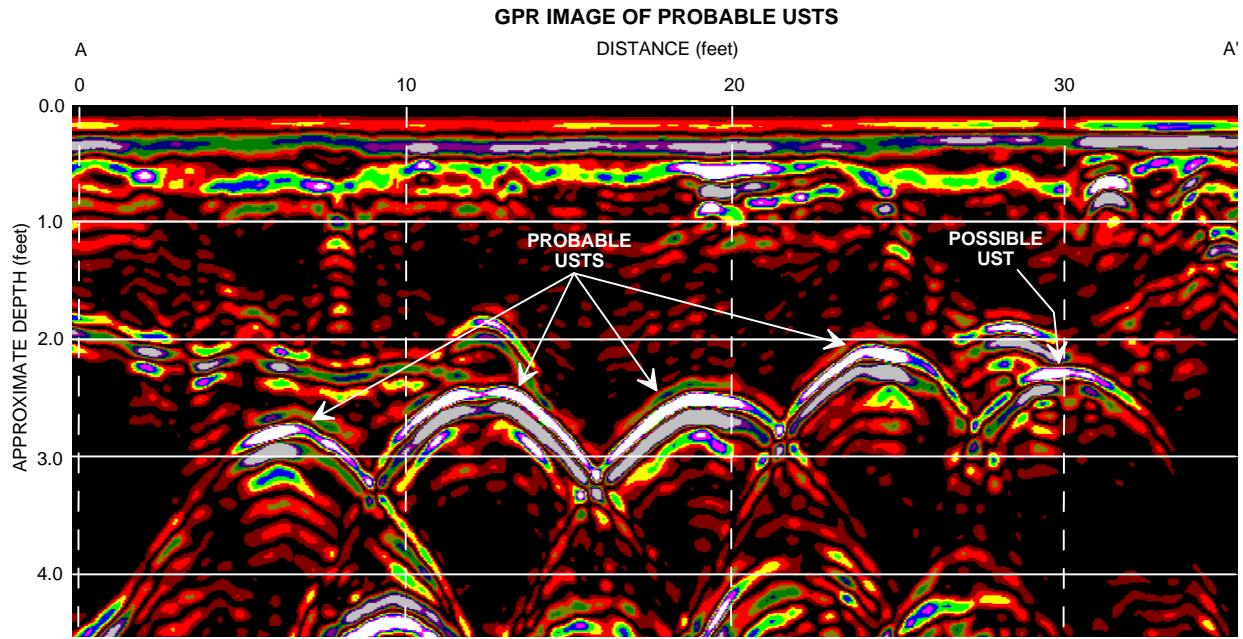
FIGURE 4

<u>Detected UST</u>	<u>Depth (approx.)</u>	<u>Length/Width (approx.)</u>
Possible UST – 1	2.3 feet	12 feet x 5.0 feet
Probable UST – 2	2.8 feet	19 feet x 4.0 feet
Probable UST – 3	2.5 feet	24 feet x 4.5 feet
Probable UST – 4	2.5 feet	21 feet x 4.5 feet
Probable UST – 5	2.0 feet	18 feet x 4.5 feet
Possible UST – 6	2.3 feet	27 feet x 5.0 feet

The GPR image obtained across a line from survey points X=74 Y=152 to X=45 Y=175 recorded five high amplitude, hyperbolic anomalies that are probably in response to four probable, metallic USTs and one possible, metallic UST buried approx. 2.0 to 2.8 feet below the asphalt pavement. The solid purple line labeled AA' in the photograph below and in Figure 3 shows the location of the GPR image.

The footprints of the six possible/probable, metallic USTs were marked in the field using orange marking paint. The image of a GPR survey line which crosses the four probable USTs and one possible UST and a photograph showing the location of the probable/possible USTs are presented in **Figure 4**.

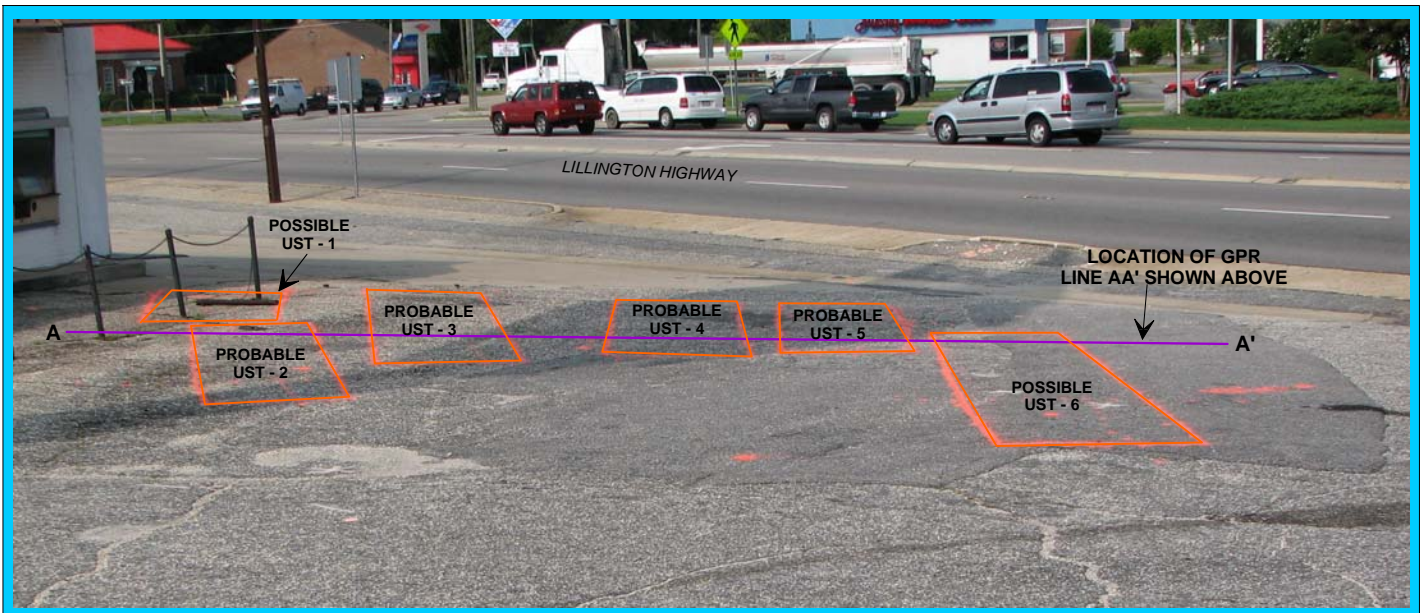
The orange rectangles in the photograph represent the approximate perimeters of the four probable, metallic USTs and two possible, metallic USTs, as suggested by the GPR data. The GPR data suggest that the six possible/probable metallic USTs lie beneath the proposed ROW area and centered near grid coordinates X=55 Y=155. The solid purple line labeled AA' in the photograph represents the approximate location of the GPR image shown above. The photograph is viewed in a southwesterly direction.

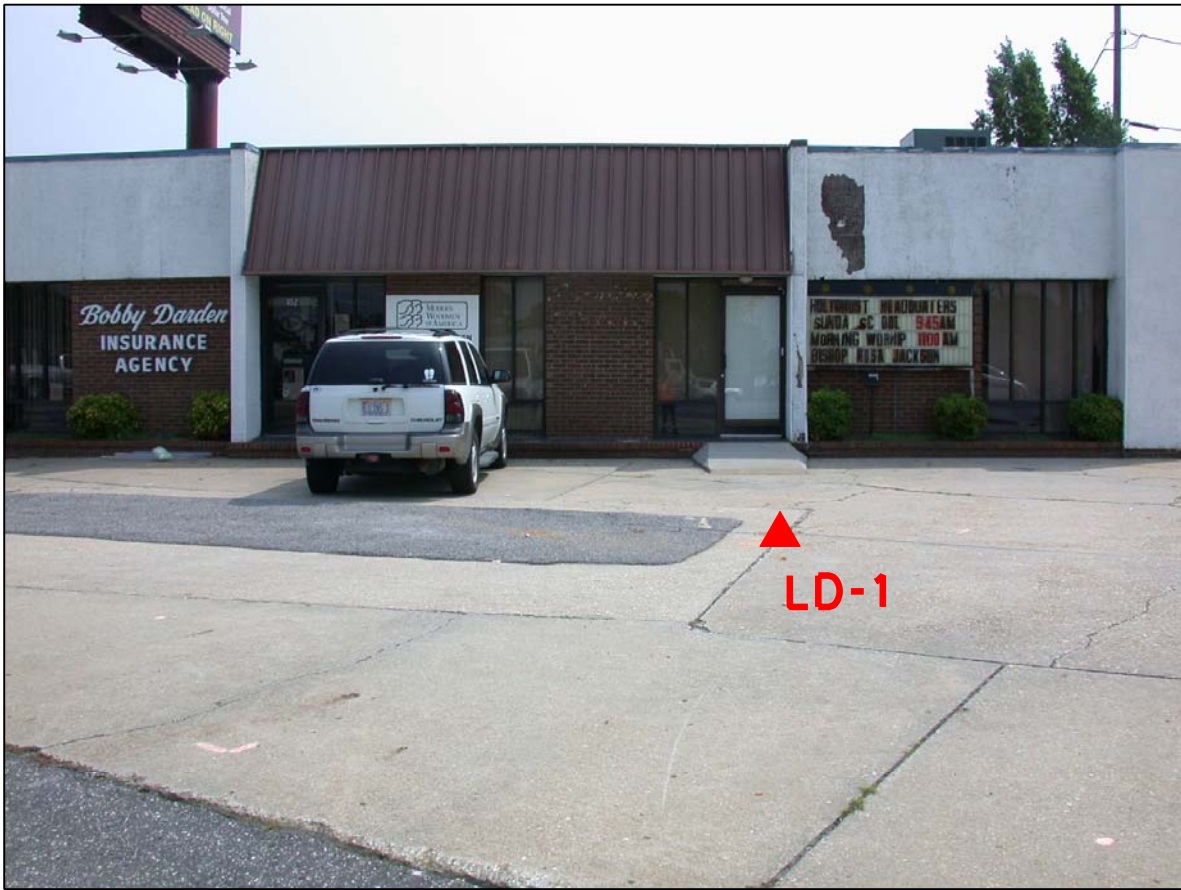
PHOTO 1 - BORING IN PROPOSED R/W LOOKING EAST

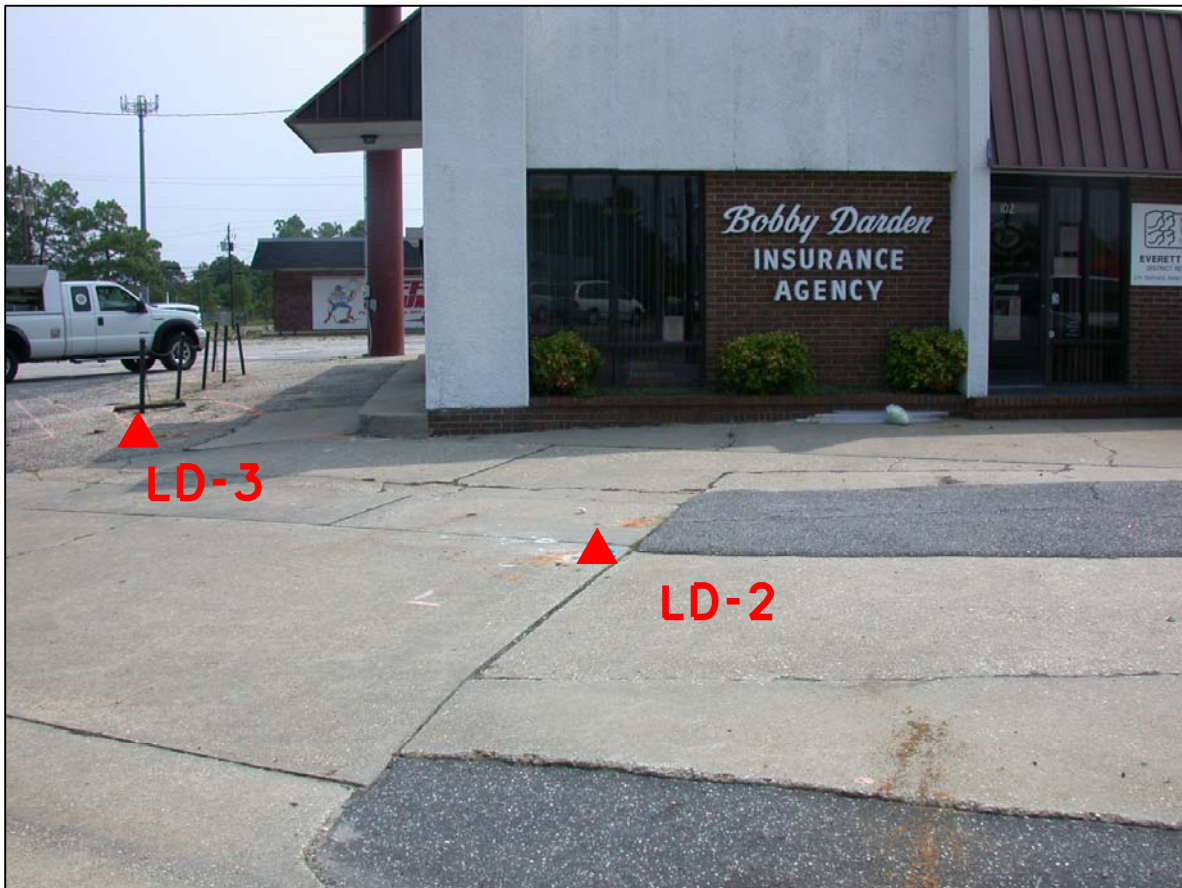
PHOTO 2 - BORINGS IN PROPOSED R/W LOOKING EAST

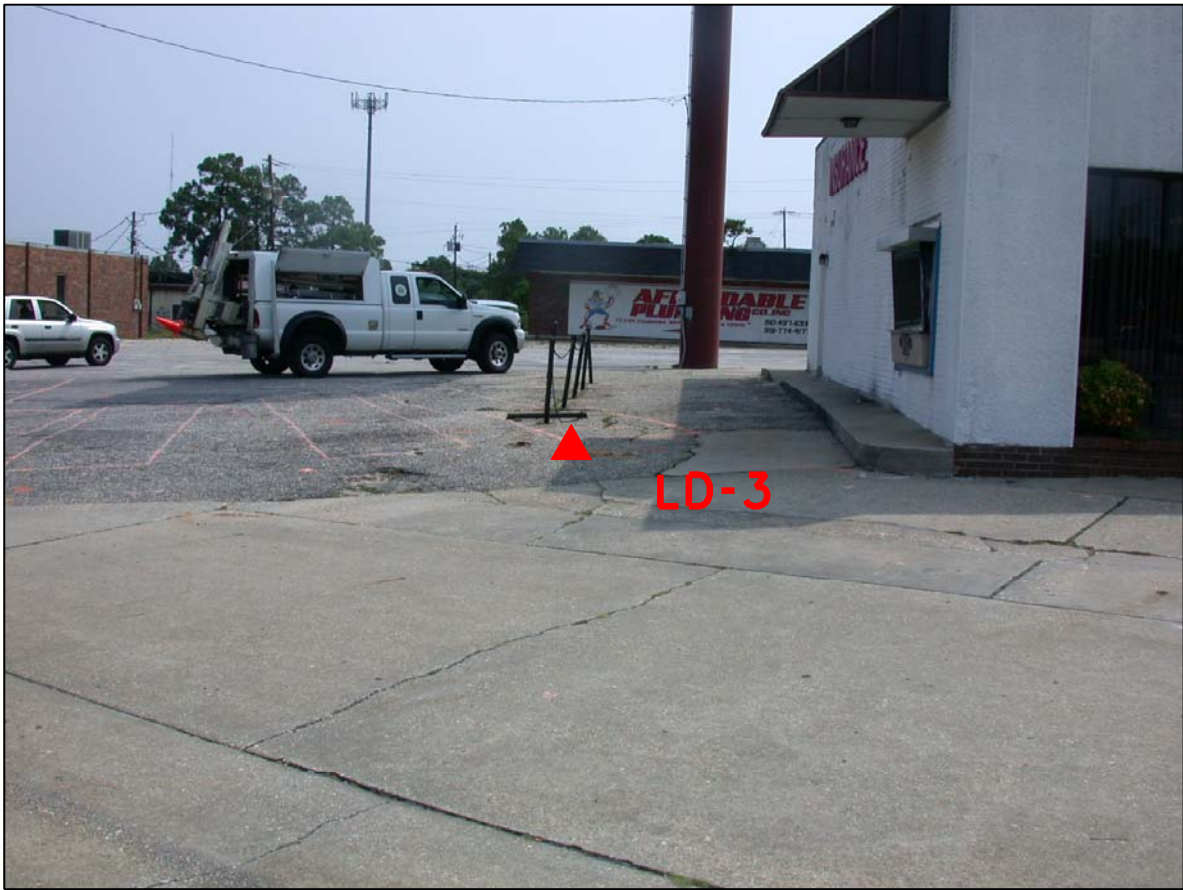
PHOTO 3 - BORING WITHIN PROPOSED R/W LOOKING EAST

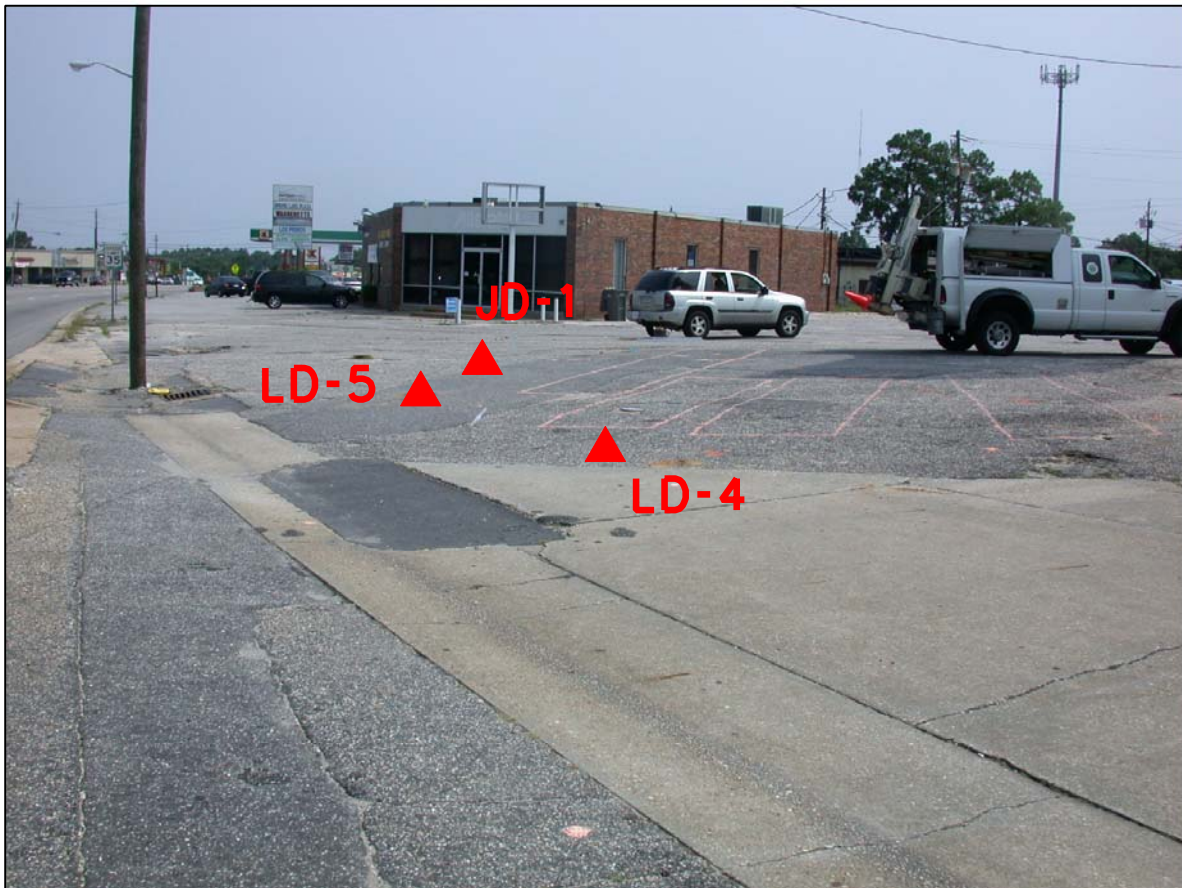
PHOTO 4 - BORINGS WITHIN PROPOSED R/W LOOKING NORTHEAST
ALSO SHOWING ADJACENT SITE BORING

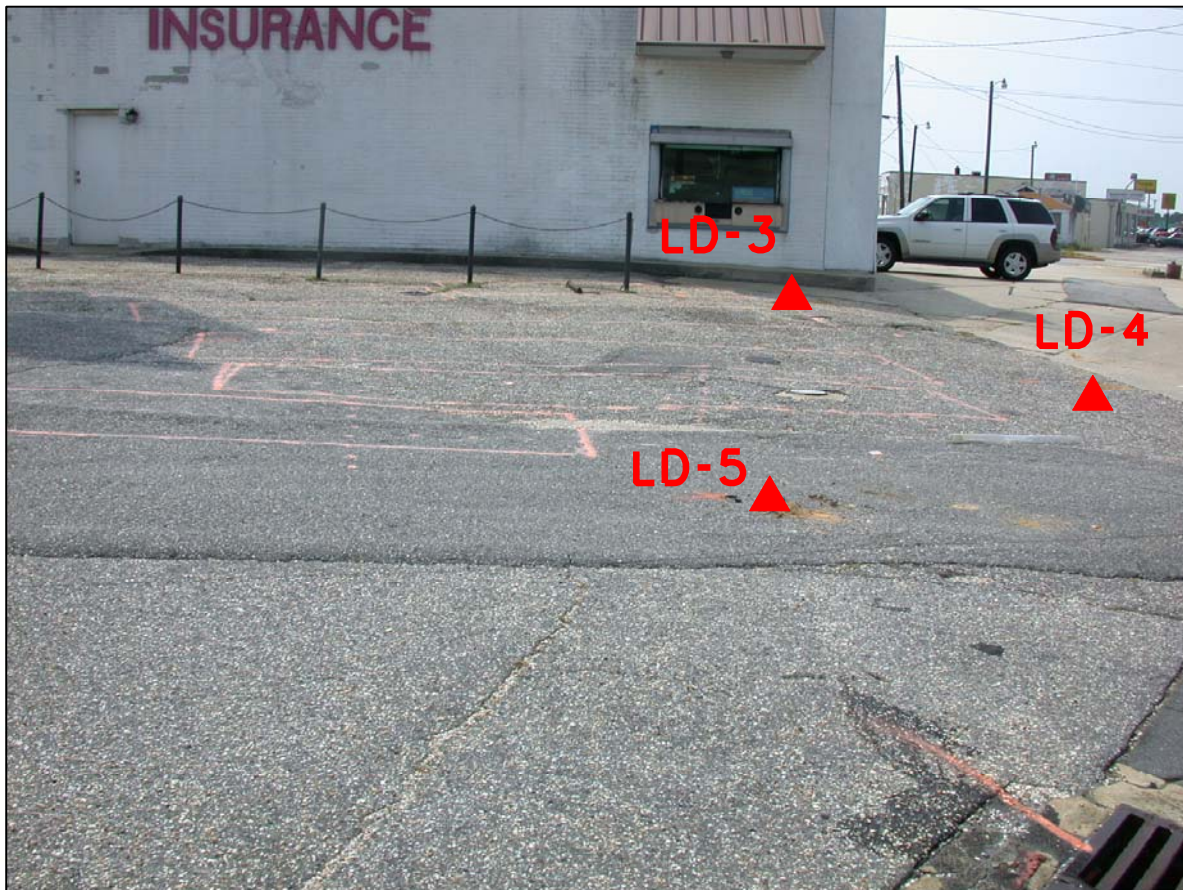
PHOTO 5 - BORINGS WITHIN PROPOSED R/W LOOKING SOUTH

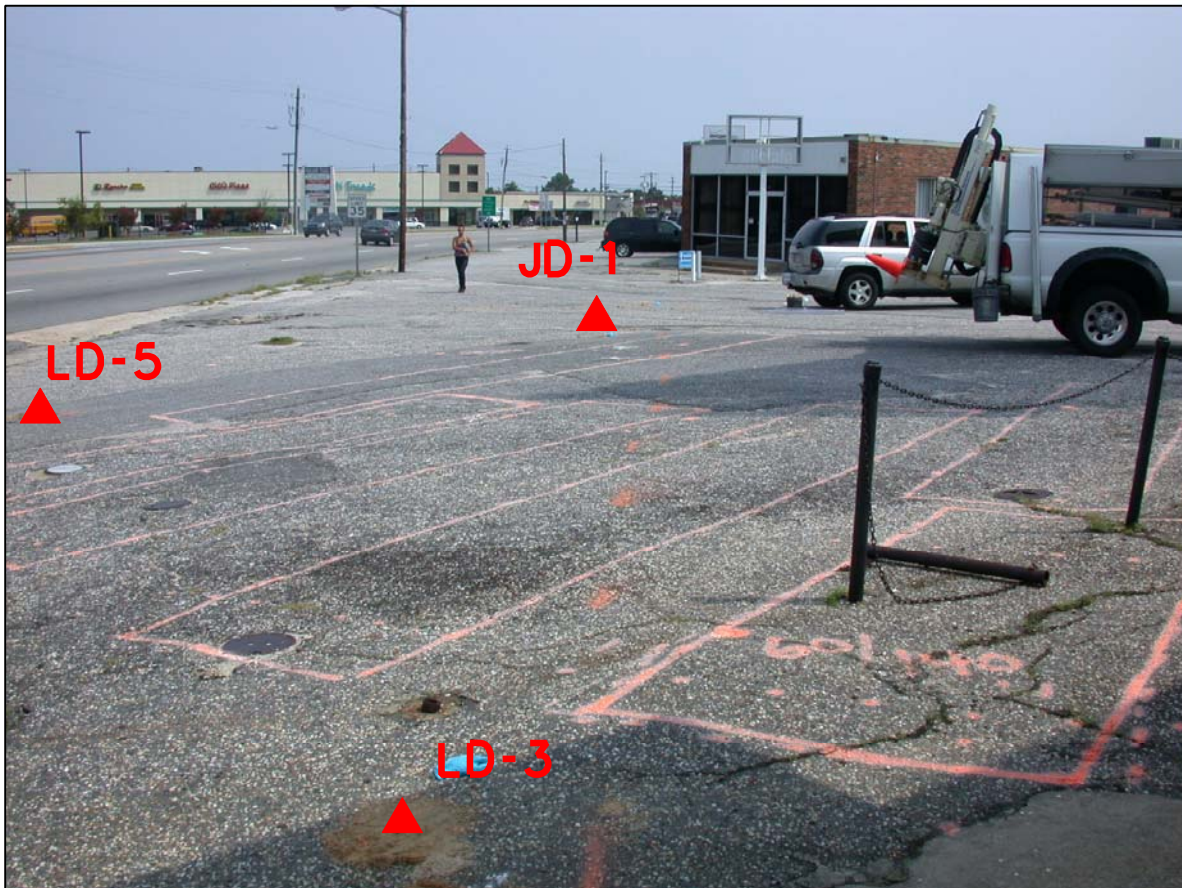
PHOTO 6 - BORINGS WITHIN PROPOSED R/W LOOKING NORTHEAST ALONG R/W
