Reference: Preliminary Site Assessment
Danny Clayton and Linda Carver Property (Parcel #007)
1047 Madison Boulevard
Roxboro, Person County, North Carolina
NCDOT Project R-2241A
WBS Element 34406.1.1
Earth Tech Project No. 100407

Earth Tech of North Carolina, Inc., (Earth Tech) has completed the Preliminary Site Assessment conducted at the above-referenced property. The work was performed in accordance with the Technical and Cost proposal dated June 6, 2007, and the North Carolina Department of Transportation's (NCDOT's) Notice to Proceed dated June 6, 2007. Activities associated with the assessment consisted of conducting a geophysical investigation, collecting soil samples for laboratory analysis, and reviewing applicable North Carolina Department of Environment and Natural Resources (NCDENR) records. The purpose of this report is to document the field activities, present the laboratory analyses, and provide recommendations regarding the property.

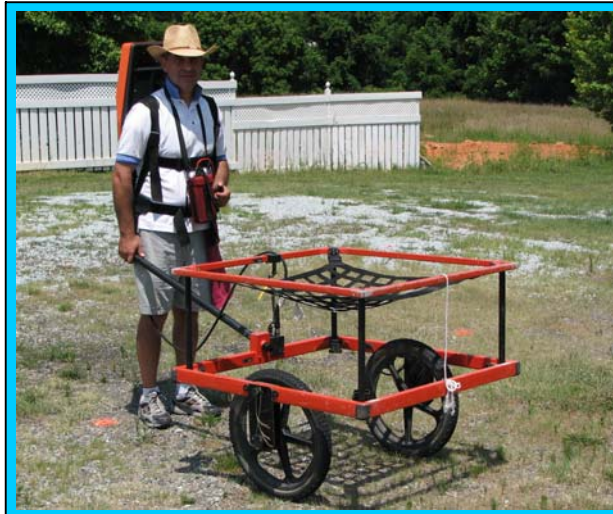
The photo shows the Geonics EM61 metal detector that was used to conduct the metal detection survey at Parcel 7 on June 22, 2007.

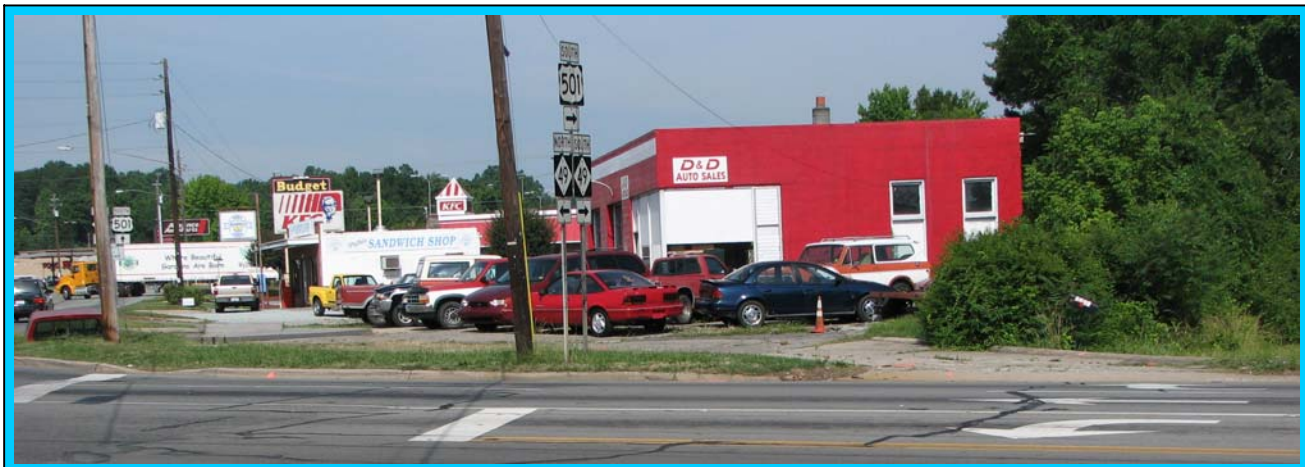
The photograph shows a portion of the geophysical survey area located at Parcel 7. The photo is viewed in a westerly direction.

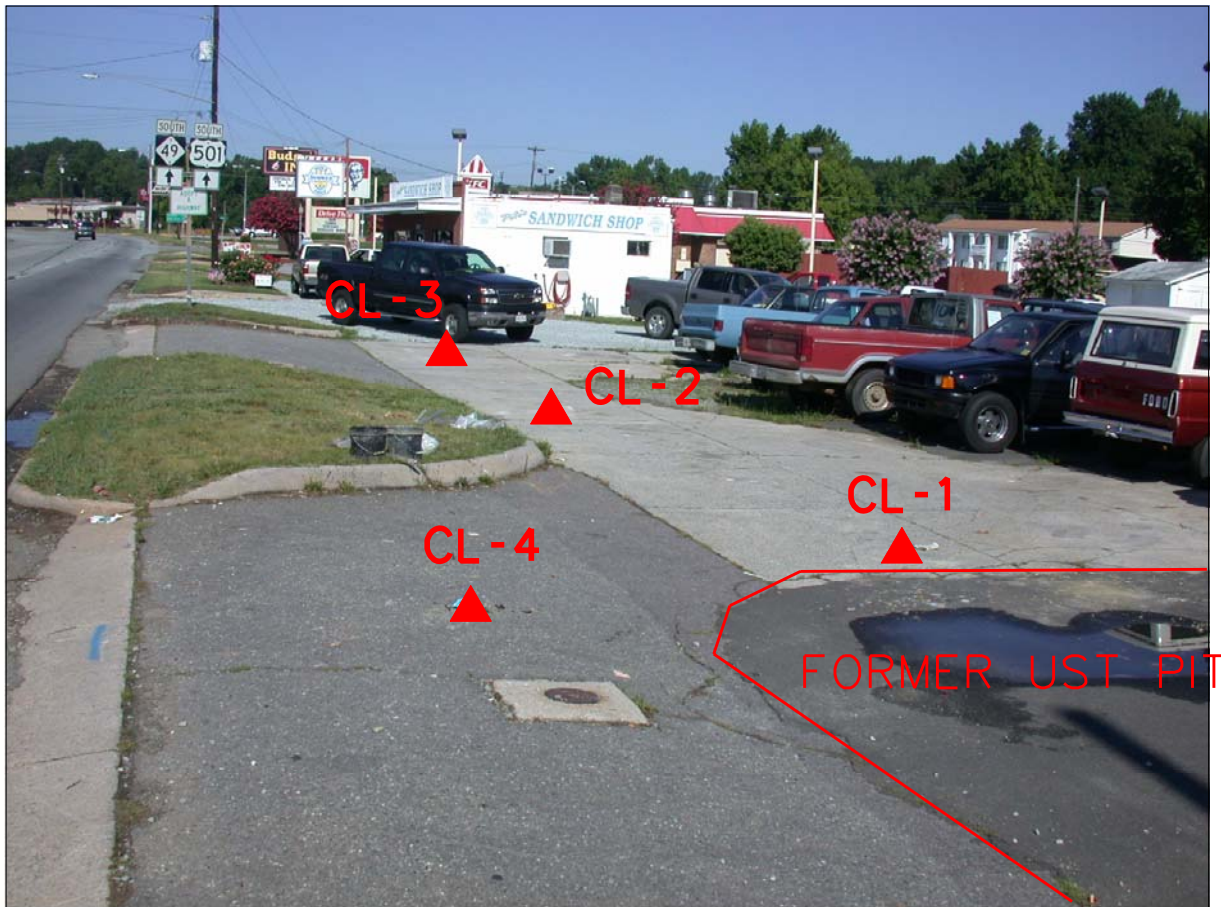
PHOTO 1 - BORINGS AT CLAYTON PROPERTY LOOKING WEST FROM STREET

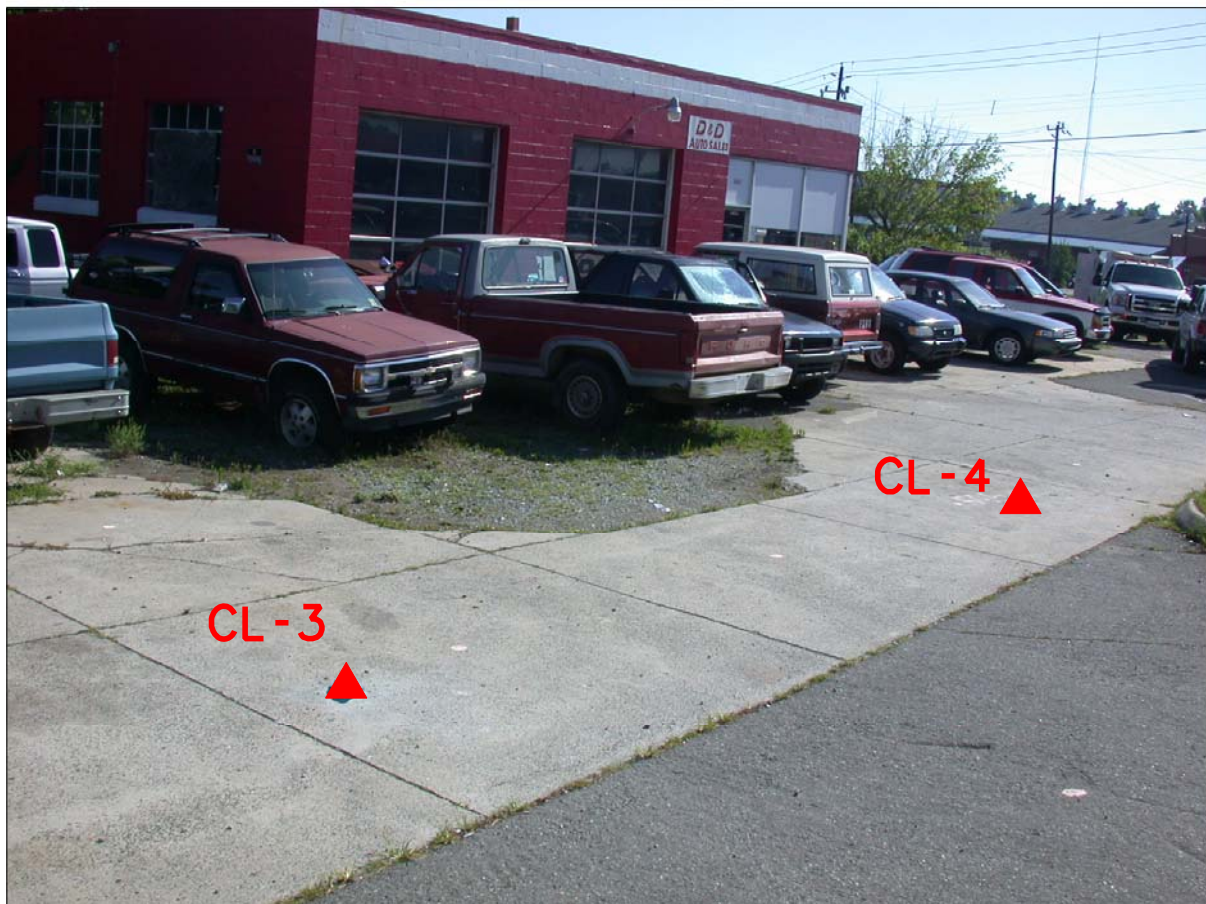
PHOTO 2 - BORINGS AT CLAYTON PROPERTY LOOKING EAST FROM STREET

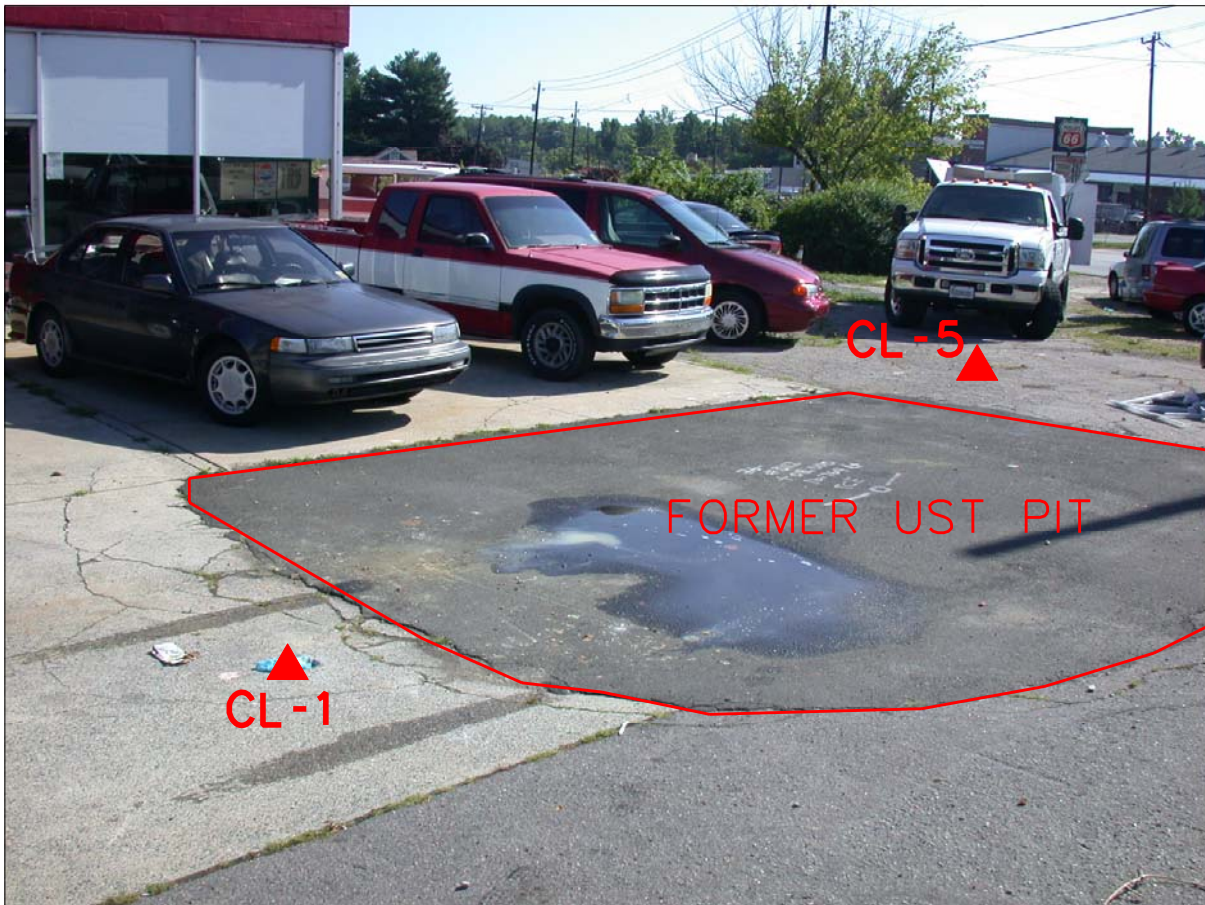
PHOTO 4 - BORINGS AT CLAYTON PROPERTY LOOKING EAST FROM STREET

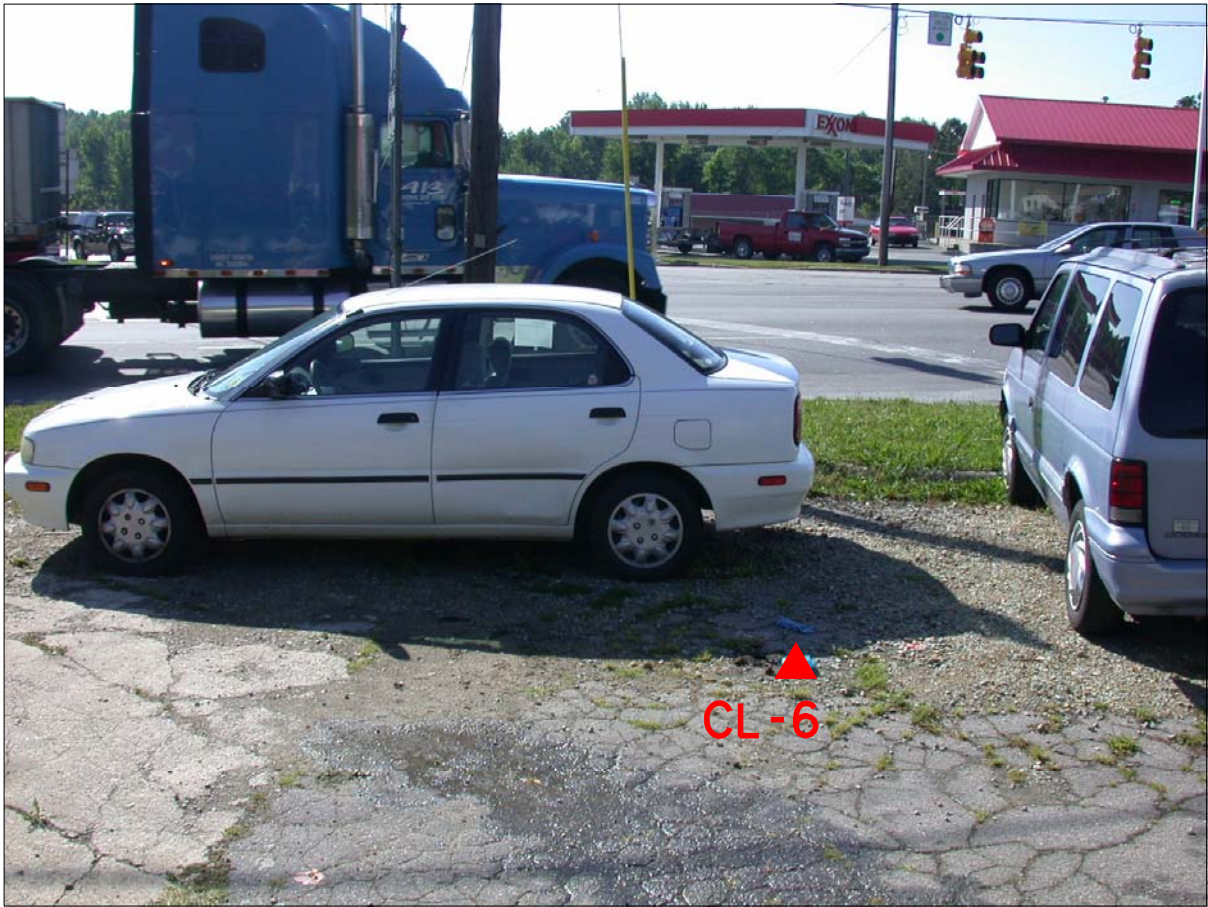
PHOTO 5 - BORING AT CLAYTON PROPERTY LOOKING SOUTHEAST FROM PARKING LOT
