PRELIMINARY SITE ASSESSMENT

**GLADE VALLEY – US HIGHWAY 21 SOUTH FROM ROARING GAP TO SPARTA
PARCEL #111, GEORGE WOODRUFF AND MARY WOODRUFF PROPERTY
6640 US HIGHWAY 21 SOUTH
GLADE VALLEY, ALLEGHANY COUNTY, NORTH CAROLINA**

**NCDOT WBS ELEMENT 37044.1.1
STATE PROJECT R-3101**

January 13, 2012

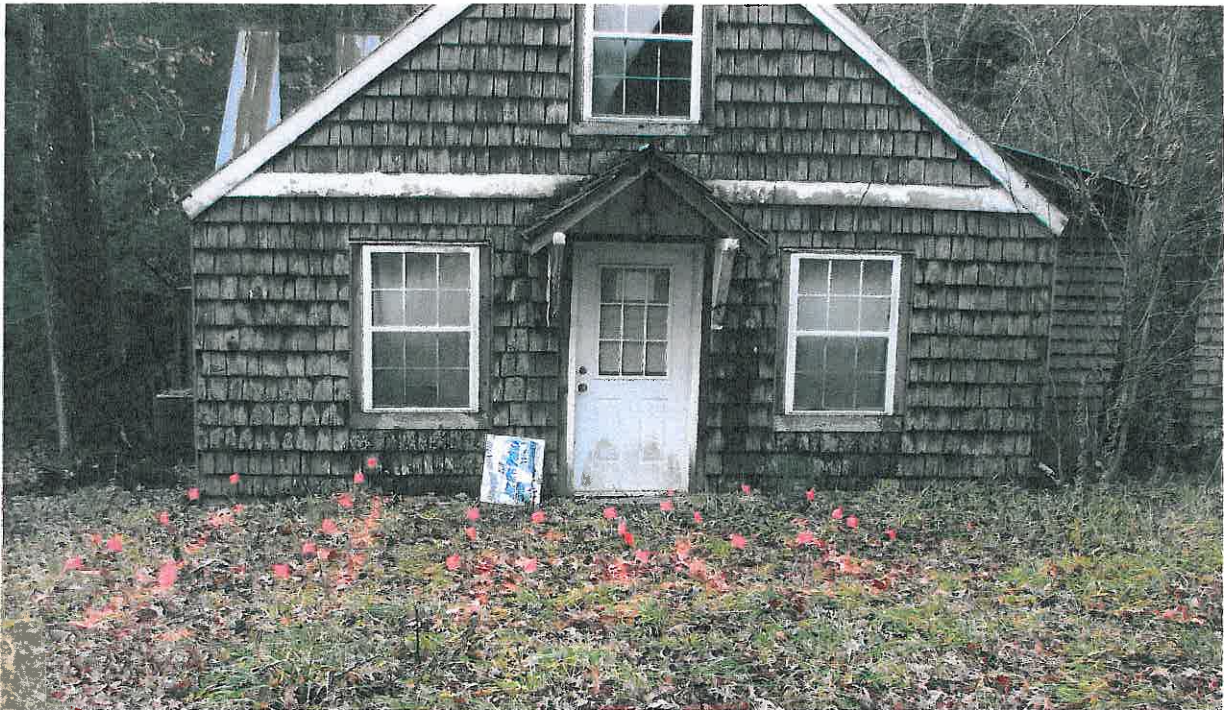
**Photograph 1 – View of the former EJ Antiques building (currently vacant) looking south.
The suspect UST field is located in the center of the photograph.**

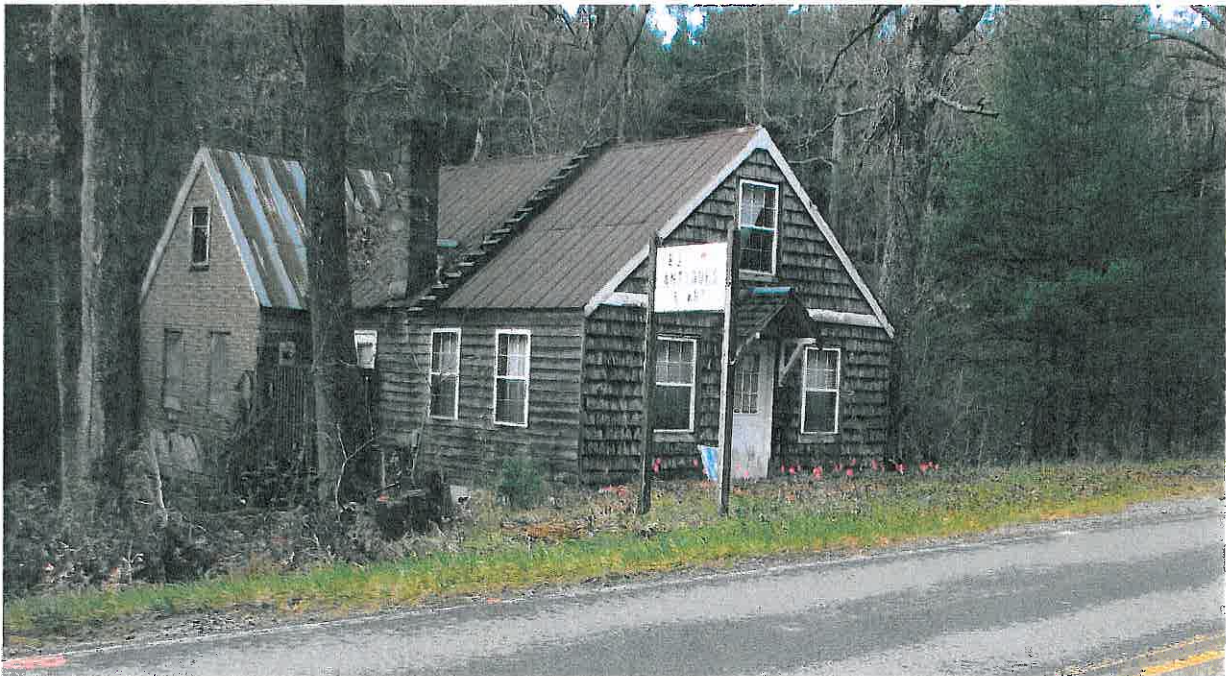
Photograph 2 – View of the building looking southwest.

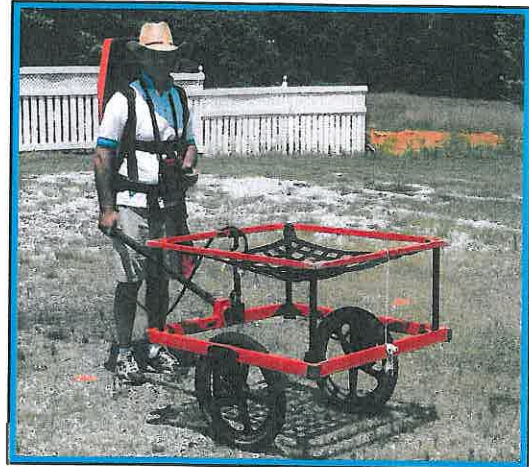
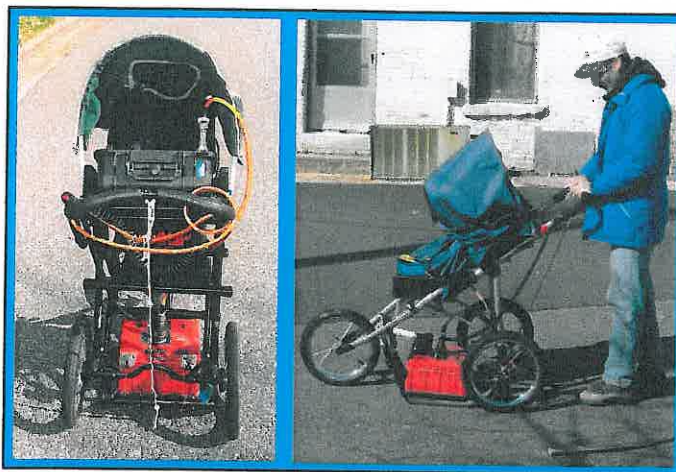
The photographs show the SIR-2000 GPR system equipped with a 400 MHz antenna that were used to conduct the ground penetrating radar investigation across selected EM61 differential anomalies at Parcel 111 on November 17, 2011.

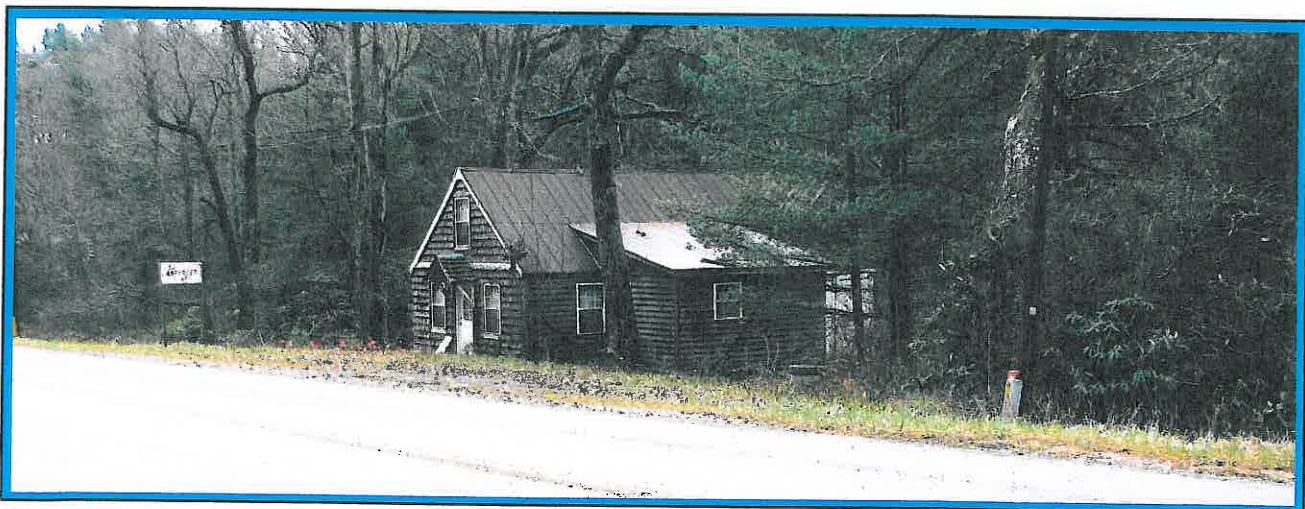
FIGURE 1

The photograph shows the front portion of the George and Mary Woodruff property (Parcel 111) located at 6640 US Highway 21 South near Glade Valley, North Carolina. The geophysical investigation was performed across the front portion of the property. The photograph is viewed in a southeasterly direction.
