# **PRELIMINARY SITE ASSESSMENT**

**GLADE VALLEY – US HIGHWAY 21 SOUTH FROM ROARING GAP TO SPARTA  
PARCEL #145 SAGE MEADOW, INC. PROPERTY  
4864 US HIGHWAY 21 SOUTH  
GLADE VALLEY, ALLEGHANY COUNTY, NORTH CAROLINA**

**NCDOT WBS ELEMENT 37044.1.1  
STATE PROJECT R-3101**

**January 13, 2012**

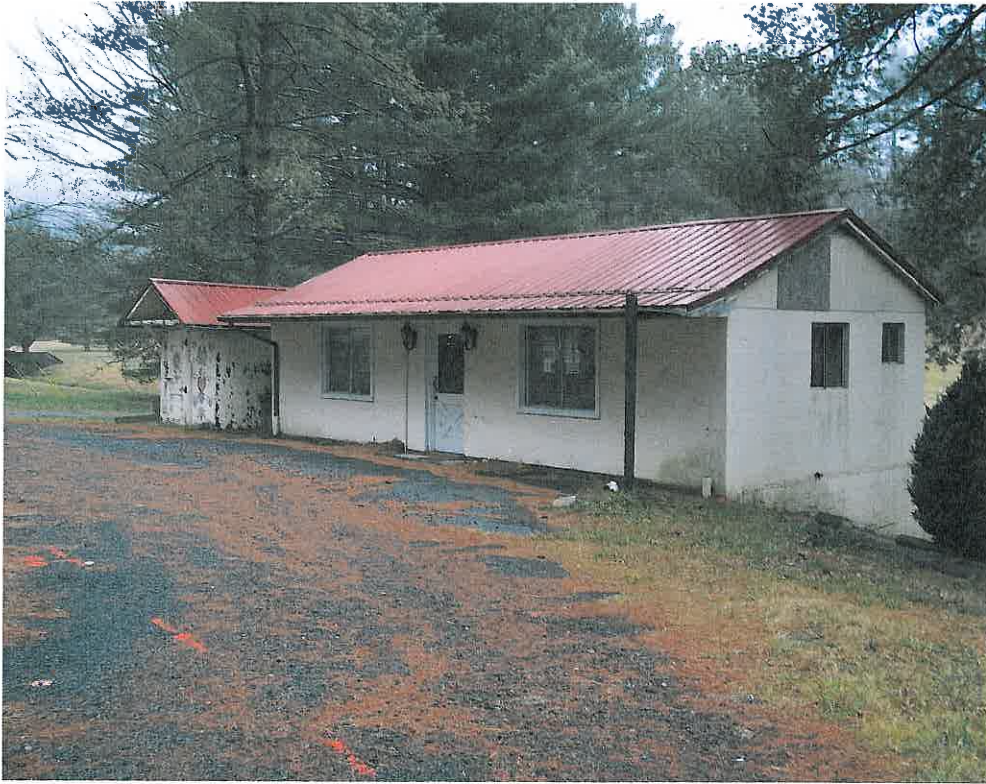
**Photograph 1 View of the structures located onsite.**

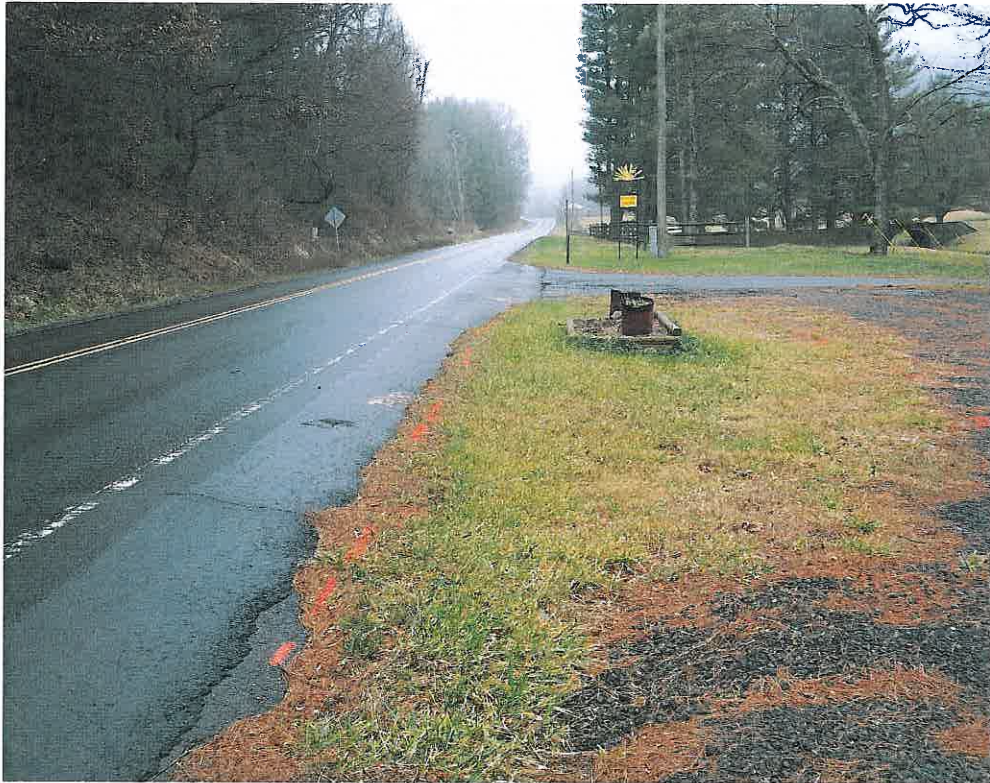
**Photograph 2 View of looking from north to south along  
US Hwy 21 S.**

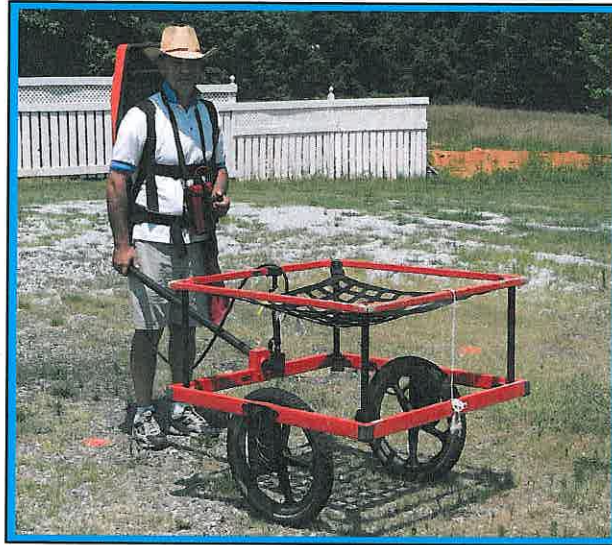
The photograph shows the Geonics EM61 metal detector that was used to conduct the metal detection survey across the proposed Right-of-Way area at Parcel 145 on November 10, 2011. Due to an absence of unexplained EM61 differential anomalies, ground penetrating radar scans were not performed at this site.

The geophysical investigation consisted of electromagnetic (EM) induction-metal detection surveys. The EM survey was performed on November 9, 2011 using a Geonics EM61-MK1 metal detection instrument. According to the instrument specifications, the EM61 can detect a metal drum down to a

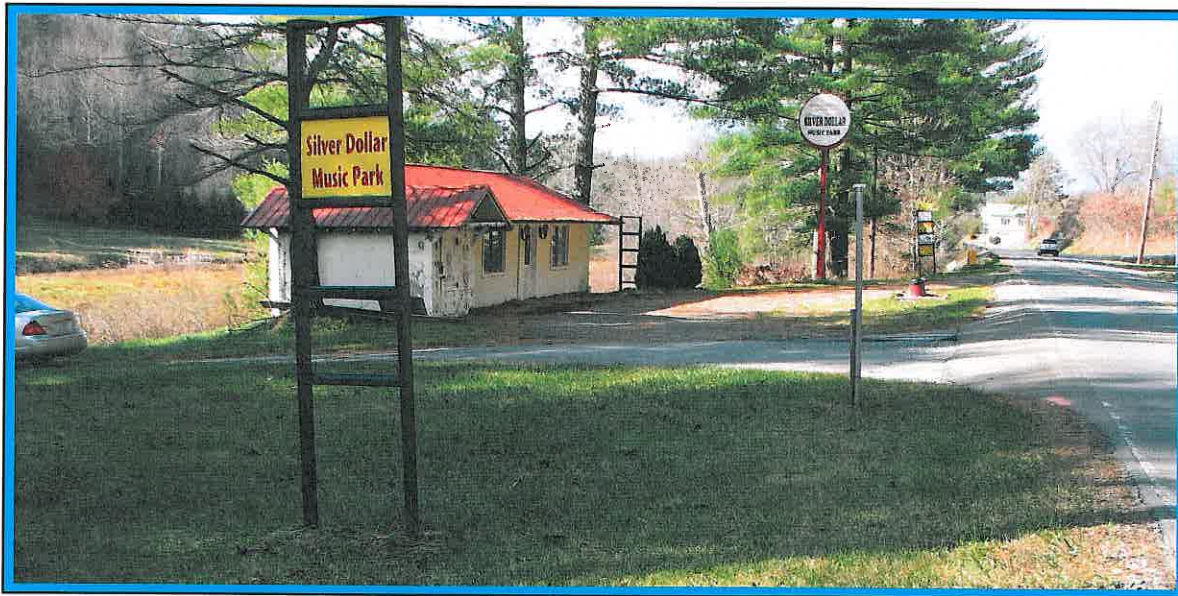
The photograph shows the front portion of the Sage Meadow, Inc. property (Parcel 145) located at 4864 US Highway 21 South near Glade Valley, North Carolina. The geophysical investigation was performed across the front portion of the property. The photograph is viewed in a northwesterly direction.

NCDOT representative Mr. Ethan J. Caldwell, LG, PE provided site information which identified the geophysical survey area to Pyramid Environmental personnel during the week of October 17, 2011. Photographs of the geophysical equipment used in this investigation and the geophysical survey area of the Sage Meadow, Inc. property are shown in **Figure 1**.
