# **PRELIMINARY SITE ASSESSMENT**

**GLADE VALLEY – US HIGHWAY 21 SOUTH FROM ROARING GAP TO SPARTA  
PARCEL #167 IRENE C. WAGONER PROPERTY  
3725 US HIGHWAY 21 SOUTH  
GLADE VALLEY, ALLEGHANY COUNTY, NORTH CAROLINA**

**NCDOT WBS ELEMENT 37044.1.1  
STATE PROJECT R-3101**

**GEOPHYSICAL INVESTIGATION REPORT**

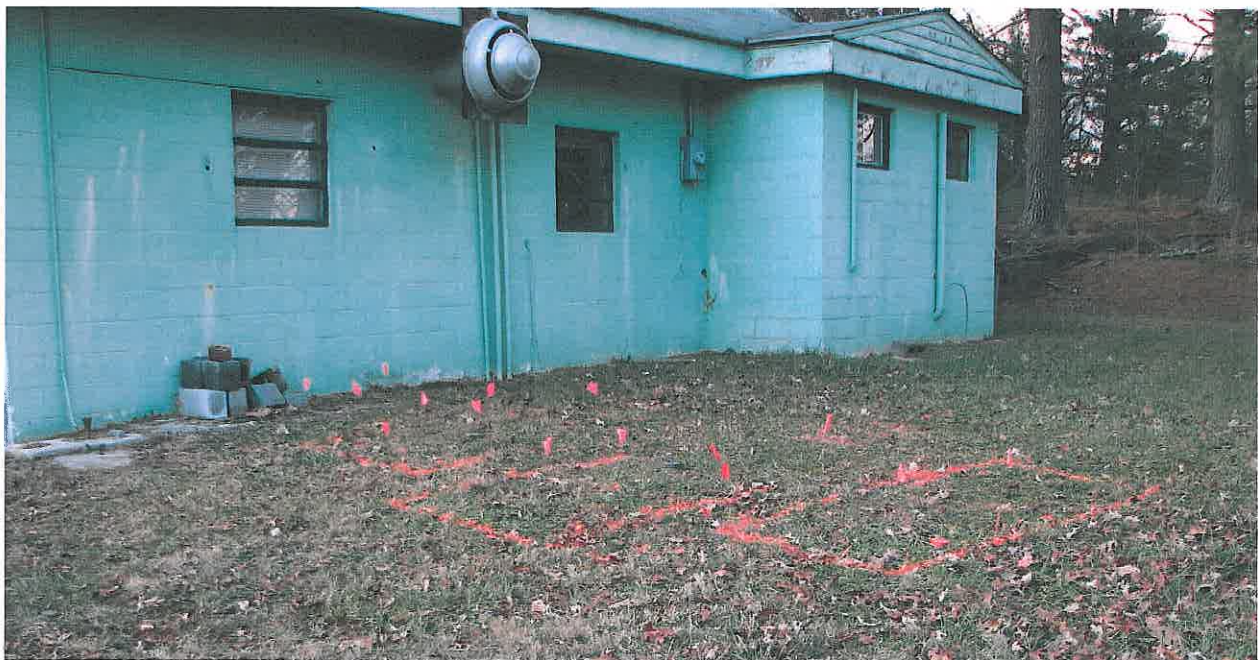
**Photograph 2 – View of the three suspected USTs**

Pyramid concluded that the GPR and EM investigation identified two probable USTs and one possible UST on the eastern side of the onsite structure. Furthermore, they identified a possible pump island south of the onsite structure. Pyramid's report is included in Appendix B.

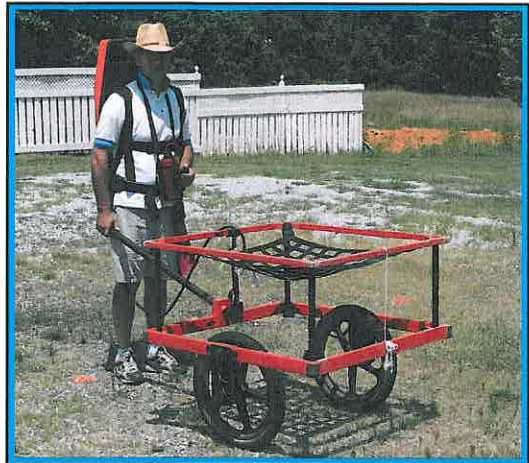
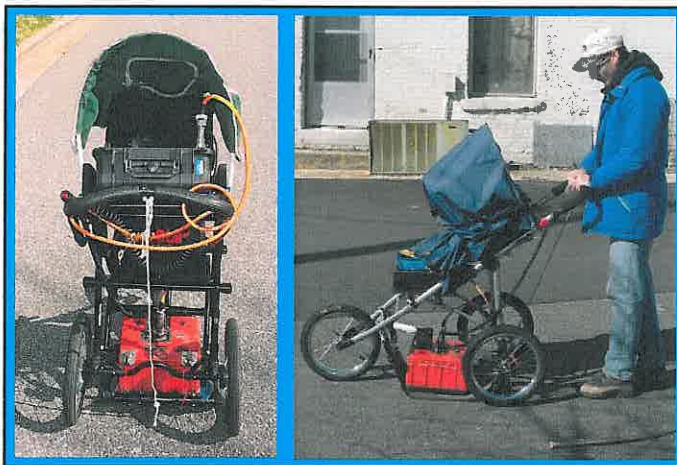
The photographs show the SIR-2000 GPR system equipped with a 400 MHz antenna that were used to conduct the ground penetrating radar investigation across selected EM61 differential anomalies at Parcel 167 on November 17, 2011.

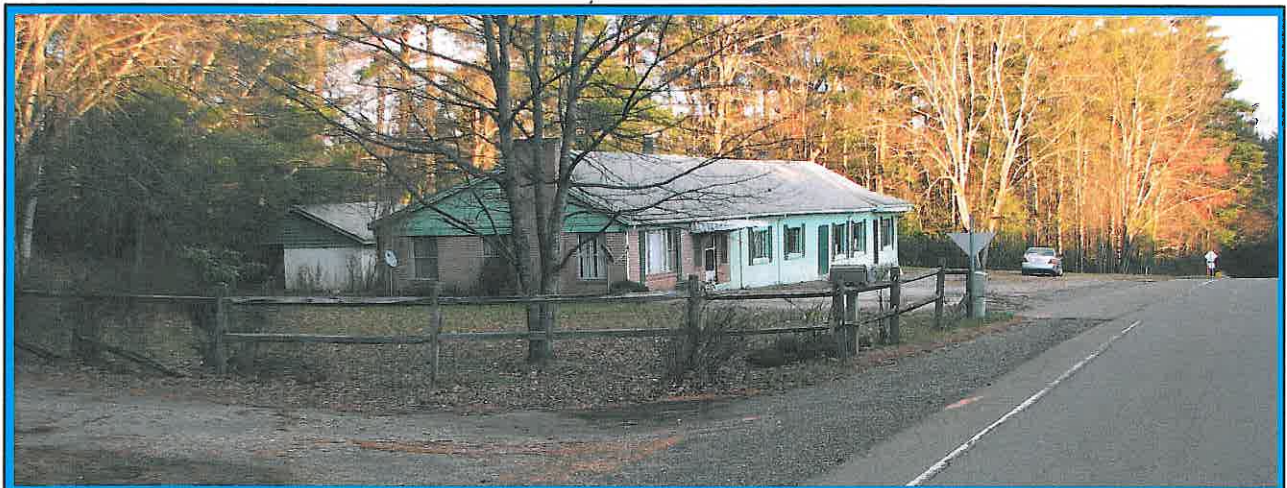
The photograph shows the front portion of the Irene C. Wagoner property (Parcel 167) located at 3725 US Highway 21 South near Glade Valley, North Carolina. The geophysical investigation was performed across the front portion of the property. The photograph is viewed in a southeasterly direction.

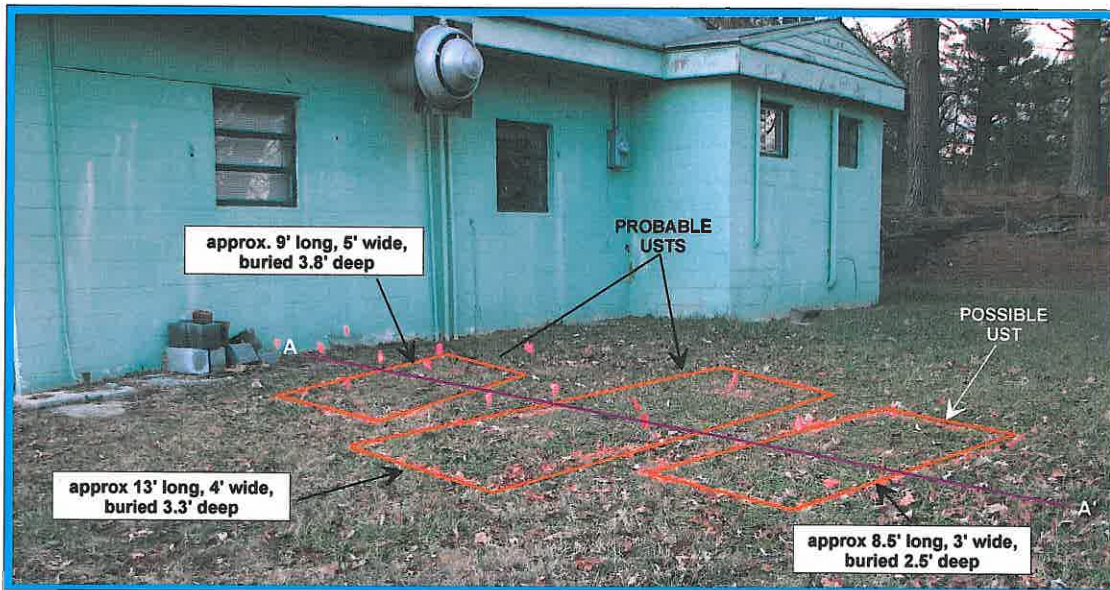
FIGURE 3

The orange rectangles in the photograph represent the approximate perimeters of two probable, metallic USTs and one possible, metallic UST, as suggested by the GPR data. Centered near grid coordinates X=217 Y=67, the approximate lengths, widths and depths of the probable and possible USTs are shown in the photograph. The solid purple line in the photograph represents the approximate location of the GPR image shown above. The photograph is viewed in a northerly direction.
