PRELIMINARY SITE ASSESSMENT

**GLADE VALLEY – US HIGHWAY 21 SOUTH FROM ROARING GAP TO SPARTA
PARCEL #181, MABEL O. LYON PROPERTY
3238 US HIGHWAY 21 SOUTH
GLADE VALLEY, ALLEGHANY COUNTY, NORTH CAROLINA**

**NCDOT WBS ELEMENT 37044.1.1
STATE PROJECT R-3101**

January 13, 2012

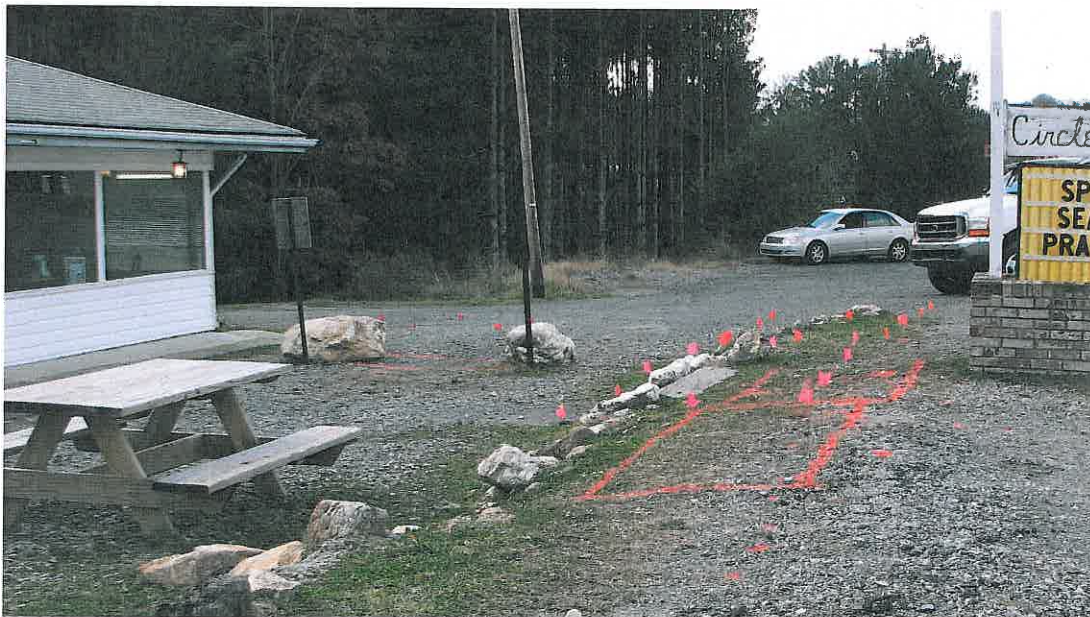
Photograph 2 View of the suspect UST's looking west. The restaurant is shown to the left (south) of the suspect UST's.

- ◆ If the USTs are encountered during the road widening project, Kleinfelder recommends that the USTs be removed in accordance with the current regulations.
- ◆ If impacted soils are encountered, Kleinfelder recommends the soils be handled appropriately and disposed of at an approved disposal facility.

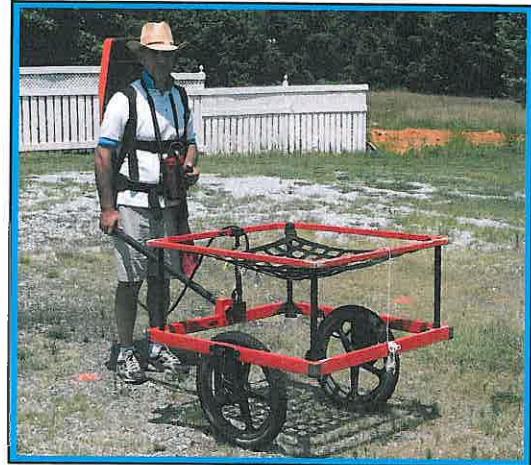
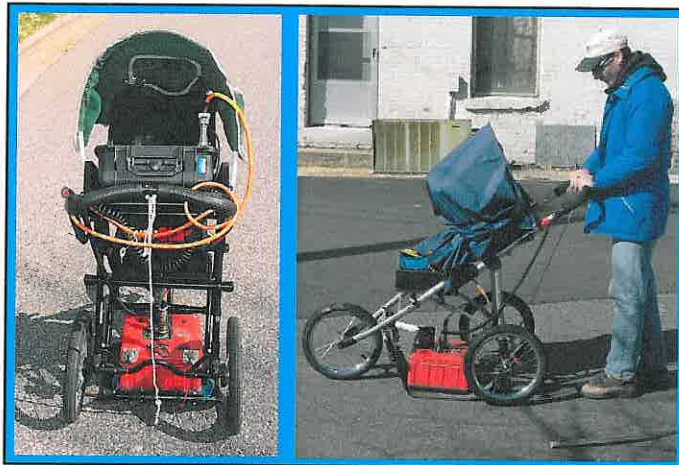
The photographs show the SIR-2000 GPR system equipped with a 400 MHz antenna that were used to conduct the ground penetrating radar investigation across selected EM61 differential anomalies at Parcel 181 on November 17, 2011.

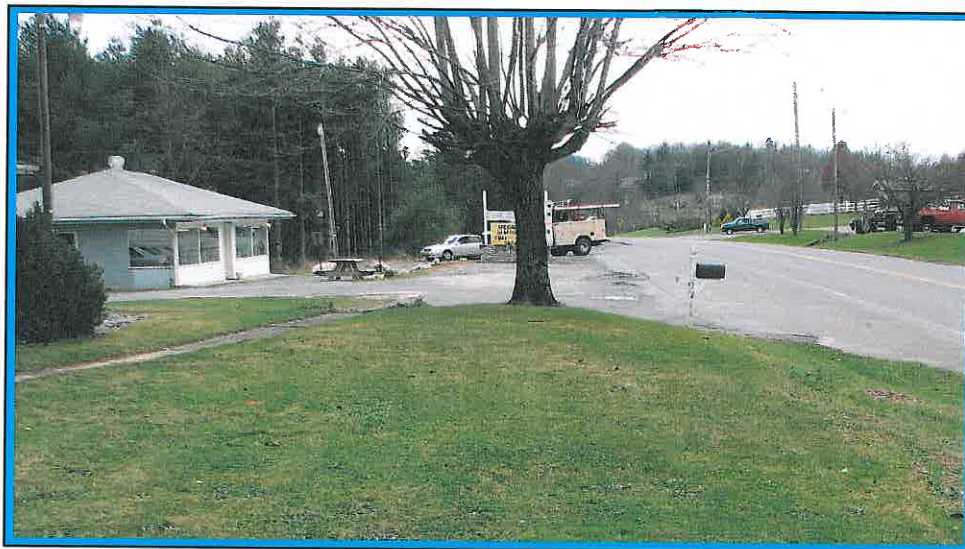
The photograph shows the front portion of the Mabel O. Lyon property (Parcel 181) located at 3238 US Highway 21 South near Glade Valley, North Carolina. The geophysical investigation was performed across the front portion of the property. The photograph is viewed in a westerly direction.

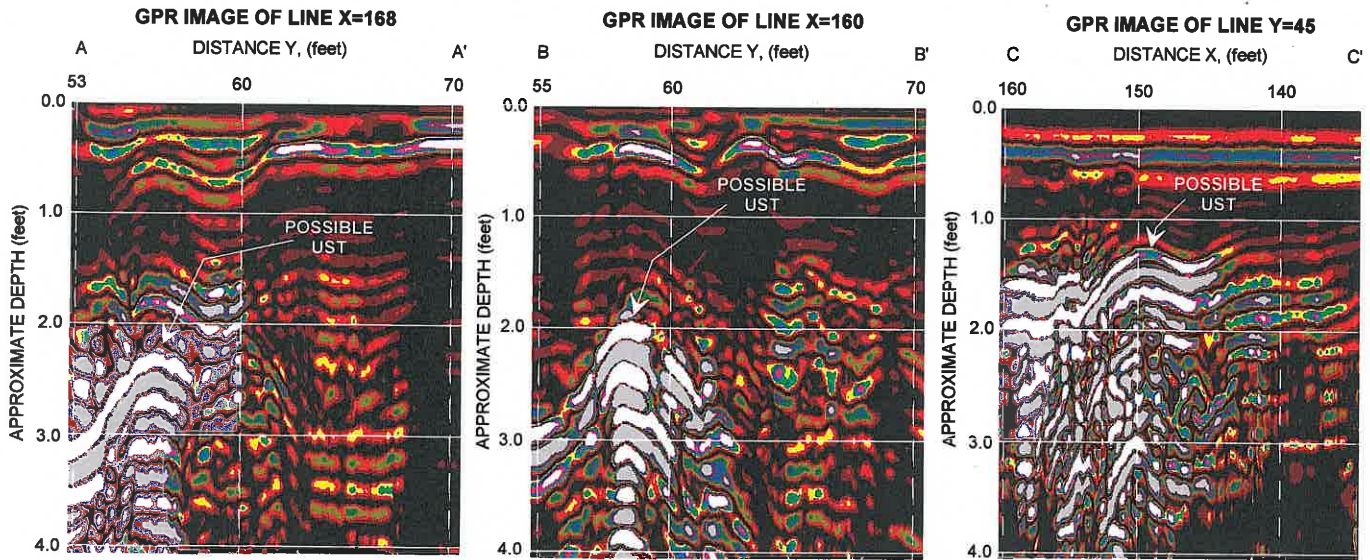
GPR images obtained along a portion of survey lines X=168, X=160 and Y=45 recorded high-amplitude, hyperbolic anomalies (GPR reflections shaded in white) that may be in response to three possible metallic USTs. The possible USTs appear to lie approximately 1.3 to 2.0 feet below present grade. The solid purple lines labeled AA', BB' and CC' and the orange rectangles in the photograph below represent the locations of the GPR images and the foot prints of the possible USTs, respectively.

GPR images obtained along a portion of survey lines Y=45, X=160 and X=168, which cross the three possible USTs, and a photograph showing the locations of the possible USTs are presented in **Figure 4**. The foot prints of the three possible USTs detected by the geophysical investigation were marked in the field using orange marking paint and pin flags.
