PRELIMINARY SITE ASSESSMENT

GLADE VALLEY – US HIGHWAY 21 SOUTH FROM ROARING GAP TO SPARTA PARCEL #193 GRANVILLE PAUL WAGONER AND SUE D WAGONER PROPERTY 2694 US HIGHWAY 21 SOUTH GLADE VALLEY, ALLEGHANY COUNTY, NORTH CAROLINA

> NCDOT WBS ELEMENT 37044.1.1 STATE PROJECT R-3101

> > January 13, 2012

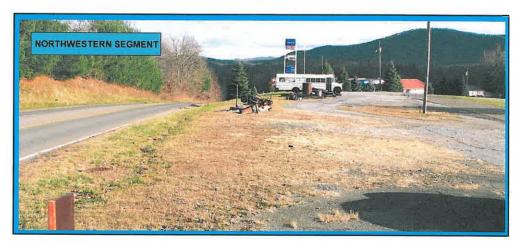
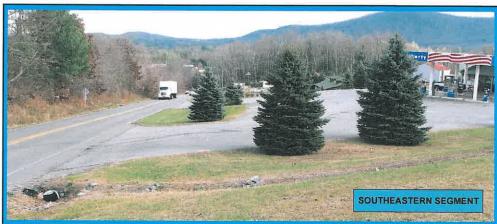
The photographs show the northwest section (top) and southeast section of the Granville and Sue Wagoner property (Parcel 193) located at 2694 US Highway 21 South, near Glade Valley, North Carolina. The geophysical investigation was performed across the front portion of the property. The photographs are viewed in a southeasterly direction.

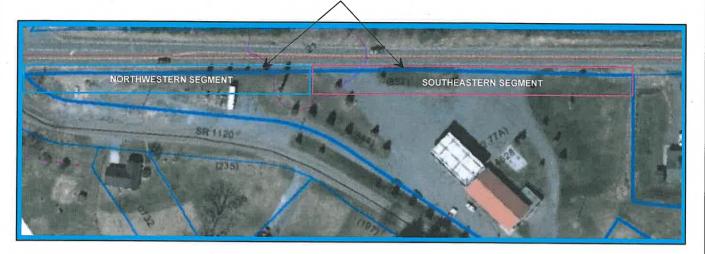
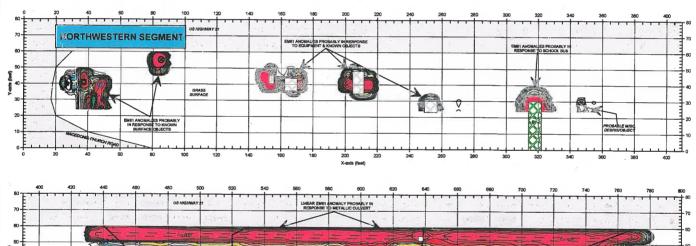
FIGURE 2

Due to the length of the geophysical survey area at Parcel 193, the survey area has been divided into a northwestern section and a southeastern section in Figures 3 and 4. The rectangles in the aerial photograph represent the division of the survey area. The contour plots (lower) show how the geophysical results are presented in Figures 3 and 4.

DIVISION OF GEOPHYSICAL SURVEY AREA
