# **PRELIMINARY SITE ASSESSMENT**

**GLADE VALLEY – US HIGHWAY 21 SOUTH FROM ROARING GAP TO SPARTA  
PARCEL #197 PARKS A. DOWNING AND ANN S. DOWNING PROPERTY  
2471 US HIGHWAY 21 SOUTH  
GLADE VALLEY, ALLEGHANY COUNTY, NORTH CAROLINA**

**NCDOT WBS ELEMENT 37044.1.1  
STATE PROJECT R-3101**

**January 13, 2012**

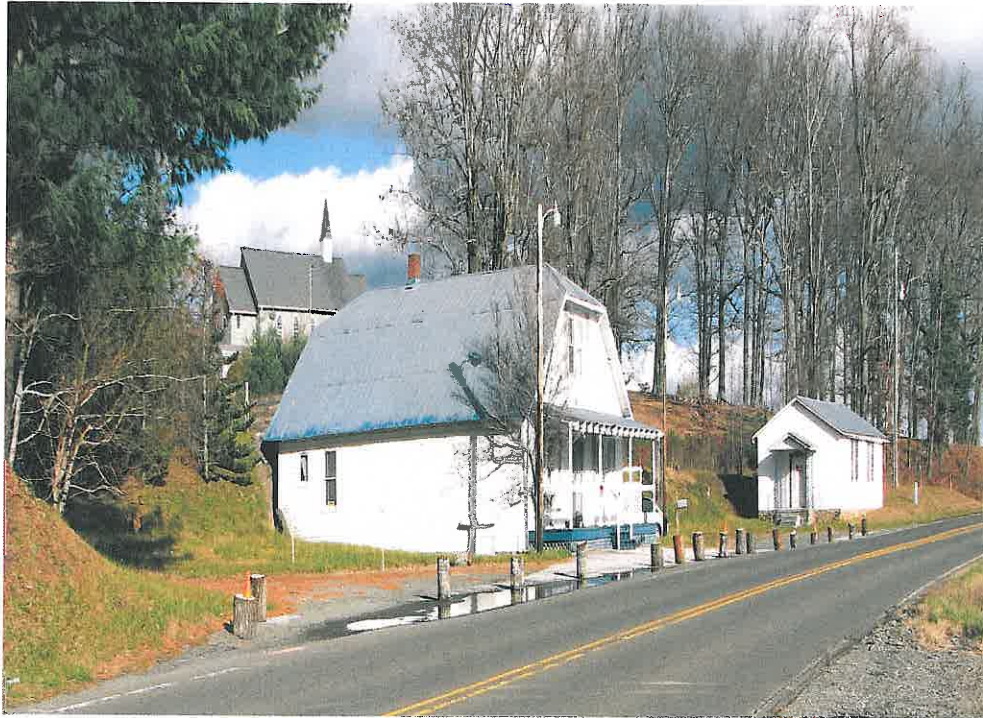
**Photograph 1** View of the site from west looking east.

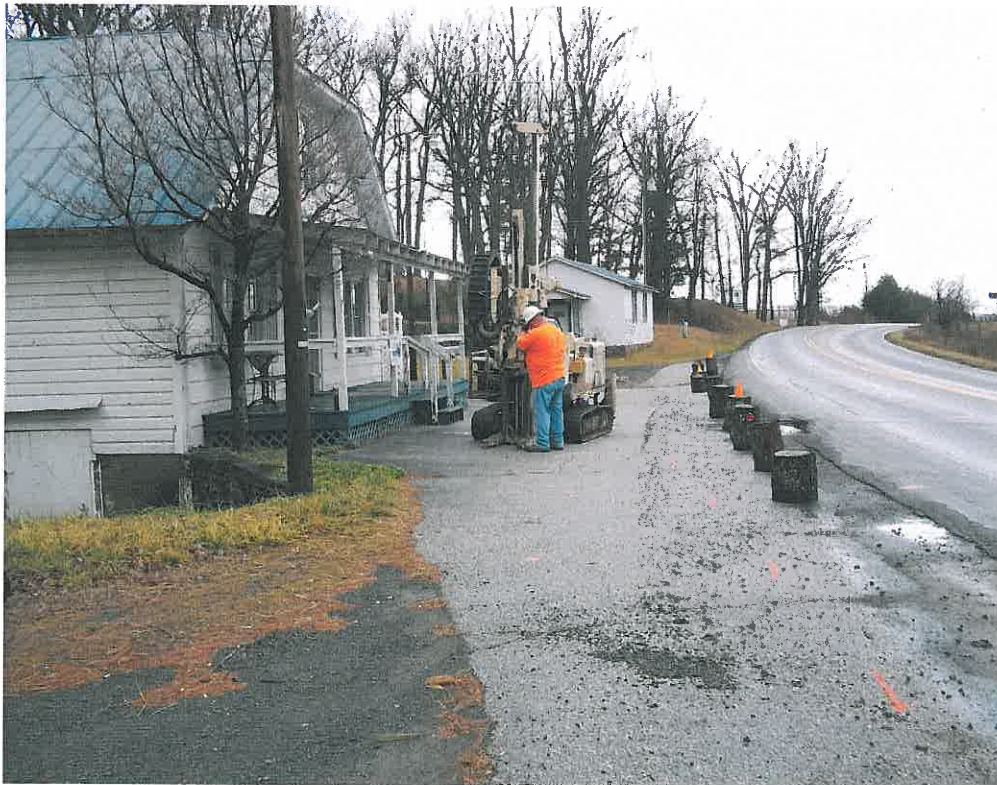
**Photograph 2** View of the proposed right-of-way from the west looking east.

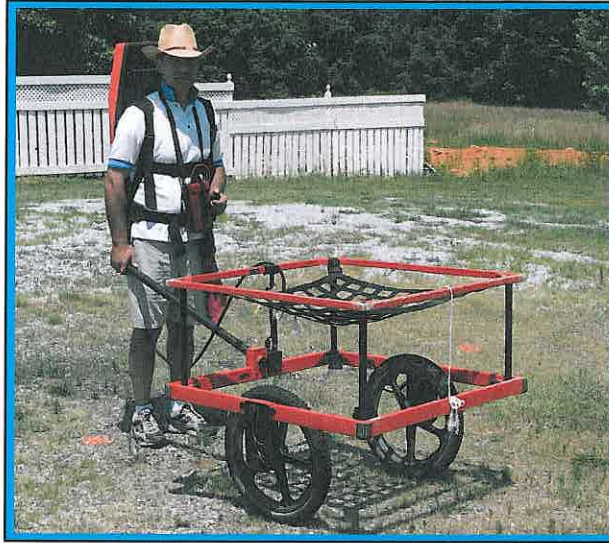
The photograph shows the Geonics EM61 metal detector that was used to conduct the metal detection survey across the proposed Right-of-Way area at Parcel 197 on November 11, 2011. Due to an absence of unexplained EM61 differential anomalies, ground penetrating radar scans were not performed at this site.

The geophysical investigation consisted of electromagnetic (EM) induction-metal detection surveys. The EM survey was performed on November 11, 2011 using a Geonics EM61-MK1 metal detection instrument. According to the instrument specifications, the EM61 can detect a metal drum down to a maximum depth of approximately 8 feet. Smaller objects (1-foot or less in size) can be detected to a maximum depth of 4 to 5 feet. All of the EM61 data were digitally collected at approximately 0.8 foot intervals along northwesterly-southeasterly parallel survey lines spaced five feet apart. All of the data were downloaded to a computer and reviewed in the field and office using the Geonics DAT61W and Surfer for Windows Version 7.0 software programs.

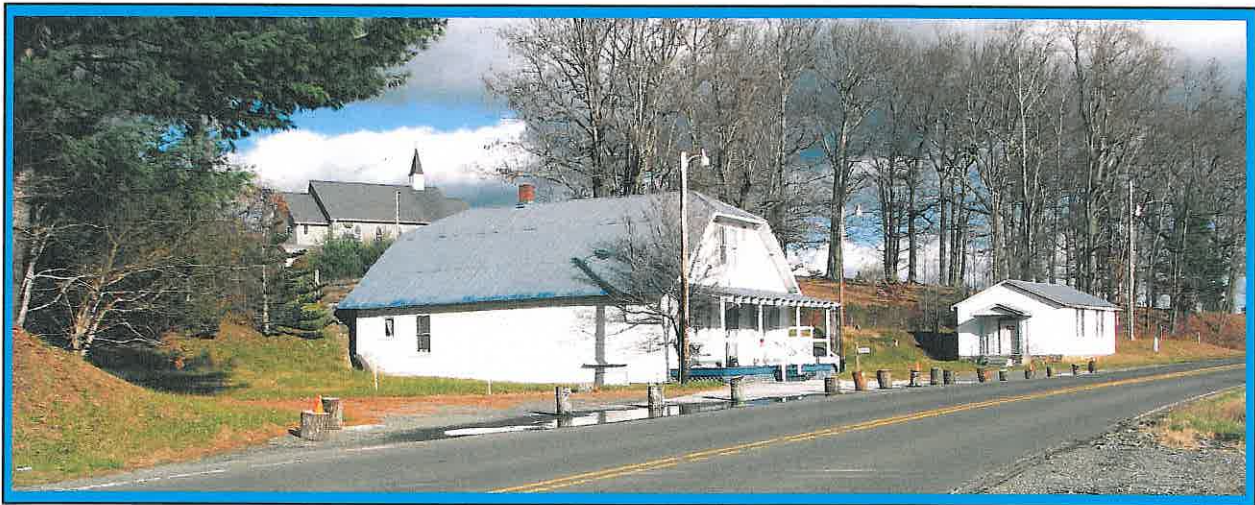
The photograph shows the front portion of the Parks and Ann Downing property (Parcel 197) located at 2471 US Highway 21 South, near Glade Valley, North Carolina. The geophysical investigation was performed across the front portion of the property. The photograph is viewed in an easterly direction.

NCDOT representative Mr. Ethan J. Caldwell, LG, PE provided site information which identified the geophysical survey area to Pyramid Environmental personnel during the week of October 17, 2011. Photographs of the geophysical equipment used in this investigation and the geophysical survey area of the Downing property are shown in **Figure 1**.
