**NC Department of Transportation  
Preliminary Site Assessment  
State Project: R-4047  
WBS Element: 34599.1.1**

**Michael Daggy Property  
Site #4  
October 23, 2009**

**AMEC Earth and Environmental, Inc. of North Carolina  
AMEC Project: 562114047**

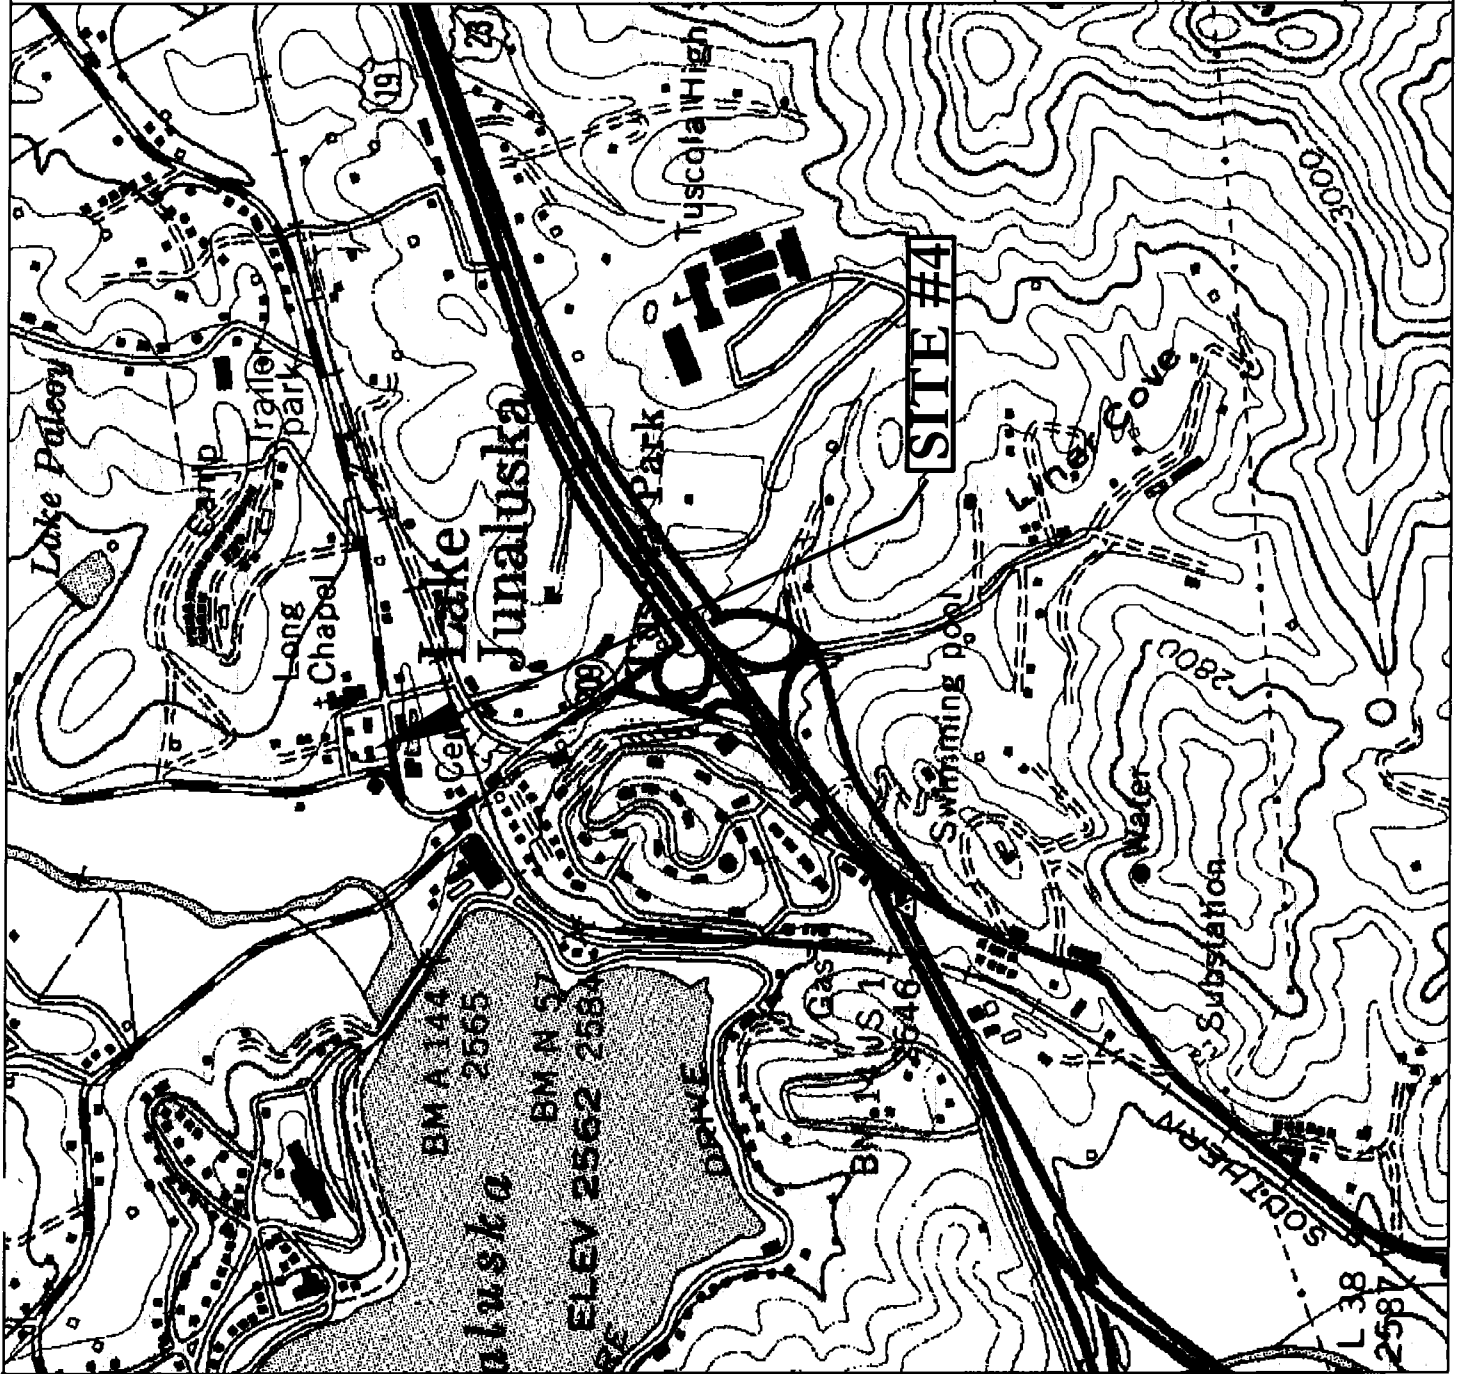
### VICINITY MAP

Site #4, Michael Daggy Property  
15 Old Clyde Road  
Haywood County, NC

The Michael Daggy Property is located on the east side of Hwy 209 (Crabtree Road) at the intersection of Old Clyde Rd in Waynesville, Haywood County, North Carolina. It is located within the Sedimentary and Metamorphic sediments of the Blue Ridge Belt Physiographic Province of western North Carolina. Figure 1 shows the site location and vicinity.

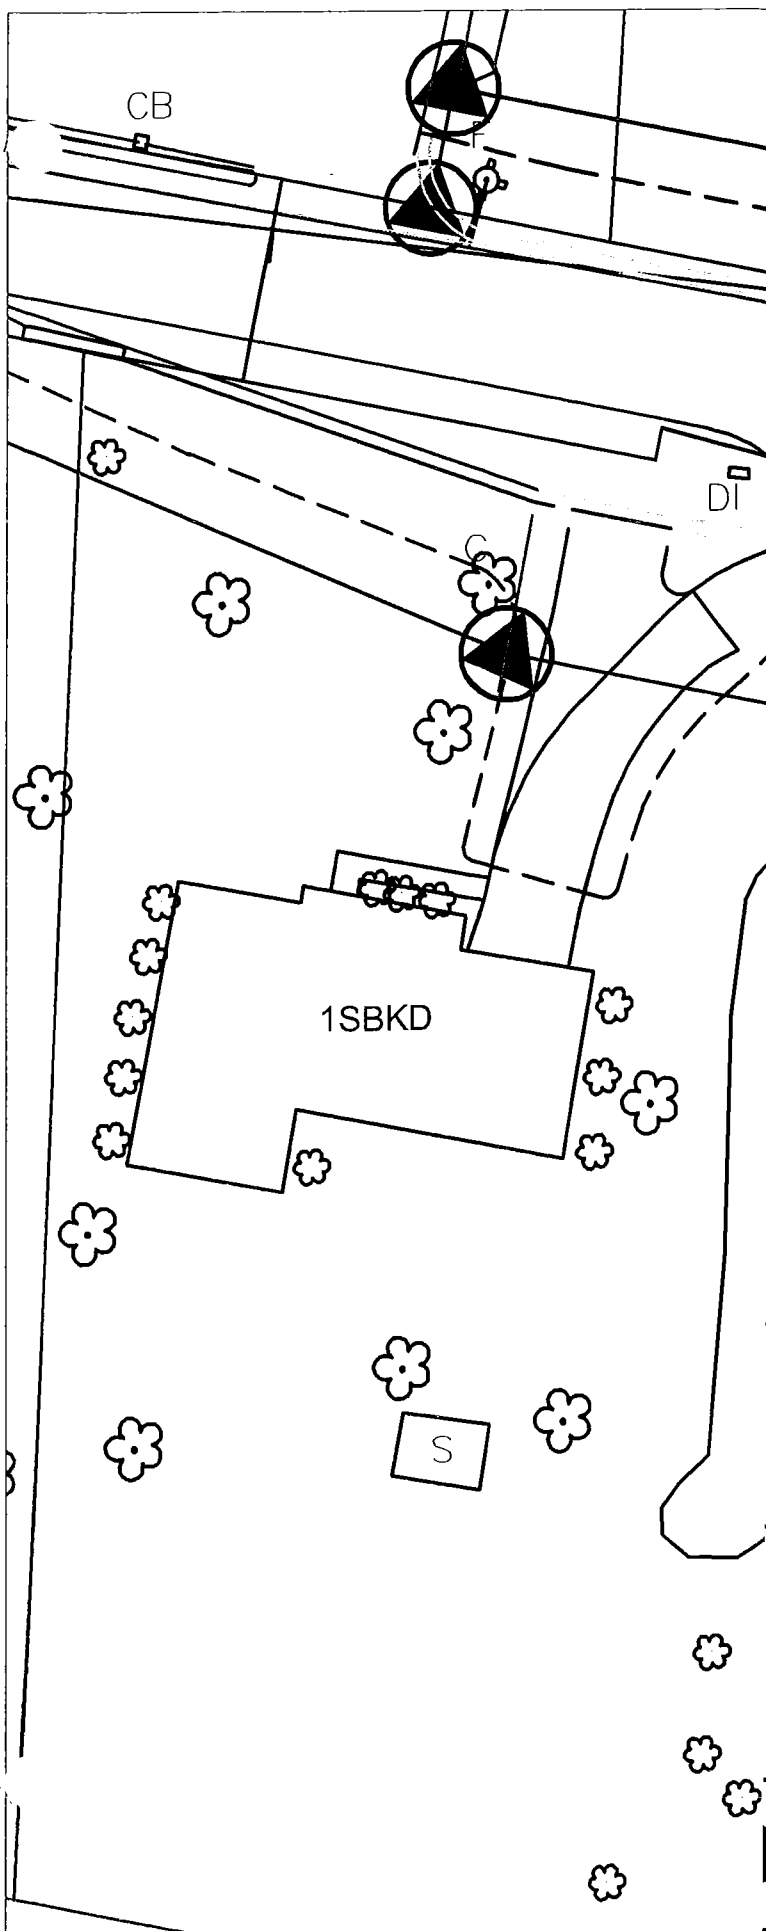
Figure 2  
 Site #4 Michael E. Daggy Property  
 Site Map

Soil boring occurred on September 1, 2009 at Site #4. Four direct push soil borings were located at the intersection of two corridors (Hwy 209 and Old Clyde Road) on Site #4. Figure 2 presents the Site Map with sample locations. Five borings were spread toward the northeast, in front of the existing building and three borings were spread toward the end of

the eastern corridor. These samples were staggered to optimize the likelihood of intercepting any potential soil contamination. Borings could not be located any more closely to the possible UST at the southernmost building corner due to a large sewer main in the subsurface that ran along the building front from northeast to southwest and a nearby above ground power pole.

One single story building with a basement level occupies the Site. The proposed road widening will traverse the length of Site #4. Figure 2 presents the Site Location Map. Appendix 1 includes a photo log for the Site. During reconnaissance, AMEC observed one monitoring well and from it recorded a total depth of 20.35 feet below ground surface (bgs) and a depth to groundwater of 13.3 feet bgs. A strong petroleum odor was evident during the measurements taking in this well, located on the east side of the building. Based on the report provided by Schnabel Engineering South of Greensboro, North Carolina, an anomaly was discovered near the southern corner of the building, suspected to be a UST, with a capacity of approximately 550 gallons.

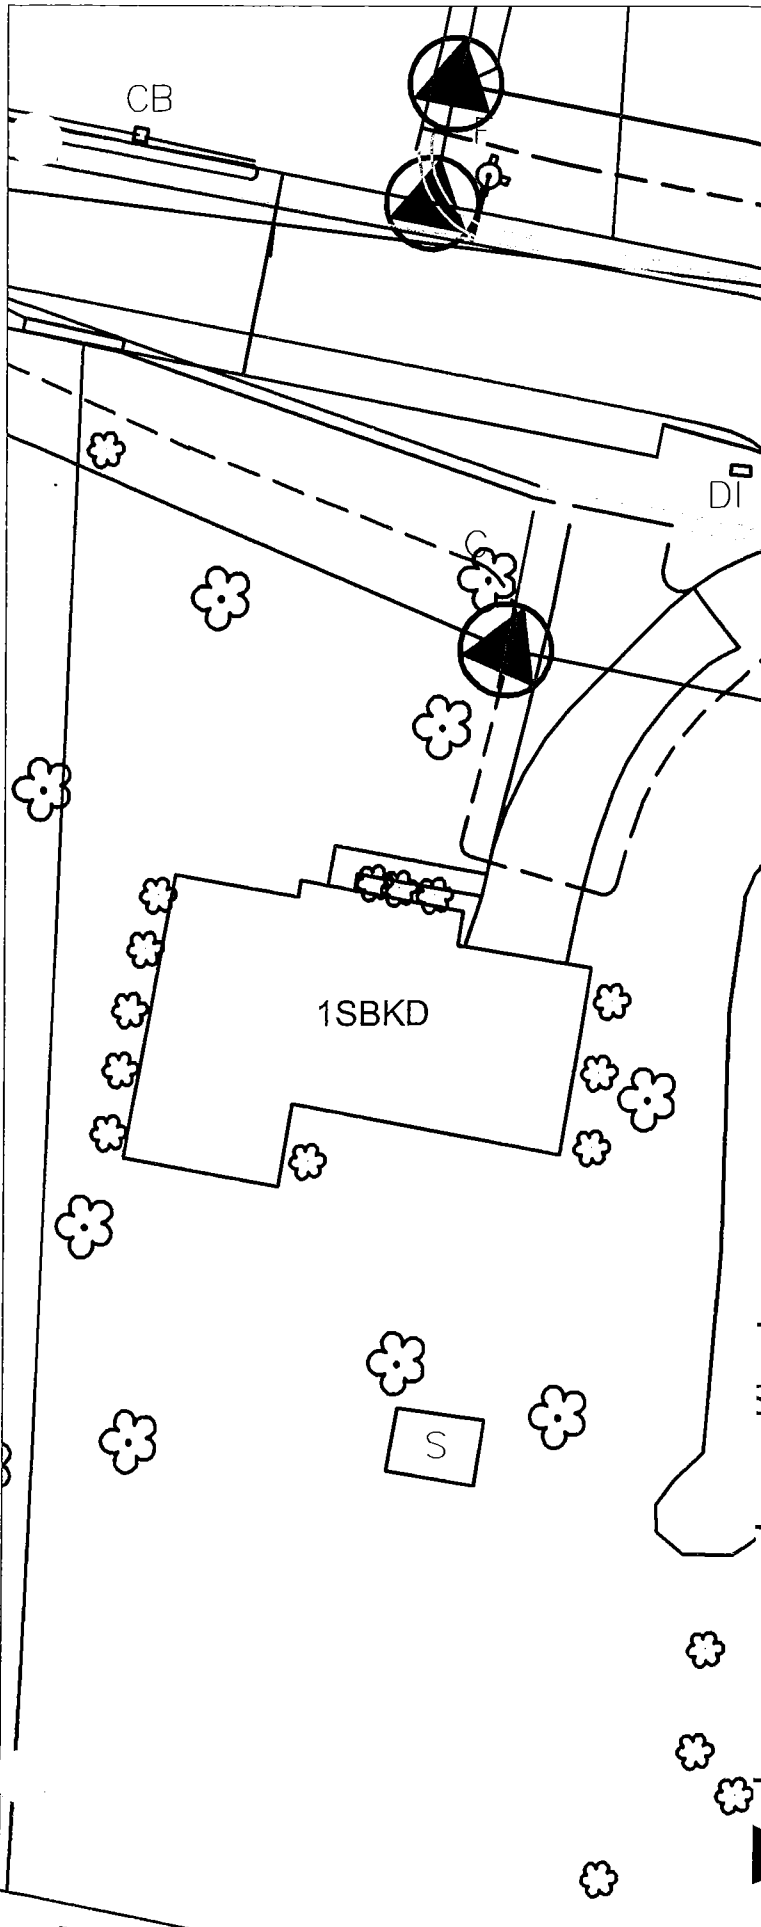
Figure 4  
 Site #4 Michael E. Daggy Property  
 Site Map With Potential Area  
 Of Soil Contamination

The only area of confirmed GRO/DRO contamination in soil was centered on borings SB-6 and SB-7. This is also the area with the existing monitoring well. The shallower samples in both borings did not indicate petroleum impact. The soil impact was identified within, on average, a 4 foot vertical section of soil located near the water table. However, the soil impact observed in boring SB-6 began at a shallower depth than in SB-7. This suggests that the source would be closer to SB-6 than SB-7 and could be the possible UST identified near the southern corner of the building. Existing underground and above ground utilities prevented drilling more borings closer to the UST. The area of the footprint of soil contamination based on soil borings done to date is shown on Figure 4, and is estimated to be 527 square feet. Assuming a 4 foot thickness, this volume of potentially impacted soil equates to 2,108 cubic feet or 78 cubic yards. This area, as drawn, is beyond the cut line and the proposed ROW, thus may not affect any roadway construction.

- The source area appears to be closer to boring SB-6 based on shallower identified soil impact in that boring. This soil boring is not within the proposed ROW. An estimated 78 cubic yards of impacted soil was calculated. However, the edge of this soil impact could possibly extend farther to the southeast into the proposed ROW in the area around the probable UST where drilling wasn't feasible due to utilities.

- The UST must be removed per the current UST guidelines, which will require additional soil sampling for closure. Excavation and proper disposal of petroleum-impacted soil may be necessary in conjunction with the UST removal.

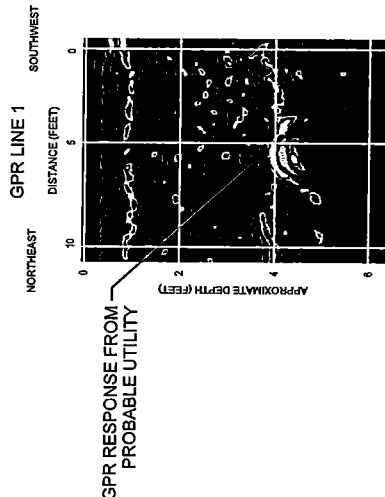
FIGURE 2

The contoured EM61 data are shown on Figures 2 and 3. The EM61 early time gate results are plotted on Figure 2. The early time gate data provide the more sensitive detection of metal object targets. Figure 3 shows the difference between the response of the top and bottom coils of the EM61 instrument (differential response). The difference is taken to remove the effect of surface and very shallowly buried metallic objects. Typically, the differential response emphasizes anomalies from deeper and larger objects such as UST's.

The early time gate and differential results show anomalies probably caused by buried utilities, reinforced concrete, and anomalies caused by known site features (Figures 2 and 3). GPR surveys near the southern corner of the building indicated the presence of two possible UST's. After further analysis of the GPR data, the western possible UST was determined to be more likely caused by a utility. Example GPR images showing the reflections from the eastern possible UST and the probable utility are included on Figures 2 and 3. Figures 2 and 3 also show the location of the possible UST as marked in the field. The GPR data indicate that the possible UST is buried about 2 to 3 feet below ground surface. The possible UST is about 3.5 feet in diameter and about 7.5 feet long, equivalent to a capacity of approximately 550 gallons.

Note: The contour plot shows the earliest and most sensitive time gate of the EM61 bottom coil/channel in millivolts (mV). The EM data was collected on August 3 through August 6, 2009, using a Geonics EM61-MK2 instrument. Positioning for the EM61 survey was provided using a submeter Trimble ProXRS DGPS system. Coordinates are in the US State Plane 1983 System, North Carolina Zone 3200, using the NAD 1983 datum. GPR data were acquired on August 12 and August 13, 2009, using a Geophysical Survey Systems SIR 3000 equipped with a 400 MHz antenna.

**SITE 4**  
**EM61 EARLY TIME**  
**GATE RESPONSE**

- The geophysical data indicate the presence of one possible UST within the accessible portions of Site 4 near the southern corner of the building. The possible UST is about 550-gallon capacity and is buried about 2 to 3 feet below ground surface.
- A second possible UST was marked in the field but later interpretation of the data indicates that this is more likely to be a buried utility line.
