Preliminary Site Assessment Report Tsoumbos Aristotelis Property

Parcel 202 Durham Durham County, North Carolina

H&H Job No. ROW-416 State Project U-0071 WBS Element #34745.1.1 August 15, 2013

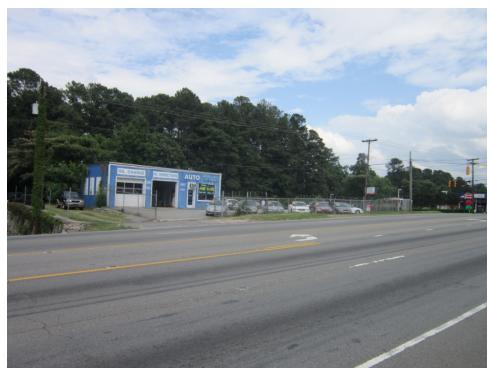
Figure 5 - Parcel 202 Photos of Possible UST Location

Parcel 202 (Tsoumbos Aristotelis Property), looking southeast

evidence characteristic of the interpreted UST. The location of Possible UST No. 1 is shown on Figures 3 and 4. Example GPR images from lines oriented over the marked location of Possible UST No. 1 are also shown on Figures 3 and 4. The GPR data suggests the top of Possible UST No. 1 is approximately 1.0 to 2.0 feet below ground surface and that the possible UST is about 3.5 feet in diameter and about 7.5 feet long, equivalent to a capacity of a 560 gallon UST. Photographs of the approximate location of the possible UST that was marked in the field are included on Figure 5.

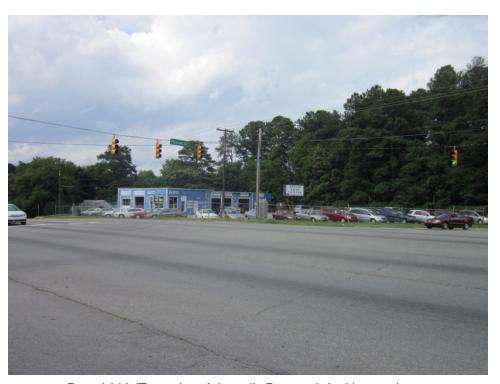
Parcel 202 (Tsoumbos Aristotelis Property), looking northeast

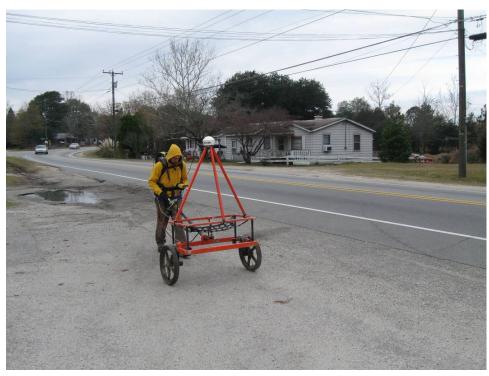
Geonics EM61-MK2 Metal Detector with Trimble DGPS Unit

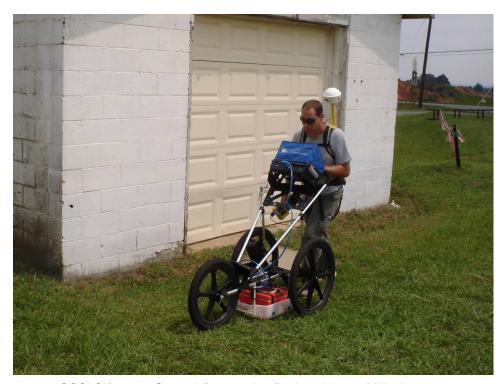
GSSI SIR-3000 Ground-Penetrating Radar with 400 MHz Antenna

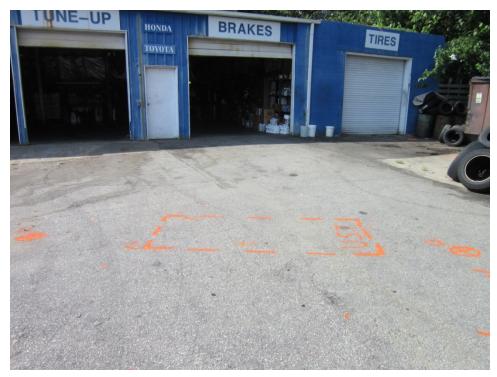
Parcel 202 (Tsoumbos Aristotelis Property), looking north. Photo shows approximate marked location of Possible UST No. 1 near the south side of the building.

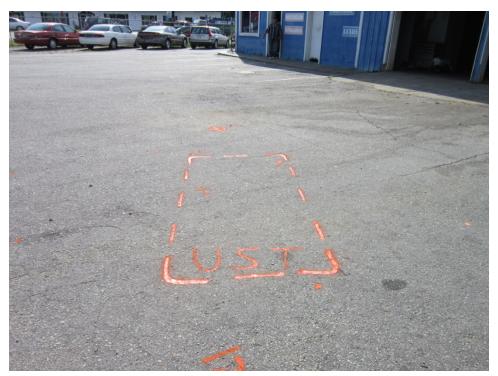
Parcel 202 (Tsoumbos Aristotelis Property), looking west. Photo shows approximate marked location of Possible UST No. 1 near the south side of the building.
