# PRELIMINARY SITE ASSESSMENT

ROYCE LEE COLLINS PROPERTY (PARCEL #13)
6524 US Highway 401
Kipling, NC

State Project: R-5523 WBS Element: 45548.1.1 F&R Project #66R-3222

June 9, 2014

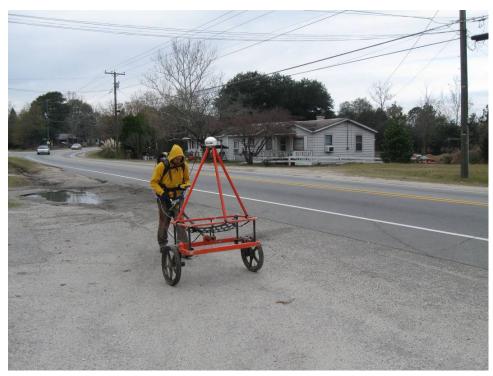
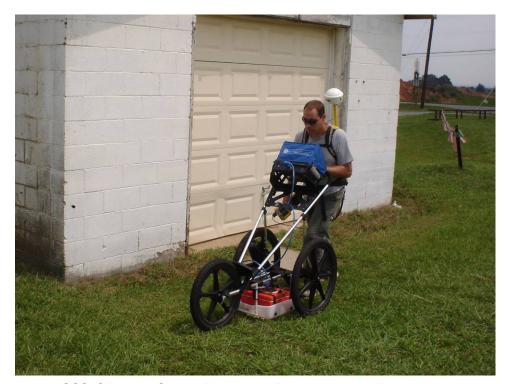
STATE PROJECT R-5523 NC DEPT. OF TRANSPORTATION HARNETT CO., NORTH CAROLINA PROJECT NO. 11821014.35 PHOTOS OF GEOPHYSICAL EQUIPMENT USED

Photographs of the equipment used are shown on Figure 2.

Geonics EM61-MK2 Metal Detector with Trimble DGPS Unit

GSSI SIR-3000 Ground-Penetrating Radar with 400 MHz Antenna

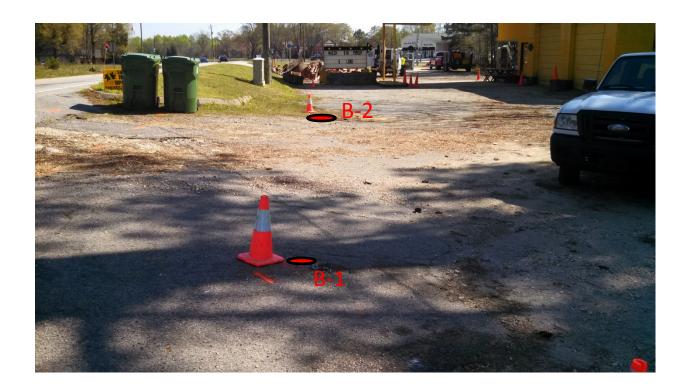
**Photo #1:** Boring locations B-1 and B-2, facing northeast

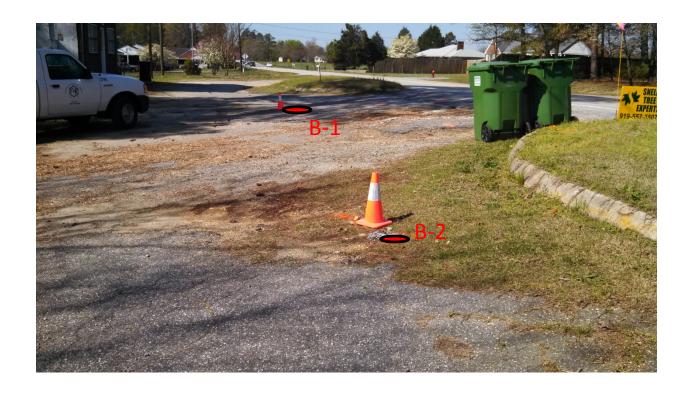
Photo #2: Boring locations B-1 and B-2, facing southwest

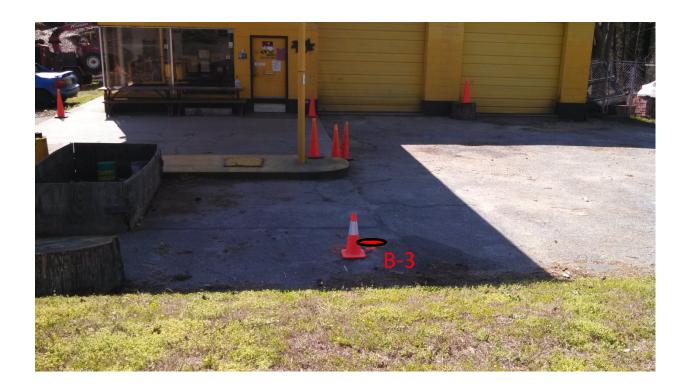
**Photo #3:** Boring location B-3, facing southeast

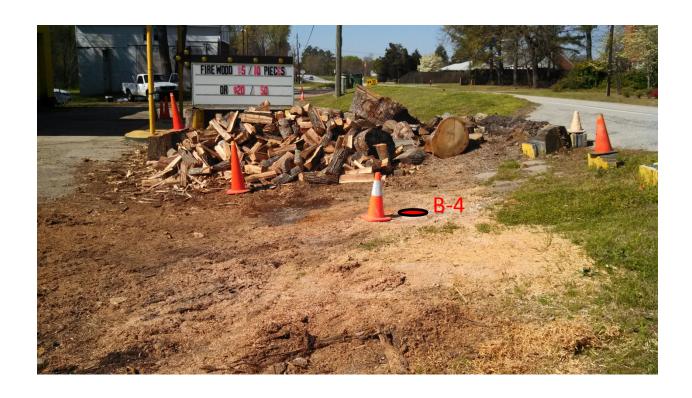
Photo #4: Boring location B-4, facing southwest
