**PRELIMINARY SITE ASSESSMENT
STAFFORD LAND COMPANY PROPERTY – PARCEL 022
JOHNSON BEAUTY CENTER
2281 RAY ROAD
SPRING LAKE, HARNETT COUNTY, NORTH CAROLINA
STATE PROJECT: U-3465
WBS ELEMNT: 39017.1.1
OCTOBER 24, 2012**

**PRELIMINARY SITE ASSESSMENT
STAFFORD LAND COMPANY PROPERTY – PARCEL 022
JOHNSON BEAUTY CENTER
SPRING LAKE, HARNETT COUNTY, NORTH CAROLINA**

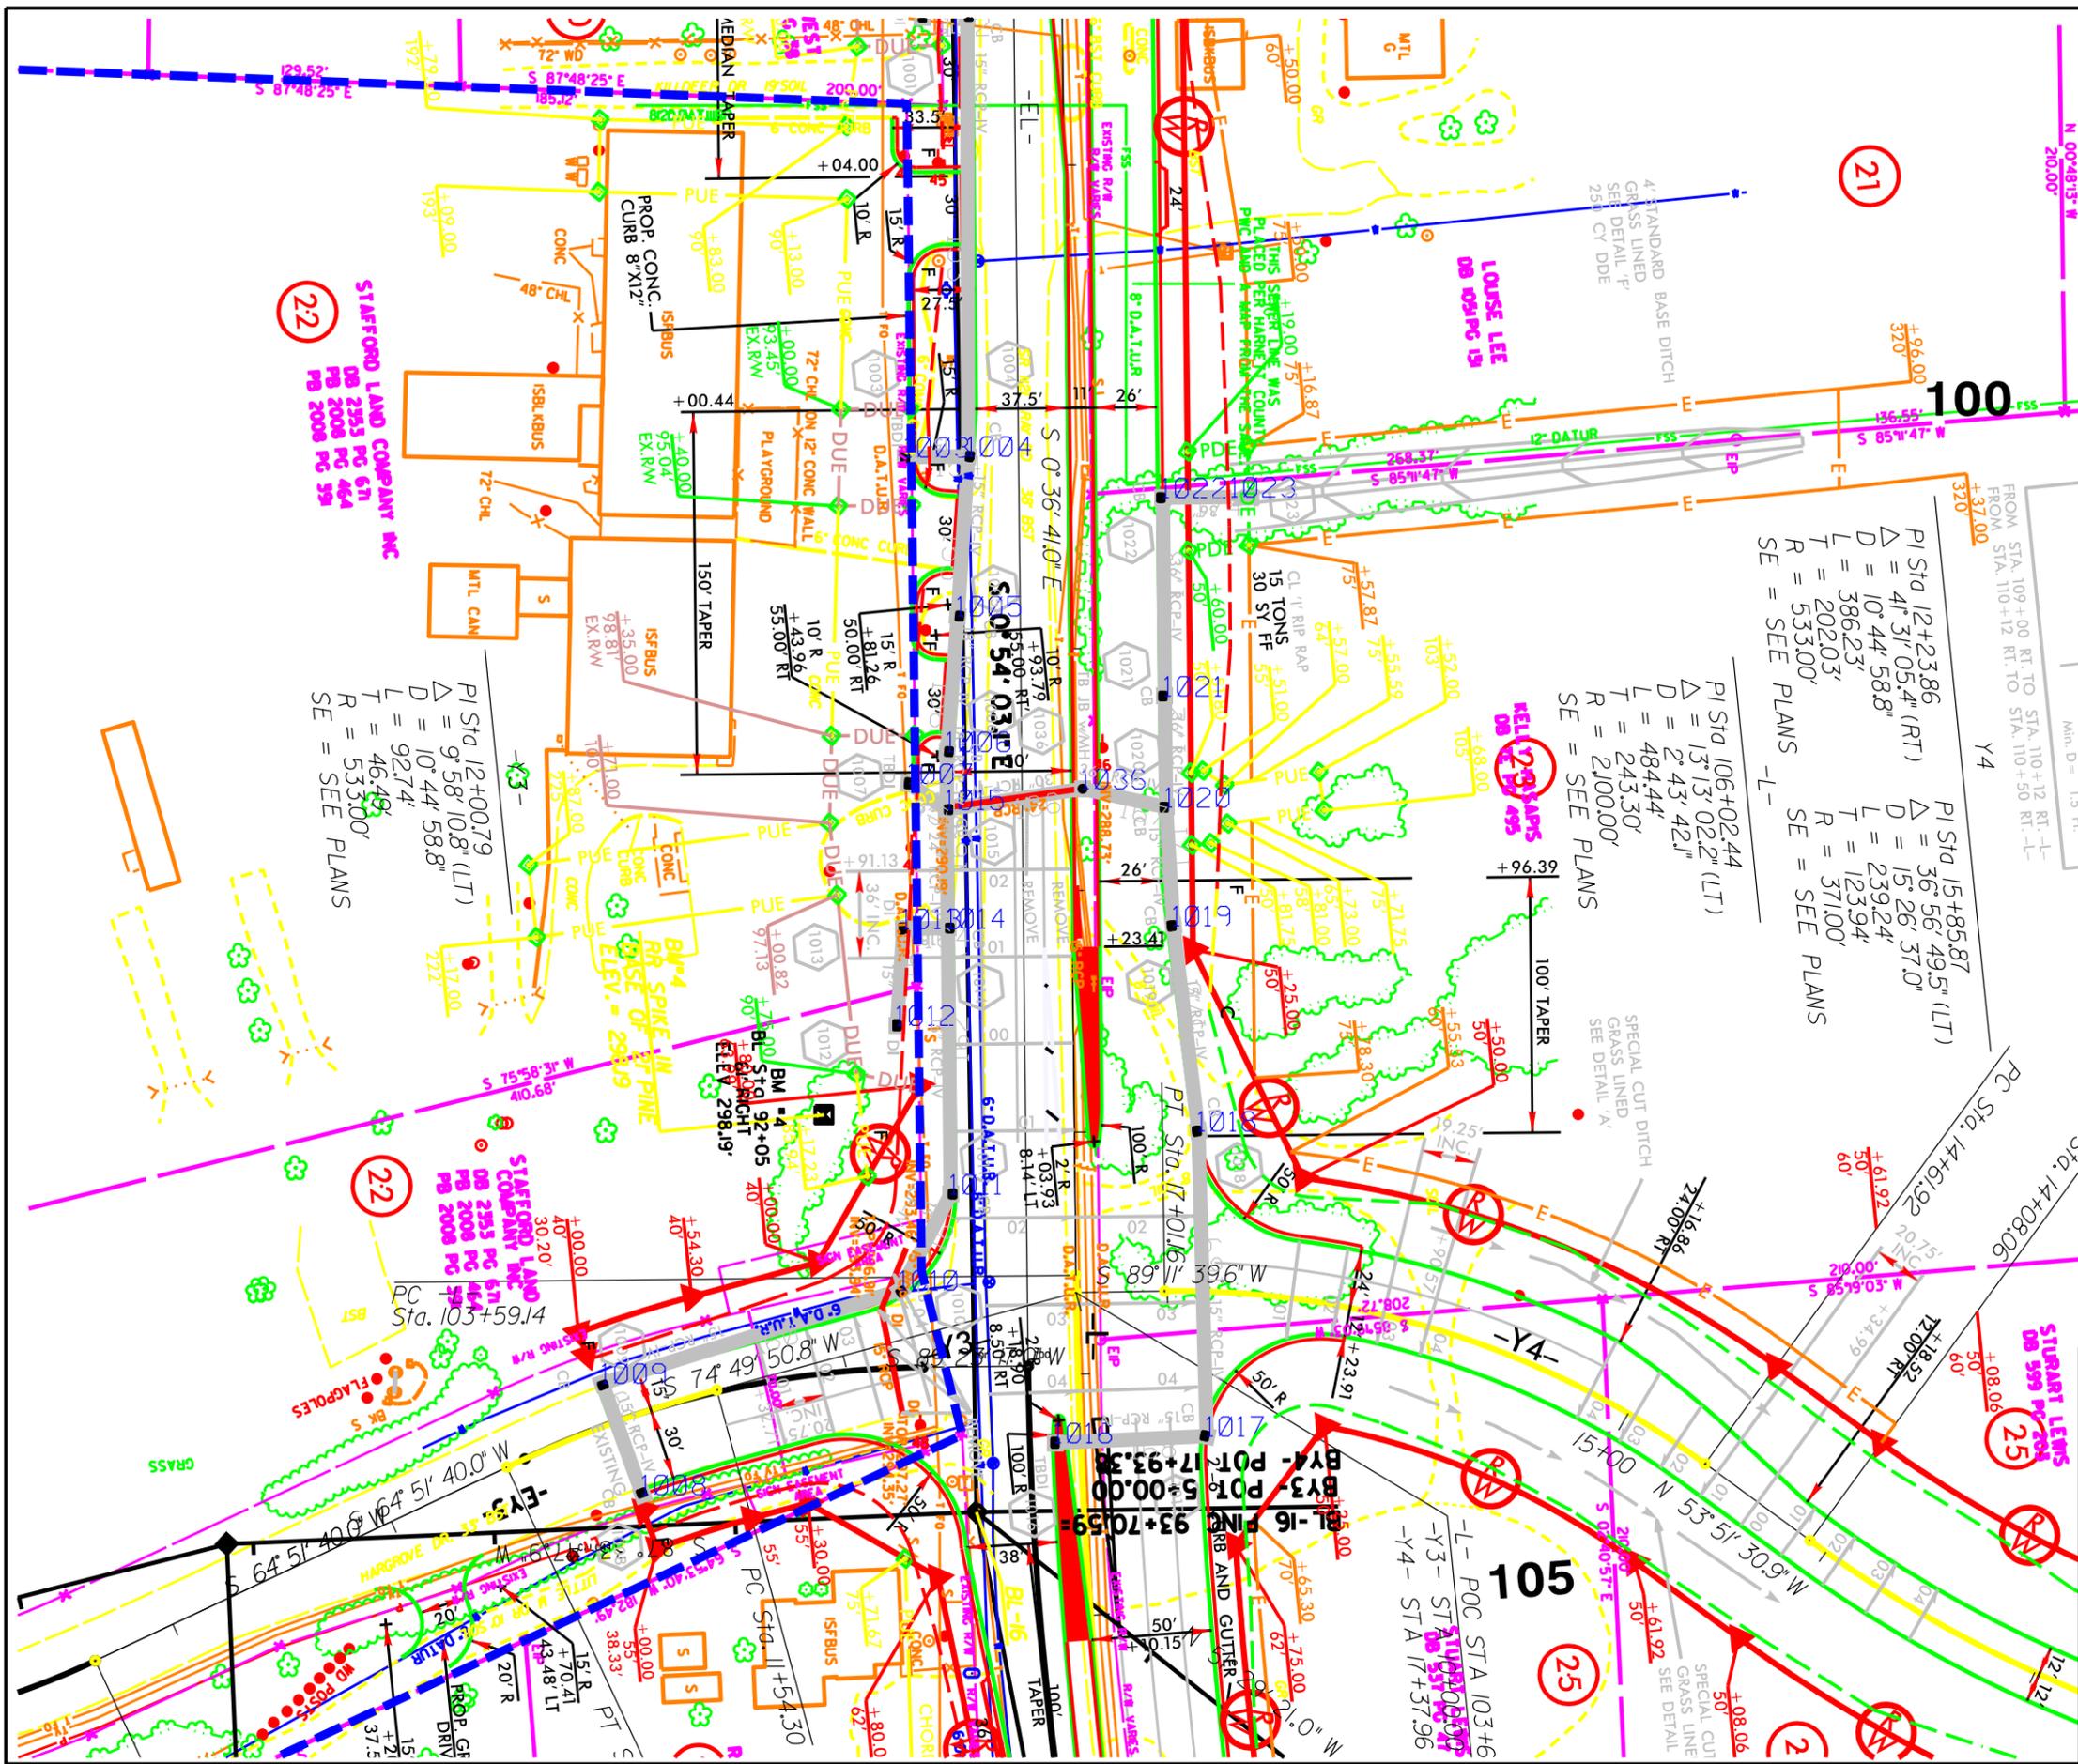
On September 13, 2012, Pyramid mobilized to the site to drill soil borings, install a temporary monitoring well, and collect the proposed soil samples and groundwater sample for the PSA. The soil borings and temporary well were completed using a track mounted Geoprobe® Direct-Push rig. Four (4) soil borings (22-1, 22-2, 22-3, and 22-4) were advanced on the subject property between the NCDOT ROW, Easement, and proposed utility easement. Soil boring 22-1 was installed between the ROW and Ray Road just north of Highgrove Road. Borings 22-2 and 22-4 were installed between the proposed utility easement and Ray Road along the ROW. Soil boring 22-3 was installed down-gradient of a possible UST in the proposed utility easement. The selected locations were chosen to avoid public utilities along Ray Road and private utilities associated with the former business. The locations of the borings are shown on **Figure 2**.

The laboratory results for soil samples 22-1(2-5), 22-2(5-7.5), 22-3(5-7.5), and 22-4(3-5) did not detect any TPH-DRO or TPH-GRO above laboratory detection limits. The soil sample laboratory results are summarized in **Table 2**. A copy of the laboratory report and chain-of-custody is included in **Appendix E**.

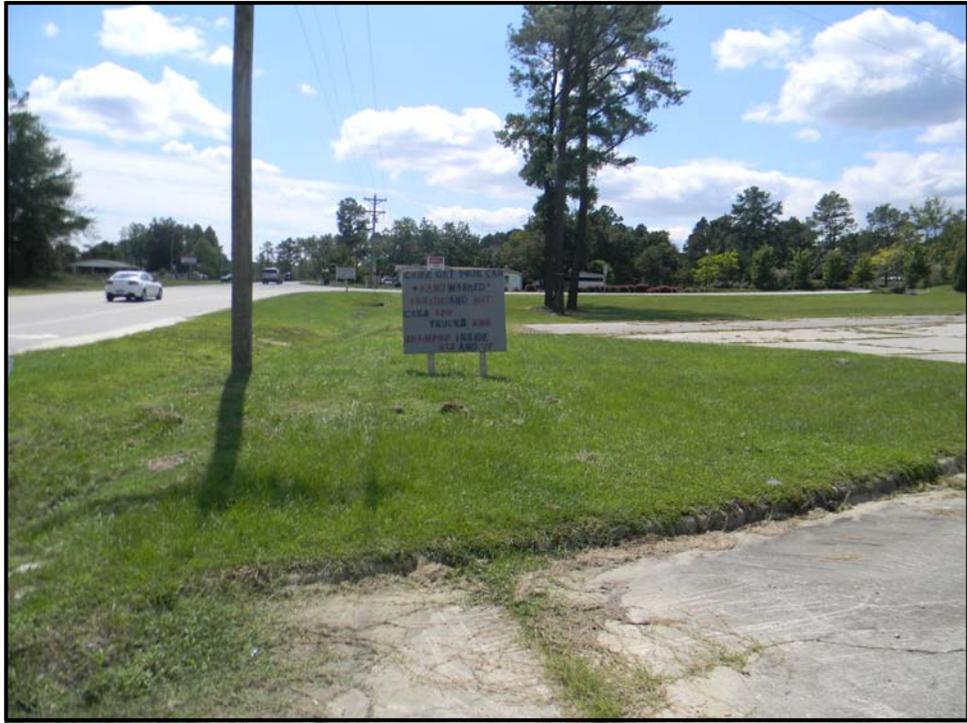
Photograph of portion of survey area, facing approximately south

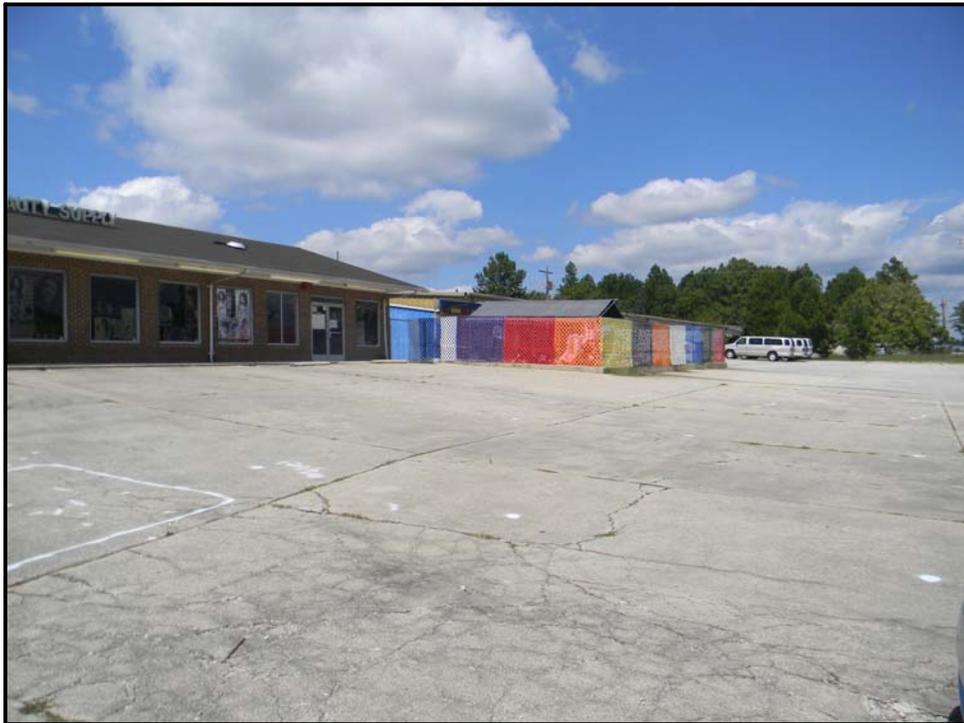
Photograph of portion of portion of survey area, facing approximately north

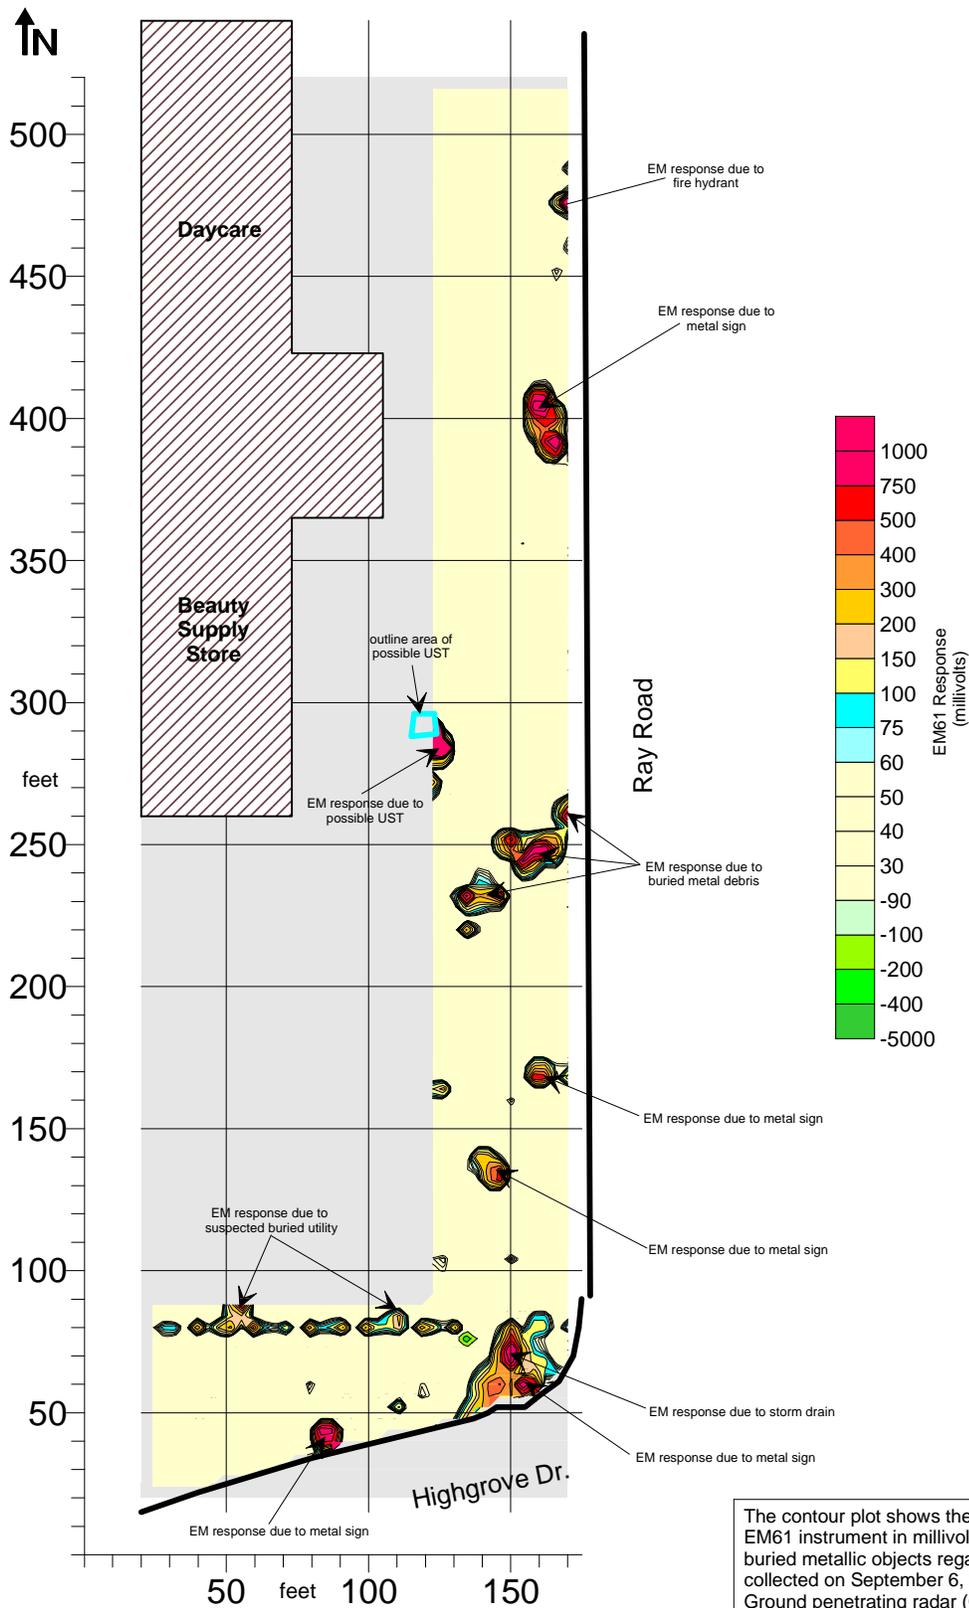
The contour plot shows the bottom coil (most sensitive) results of the EM61 instrument in millivolts (mV). The bottom coil response shows buried metallic objects regardless of size. The EM61 data were collected on September 6, 2012 using a Geonics EM61 instrument. Ground penetrating radar (GPR) data were acquired across selected EM61 anomalies on September 7, 2012, using a Geophysical Survey Systems SIR 3000 instrument with a 400 MHz antenna.

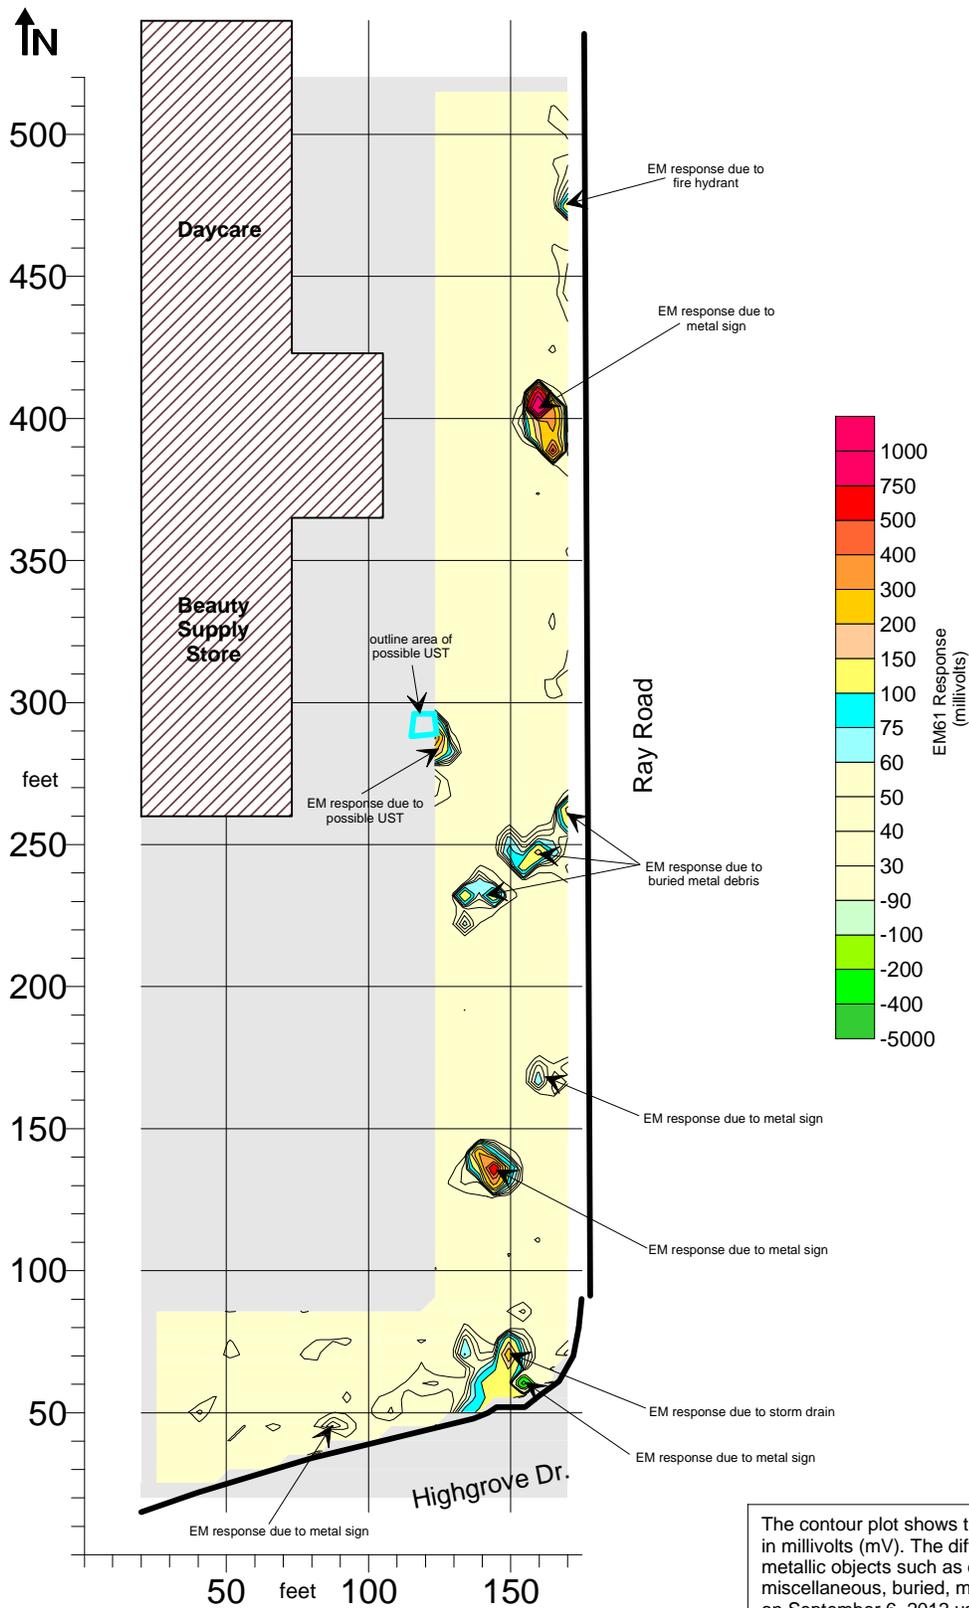
EM61 DIFFERENTIAL RESPONSE CONTOURS

The contour plot shows the differential results of the EM61 instrument in millivolts (mV). The differential response focuses on larger, buried metallic objects such as drums and USTs and ignores smaller miscellaneous, buried, metal debris. The EM61 data were collected on September 6, 2012 using a Geonics EM61 instrument. Ground penetrating radar (GPR) data were acquired across selected EM61 Anomalies on September 7, 2012 using a Geophysical Survey Systems SIR 3000 instrument with a 400 MHz antenna.

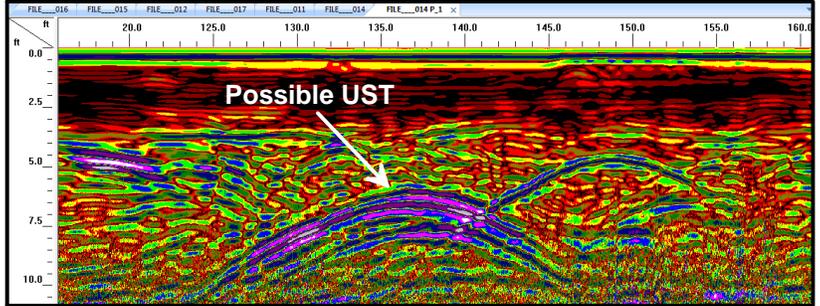
GPR Transect Image Across Possible Metallic UST

characteristics that were consistent with a possible metallic UST; however, the shape of the object appeared to be spherical rather than elongated like a typical UST, and thus this anomaly is classified as a Possible UST. The possible tank was observed to exhibit an average width of approximately 15 feet and was at a depth of approximately 7 feet below land surface (bls).

GPR scans were performed to verify the buried debris and further investigate a possible metallic UST recorded during the EM survey. The anomaly in front of the Beauty Supply Store exhibited characteristics that were consistent with a possible metallic UST, however, the shape of the object appeared to be spherical rather than elongated like a typical UST, and thus this anomaly is classified as a Possible UST. The possible tank was observed to exhibit an average width of approximately 15 feet and was at a depth of approximately 7 feet bls.

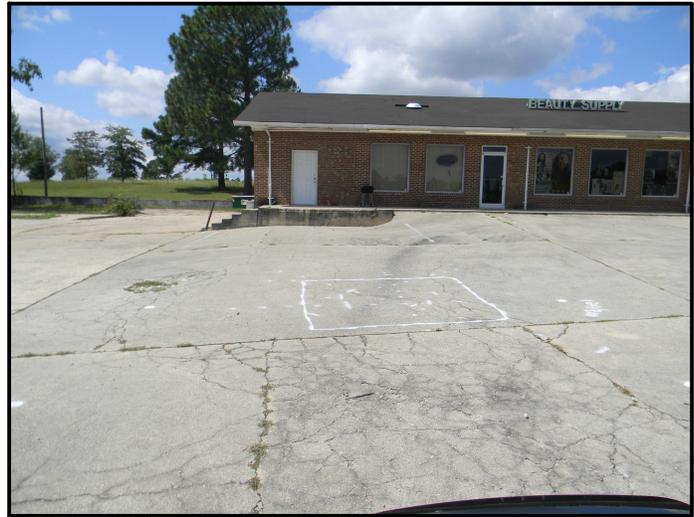
Approximate Location of Possible Metallic UST

The geophysical investigation provides evidence that the area containing the proposed ROW and easement at Parcel 022 contains a possible metallic UST to the east of the Beauty Supply Store building. The full details of the geophysical investigation are included in the Geophysical Investigation Report as **Appendix C**.
