PRELIMINARY SITE ASSESSMENT
STUART LEWIS PROPERTY – PARCEL 071
STANLEY FENCING COMPANY
14120 NC 210 SOUTH
SPRING LAKE, HARNETT COUNTY, NORTH CAROLINA
STATE PROJECT: U-3465
WBS ELEMNT: 39017.1.1
December 17, 2012

**PRELIMINARY SITE ASSESSMENT
STUART LEWIS PROPERTY – PARCEL 071
STANLEY FENCING COMPANY
SPRING LAKE, HARNETT COUNTY, NORTH CAROLINA**

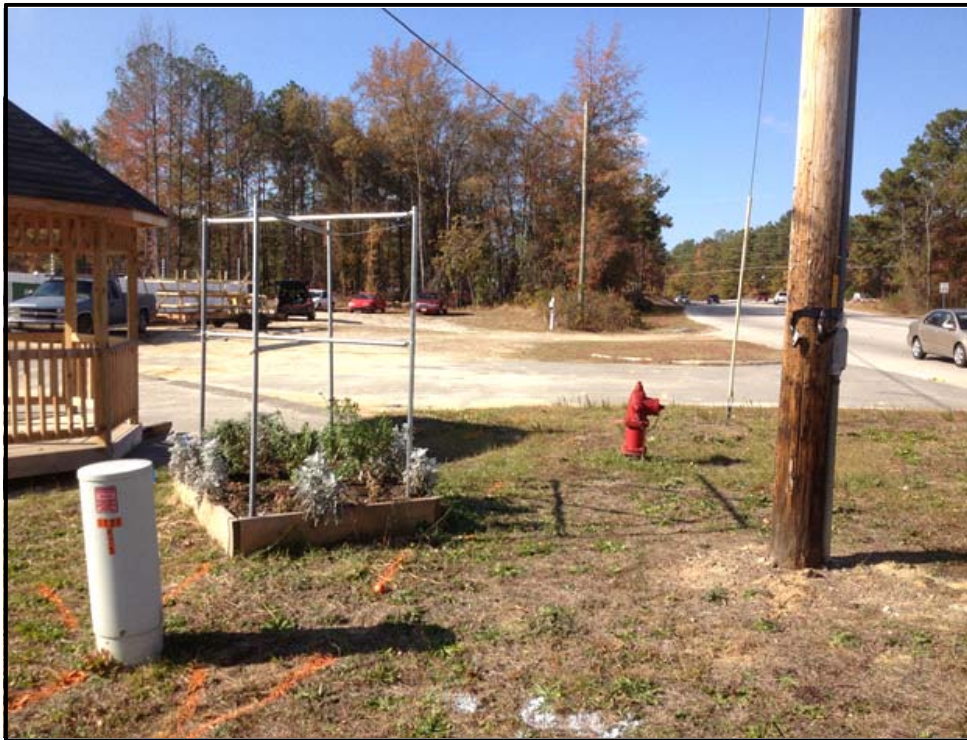
Photograph of survey area, facing approximately north

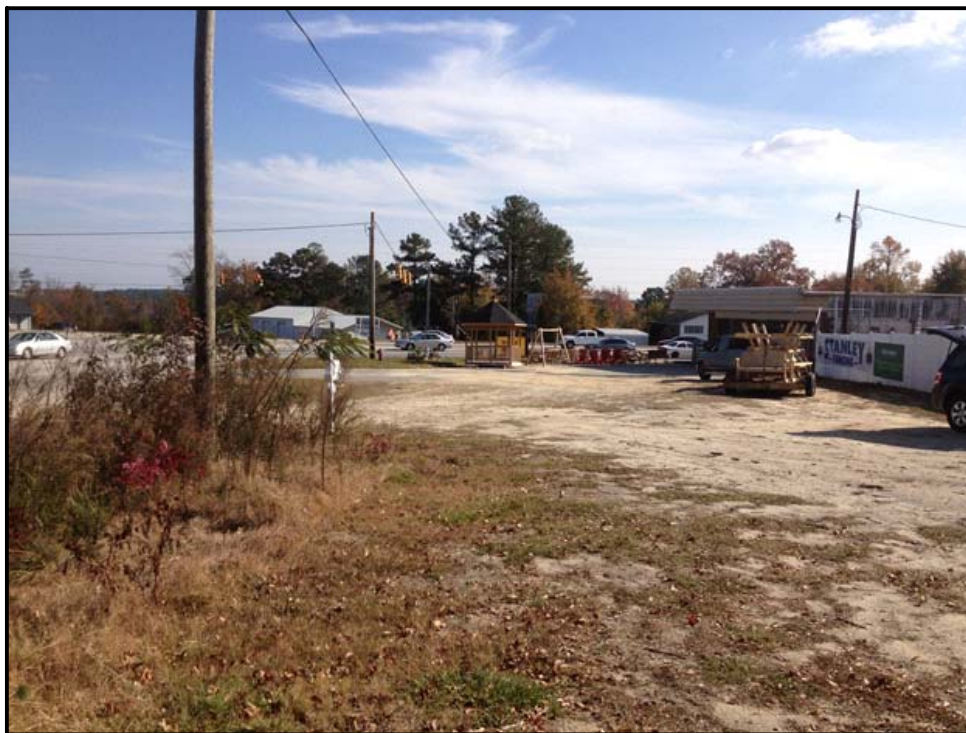
Photograph of survey area, facing approximately south
