Reference: Preliminary Site Assessment
Gilliani Property
1426 US 19 East
Spruce Pine, Mitchell County, North Carolina
NCDOT Tip No. R-2519B
WBS Element 35609.1.1
Earth Tech Project No. 105676

TABLE 1
SOIL FIELD SCREENING AND ANALYTICAL RESULTS
GILLIANI PROPERTY
SPRUCE PINE, MITCHELL COUNTY, NORTH CAROLINA
NCDOT PROJECT NO. R-2519B
WBS ELEMENT 35609.1.1
EARTH TECH PROJECT NO. 105676

GEOPHYSICAL INVESTIGATION REPORT

**GILLIANI PROPERTY (SAMIR'S 8 STORE)
Spruce Pine, North Carolina**

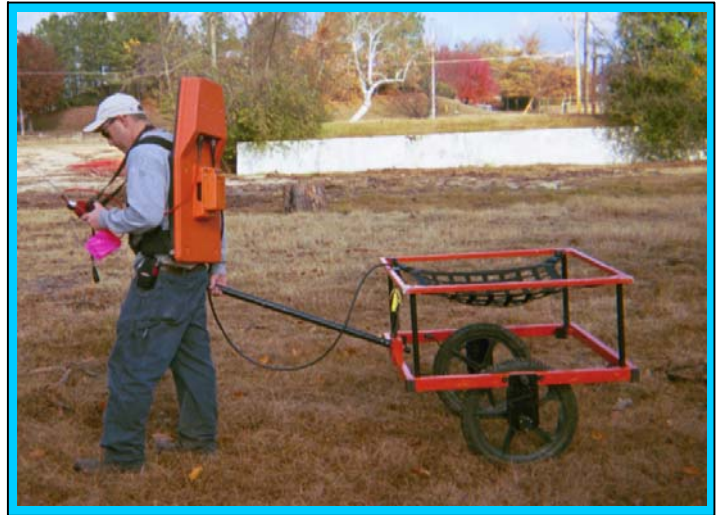
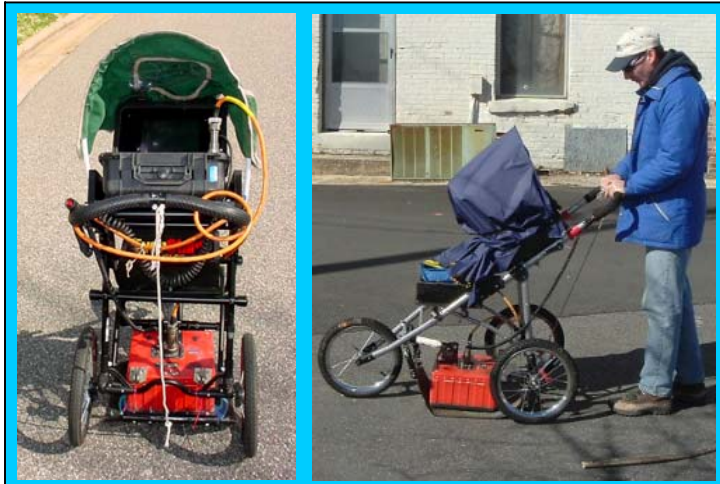
The photographs show the SIR-2000 GPR system equipped with a 400 MHz antenna that were used to conduct the ground penetrating radar investigation at the Gilliani property on August 8, 2008.

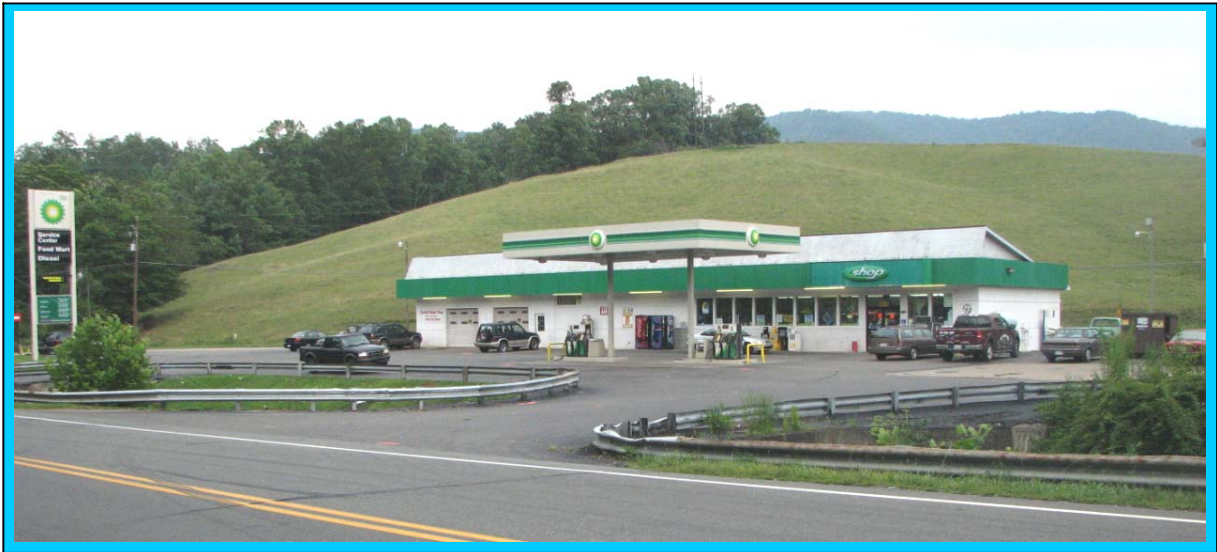
The photograph shows a portion of the geophysical survey area located at the Gilliani property. The photograph is viewed in a southeasterly direction.
