Reference: Preliminary Site Assessment
Barbara Huskins Property (Parcel #118)
Route 1, Box 251, US 19E
Spruce Pine, Mitchell County, North Carolina
NCDOT Tip No. R-2519B
WBS Element 35609.1.1
AECOM Project No. 60241470

GEOPHYSICAL INVESTIGATION REPORT

BARBARA HUSKINS PROPERTY - PARCEL 118

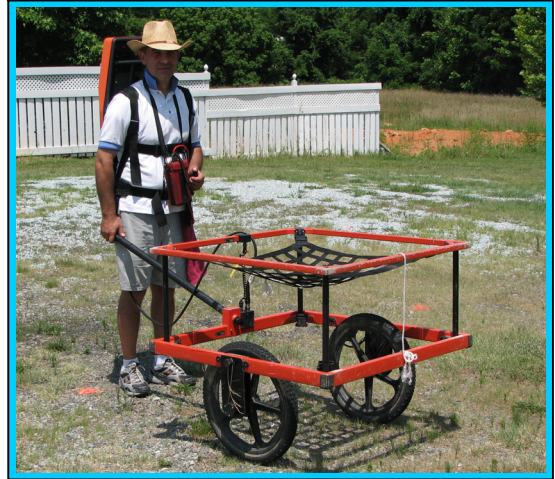
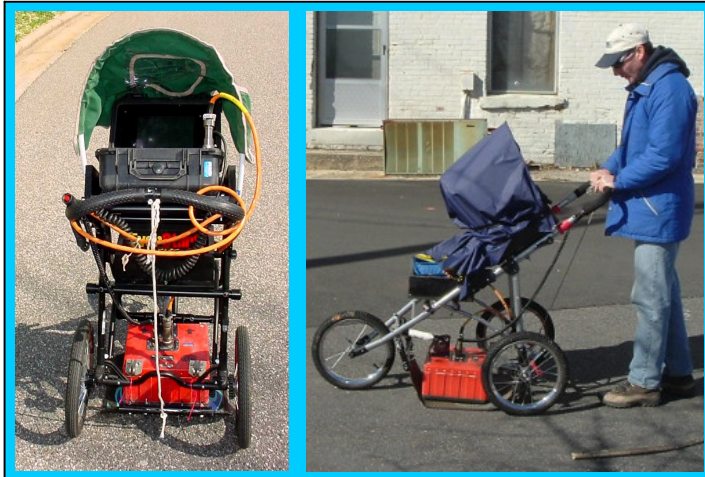
The photographs show the SIR-2000 GPR system equipped with a 400 MHz antenna that were used to conduct the ground penetrating radar investigation at the Huskins property on February 15, 2012.

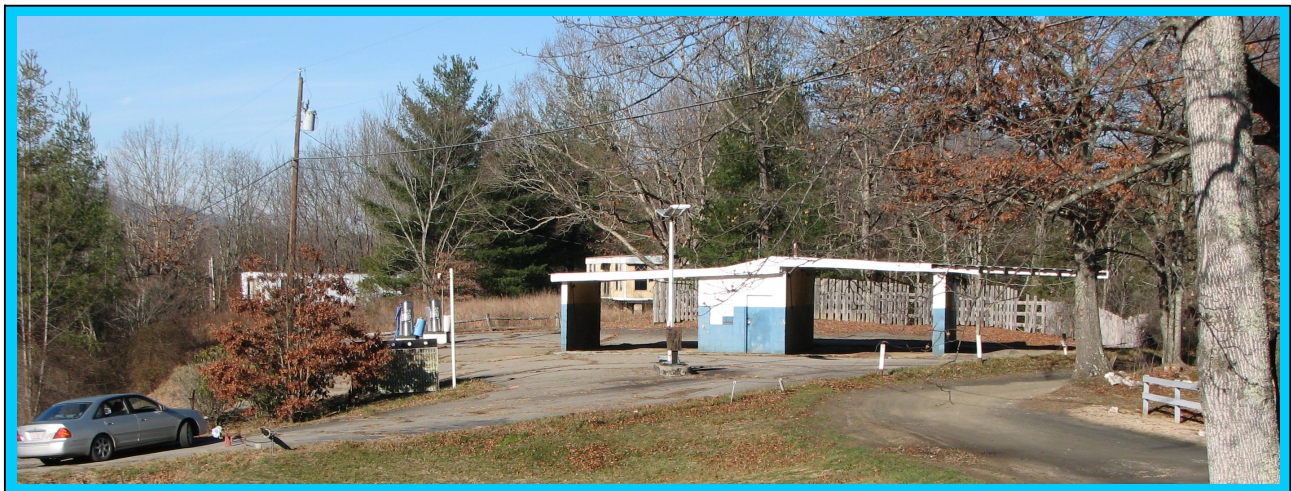
The photograph shows the Barbara Huskins property (Parcel 118) located near the intersection of US 19E and Windy Cove Drive in Mitchell County, North Carolina. The photograph is viewed in a westerly direction.

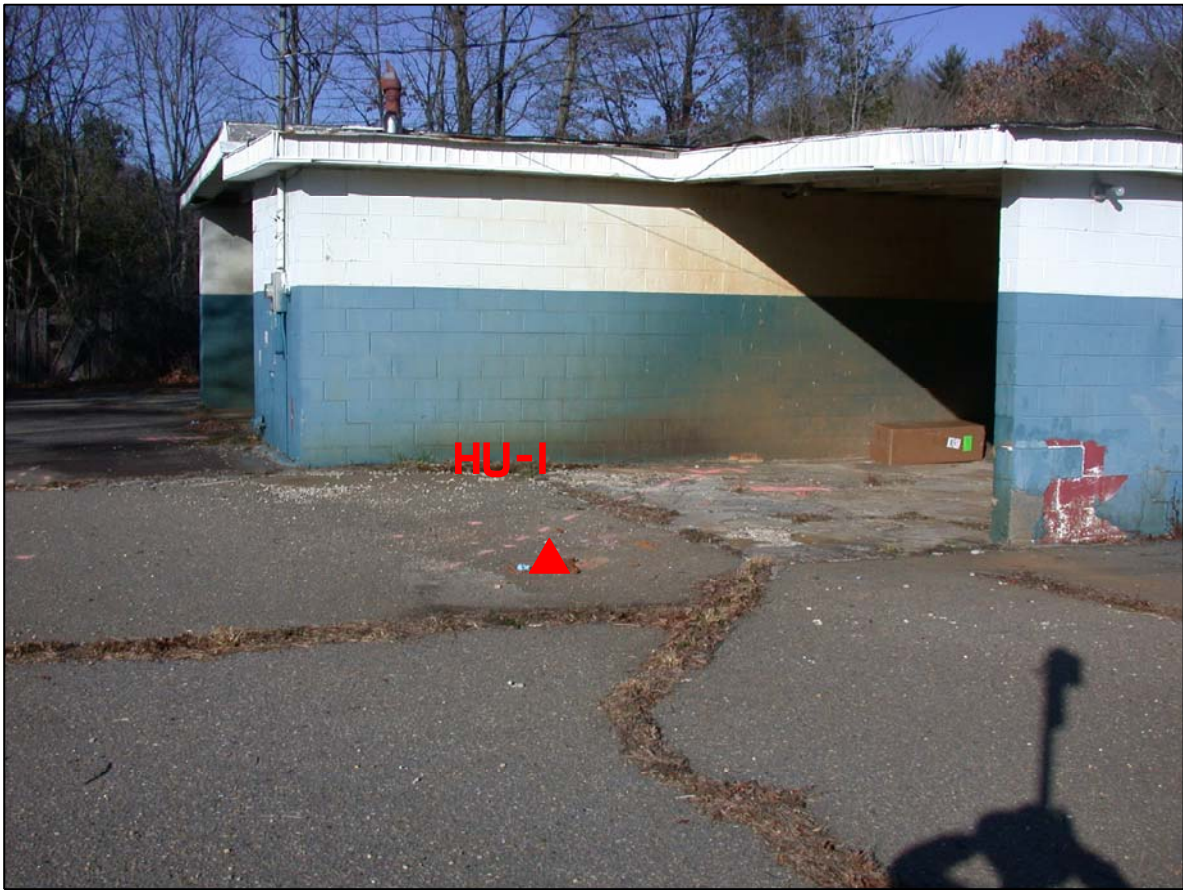
PHOTO 1 - BORING ON WEST SIDE OF CAR WASH LOOKING NORTHEAST

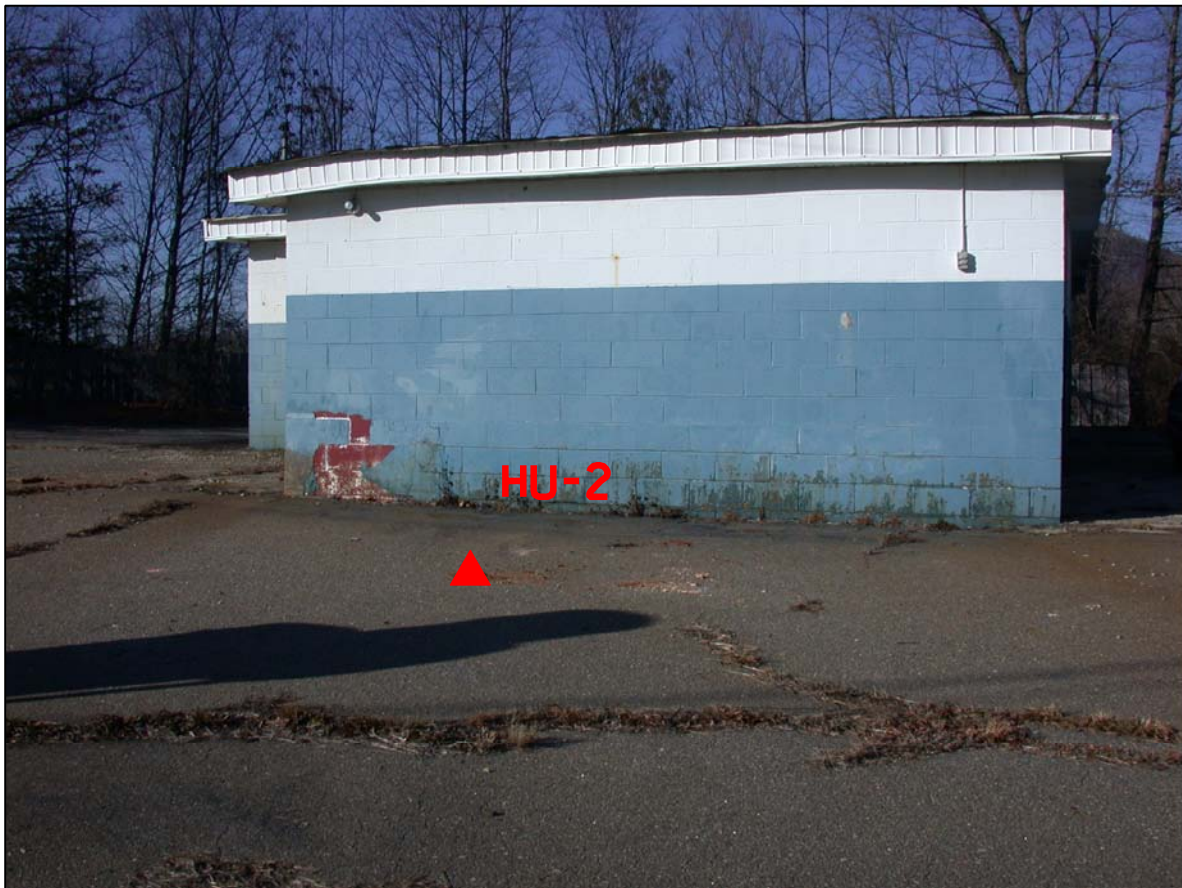
PHOTO 2 - BORING ON SOUTH SIDE OF CAR WASH LOOKING NORTHEAST

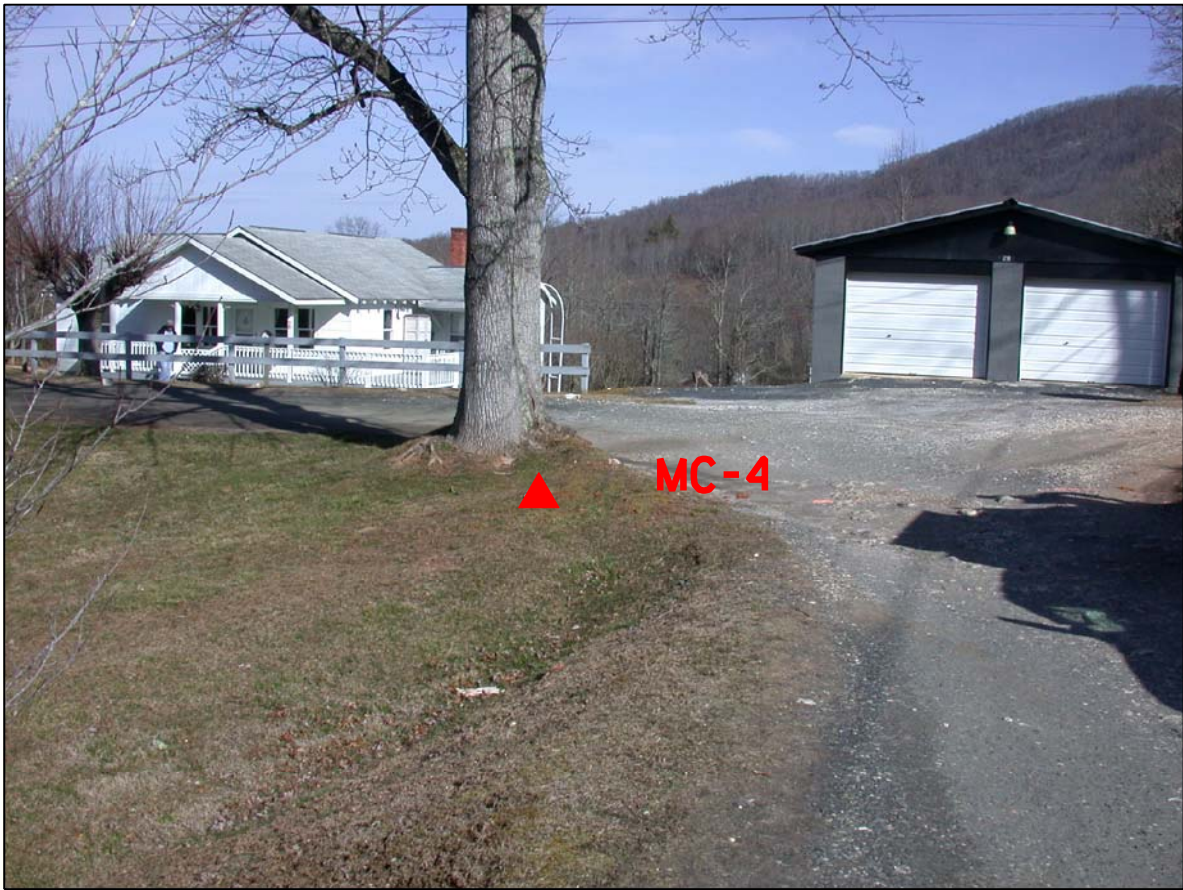
PHOTO 3 - BORING IN RIGHT-OF-WAY AT ANOMALY LOOKING NORTH

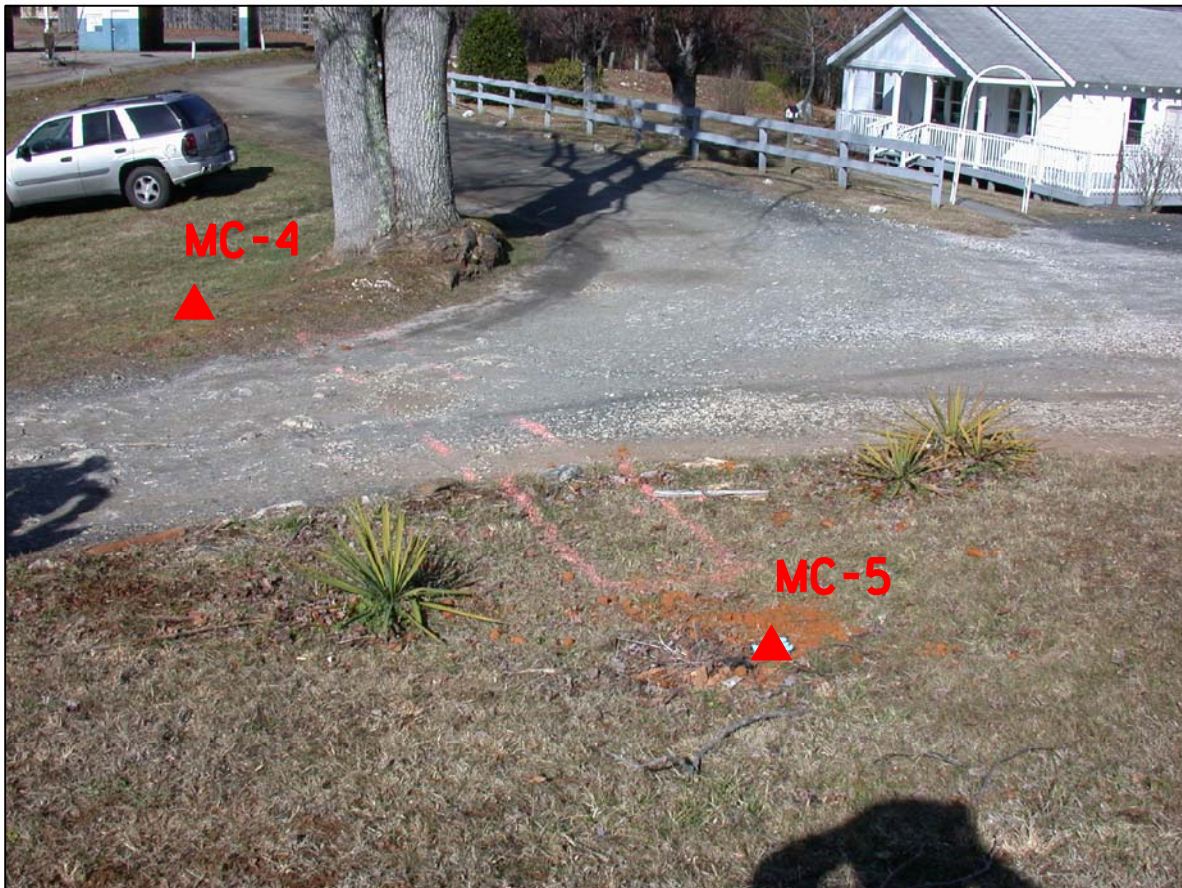
PHOTO 4 - BORINGS IN RIGHT-OF-WAY AT ANOMALY LOOKING WEST
