PYRAMID ENVIRONMENTAL & ENGINEERING
(PROJECT 2013-149)

NCDOT PROJECT U-5305 (WBS 47025.1.1)

GEOPHYSICAL SURVEYS OF PARCEL 7 – UNDERGROUND STORAGE TANK INVESTIGATION

**GEOPHYSICAL INVESTIGATION REPORT
NCDOT ROW GEOPHYSICAL SURVEY
PARCEL 7 – THOMAS TIRE SHOP, U.S. 64
Asheboro, Randolph County, North Carolina**

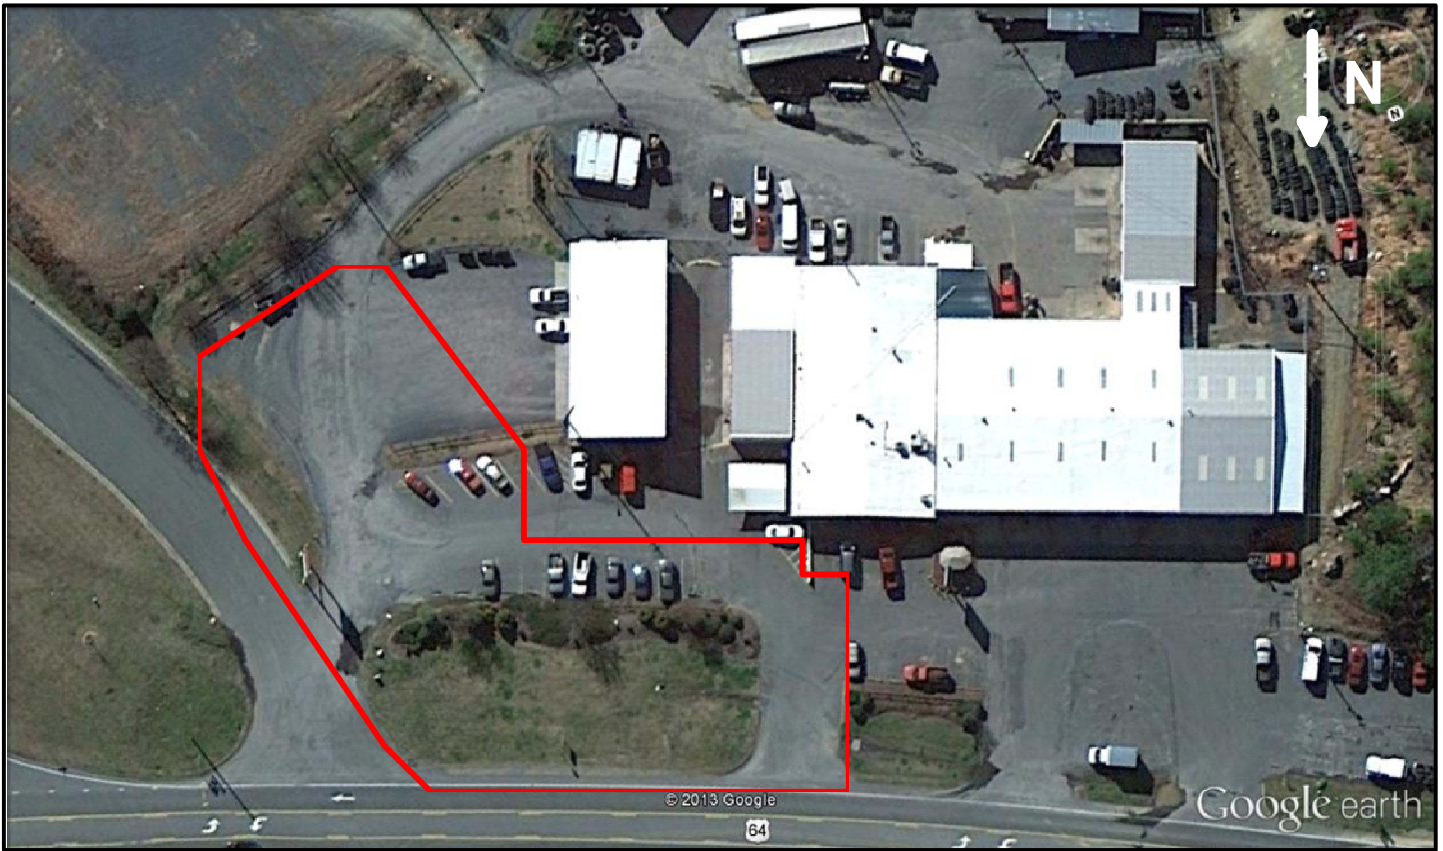
SURVEY BOUNDARIES &
SITE PHOTOGRAPHS

Aerial Photograph Showing Approximate Geophysical Survey Boundaries

The site was relatively open, and consisted of a combination of asphalt/gravel parking space and grassy medians. Aerial photographs showing the survey area boundaries and ground-level photographs are shown in **Figure 1**.

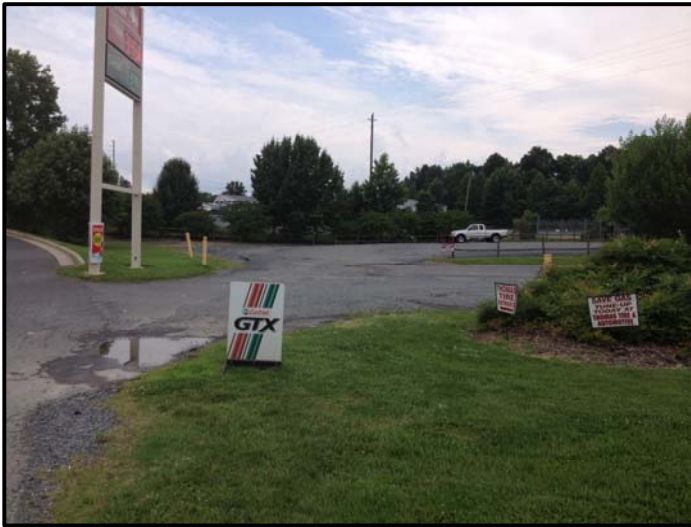
Eastern Portion of Geophysical Survey Area
(Facing Approximately South)

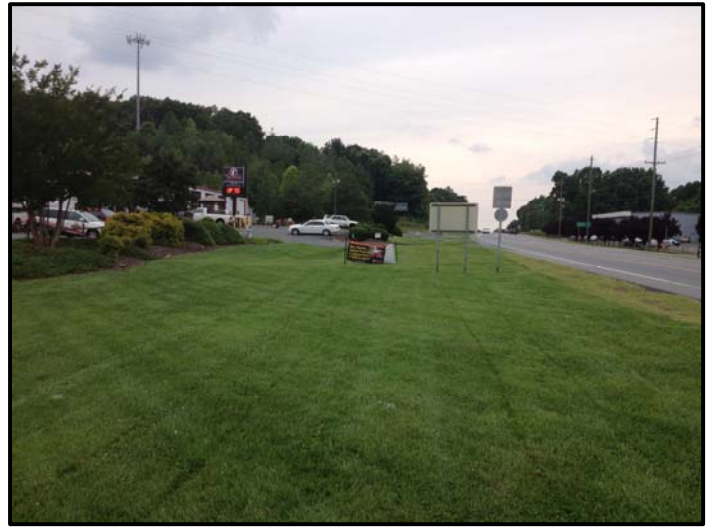
Western Portion of Geophysical Survey Area
(Facing Approximately West)

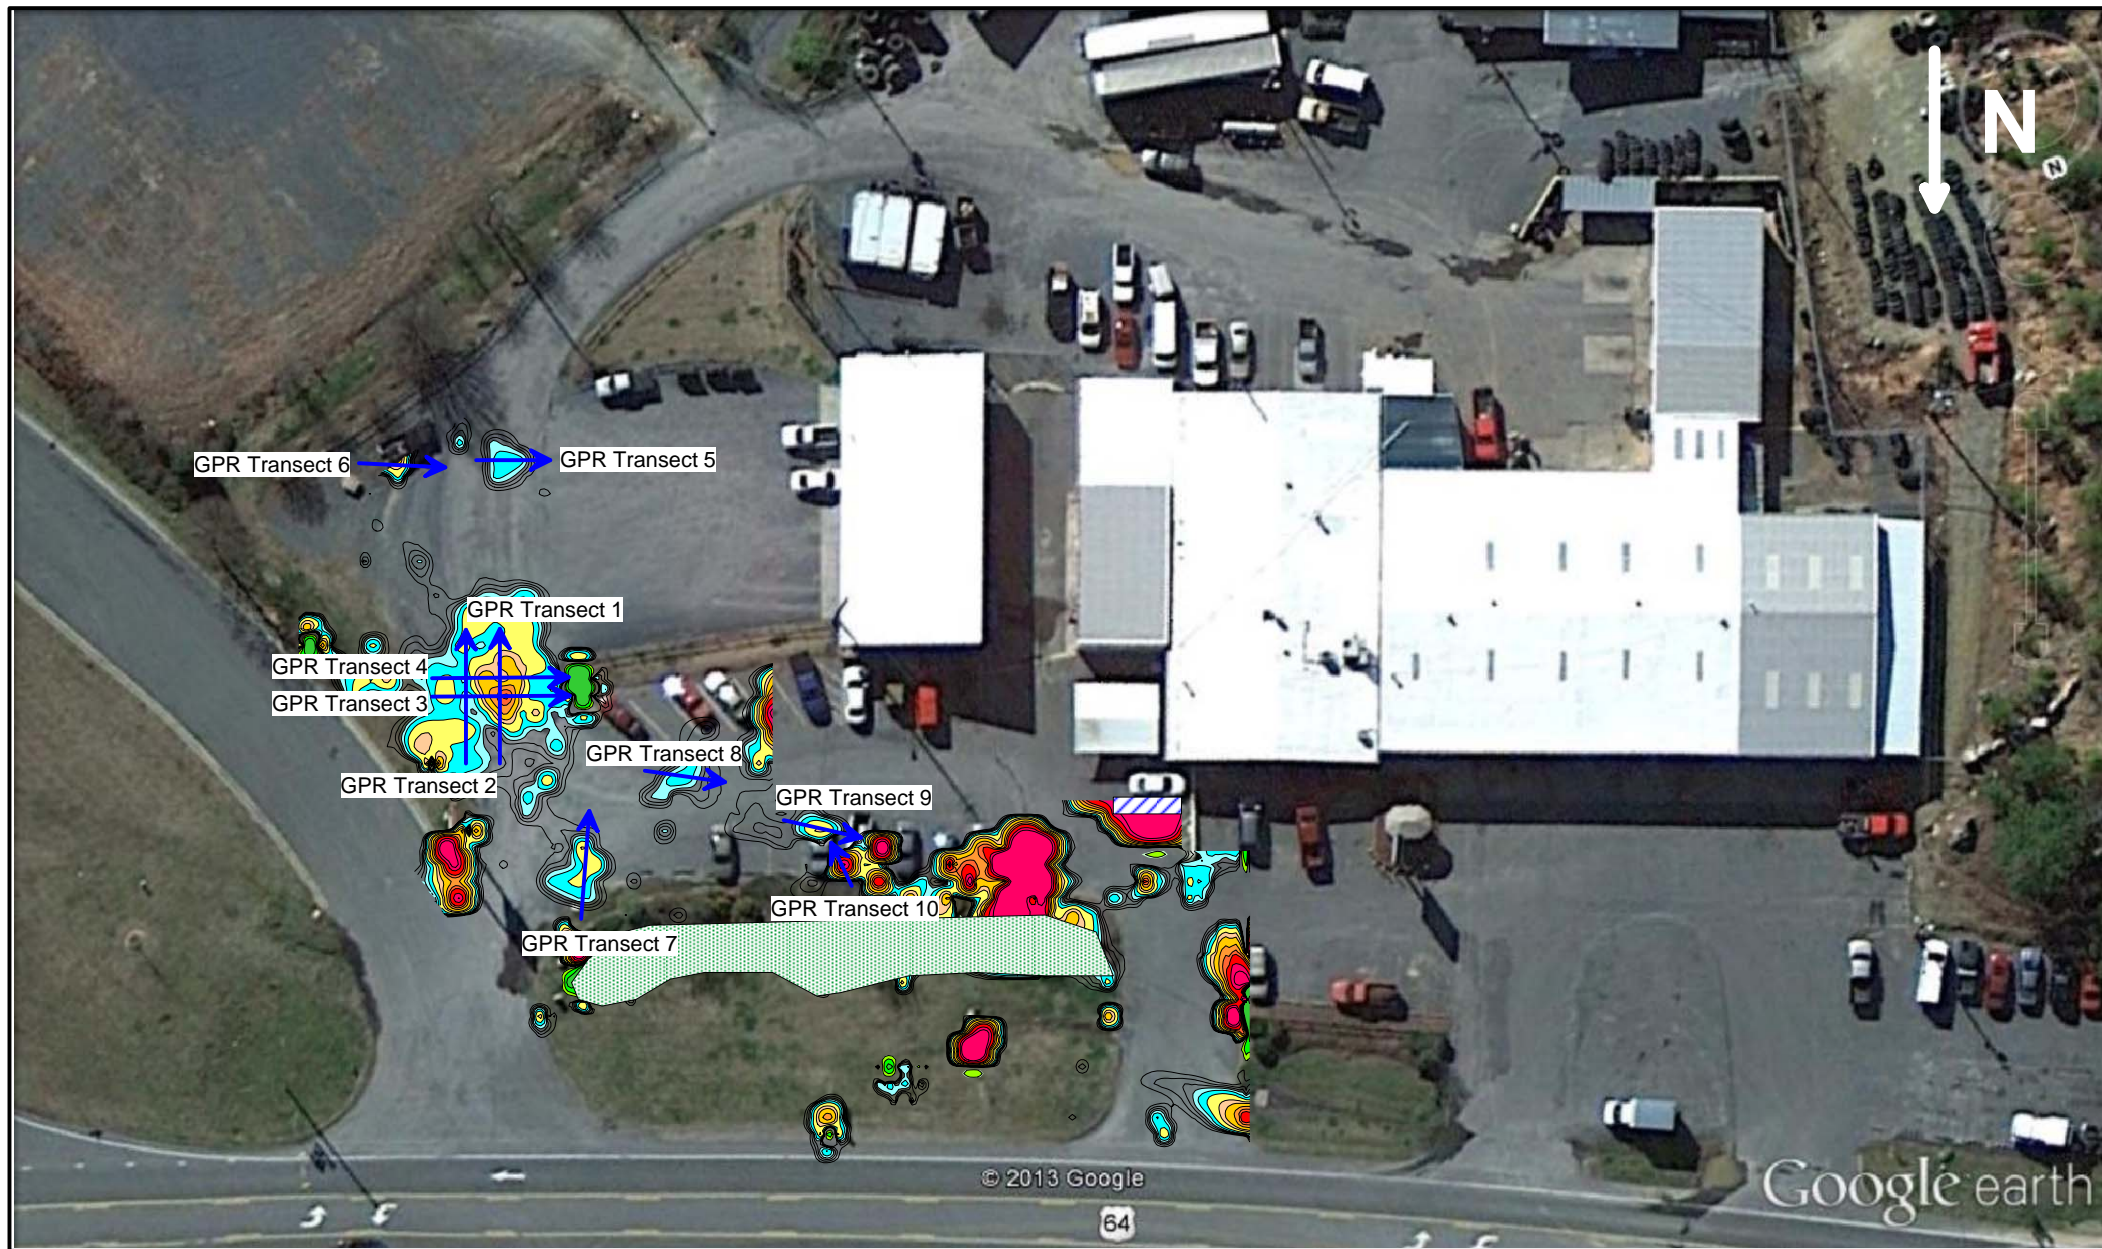
TITLE		PARCEL 7 - GPR TRANSECT LOCATIONS AND IMAGES	
PROJECT		NC DEPARTMENT OF TRANSPORTATION ROW IMPROVEMENT PROJECT ASHEBORO, RANDOLPH COUNTY, NC

GPR Transects Across Possible UST Field
(No evidence of USTs observed in GPR data)

The GPR data were viewed in real time as the equipment was surveyed across the anomalies. Transects across EM anomalies were saved to the hard drive for post-processing in the office. **Figure 4** presents an aerial photograph showing the location of

the GPR transects performed across the unexplained EM anomalies as well as the GPR images that were collected.

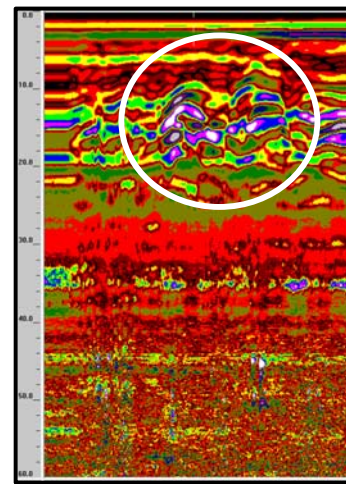
Transects 6-10: Suspected areas of isolated buried metallic debris

The remaining GPR Transects did not record any evidence of metallic USTs at the locations of the anomalies described above and shown in **Figure 4**. The anomaly at X=80, Y=230 exhibited characteristics of a possible utility line or buried debris. The remaining GPR transects indicated that the other anomalies investigated were likely the result of buried metallic debris.

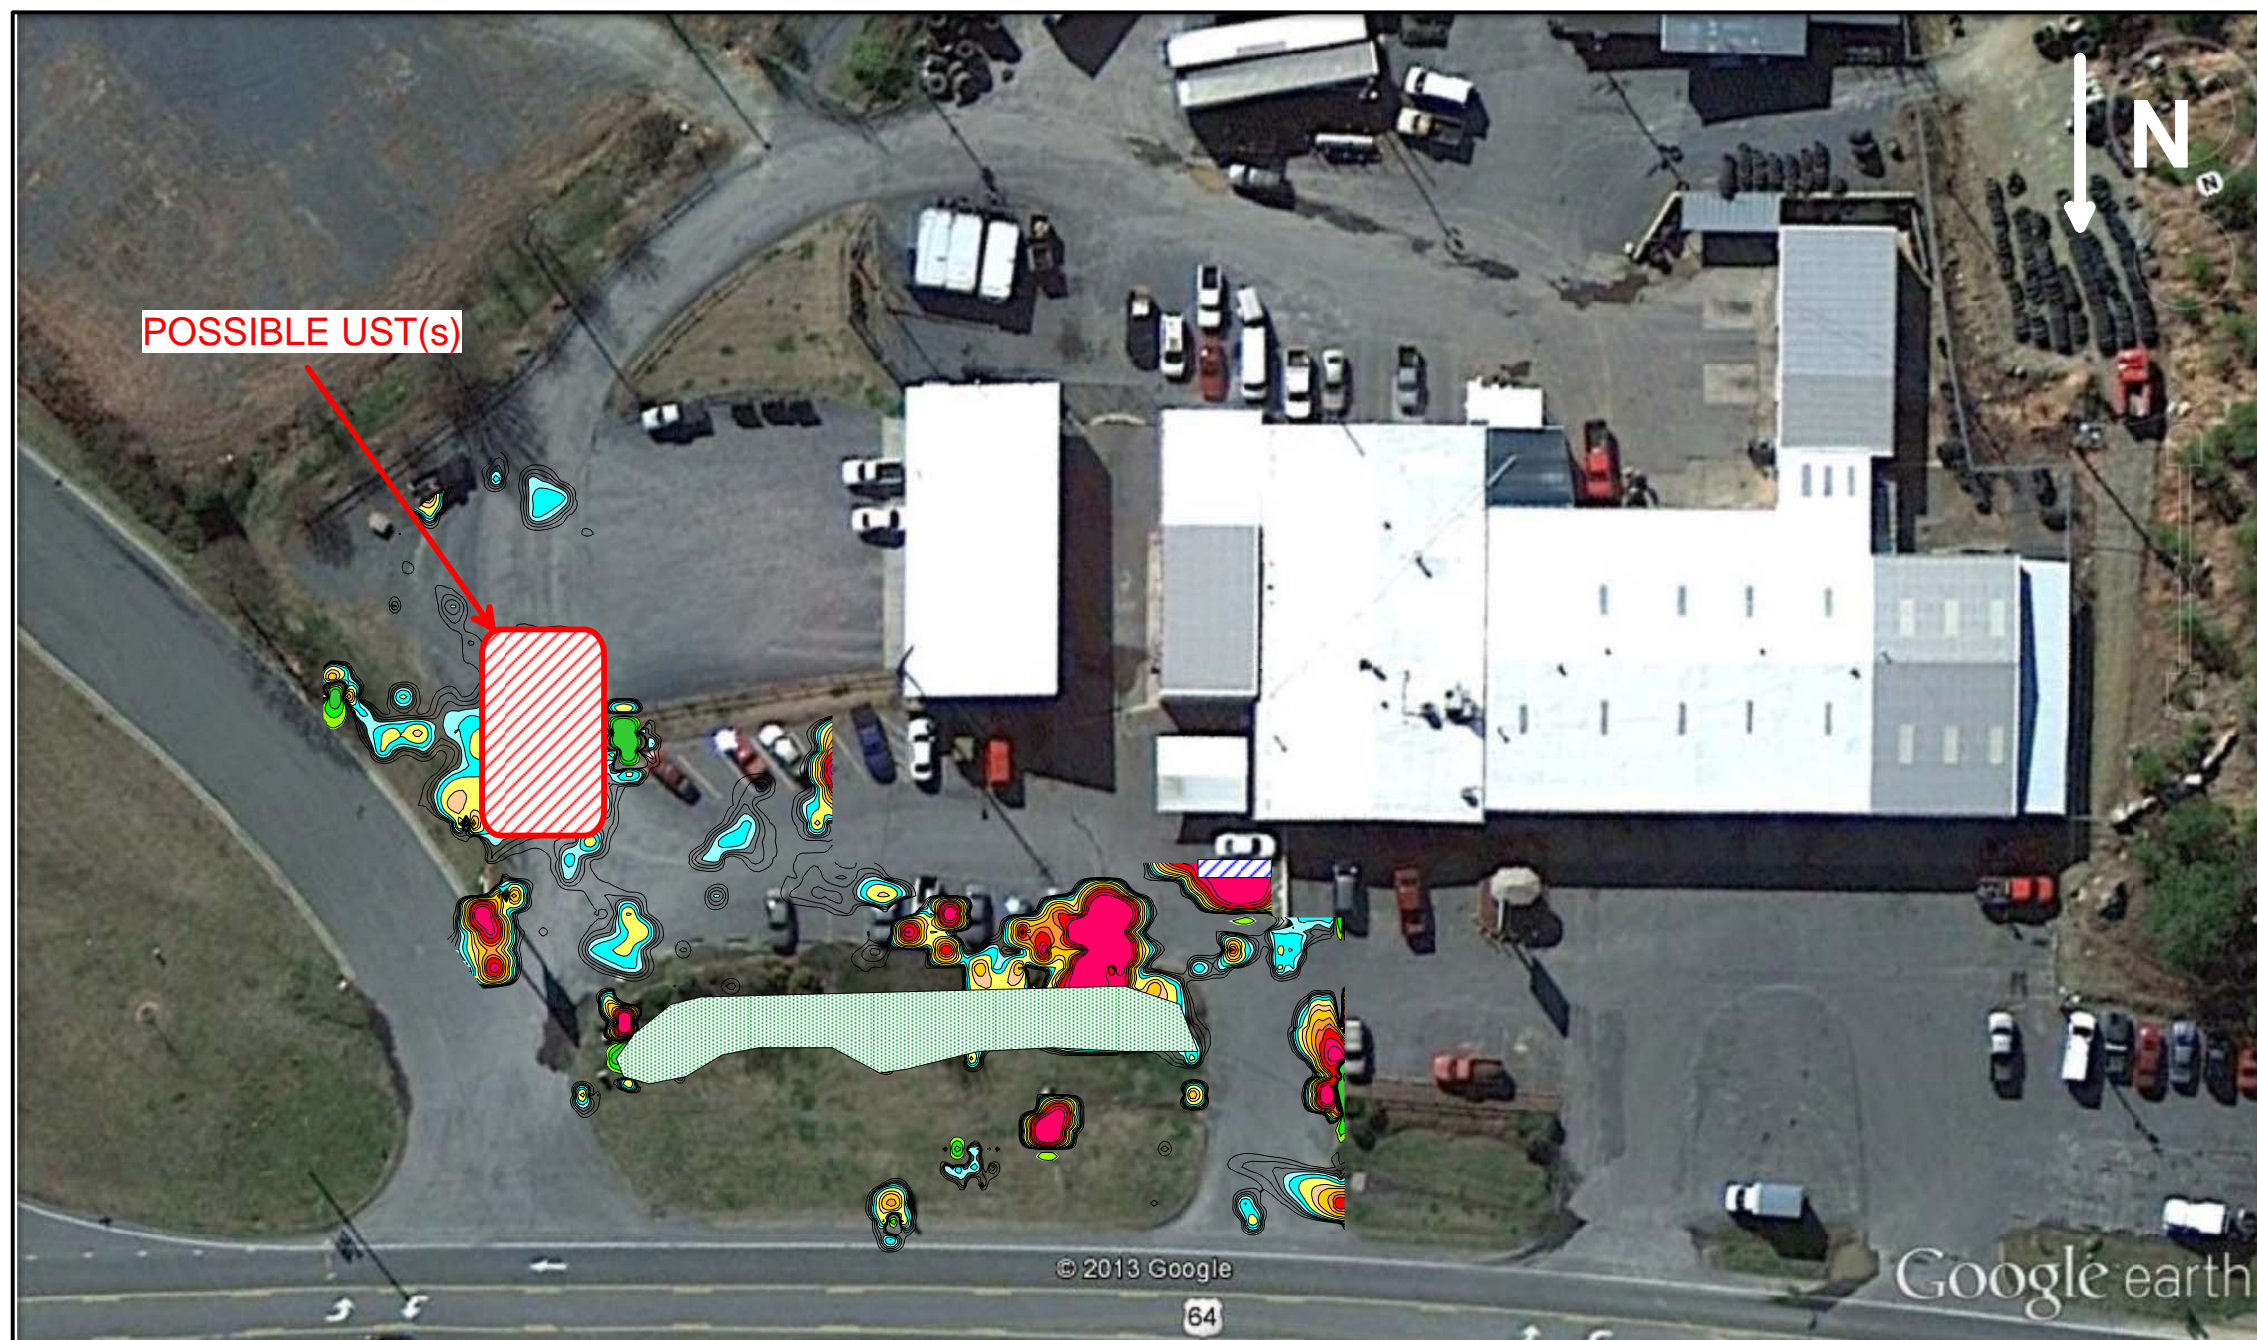
TITLE
 PARCEL 7 - LOCATION OF POSSIBLE UST(s)

The nature of the EM anomaly was characteristic of a possible UST or multiple USTs, although the amplitude of the signal was lower than would be expected for a large metallic UST(s). GPR Transects 1-4 did not record any evidence of USTs in the vicinity of the EM anomaly at X=80, Y=160. However, it should be noted that the depth of penetration of the GPR unit at this parcel was limited to approximately 4 feet below the ground surface (bgs), due to the site geology and/or the depth of the water table. Therefore, it is possible that USTs, or some other large metallic object, is present at the location of this EM anomaly, but at a depth greater than 4 feet. For this reason, we are characterizing this area as containing a possible UST or multiple possible USTs, as categorized by the NCDOT system of labeling possible tanks. The geophysics were unable to delineate the depth or lateral extent of these possible tanks. It should be noted that this feature may also be the result of scattered buried metallic debris.

The geophysical investigation suggests that a possible UST or multiple USTs are present at the location of the EM anomaly centered at X=80, Y=160. The limited depth of penetration of the GPR unit prevented confirmation of the nature of this anomaly, but its lateral extent and signal are characteristic of a possible UST(s). The area containing the possible UST(s) is shown on **Figure 5**. The remaining portions of the geophysical investigation did not record any evidence of metallic USTs within the directed survey area.
