# NCDOT PROJECT U-5305 (WBS 47025.1.1)

## GEOPHYSICAL SURVEYS OF PARCEL 9 – UNDERGROUND STORAGE TANK INVESTIGATION

ASHEBORO, RANDOLPH COUNTY, NC

**GEOPHYSICAL INVESTIGATION REPORT  
NCDOT ROW GEOPHYSICAL SURVEY  
PARCEL 9 – ECONO OIL, WEST U.S. 64  
Asheboro, Randolph County, North Carolina**

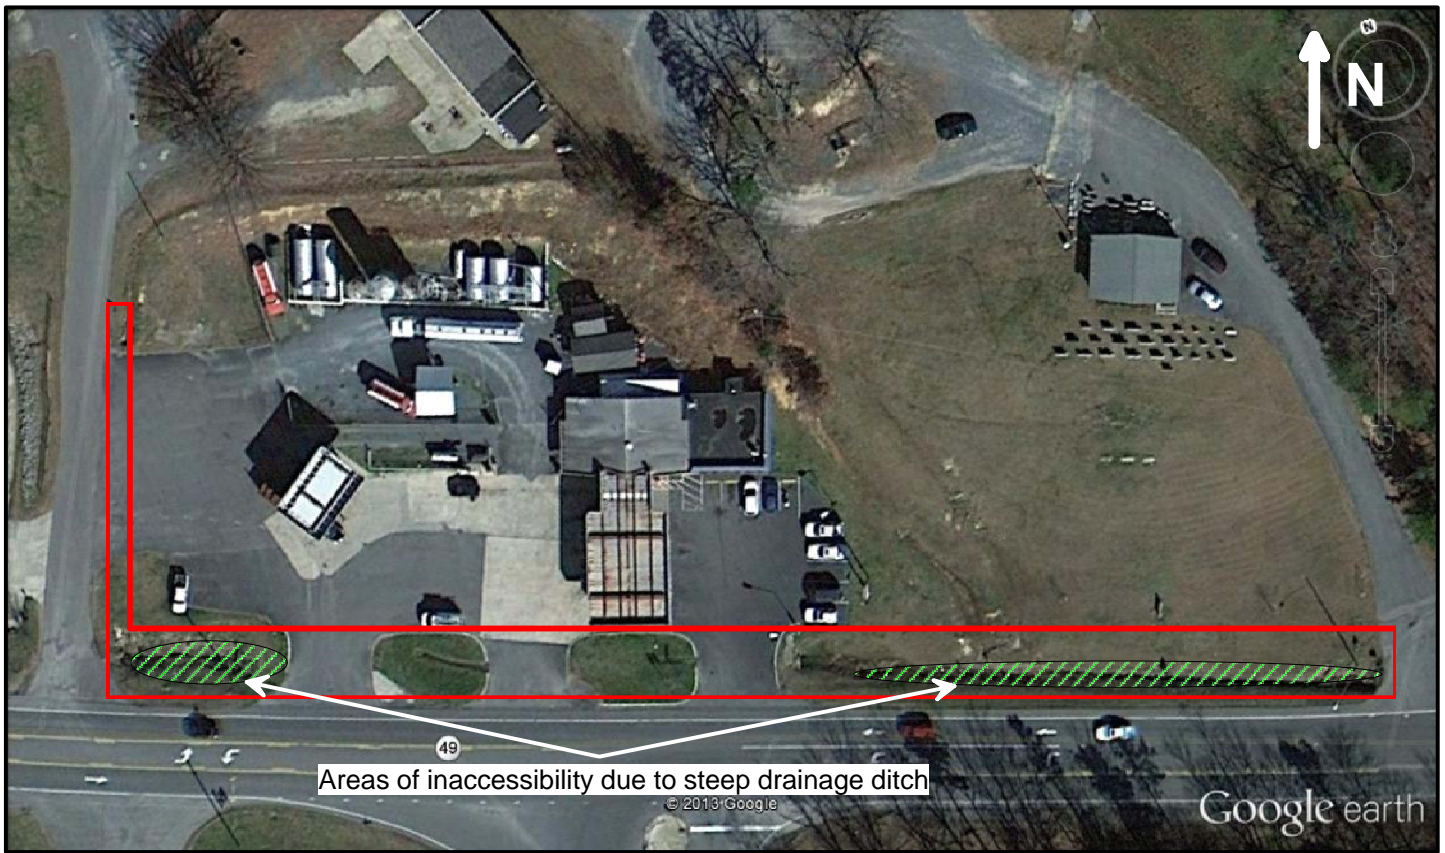
Aerial Photograph Showing Approximate Geophysical Survey Boundaries

The site was relatively open (with the exception of two inaccessible drainage ditch areas), and consisted of a combination of asphalt/gravel parking space and grassy medians. Aerial photographs showing the survey area boundaries and ground-level photographs are shown in **Figure 1**.

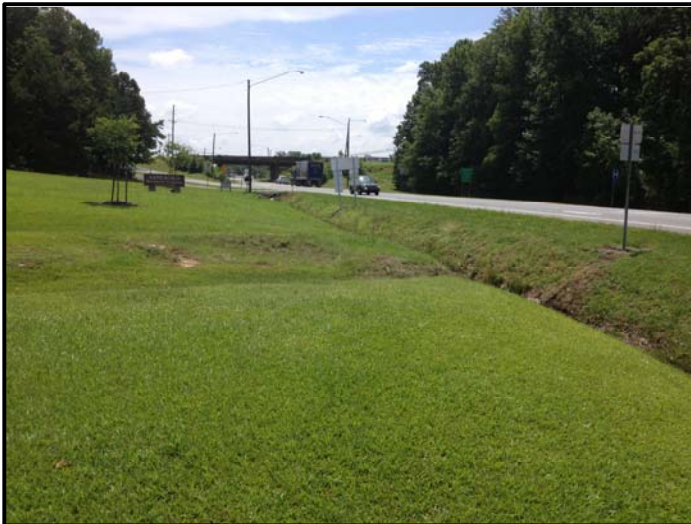
View of East Portion of Survey Area  
(Facing Approximately Southeast)

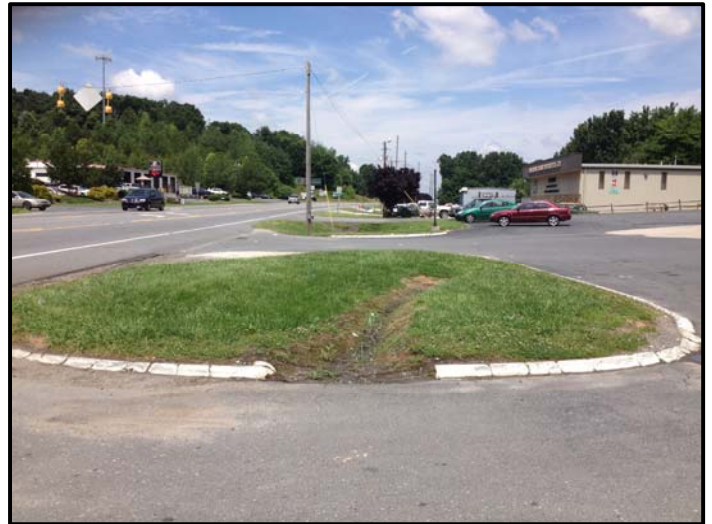
View of West Portion of Survey Area  
(Facing Approximately West)

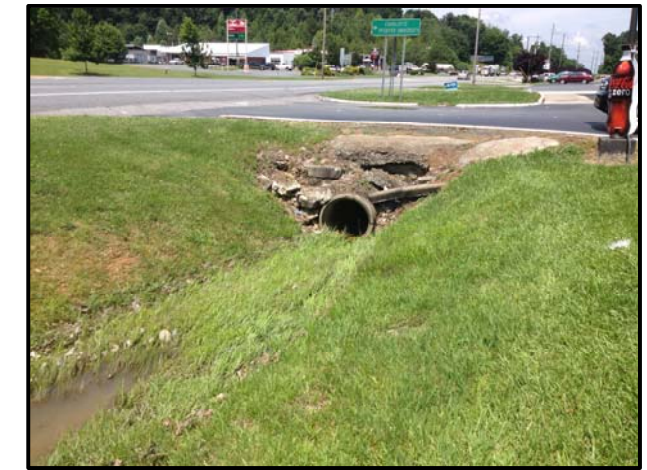
Photo #1: Drainage pipe extending under east driveway entrance

**Discussion of EM Anomalies:** The EM anomaly at X=80, Y=25 was the result of a power pole. The EM anomaly at X=95, Y=50 was the result of a sign post. The EM anomalies at X=160, Y=40 and at X=265, Y=35 were the result of storm drains. The EM anomalies at X=265, Y=25 and at X=275, Y=30 were the result of street signs. The EM anomaly at X=335, Y=50 was the result of a light pole. The EM anomalies at X=365, X=405, and X=495 at Y=20 were the result of street signs. The EM anomaly at X=575, Y=45 was the result of a mailbox. The EM anomaly at X=575, Y=25 was the result of a stop sign. The feature that is generally observed at Y=35 between the two inaccessible drainage ditch areas was attributed to a storm drain pipe extending across this area (see photos on **Figure 3**). The remaining anomalies could not be attributed to objects at the ground surface.

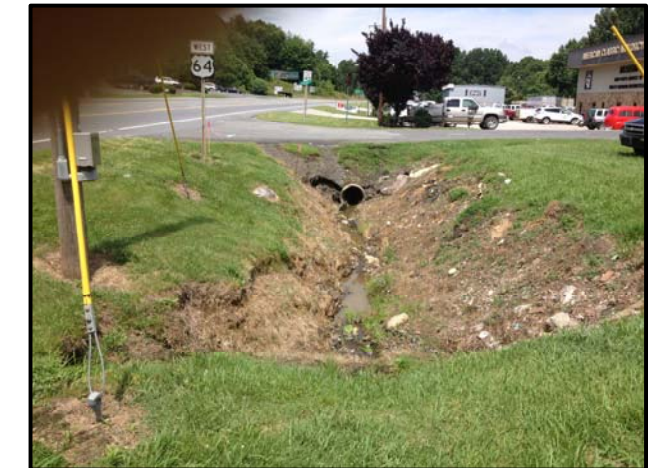
Photo #2: Drainage pipe extending under west driveway entrance

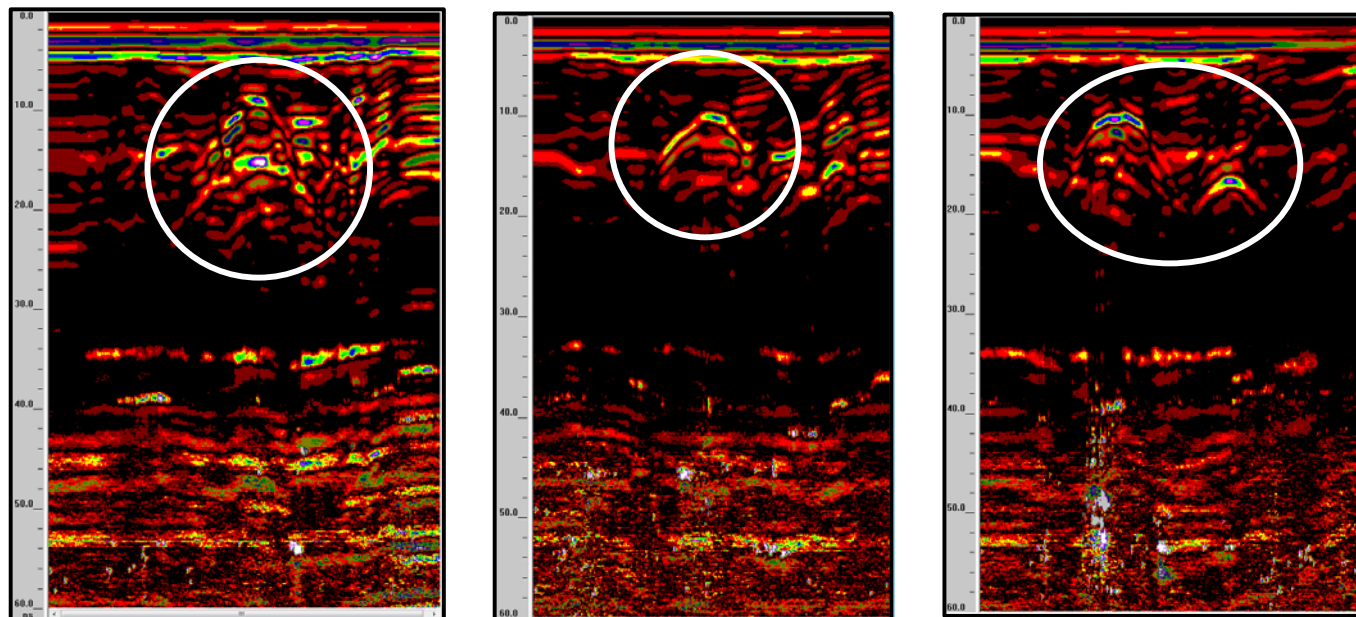
Suspected drainage pipe(s) or utilities along west side of survey area

GPR Transect 1

GPR Transect 2

GPR Transect 3

GPR Transects 1, 2, and 3 were oriented from east to west across the north/south anomaly at X=20-30. These transects recorded evidence of a utility line or storm drain pipe extending from south to north across this location. GPR Transect 4 was oriented
