Preliminary Site Assessment

NCDOT Project U-5008 Charlotte - Sugar Creek Grade Separation Parcel: Tzannis Property Owner: Andromache and Magdaline Tzannis 917 E. Sugar Creek Road Charlotte, Mecklenburg County, North Carolina WBS Element: 41141.1.1 January 3, 2014 Terracon Project No. 71137774

PRELIMINARY SITE ASSESSMENT

U-5008 – SUGAR CREEK GRADE SEPARATION PARCEL – TZANNIS PROPERTY 917 E. SUGAR CREEK ROAD CHARLOTTE, MECKLENBURG COUNTY, NORTH CAROLINA

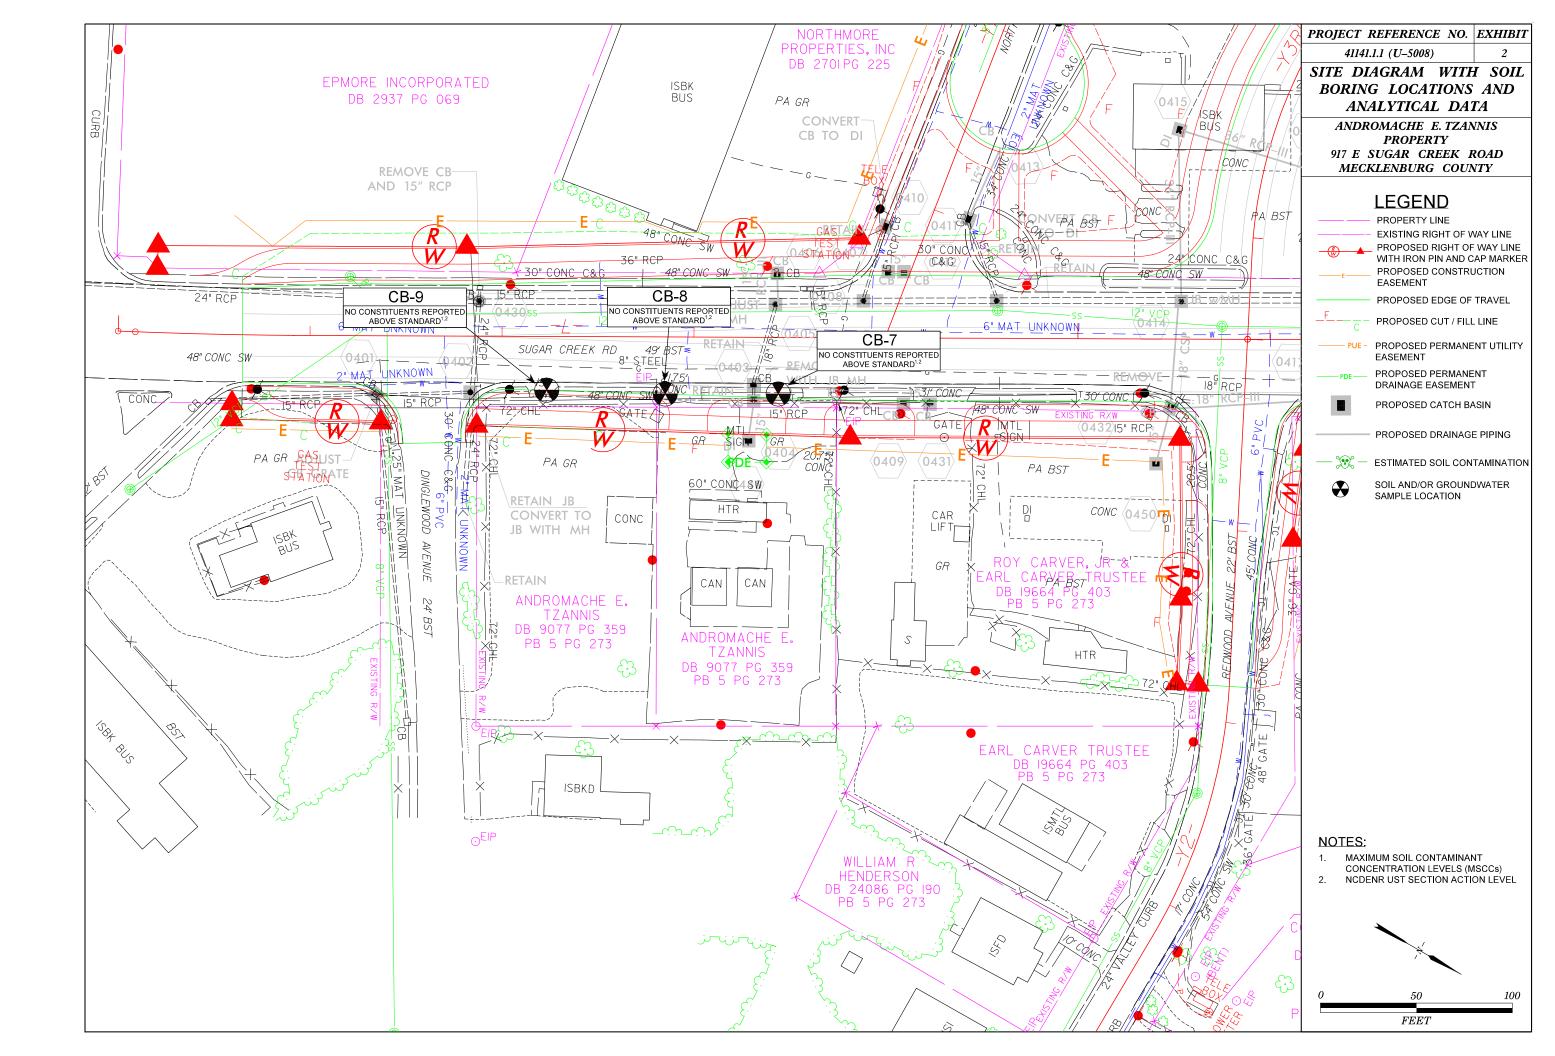
FIGURES EXHIBIT 1 - TOPOGRAPHIC MAP EXHIBIT 2 – SITE DIAGRAM WITH SOIL BORING LOCATIONS AND ANALYTICAL DATA

The following PSA activities are presented in the order that they were conducted in the field on November 5, 2013 and November 20, 2013. Exhibit 1 presents the general boundaries and topography of the site on portions of the Charlotte East, North Carolina USGS topographic quadrangle map dated 1967 and the Derita, North Carolina USGS topographic quadrangle map dated 1993. Exhibit 2 is a site layout plan that depicts the approximate locations of the site features, soil boring locations and analytical data.

Based on the findings of the geophysical investigation, Terracon directed the advancement of three soil borings (CB-7, CB-8, and CB-9) along the western boundary of the Tzannis property on November 20, 2013. The borings were completed by Probe Technology, Inc., a North Carolina licensed driller using a Geoprobe® direct-push rig. The drilling equipment was cleaned prior to beginning the project and before the advancement of each boring.

The soil borings were advanced within a grassed and paved area of the Tzannis property within the proposed right of way along Sugar Creek Road. Soil samples were collected in 5-foot, disposable, acetate sleeves and were observed to document soil lithology, color, moisture content, and sensory evidence of impairment. Soil samples were placed in re-sealable plastic bags that were set aside for a sufficient amount of time to allow volatilization of organic compounds that may have been present in the soils. The soil samples were then screened using a field-portable *MiniRAE 3000* Photo-Ionization Detector (PID) by inserting the probe tip into the headspace of the bag. The PID readings and soil sample depths are included on individual Boring Logs in Appendix A and in Table 1.

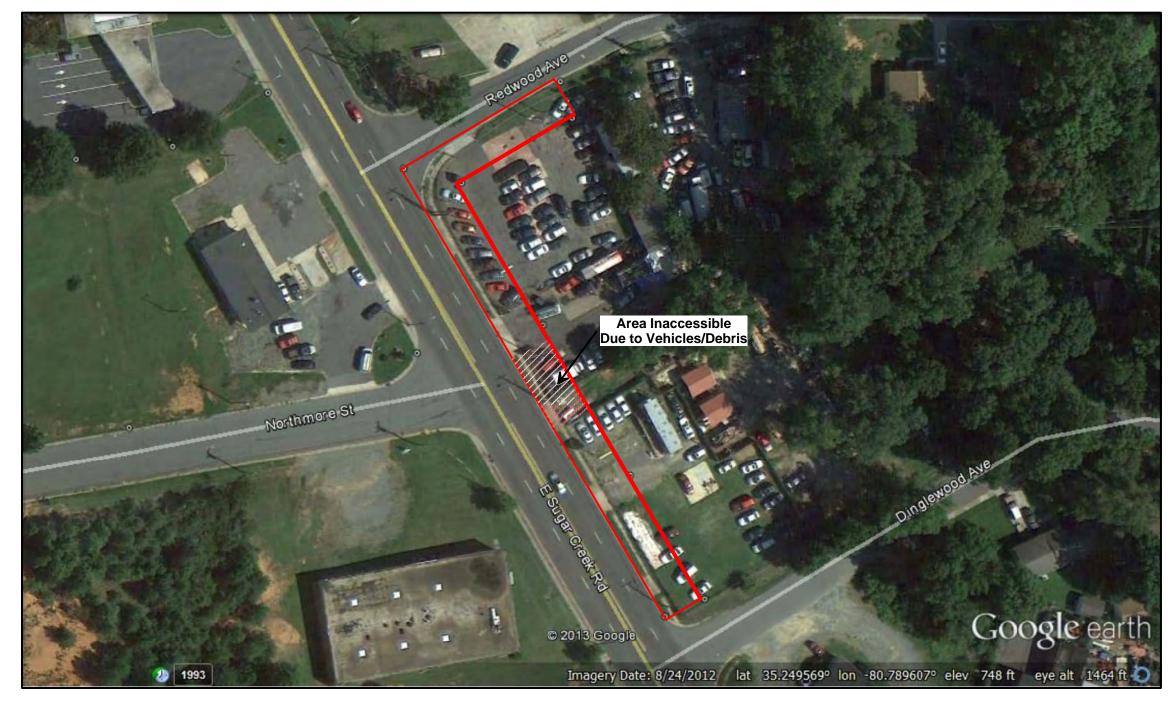
| | EOPHYSICAL SU | VER PROPERTIES: RVEY BOUNDARIES HOTOGRAPHS | | | | | | | | |
|--|---|---|--|--|--|--|--|--|--|--|
| PYRAMID PROJECT #: | 2013-259 | FIGURE 1 | | | | | | | | |

Approximate Boundaries of the Geophysical Survey Area

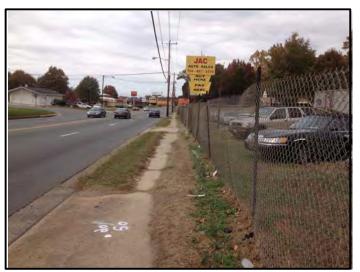
View of South & West Portion of Survey Area (Facing Approximately North)

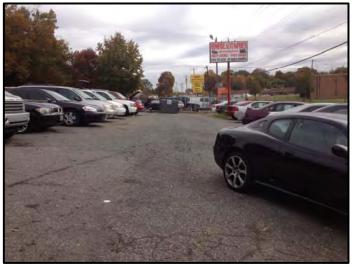
View of Northwest Portion of Survey Area (Facing Approximately South)

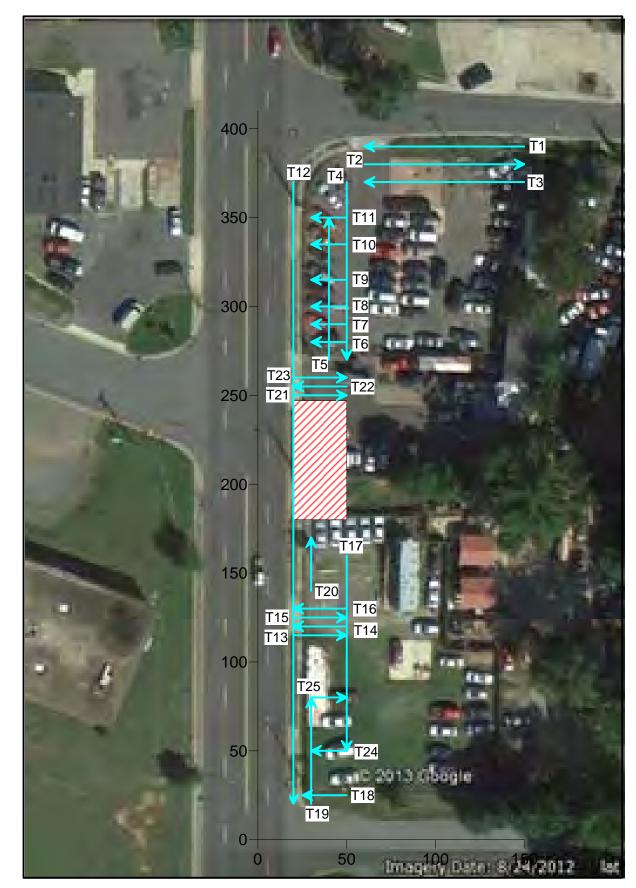
The locations of the GPR transect performed at the property, as well as images of select GPR transects, are presented in **Figure 2**. Images of all GPR transects are included in **Appendix A**. Transects were performed wherever possible in between parked vehicles, along the roadway, within median areas, and within open areas at the properties that fell within the NCDOT proposed ROW. It should be noted that the limited access prevented the property from being surveyed to the resolution and accuracy that our standard survey would provide under more normal site conditions. Additionally, one area of the property between Y=180 and Y=245 was completely inaccessible due to vehicles and fences.

Locations of GPR Transects at Tzannis & Carver Properties

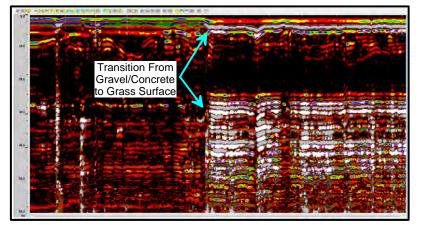
GPR Transect 17 - Across Majority of Carver Property

NO EVIDENCE OF METALLIC USTs OBSERVED
