Prioritization Assessment Report Scott's Cleaners

DSCA ID: 74-0010
111 W. 10th Street
Greenville, Pitt County

North Carolina Dry-Cleaning Solvent Cleanup Act Program

H&H Job No. DS0-82A
October 29, 2013

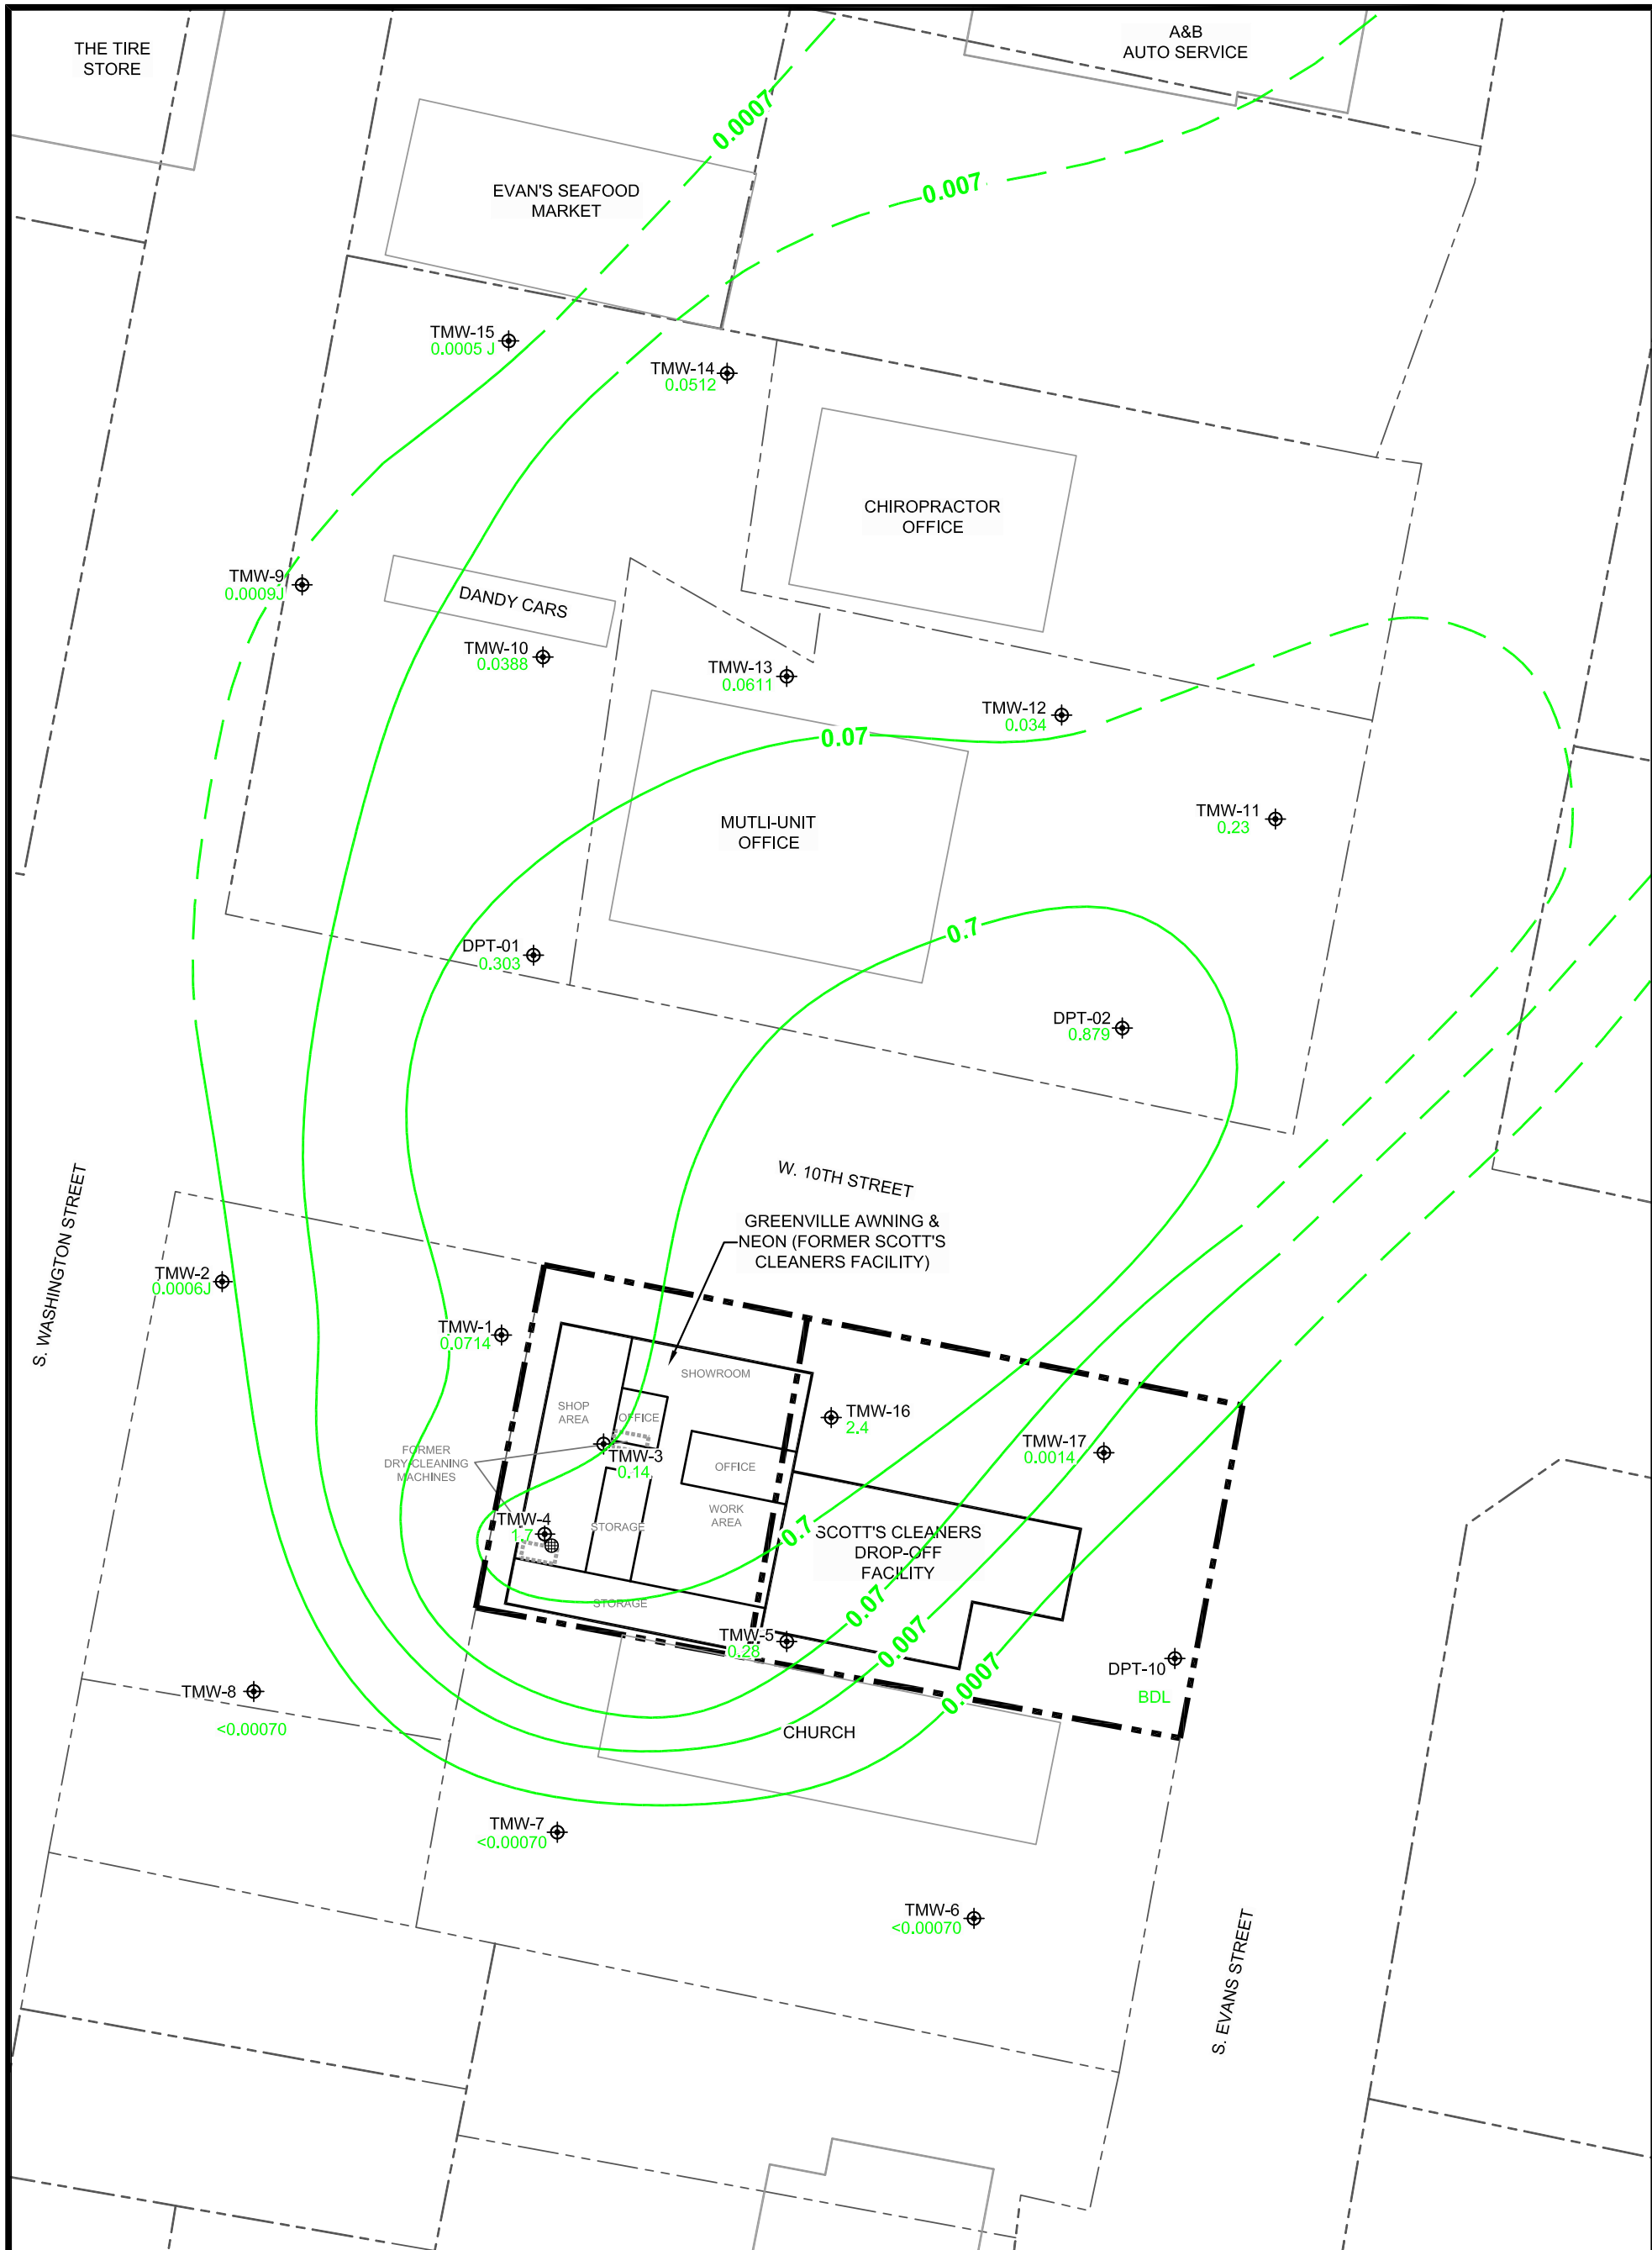
The primary constituents of concern associated with the former dry-cleaning operations are tetrachloroethene (PCE) and trichloroethene (TCE). These constituents have been detected at concentrations above the DSCA Tier 1 RBSLs in groundwater and/or soil. Cis-1,2-DCE (dichloroethene) and trans-1,2-DCE, which are degradation products of PCE, were also detected in soil and/or groundwater but at concentrations below the DSCA Tier 1 RBSL.
