# Preliminary Site Assessment

1006 Bancroft Avenue  
Parcel #20, Claudius E. Baines  
Previous Greenville Shop 2 Gas Station  
Greenville, Pitt County, North Carolina

State Project No. U-3315

Terracon Project No. 70127335

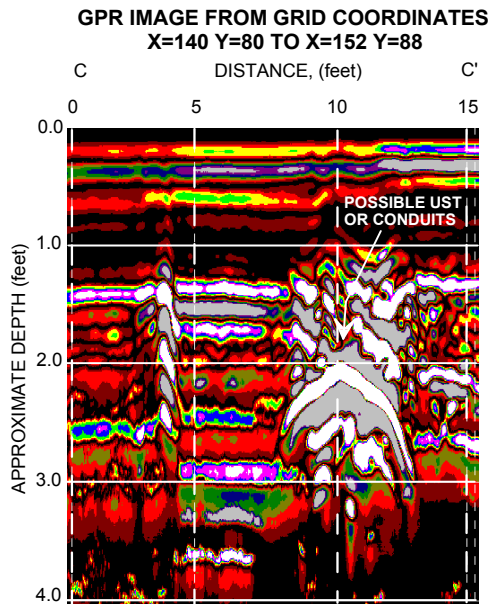
The GPR image obtained across the EM61 differential anomaly centered near grid coordinates X=148 Y=85 recorded a higher amplitude, hyperbolic anomaly that may possibly be in response to a metallic UST or a segment of wide diameter conduit buried approximately 2.0 feet below present grade. The solid purple line labeled AA' in the photograph below represents the approximate location of the GPR image.
