Reference: Preliminary Site Assessment

Parcel 170

1309 W 14th Avenue, Greenville, NC 27834

State Project: U-3315 WBS Element 35781.1.2

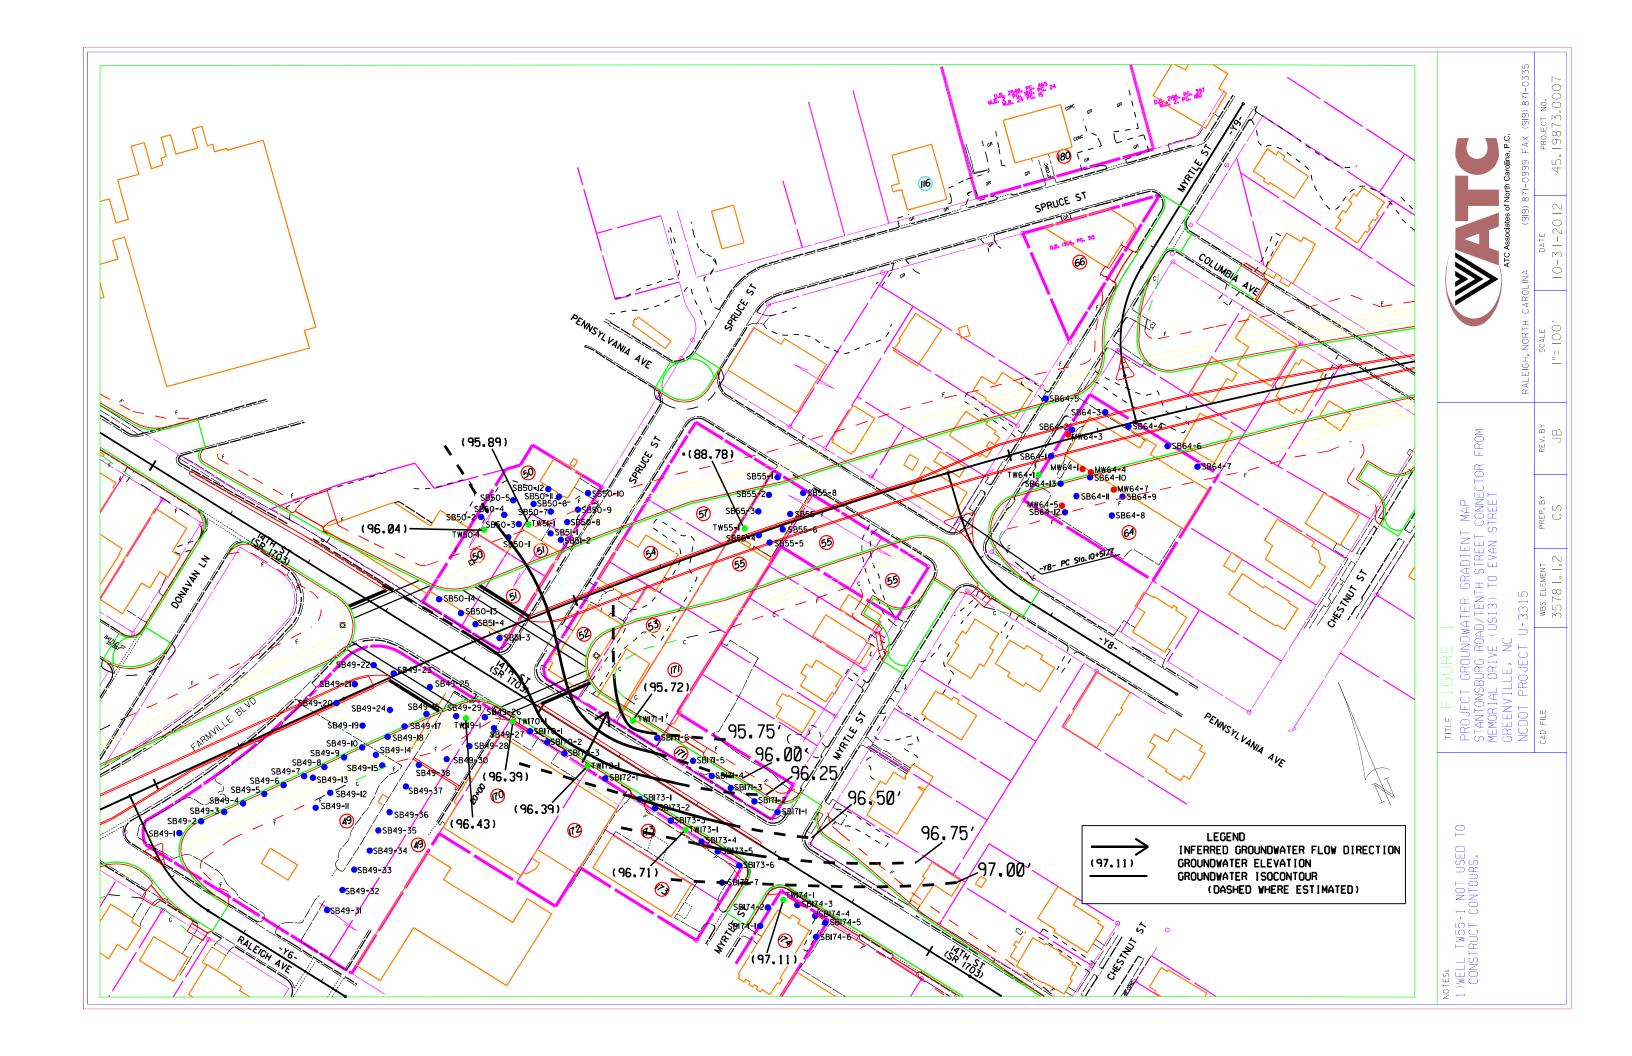
The site lies within the coastal plain of North Carolina and is underlain by the Yorktown formation, which generally consists of fossiliferous clays and sands. The site lies in the Tar-Pamlico river basin and groundwater flows generally to the northeast across the site. A groundwater gradient map for the site and surrounding parcels is included as *Figure 1*.

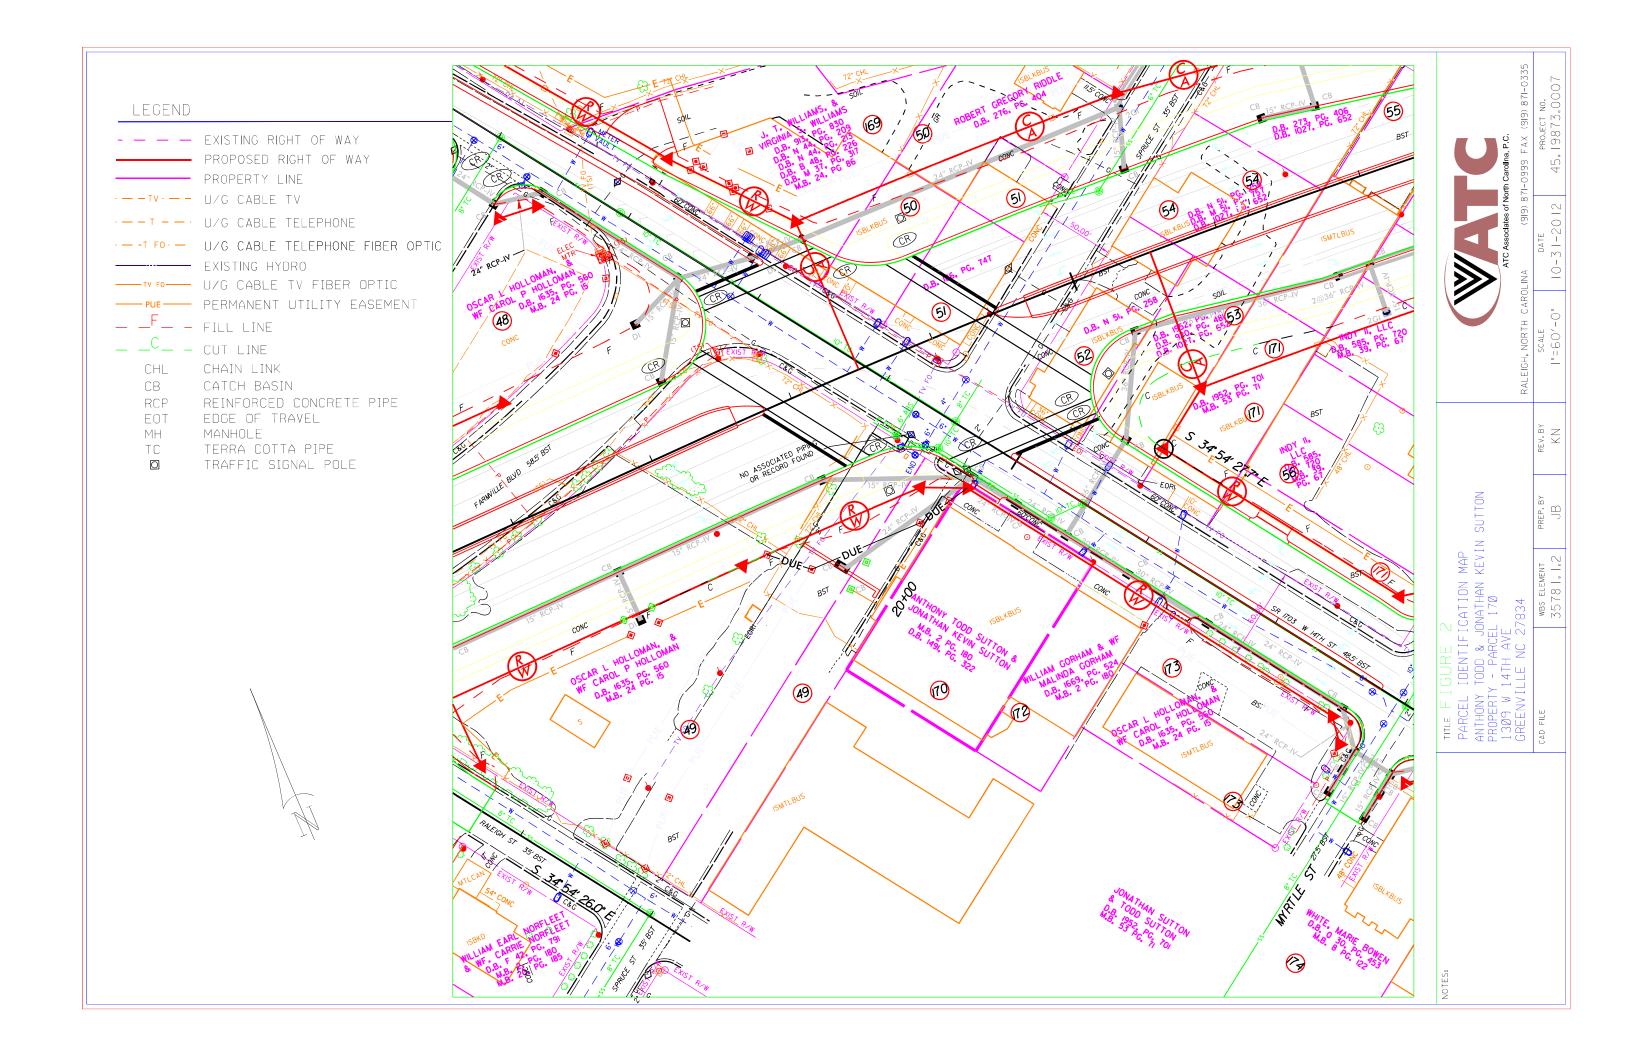
Due to the partial take status of the site, a soil and groundwater assessment was completed only for the area within the proposed NCDOT right-of-way and/or easement as indicated on the construction plans. A parcel identification map is included as *Figure 2*.

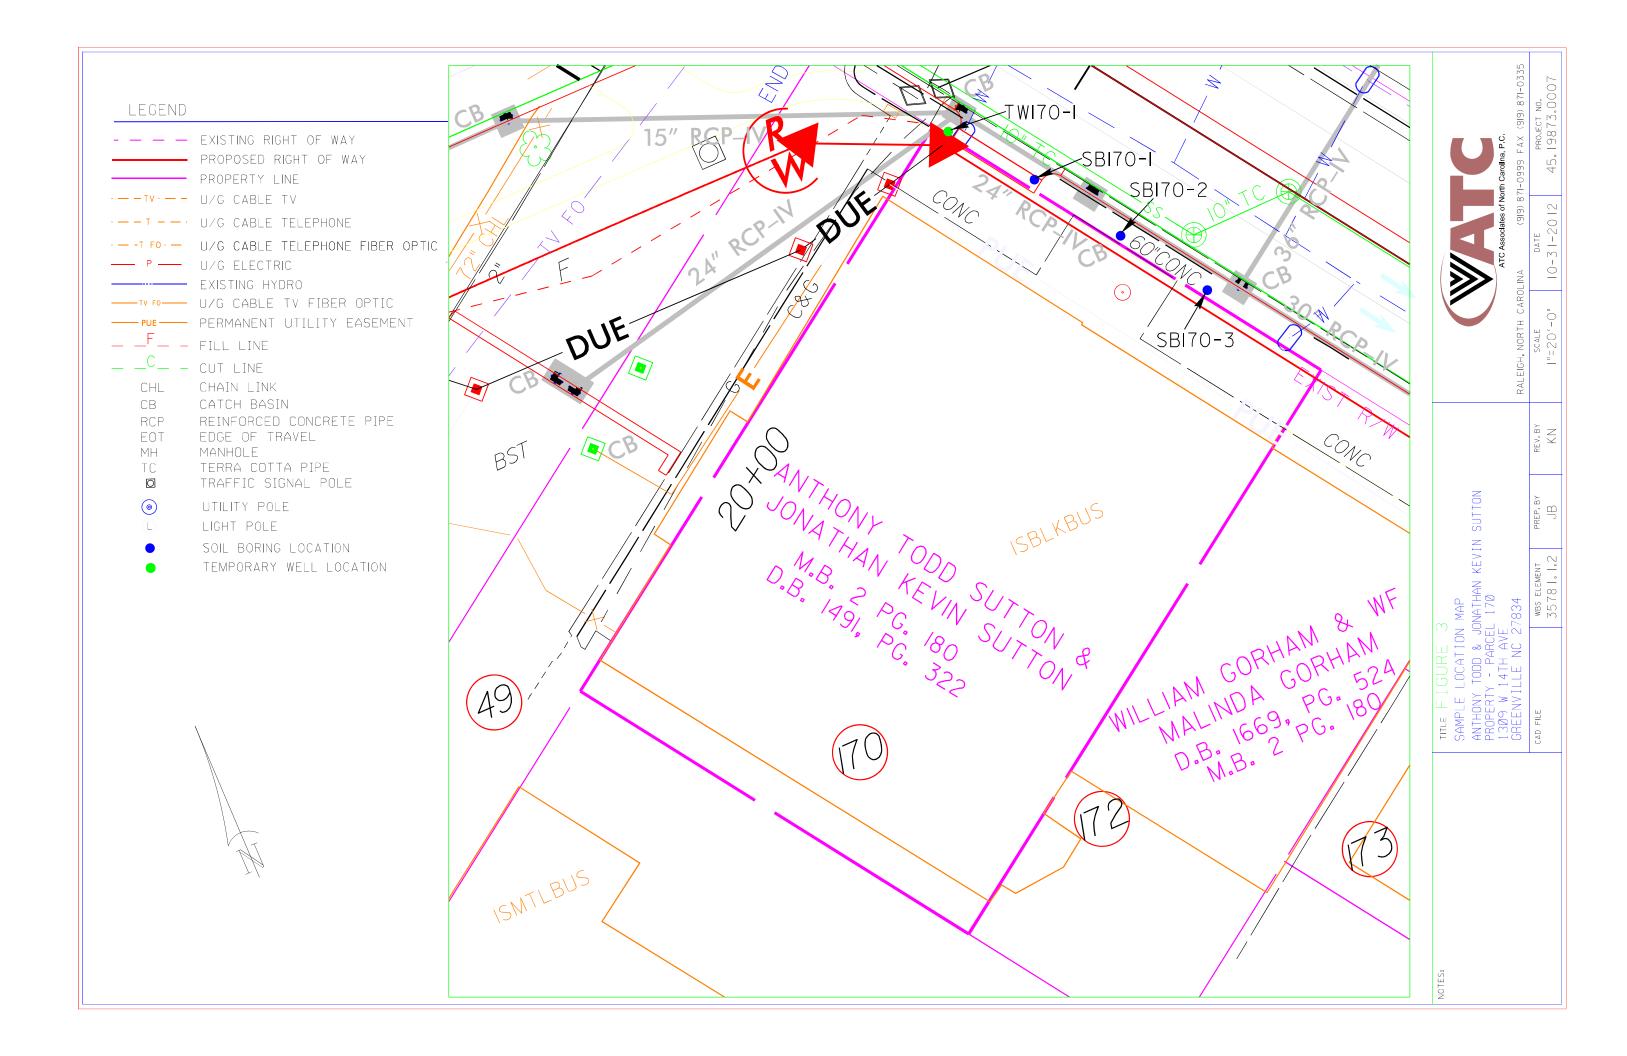
The locations of the borings are shown on the attached *Figure 3*. Each boring was advanced to a depth of five feet below ground surface (bgs) via hand auger prior to utilizing DPT drilling techniques to complete the sampling. Soil samples were collected every 1 to 3 feet and screened with a photo-ionization detector (PID). Soils encountered consisted primarily of moist, tan to gray silty sands and clays. The highest PID reading collected during the soil assessment was 0.6 parts per million (ppm) in the 0-2.5 feet bgs interval of SB170-3. Boring logs are included in *Appendix C*.

ATC supervised SAEDACCO during the installation of temporary well TW170-1 on August 1, 2012. The boring was advanced to a depth of five feet bgs via hand auger prior to utilizing DPT drilling techniques to complete the well installation activities. Temporary well TW170-1 was installed to a depth of 12 feet bgs using 10 feet of 0.010-inch machine slotted 1-inch poly vinyl chloride (PVC) well screen and solid PVC riser. The annular space of the boring was filled with washed silica sand to an approximate depth of 2 feet bgs. The location of the temporary well is shown on the attached *Figure 3* and a boring log is included in *Appendix C*.

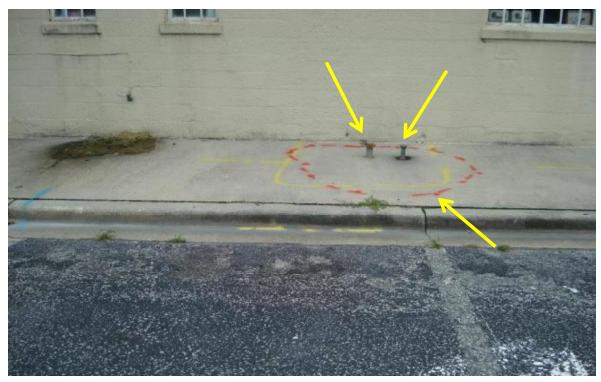
Target A: A Known UST of approximately six (6) feet by six (6) feet was noted which is also in Parcel 49 report. There are two (2) small metal vent pipes approximately two (2) inches in diameter protruding from the delineated area of the known UST. This anomaly abuts to the face of the exterior wall in which the footings interfere with the readings of the instrumentation used. This discovery was made using magnetics indicating metallic objects and Surface Ground Penetrating Radar. Surface Ground Penetrating Radar data showed a metallic signature and the stratigraphic walls of two different soil conditions. A sketch of this area is included on page 10.

Known UST shown with two metal vents physically on Parcel 49

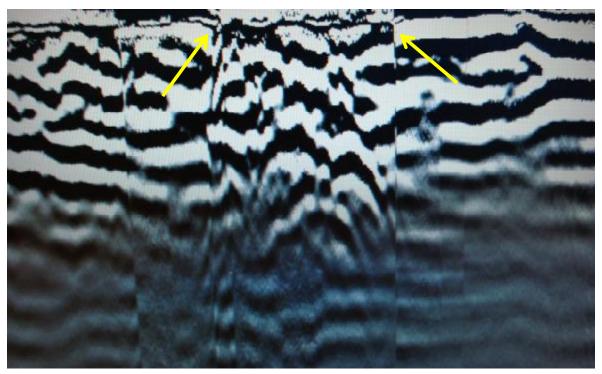
Anomaly showing Probable UST with two spikes at surface metal locations of vents

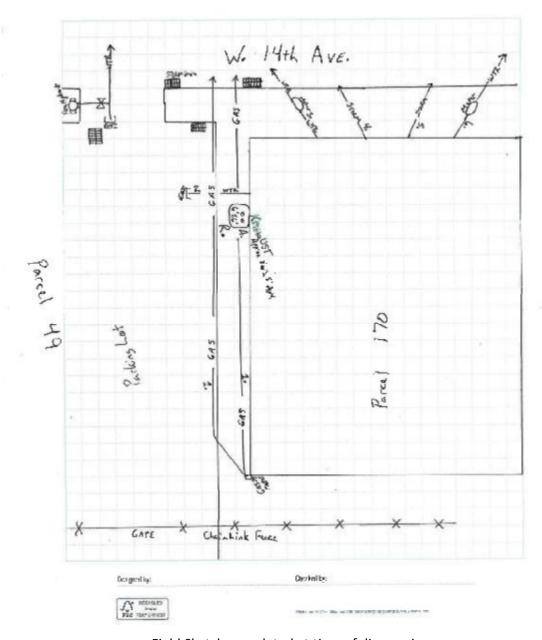
- ends. Line may continue from that point but no metal signatures found after end of information. A sketch of this area is included on page 10.
- 3. A water service was detected using Electromagnetic Induction from a water meter located at the north side of building just east of parking lot entrance. Water was detected to run to building from meter using 33 kHz. A sketch of this area is included on page 10.

- 4. Storm drain was found traveling from building roof drain entering ground to West 14th
 Ave curb in a westerly direction using ground penetrating radar (GPR). Line is shallow within the first foot of earth. A sketch of this area is included on page 10.

- 5. Storm drain was found traveling from building roof drain entering ground to West 14th Ave curb in a easterly direction using ground penetrating radar (GPR). Line is shallow within the first foot of earth. A sketch of this area is included on page 10.

- 6. A water service was detected using Electromagnetic Induction from a water meter located at the north side of building east of parking lot entrance. Water was detected to run to building from meter using 33 kHz. A sketch of this area is included on page 10.

Field Sketch completed at time of discoveries

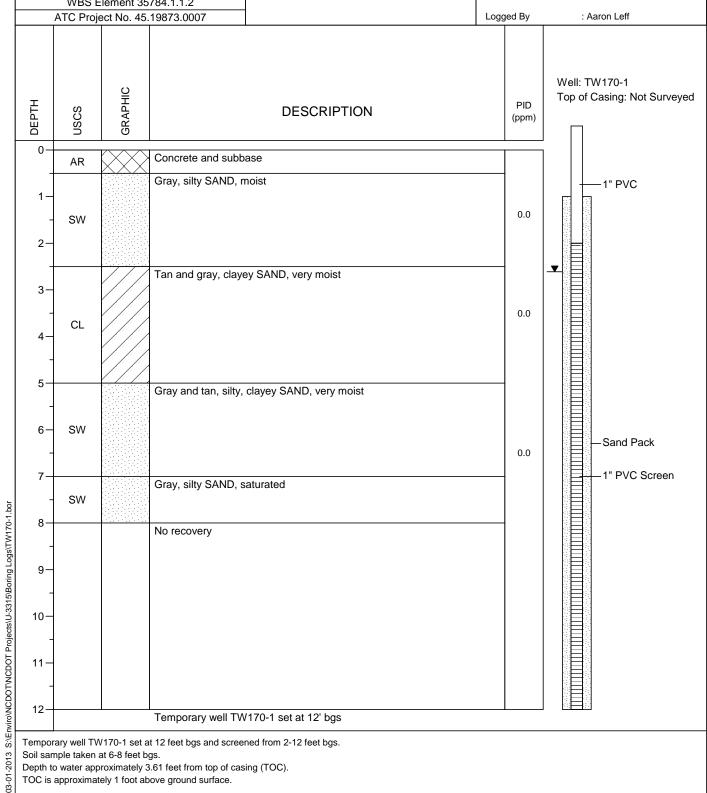
Temporary well TW170-1 set at 12 feet bgs and screened from 2-12 feet bgs. Soil sample taken at 6-8 feet bgs.

Depth to water approximately 3.61 feet from top of casing (TOC).
