PRELIMINARY SITE ASSESSMENT

NC 268 FROM MULTI-LANES EAST OF NC 18
TO SR 1966 (AIRPORT ROAD)
PARCEL 44 DOUGLAS HINCHER
CAROLINA AUTO SALES
516-600 ELKIN HIGHWAY
WILKESBORO, WILKES COUNTY, NORTH CAROLINA

NCDOT WBS ELEMENT 36001.1.2 STATE PROJECT R-2603

July 12, 2013

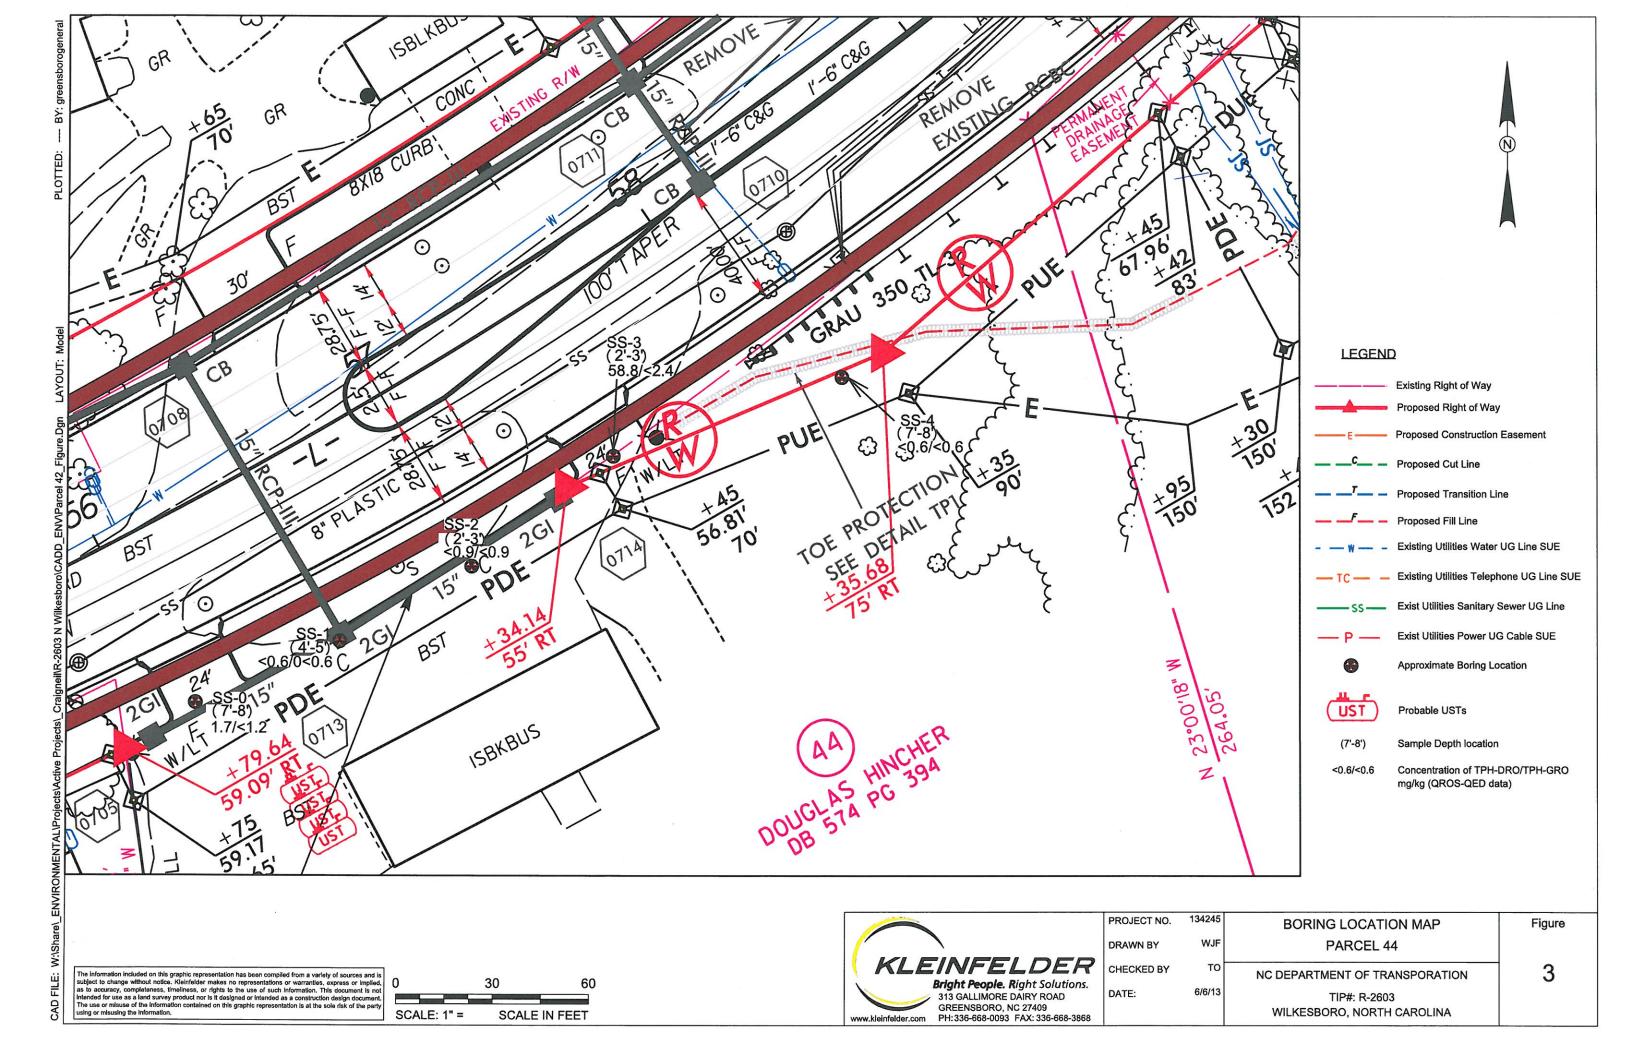
To determine if contaminated soil may be encountered during the proposed construction activities, five soil samples were collected along the NCDOT proposed easement. Prior to conducting soil borings, utilities were marked by NC One Call and Taylor Wiseman & Taylor (TWT). Kleinfelder met Probe Technology at the site on May 28, 2013. Probe Technology advanced five soil borings (SS-0 to SS-4) by direct push technology (DPT). The approximate location of the borings is shown on Figure 3.

TPH-DRO were detected in SS-3 (58.8 milligrams per kilogram (mg/kg)) above the North Carolina action level (10 mg/kg) at 2 to 3 feet below ground surface (bgs). Targeted constituent were also identified in SS-0 at concentrations above the method detection limits, however, below the North Carolina action level. The field analytical results are summarized in Table 2 and on Figure 3. The field analytical report is included in Appendix D.

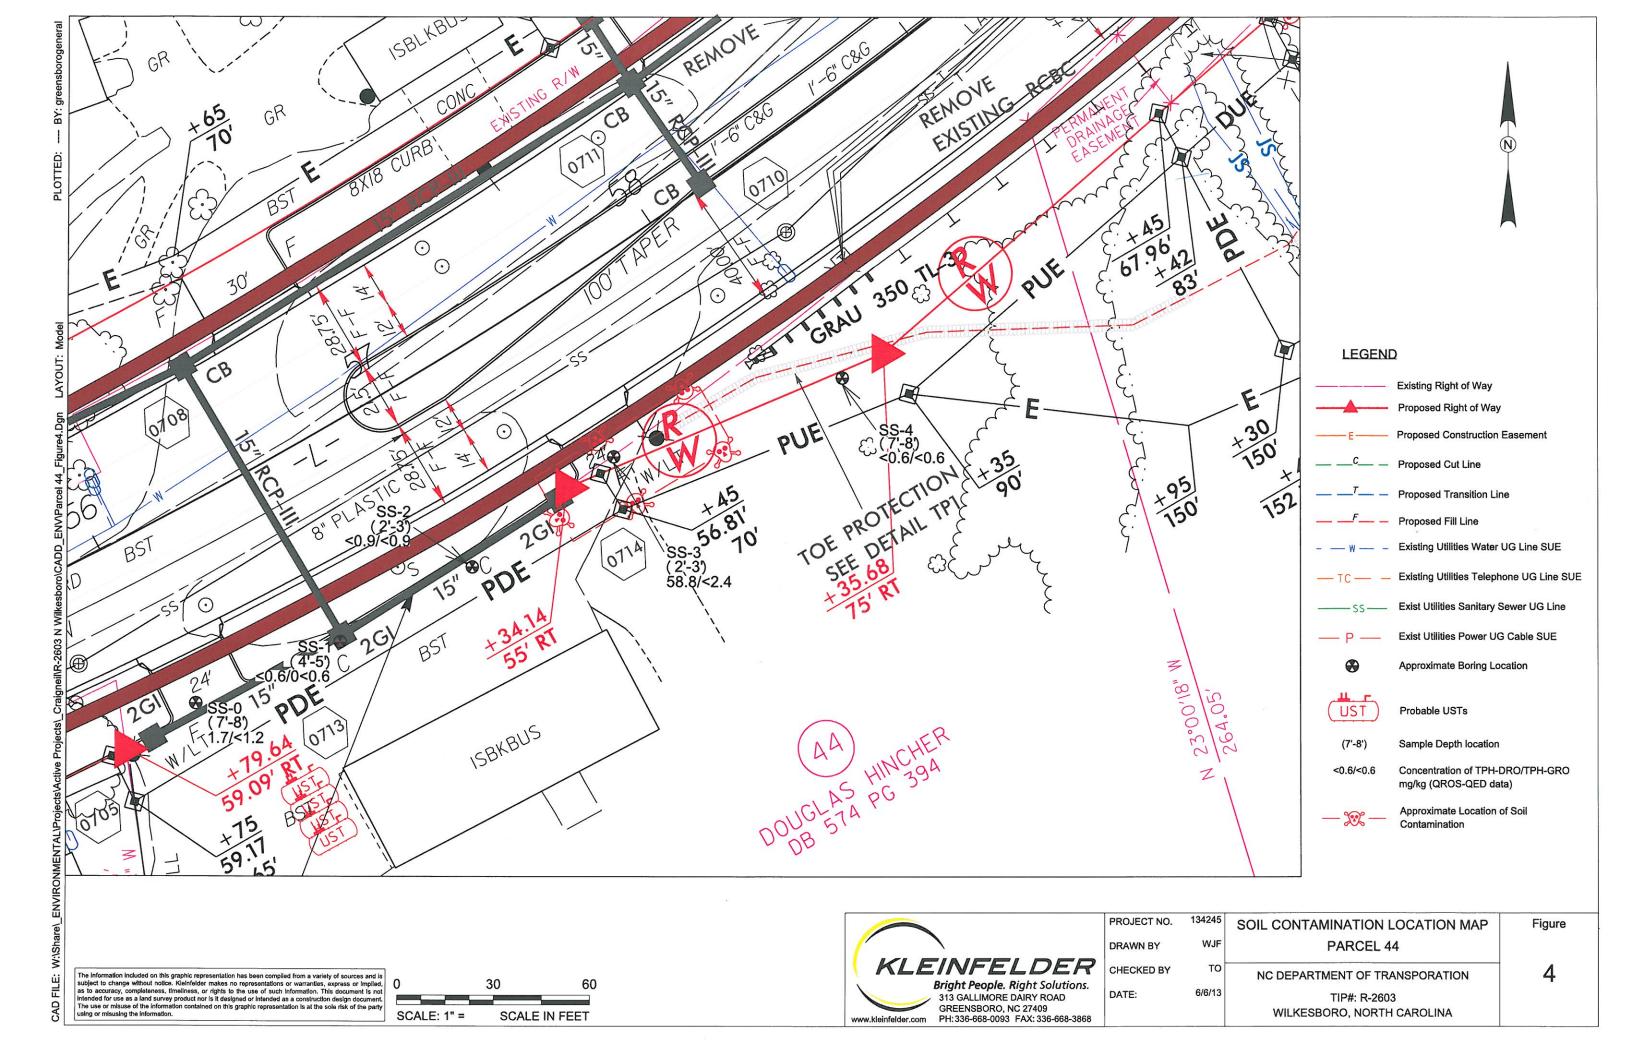
Based on field analytical results and PID readings, petroleum impacted soils were identified in the vicinity of SS-3. Kleinfelder was unable to identify a source for the impacted soils identified during the investigation. The estimated extent of contaminated oil was extrapolated based on the limited soil borings and the concentrations of the impacts. Kleinfelder estimates that the contaminated soil covers an area approximately 1,000 square feet in size. The contaminated soil vertical extent is estimated to be approximately five feet bgs, which is two feet deeper than the maximum depth of proposed future excavation activities to install a drainage pipe. Based on these dimensions Kleinfelder, estimates that there are approximately 185 cubic yards of impacted soil at the site. The area of soil contamination is depicted on Figure 4.

Kleinfelder recommends that the petroleum impacted soil in the vicinity of soil boring SS-3 be removed and disposed of at an approved disposal facility prior to the start of construction activities.

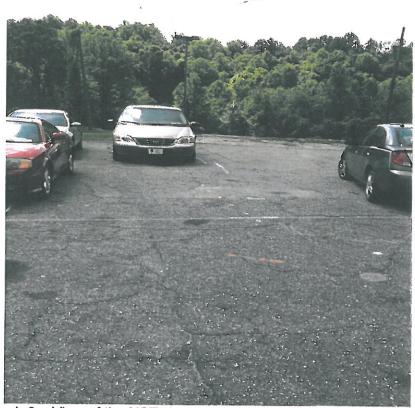
Photograph 3 – View of the USTs located on the western portion of the property.

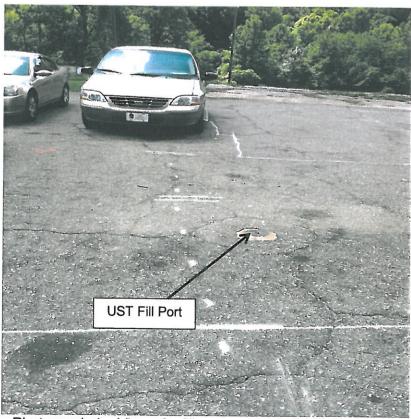
Photograph 4 – View of a fill port associated with the USTs.

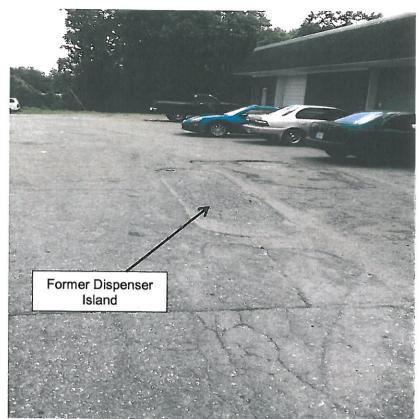
Photograph 5 – View of the former dispenser island located north of the structure.

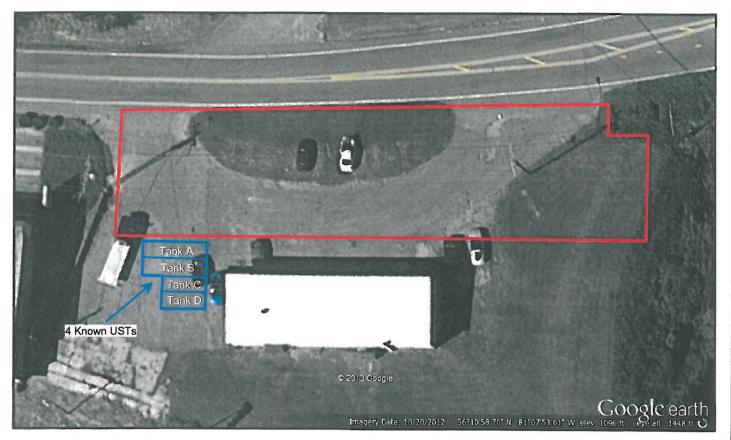
FIGURE 1

The site was relatively open, and consisted primarily of an asphalt parking lot. Aerial photographs showing the survey area boundaries, the boundaries of the known USTs, and ground-level photographs are shown in **Figure 1**.

Aerial Photograph Showing Approximate Geophysical Survey Boundaries and the Approximate Outline of the Known UST Tank Field

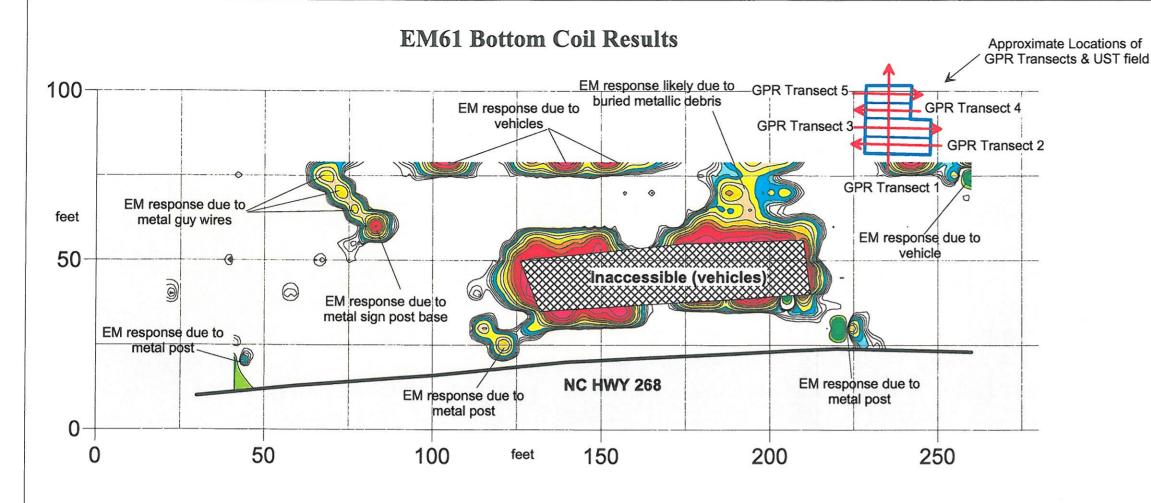
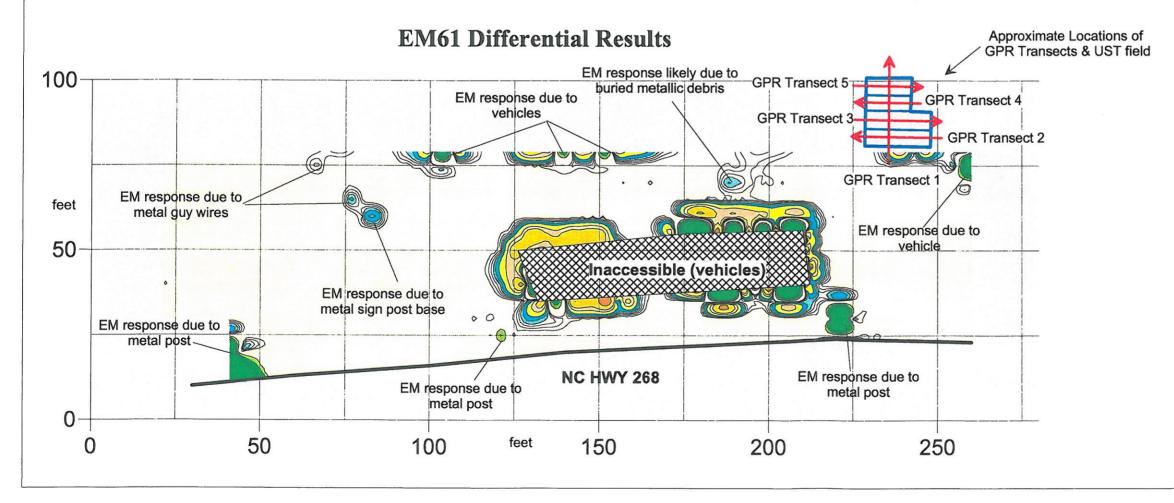
DATE	06/05/2013	CLIENT	KLEINFELDER
PYRAMID PROJECT #:	2013-124		FIGURE 2

Contour plots of the EM61 bottom coil and differential results obtained across the proposed ROW/easement areas at the property are presented in **Figure 2**. The bottom coil results represent the most sensitive component of the EM61 instrument and detect metal objects regardless of size. The bottom coil response can be used to delineate metal conduits or utility lines, small, isolated metal objects, and areas containing insignificant metal debris. The differential results are obtained from the difference between the top and bottom coils of the EM61 instrument. The differential results focus on the larger metal objects such as drum and UST-size objects and ignore the smaller insignificant metal objects.

area of vehicles is noted on **Figure 2**, and the EM response surrounding this area of inaccessibility was the result of the metal cars. Additionally, vehicles were present at the following coordinates: X=105, X=135, X=150, and X=240 at the south edge of the survey area (Y=80). Each of these vehicles created an EM response anomaly, as noted on **Figure 2**. The EM anomaly at X=45, Y=20 was the result of a metal post. The EM anomaly at X=80, Y=60 was the result of a metal sign post base, and the anomaly extending from this feature to the southeast was the result of metal guy wires across this area. The EM anomalies at X=120, Y=25 and at X=225, Y=30 were the result of a metal posts. The EM response centered at X=190, Y=70 was not attributed to any visible objects at the ground surface, and was likely the result of buried metallic debris.

NO EVIDENCE OF METALLIC USTs OBSERVED WITHIN MAIN SURVEY AREA (4 KNOWN USTs ON WEST SIDE OF BUILDING)

The contour plots show the bottom coil (most sensitive) and differential results of the EM61 instrument in millivolts (mV). The bottom coil response shows buried metallic objects regardless of size. The differential response focuses on larger, buried metallic objects such as drums and USTs and ignores smaller miscellaneous buried, metal debris. The EM61 data were collected on May 16, 2013 using a Geonics EM61 instrument. Ground penetrating radar (GPR) data were collected on May 16, 2013, using a GSSI SIR 200 coupled to a 400MHz antennae.

Note: All EM responses surrounding the area of inaccessibility are the result of the vehicles parked in this area.

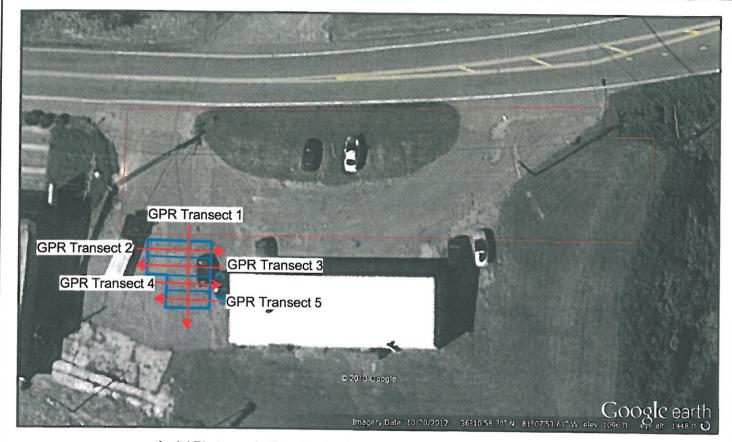
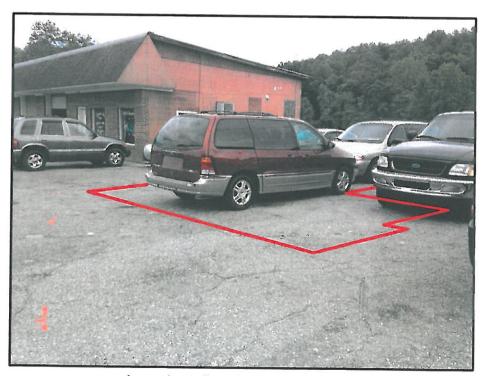
Known UST Locations, GPR Transect Locations and Boundary of UST Pit

GPR Survey of Known USTs: Pyramid performed a reconnaissance GPR survey across the area containing the four known USTs at the property in order to delineate their general locations. GPR scans were performed generally from north to south and east to west across the entire area to locate the tanks. All four tanks were observed during the survey. Figure 3 presents an aerial photograph showing the approximate locations of the tanks, as well as ground-level photographs of the outline of the tanks established by Pyramid during our survey. The tanks were generically labeled Tanks A-D, from south to north. All tanks were observed to be approximately 2.5 to 3 feet below the ground surface.

Aerial Photograph Showing the Approximate Outlines of the Known USTs and the Locations of the GPR Transects

Approximate Boundary of Known USTs

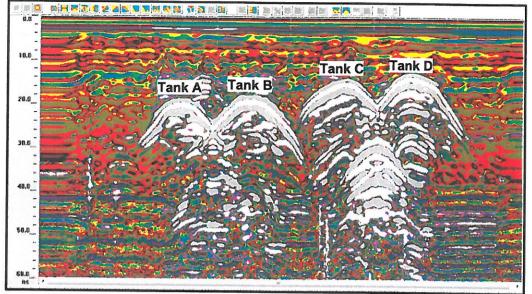
GPR Transect Images

Once the tanks were located, GPR transects were performed across the width and length of the tanks and saved to the hard drive. Transect 1 was oriented from north to south across the width of all four tanks, and Transects 2-5 were performed across the length of each tank. The GPR images obtained from all of the transects are presented in **Figure 4**.

GPR Transect 1 - North to South Across Known USTs
