PRELIMINARY SITE ASSESSMENT

NC 268 FROM MULTI-LANES EAST OF NC 18
TO SR 1966 (AIRPORT ROAD)
PARCEL 45 JAMES BROWN
TOTAL IMAGE BEAUTY SALON
517 ELKIN HIGHWAY
WILKESBORO, WILKES COUNTY, NORTH CAROLINA

NCDOT WBS ELEMENT 36001.1.2
STATE PROJECT R-2603

Kleinfelder Project No. 134245

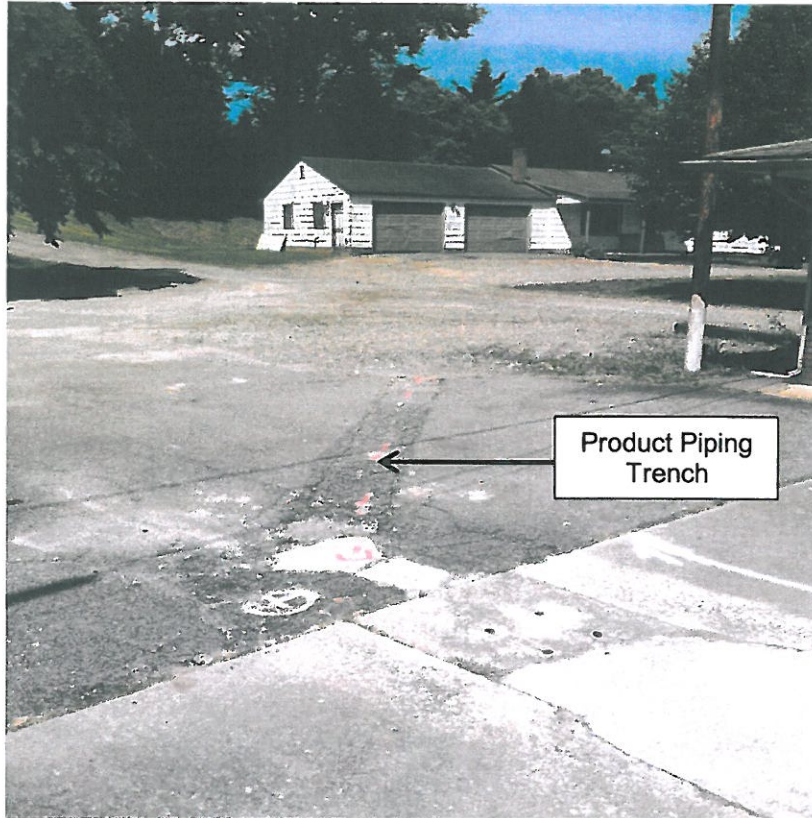
Pyramid concluded that the GPR and EM investigation did not detect metallic USTs within the survey area, however, they did identify suspect product piping in front of the Total Image Beauty Salon. The suspected product piping extended from an area that appeared to be an historical dispenser island to the western side of the Total Image Beauty Salon. Kleinfelder also observed a fillport of what appeared to be a heating oil UST adjacent to the residence located on the western portion of the property which had not been identified and was not investigated during the geophysical investigation within the proposed right-of-way. Pyramid's report is included in Appendix B.

Photograph 5 –View of the product piping trench.

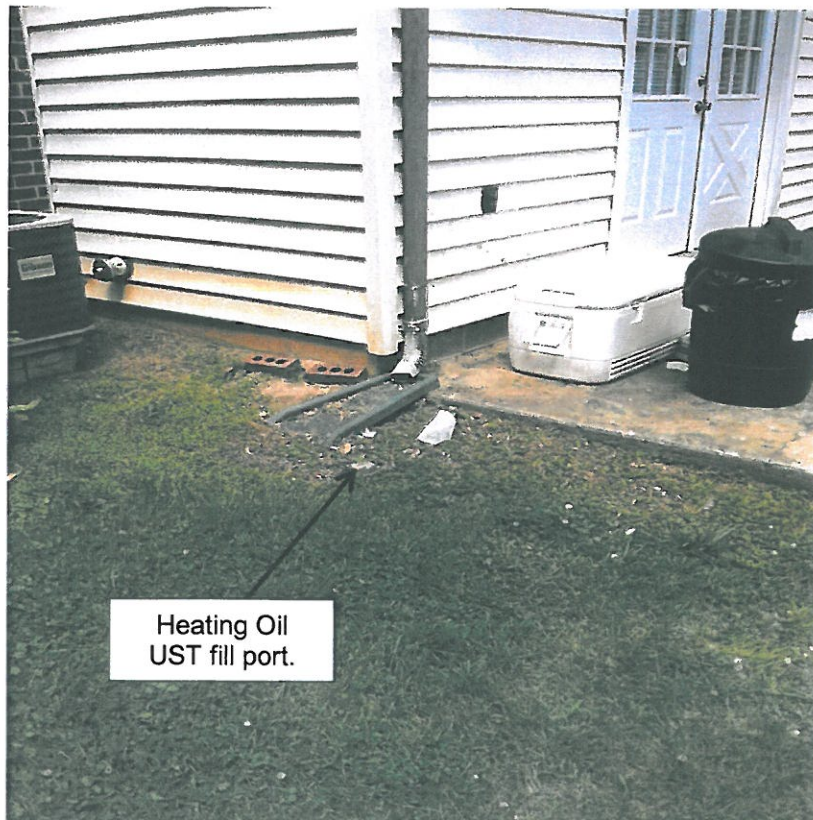
- ◆ Kleinfelder observed a fillport of what appeared to be a heating oil UST adjacent to the residence located on the western portion of the property.
- ◆ Groundwater was not encountered in the soil borings.

Photograph 8 – View of a heating oil UST fill port.

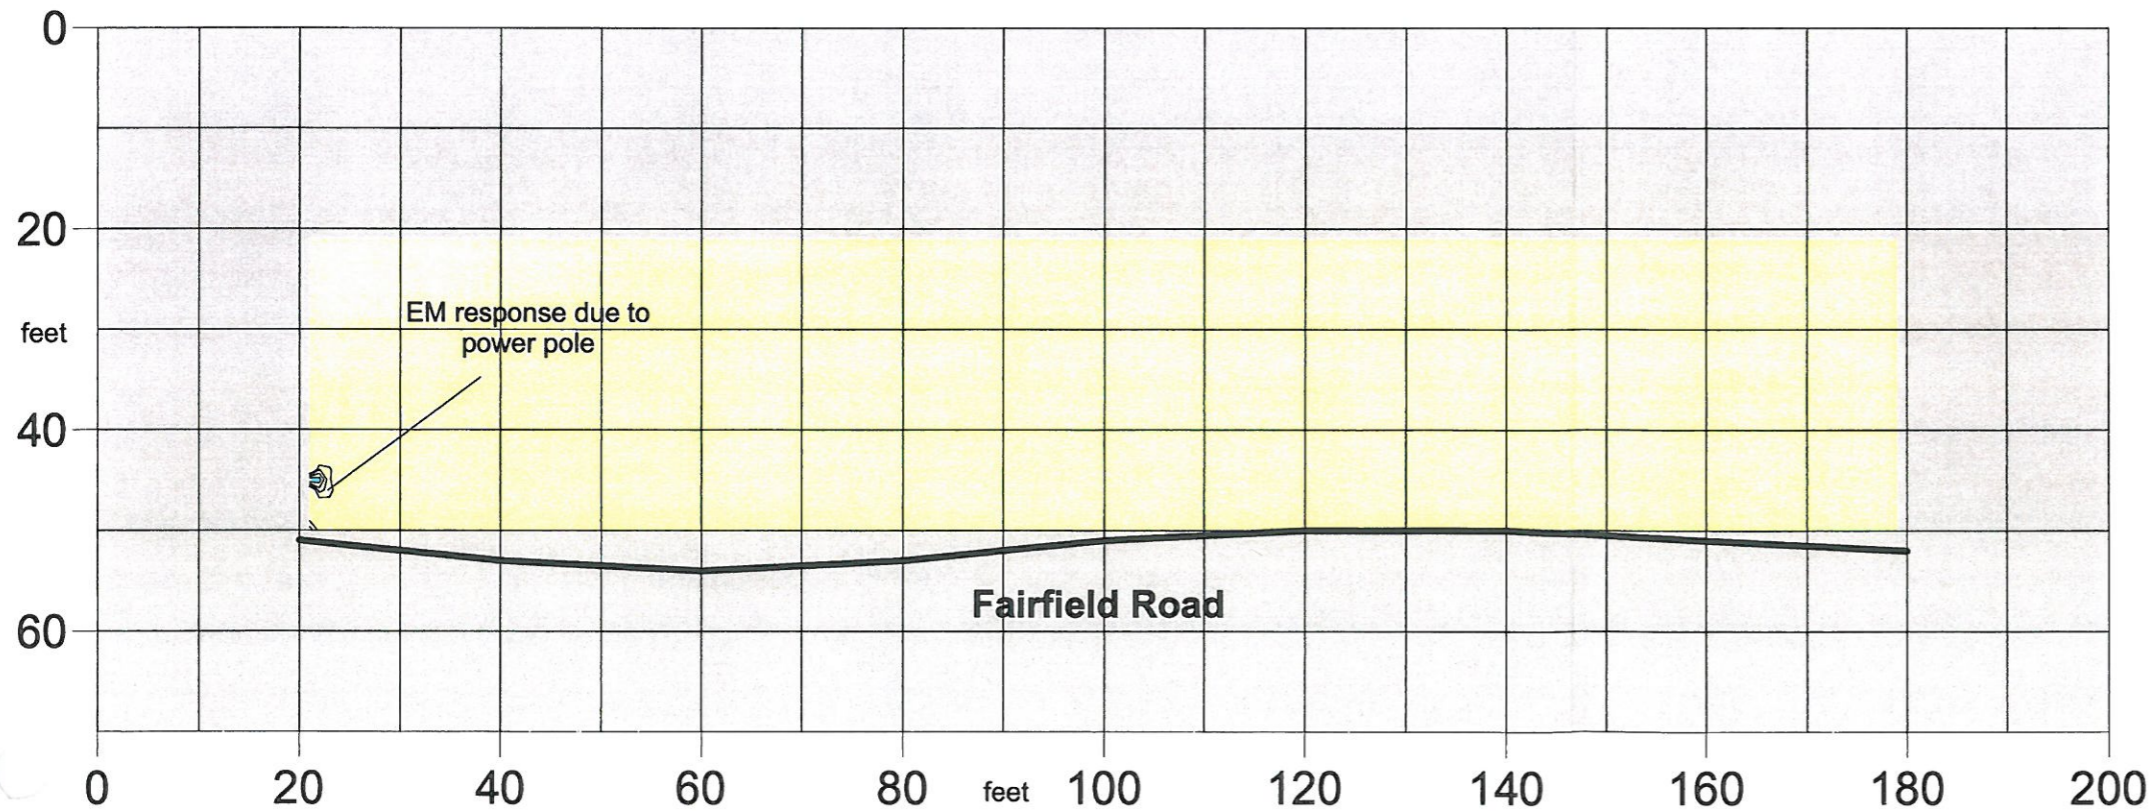
503 INDUSTRIAL AVENUE GREENSBORO, NC 27460 (336) 335-3174 (p) (336) 691-0648 (f) License # C1251 Eng. / License # C257 Geology	
DATE	06/05/2013
CLIENT	KLEINFELDER
PYRAMID PROJECT #:	2013-124
FIGURE 3

East Survey Grid: The EM anomaly at X=20, Y=45 was the result of a power pole. Minor anomalies that were only apparent in the bottom coil results on the northern half of the survey area were the result of minor metallic debris. No significant features were observed that would warrant further investigation by the GPR.

EM61 Bottom Coil Results

EM61 Differential Results

NO EVIDENCE OF METALLIC USTs OBSERVED

The contour plots show the bottom coil (most sensitive) and differential results of the EM61 instrument in millivolts (mV). The bottom coil response shows buried metallic objects regardless of size. The differential response focuses on larger, buried metallic objects such as drums and USTs and ignores smaller miscellaneous buried, metal debris. The EM61 data were collected on May 16, 2013 using a Geonics EM61 instrument. Ground penetrating radar (GPR) data were not collected due to the lack of any unexplained anomalies in the EM survey.
