PRELIMINARY SITE ASSESSMENT

NC 268 FROM MULTI-LANES EAST OF NC 18
TO SR 1966 (AIRPORT ROAD)
PARCEL 48 AMANDA JOLLY
MODERN AUTO SALES
603 ELKIN HIGHWAY
WILKESBORO, WILKES COUNTY, NORTH CAROLINA

NCDOT WBS ELEMENT 36001.1.2
STATE PROJECT R-2603

July 12, 2013

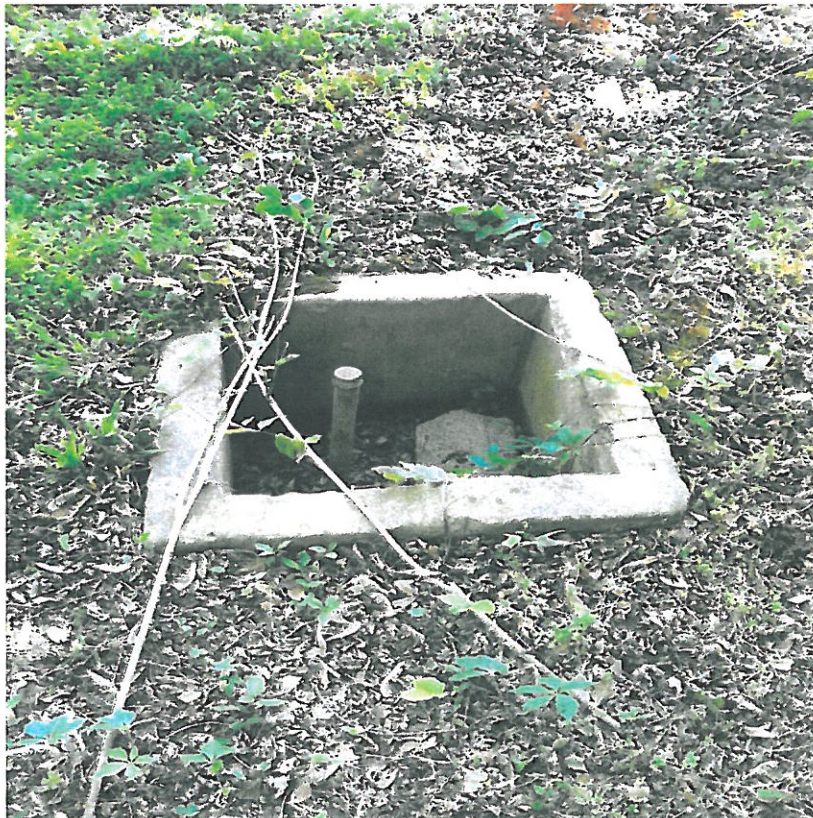
Pyramid Environmental & Engineering, P.C (Pyramid) conducted a geophysical investigation of the property on May 17, 2013. Pyramid utilized ground penetrating radar (GPR) and electromagnetic (EM) induction technology to locate potential geophysical anomalies and potential USTs at the site. The geophysical investigation located a probable UST located outside the proposed right-of-way at the southwestern corner of the structure. The fillport of the UST was observed, however, Pyramid was unable to determine the size of the UST. No unidentified anomalies were located during the geophysical investigation within the proposed right-of-way. A copy of the Pyramid Geophysical Investigation Report is included in Appendix B. A concrete vault with a capped pipe was observed north of the onsite structure. Since the vault and pipe were well outside the proposed easement, no further investigation was conducted. A photograph of the vault and pipe is included in Appendix A.

Photograph 8 – View of a vault and pipe observed north of the structure.

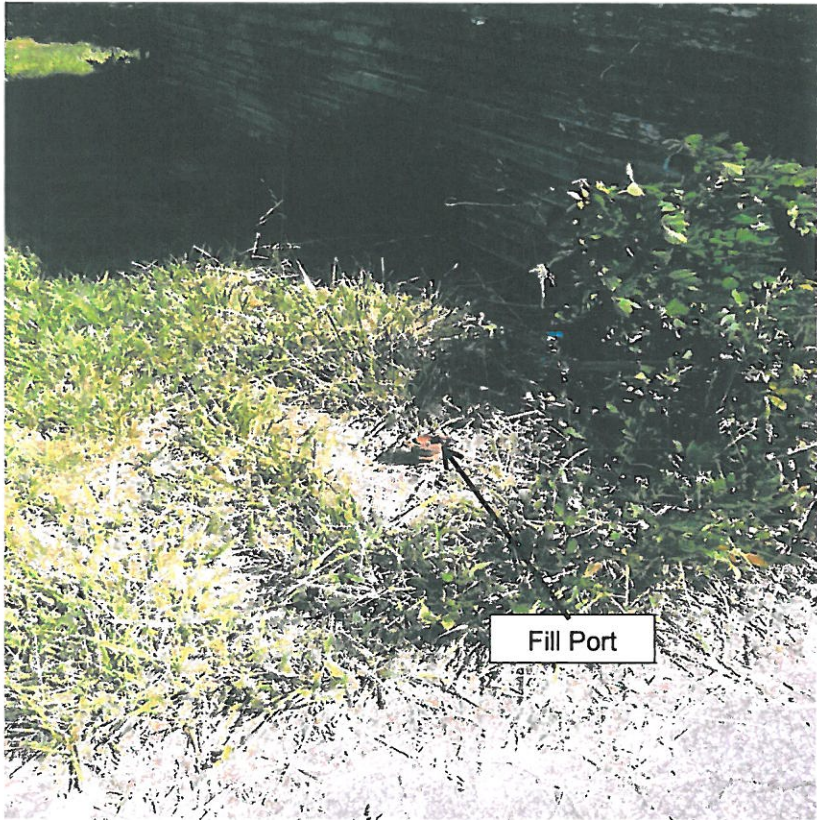
Pyramid concluded that the GPR and EM investigation did not detect metallic USTs within the survey area, however, they did identify a probable UST at the southwestern corner of the structure. No unidentified anomalies were located during the geophysical investigation within the proposed right-of-way. Pyramid's report is included in Appendix B.

- ◆ The GPR and EM investigation did not detect metallic USTs within the survey area. Pyramid did identify a probable UST located outside the proposed right-of-way at the southwestern corner of the structure. The fillport of the UST was observed, however, Pyramid was unable to determine the size of the UST.

Photograph 9 – View of a fill port observed on the western side of the structure.

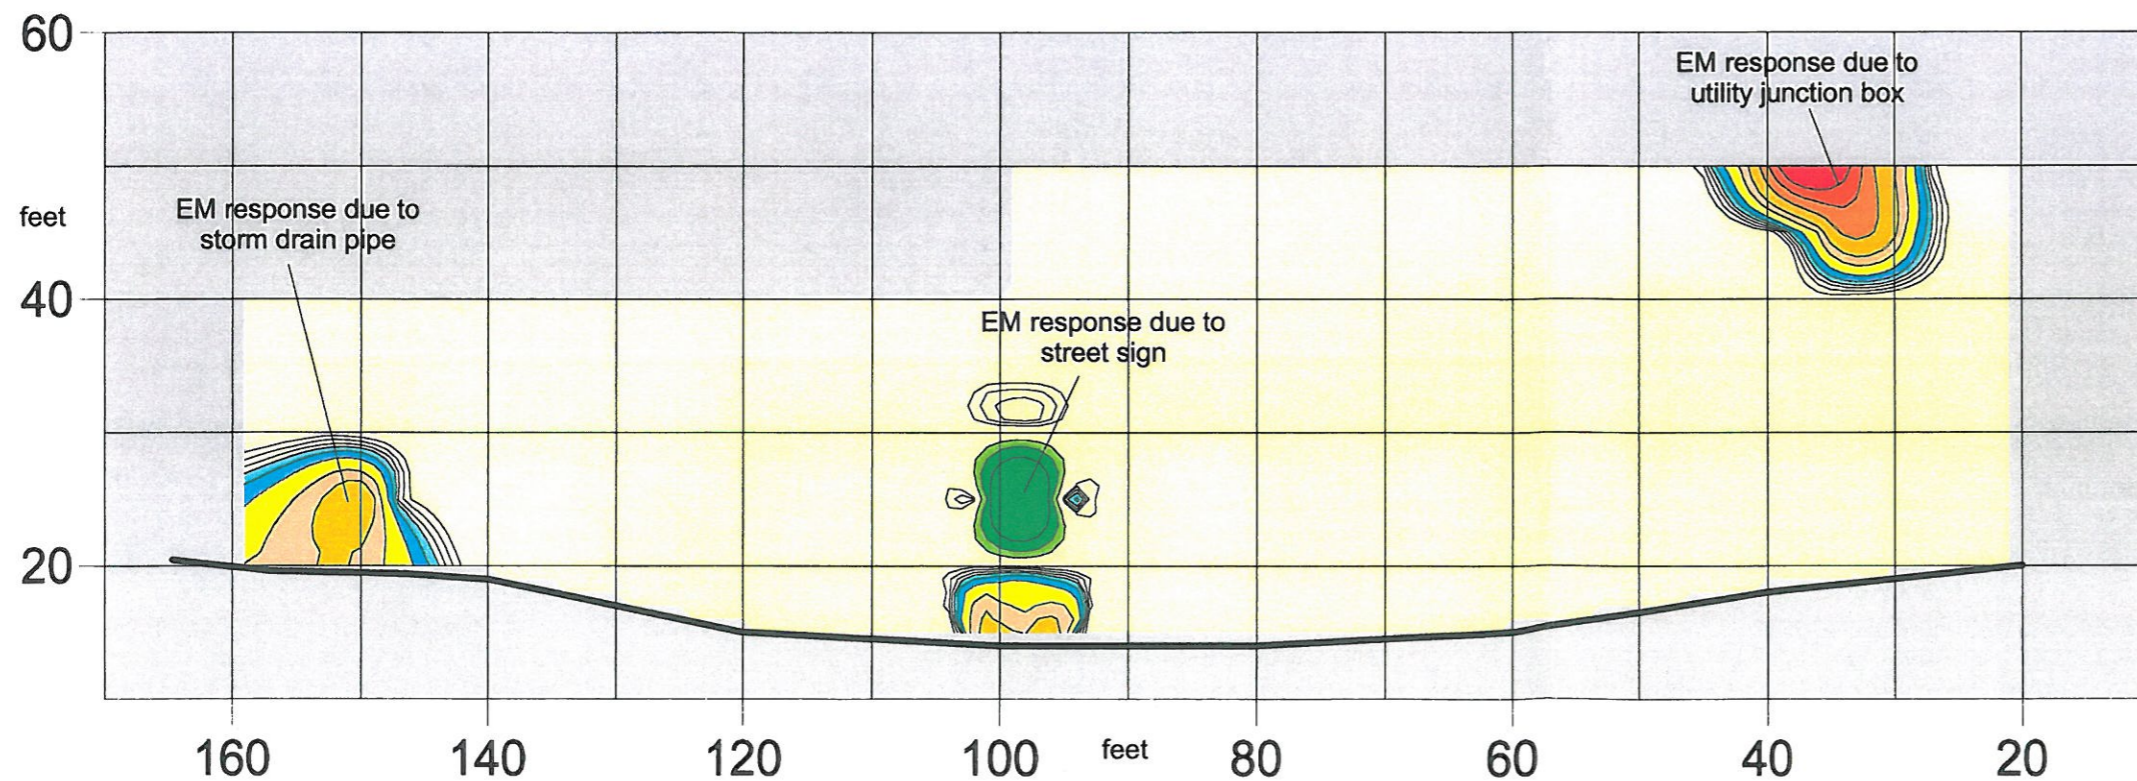
West Survey Grid: The EM anomaly at X=152, Y=25 was the result of a storm drain pipe. The EM anomalies between X=135 and 115 at Y=35, as well as at X=55, Y=35 were likely the result of minor buried metallic debris. These features were only evidence on the bottom coil results, and are not indicative of a UST. The EM anomaly at X=100, Y=25 and the surrounding feature was the result of a street sign. The EM anomaly at X=35, Y=45 was the result of a metal utility junction box. No significant features were observed that would warrant further investigation by the GPR.

NO EVIDENCE OF METALLIC USTs OBSERVED

The contour plots show the bottom coil (most sensitive) and differential results of the EM61 instrument in millivolts (mV). The bottom coil response shows buried metallic objects regardless of size. The differential response focuses on larger, buried metallic objects such as drums and USTs and ignores smaller miscellaneous buried, metal debris. The EM61 data were collected on May 17, 2013 using a Geonics EM61 instrument. Ground penetrating radar (GPR) data were not collected due to no unexplained anomalies in the EM survey.

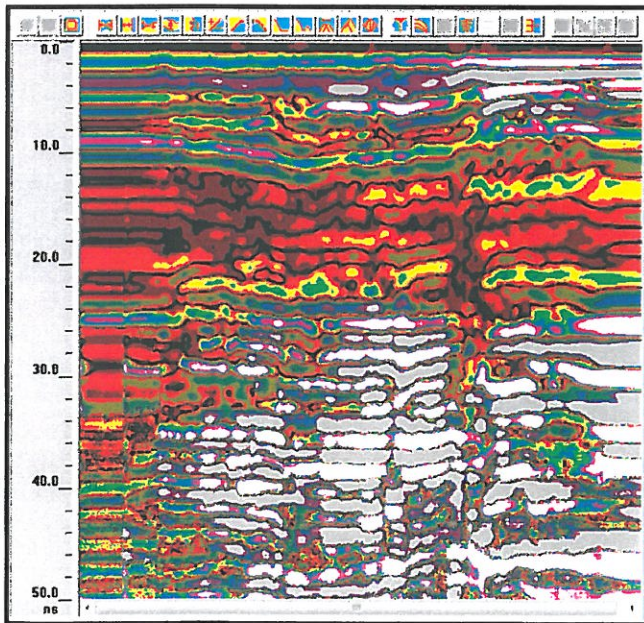
GPR Transect 1 was performed from north to south, directly on the west side of the visible pipe. GPR Transect 2 was performed from west to east, directly to the south of the pipe. Transects could not be performed directly across the location of the pipe due to debris and the pipe itself. The two GPR Transects did not record any evidence that would confirm a UST extended away from the building at this location. However, due to the presence of the pipe, the EM anomaly at the southwest corner of the building, and the inability to perform a GPR transect directly adjacent to the building, we are classifying this feature as a possible UST. The possible UST is likely oriented from south to north, directly adjacent to the structure where the GPR could not be performed.

GPR Transect 1 - North to South
Adjacent to Possible UST
(No Evidence Detected)
