PRELIMINARY SITE ASSESSMENT

NC 268 FROM MULTI-LANES EAST OF NC 18
TO SR 1966 (AIRPORT ROAD)
PARCEL 58 JENNIFER WYATT
ROBERT'S PRODUCE
634 ELKIN HIGHWAY
WILKESBORO, WILKES COUNTY, NORTH CAROLINA

NCDOT WBS ELEMENT 36001.1.2 STATE PROJECT R-2603

July 12, 2013

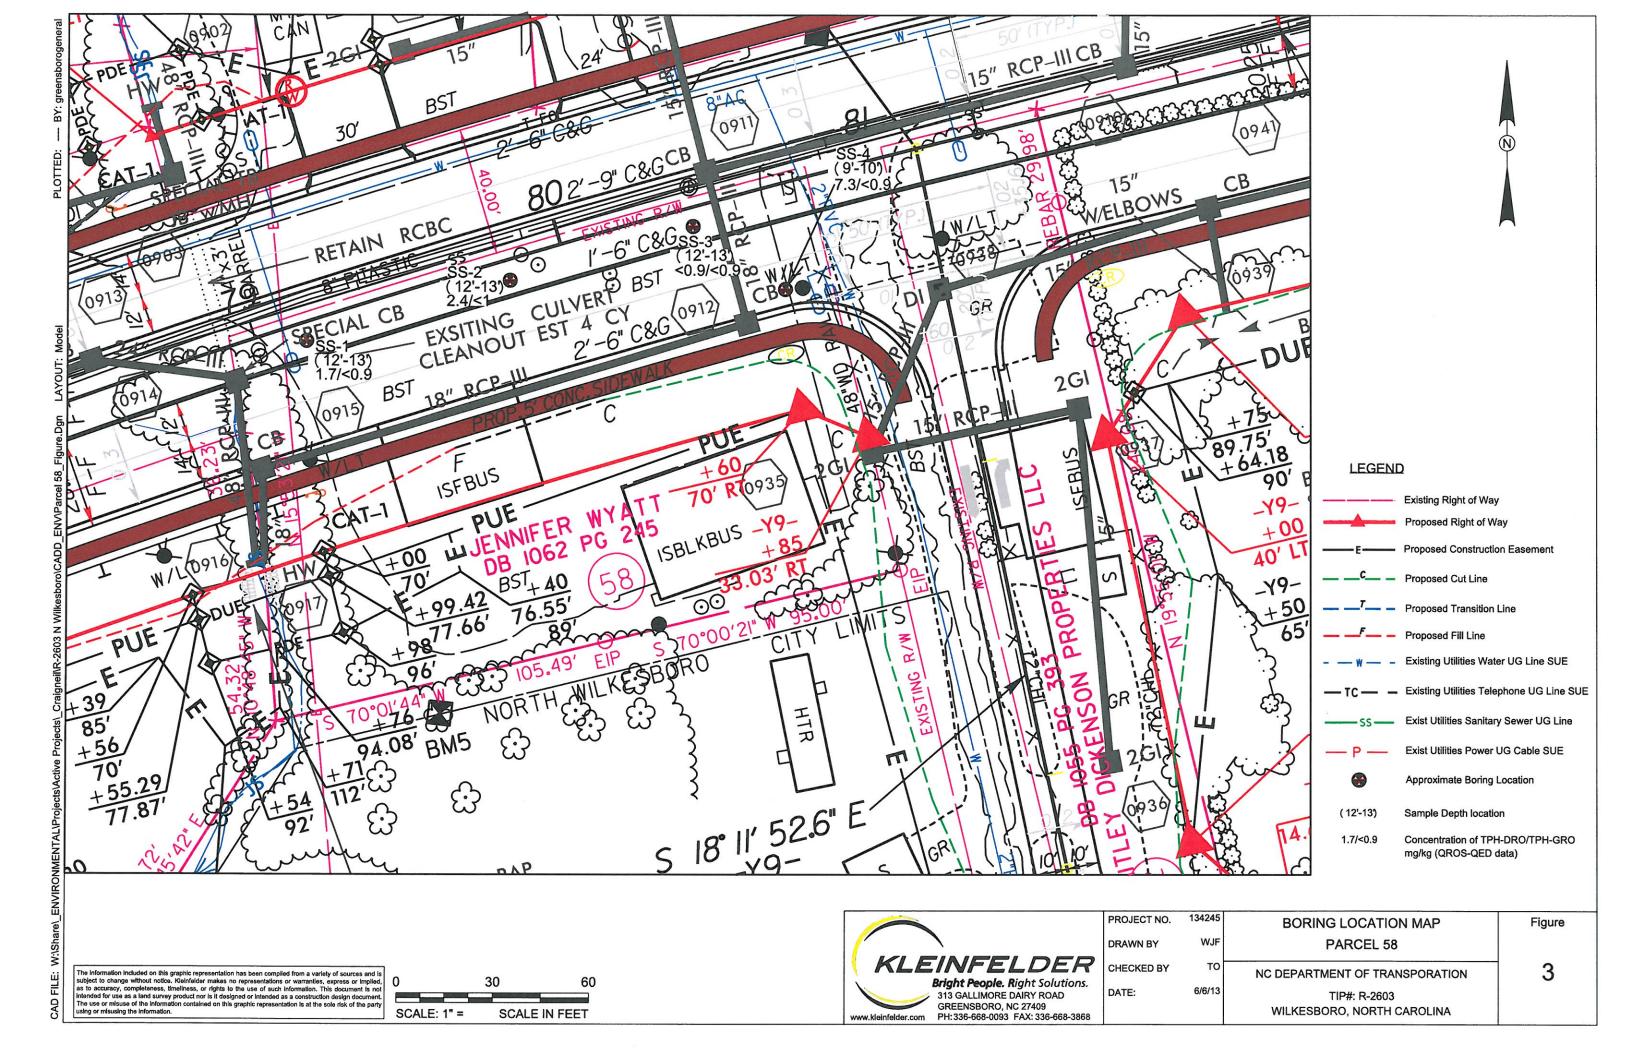
To determine if contaminated soil may be encountered during the proposed construction activities, four soil samples were collected along the NCDOT proposed easement. Prior to conducting soil borings, utilities were marked by NC One Call and Taylor Wiseman & Taylor (TWT). Kleinfelder met Probe Technology at the site on May 29, 2013. Probe Technology advanced four soil borings (SS-1 to SS-4) by direct push technology (DPT). The approximate location of the borings is shown on Figure 3.

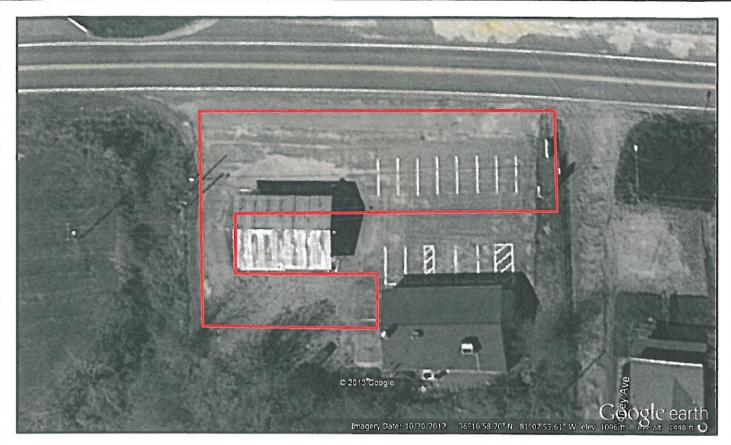
FIGURE 1

The site was relatively open, and consisted predominantly of asphalt parking space. Aerial photographs showing the survey area boundaries and ground-level photographs are shown in **Figure** 1.

Aerial Photograph Showing Approximate Geophysical Survey Boundaries

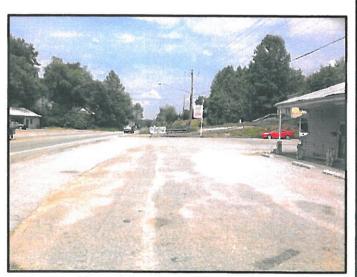
View of Geophysical Survey Area (Photograph Facing Approximately West)

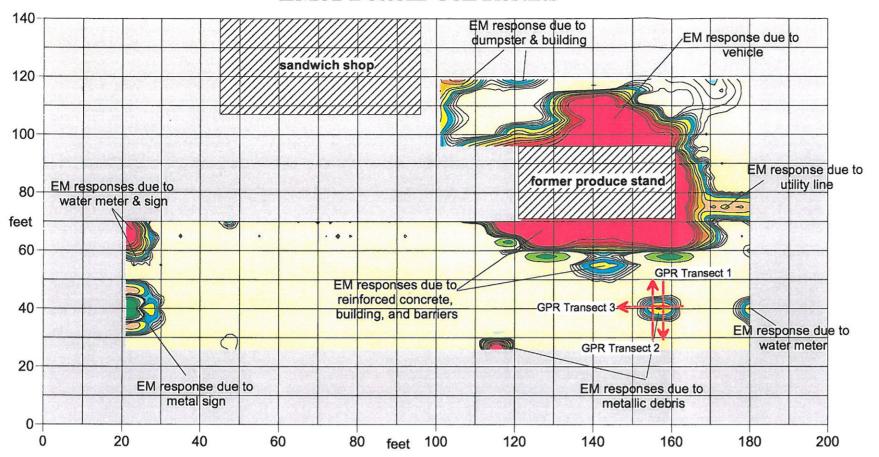
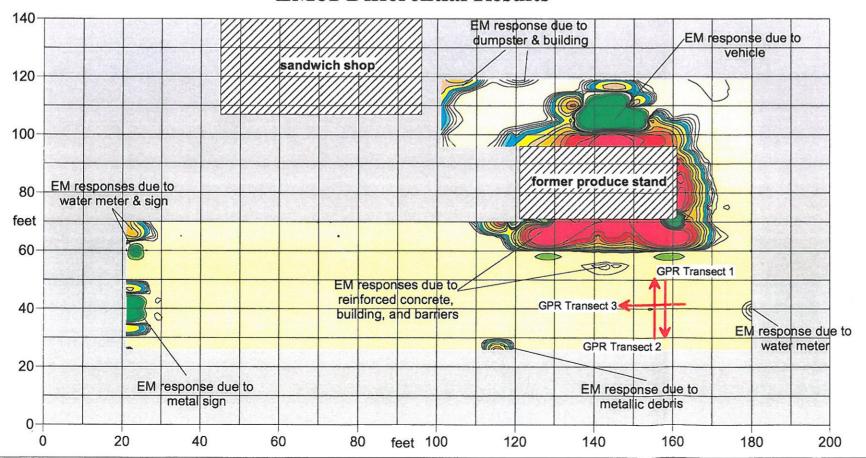
DATE	06/05/2013	CLIENT	KLEINFELDER
PYRAMID PROJECT #:	2013-124		FIGURE 2

Contour plots of the EM61 bottom coil and differential results obtained across the proposed ROW/easement areas at the property are presented in **Figure 2**. The bottom coil results represent the most sensitive component of the EM61 instrument and detect metal objects regardless of size. The bottom coil response can be used to delineate metal conduits or utility lines, small, isolated metal objects, and areas containing insignificant metal debris. The differential results are obtained from the difference between the top and bottom coils of the EM61 instrument. The differential results focus on the larger metal objects such as drum and UST-size objects and ignore the smaller insignificant metal objects.

Discussion of EM results: The EM anomaly at X=25, Y=65 was the combined result of a metal sign and water meter cover. The EM anomaly at X=180, Y=40 was the of a water meter cover. The EM response surrounding the west building was the result of the building foundation, reinforced concrete, and concrete parking barriers. The EM response at the southeast portion of the survey area near the sandwich shop was the result of a metal dumpster and the building foundation. The EM anomaly centered at X=145, Y=105 was the result of a vehicle. The EM anomaly between X=170 and X=180 at Y=75 is associated with a utility running from the edge fo the property to the building. The anomalies at X=115, Y=25 and at X=155, Y=40 could not be attributed to any visible objects at the ground surface, and were likely the result of buried metallic debris. The isolated nature and

small size of the anomaly at X=115, Y=25 was not indicative of a possible UST. The anomaly at X=155, Y=40 was investigated further by the GPR.

The contour plots show the bottom coil (most sensitive) and differential results of the EM61 instrument in millivolts (mV). The bottom coil response shows buried metallic objects regardless of size. The differential response focuses on larger, buried metallic objects such as drums and USTs and ignores smaller miscellaneous buried, metal debris. The EM61 data were collected on May 16, 2013 using a Geonics EM61 instrument. Ground penetrating radar (GPR) data were collected on May 20, 2013, using a GSSI SIR 2000 coupled to a 400 MHz antennae.

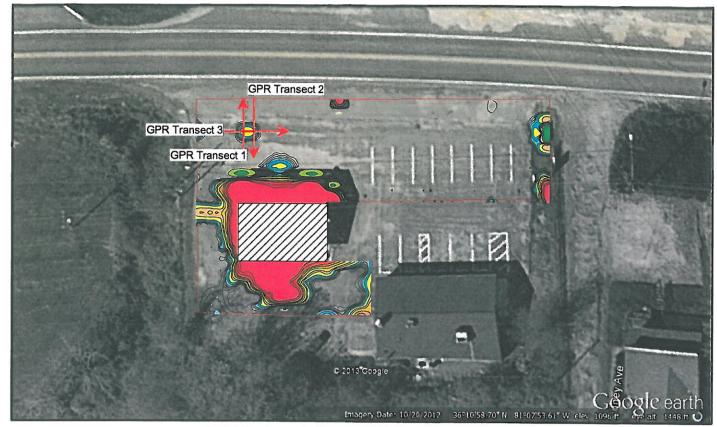
FIGURE 3

GPR scans were performed across the anomaly at X=155, Y=40. The GPR data were viewed in real time as the equipment was surveyed across the anomalies. Transects across the anomaly were saved to the hard drive for post-processing in the office. **Figure 3** presents an aerial photograph showing the location of the GPR transects performed as well as the GPR images that were collected.

GPR Transects 1 and 2 were performed from north to south and south to north, respectively, across the unknown anomaly at X=155. GPR Transect 3 was performed from west to east across the anomaly. The three GPR transects recorded evidence of disturbed soil that is typical of buried debris. Combined with the EM results, we conclude that this feature is associated with isolated buried metallic debris. No other significant features were recorded by the GPR that would be indicative of any large objects below the ground surface, such as metallic USTs.

Aerial Photograph Showing EM Anomalous Areas and Locations of GPR Transects

GPR Transect 1 - S/N Across Anomaly (suspected metallic debris)

GPR Transect 2 - N/S Across Anomaly GPR Transect 3 - W/E Across Anomaly (suspected metallic debris)

(suspected metallic debris)
