PRELIMINARY SITE ASSESSMENT

NC 268 FROM MULTI-LANES EAST OF NC 18
TO SR 1966 (AIRPORT ROAD)
PARCEL 60 VERNON WYATT
HOLLAND'S USED CARS
703 ELKIN HIGHWAY
WILKESBORO, WILKES COUNTY, NORTH CAROLINA

NCDOT WBS ELEMENT 36001.1.2 STATE PROJECT R-2603

July 12, 2013

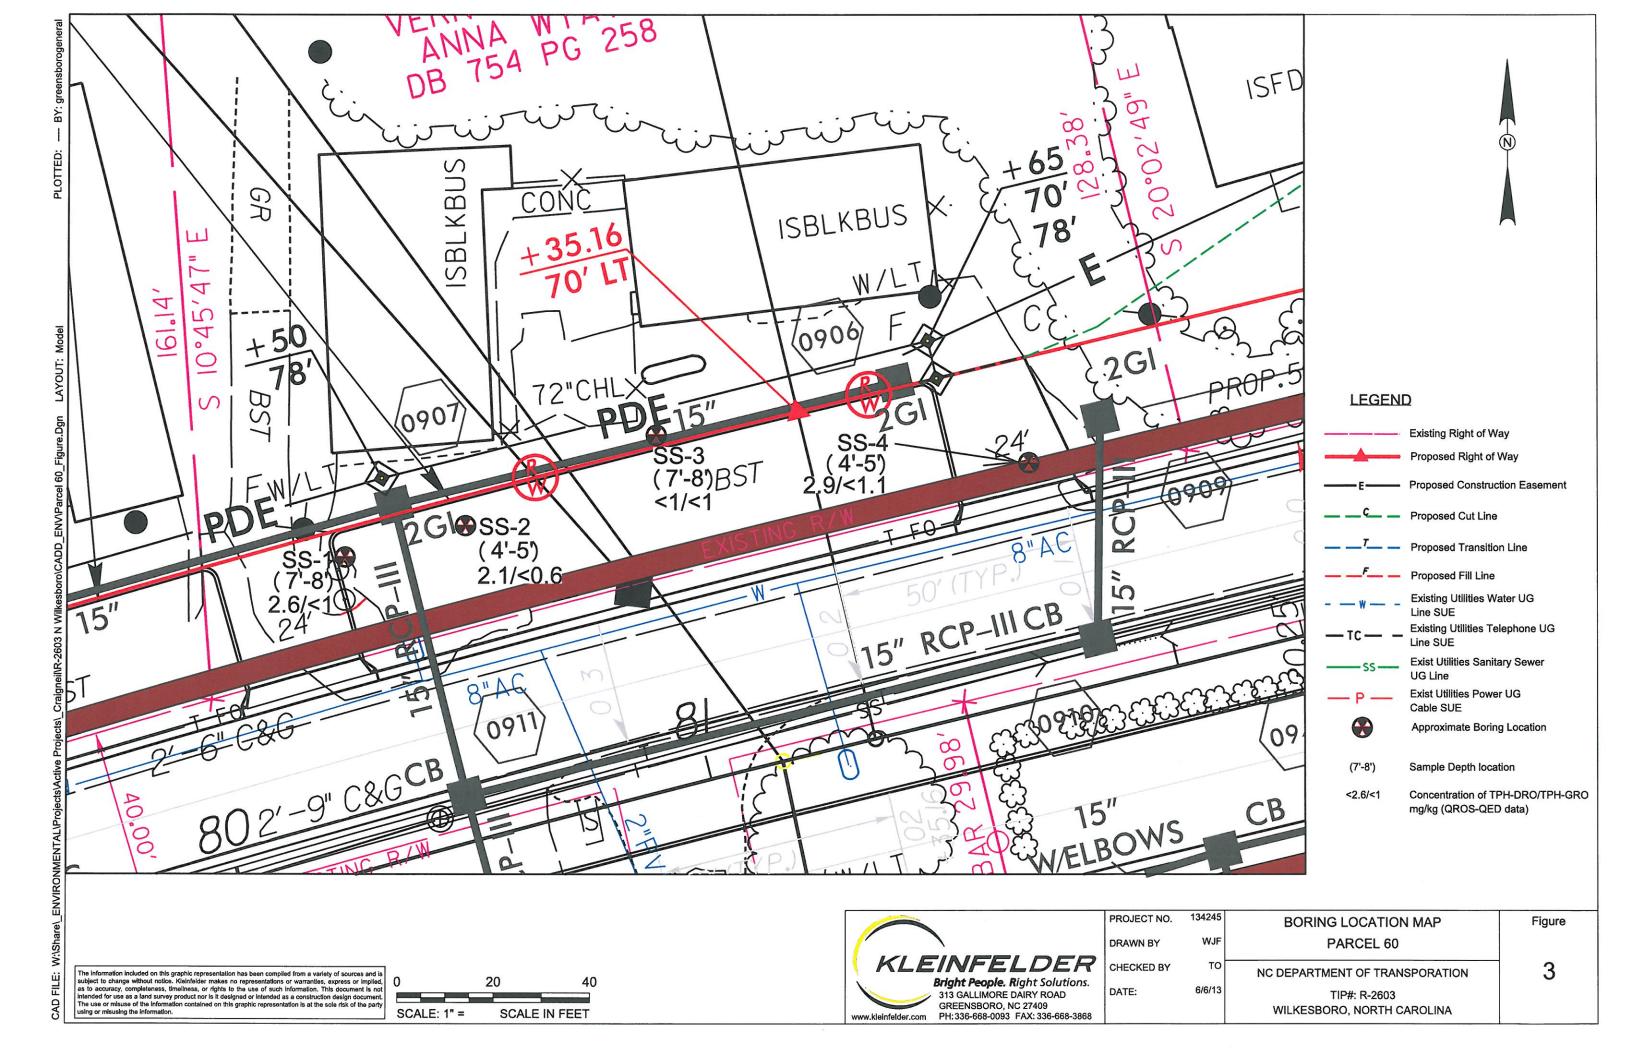
To determine if contaminated soil may be encountered during the proposed construction activities, four soil samples were collected along the NCDOT proposed easement. Prior to conducting soil borings, utilities were marked by NC One Call and Taylor Wiseman & Taylor (TWT). Kleinfelder met Probe Technology at the site on May 30, 2013. Probe Technology advanced four soil borings (SS-1 to SS-4) by direct push technology (DPT). The approximate location of the borings is shown on Figure 3.

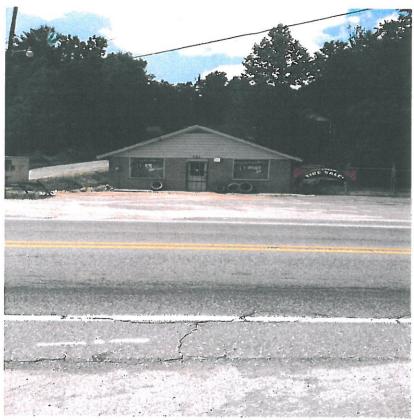
Photograph 1 – View of the used tire sales located on the western portion of the property.

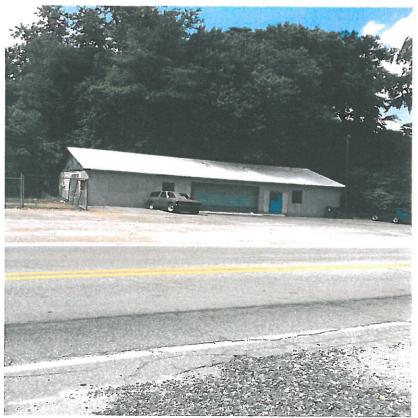
Photograph 2 – View of the automotive repair shop located on the eastern portion of the site.

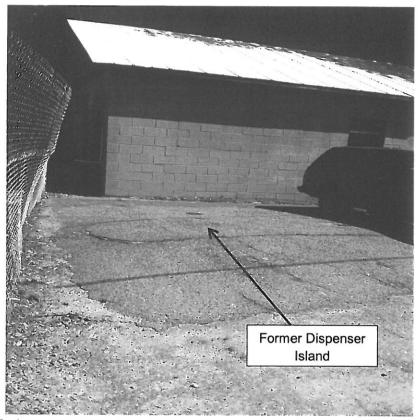
Photograph 3 – View of what appears to be a former dispenser island located at the southwestern corner of the automotive repair shop.

The proposed right-of-way includes the construction areas related to the widening of Elkin Highway east of NC 18 to SR 1966. At the time of our site reconnaissance, the site contained an active used car dealership named Holland's Used Cars. Based on information provided by NCDOT, the site is a used car dealership called Holland's Used Cars that may have formerly operated as a gas station, but there are no known USTs. During the field activities the two onsite structures were occupied with a used tire sales and an automotive repair shop. The geophysical investigation did not identify suspect USTs or unidentified anomalies within the proposed right-of-way. However, Kleinfelder did observe what appeared to be a former dispenser island located at the southwestern corner of the automotive repair shop. Site photographs are shown in Appendix A.

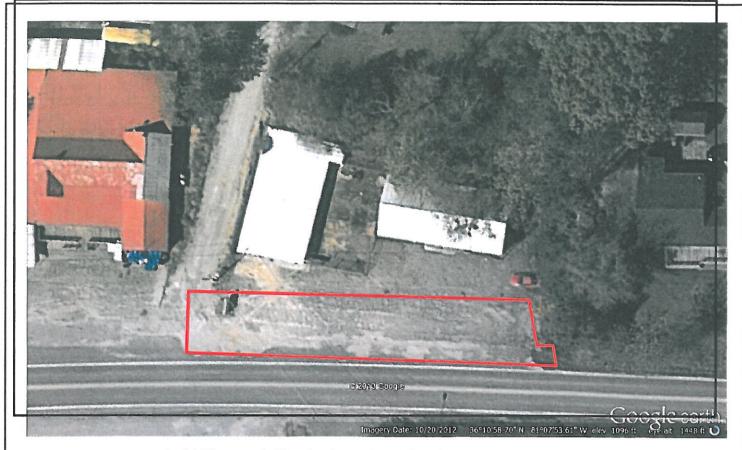
Aerial Photograph Showing Approximate Geophysical Survey Boundaries

The site was relatively open, and consisted primarily of an asphalt parking lot. Aerial photographs showing the survey area boundaries and ground-level photographs are shown in **Figure 1**.

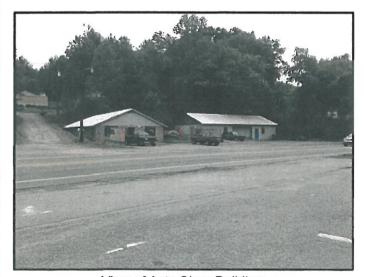
View of Auto Shop Building (Photograph Facing Approximately North)

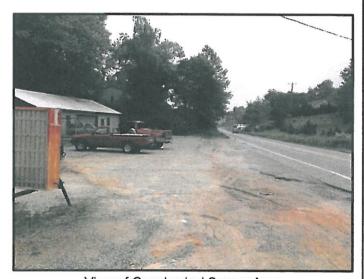
View of Geophysical Survey Area (Photograph Facing Approximately West)

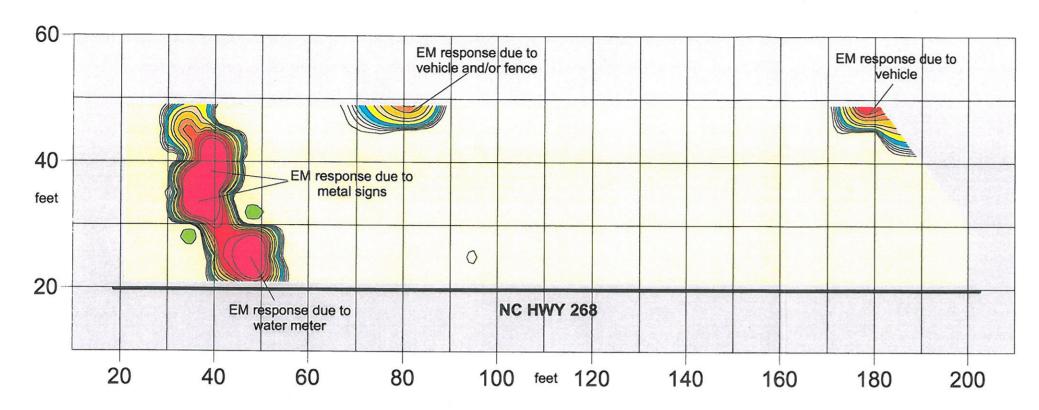
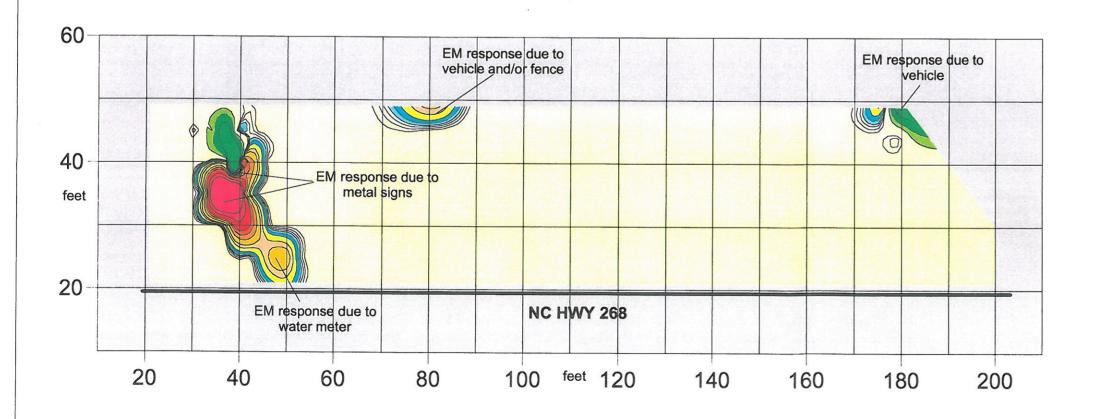
DATE	06/05/2013	CLIENT	KLEINFELDER
PYRAMID PROJECT #:	2013-124		FIGURE 2

Discussion of EM anomalies: The EM anomaly at X=45, Y=25 was the result of a metal water

meter cover. The EM anomaly at X=40, between Y=30 and Y=45 was the result of a metal signs.

The EM anomaly at X=80, Y=50 was the result of a vehicle and/or a metal fence at this location.

The EM anomaly at X=180, Y=50 was the result of a vehicle.

EM61 Bottom Coil Results

EM61 Differential Results

NO EVIDENCE OF METALLIC USTs OBSERVED

The contour plots show the bottom coil (most sensitive) and differential results of the EM61 instrument in millivolts (mV). The bottom coil response shows buried metallic objects regardless of size. The differential response focuses on larger, buried metallic objects such as drums and USTs and ignores smaller miscellaneous buried, metal debris. The EM61 data were collected on May 16, 2013 using a Geonics EM61 instrument. Ground penetrating radar (GPR) data were not collected due to no unexplained anomalies in the EM survey.

Contour plots of the EM61 bottom coil and differential results obtained across the proposed

The geophysical investigation suggests that the area of the proposed ROW/easement at Parcel 60 in
