Pyramid Environmental & Engineering, P.C. Project # 2013-131
Preliminary Site Assessment (PSA) – Parcel 78, Hutchinsons, LLC

PRELIMINARY SITE ASSESSMENT
PARCEL 78, HUTCHINSONS, LLC
1330 ELKIN HIGHWAY (NC 268)
NORTH WILKESBORO, WILKES COUNTY, NORTH CAROLINA
STATE PROJECT: R-2603
WBS ELEMENT: 36001.1.2
July 22, 2013

GEOPHYSICAL SURVEYS OF PARCEL 78 – UNDERGROUND STORAGE TANK INVESTIGATION

**GEOPHYSICAL INVESTIGATION REPORT
NCDOT PRELIMINARY SITE ASSESSMENT
PARCEL 78 – 1330 ELKIN HIGHWAY
North Wilkesboro, Wilkes County, North Carolina**

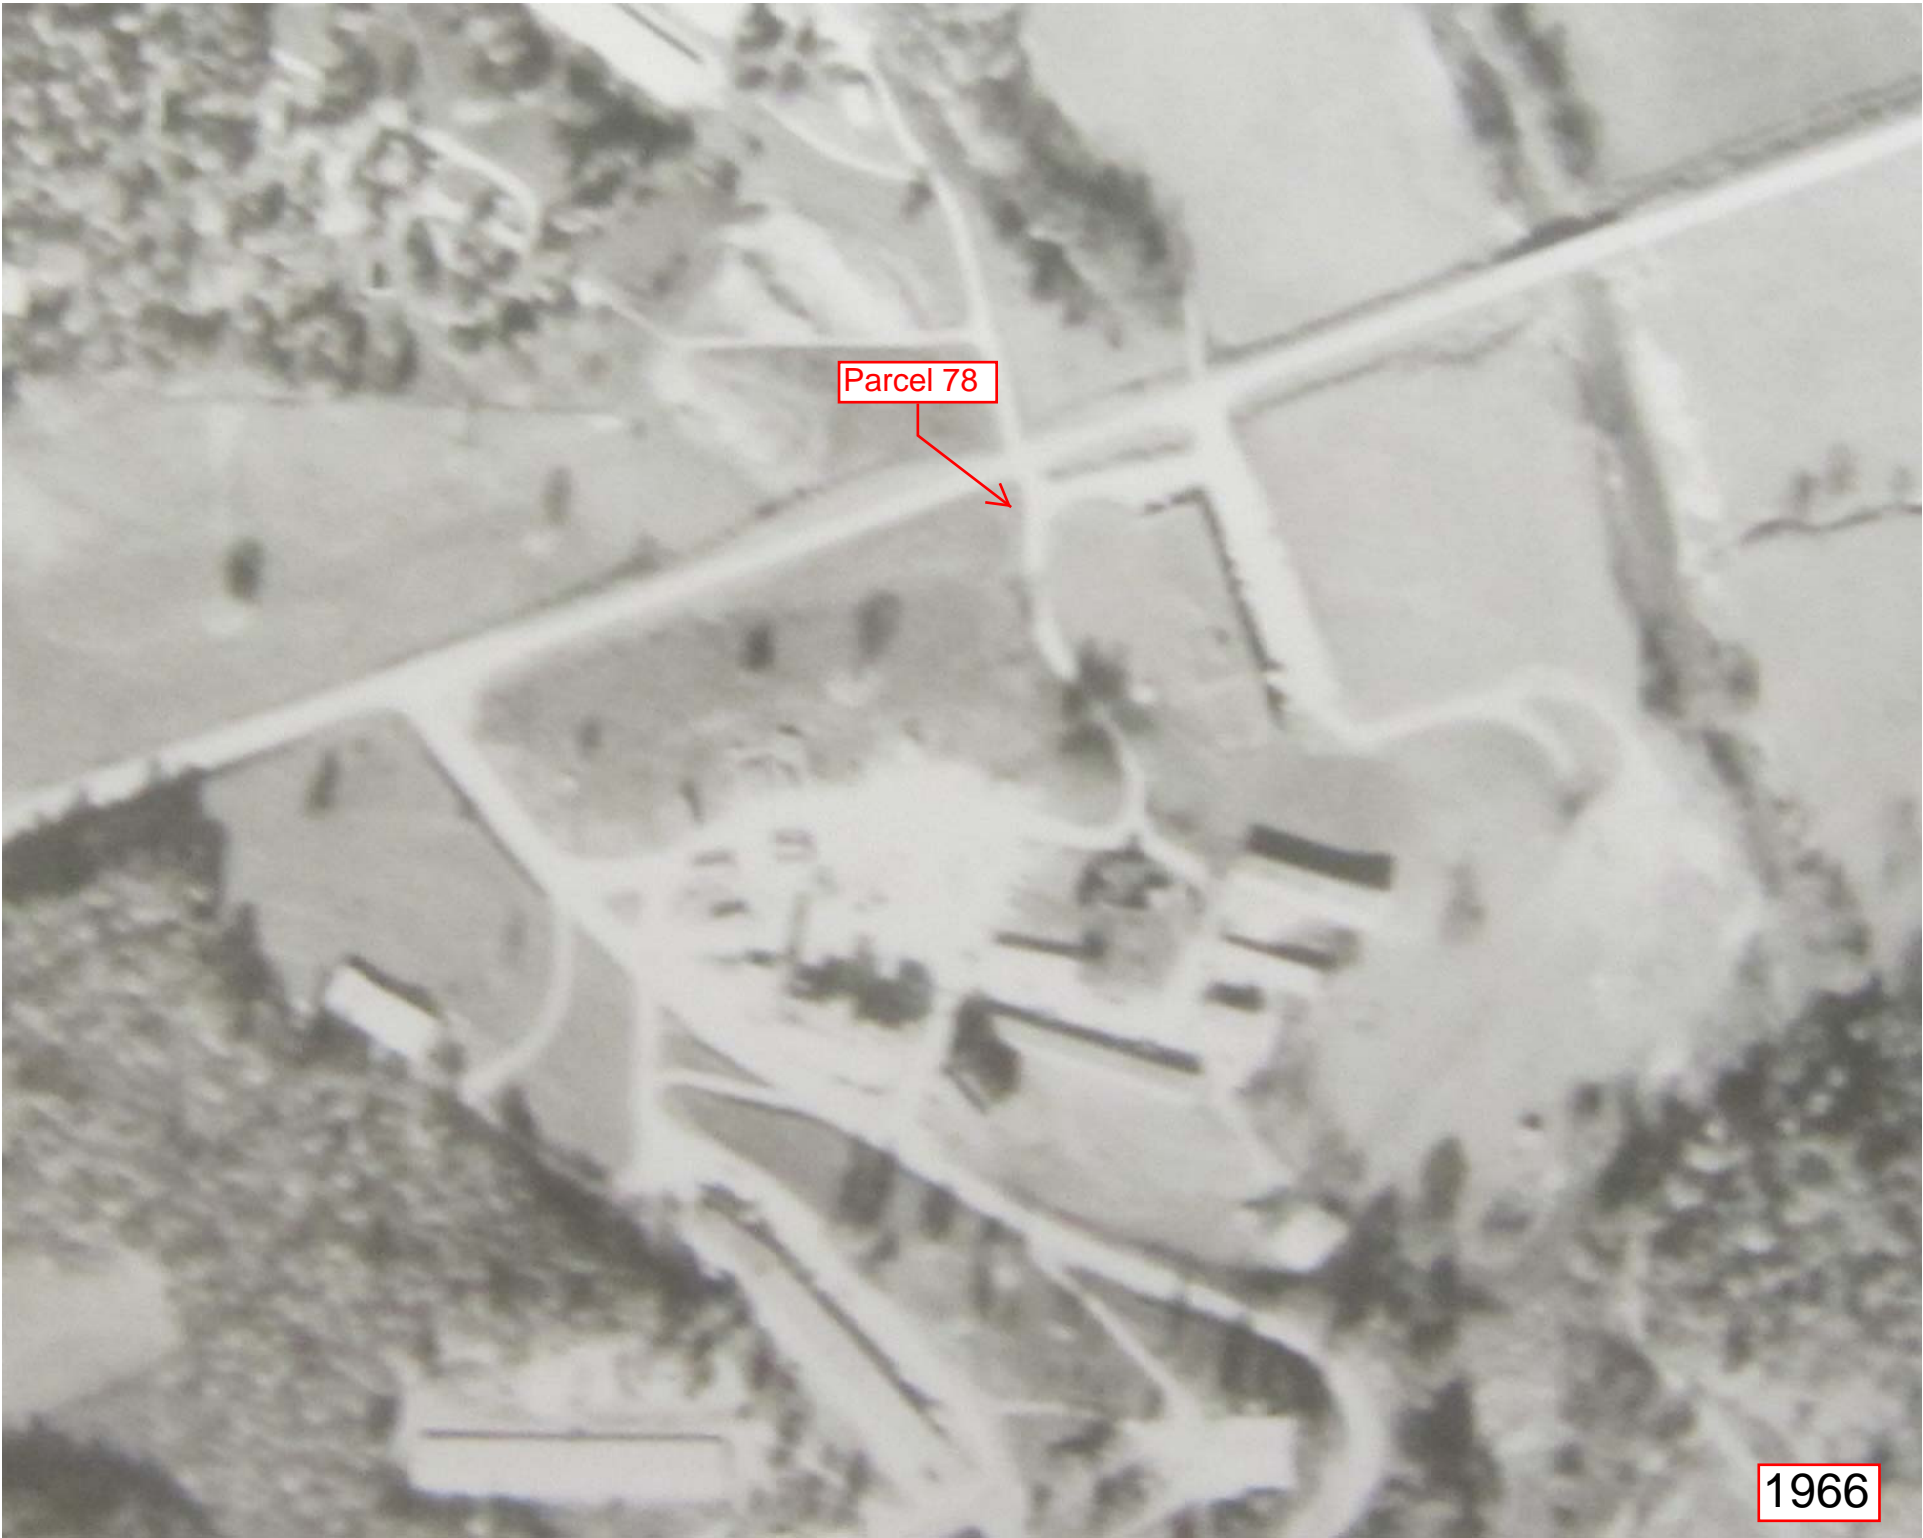
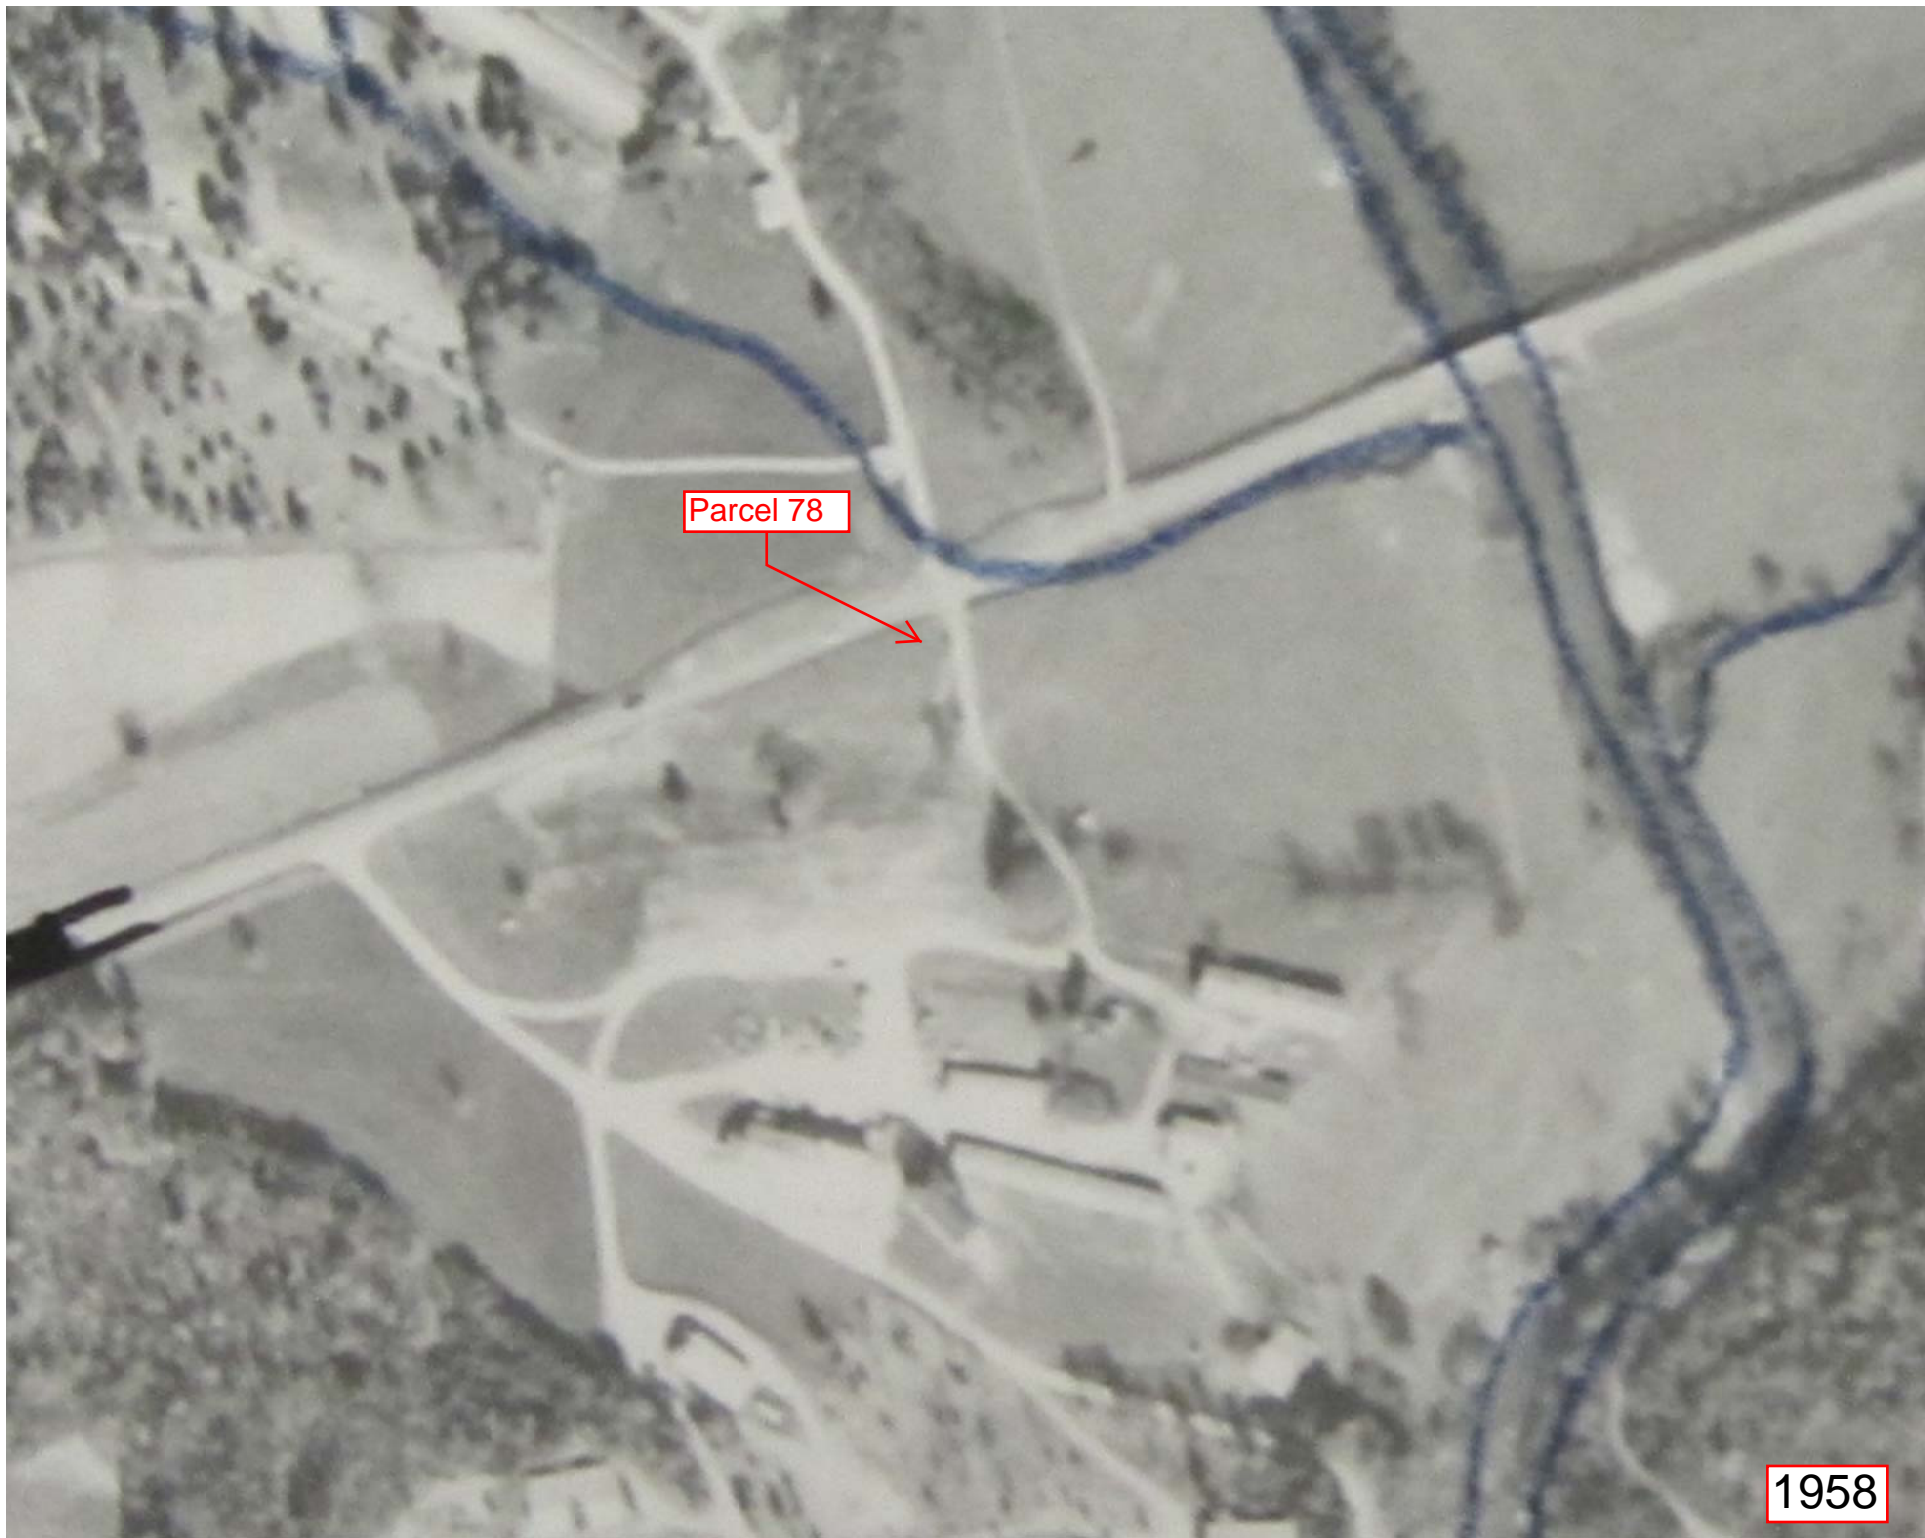
Parcel 78

1958

- **Site History:** Historical information reviewed as part of the PSA indicated that the main truck repair building that is currently on the property closest to Elkin Highway was constructed sometime between 1958 and 1966. The 1958 aerial shows the property partially cleared, with structures on the south side of the parcel, and undeveloped open land at the location of the current repair facility. The existing repair facility building first appears on the 1966 aerial photograph, indicating it was constructed between 1958 and 1966. No other significant changes occurred to the structures between 1966 and the present.

Pyramid completed a records review of the NC DENR file, interviewed NC DENR personnel, interviewed property owners, and reviewed aerial photographs to assess past uses of the property. It should be noted that the NCDOT directed Pyramid to not obtain a First Search radius report detailing the history of the site and surrounding area. For this reason, Pyramid reviewed historical aerial photographs dating back to 1958 available from Wilkes Soil and Water Conservation office in Wilkesboro and on Google Earth for past uses. The 1958, 1966, 1993, 2006, 2008, and 2012 aerial photographs are included in **Appendix A**. Historical information reviewed as part of the PSA indicated that the main truck repair building that is currently on the property closest to Elkin Highway was constructed sometime between 1958 and 1966. The 1958 aerial shows the property partially cleared, with structures on the south side of the parcel, and undeveloped open land at the location of the current repair facility. The existing repair facility building first appears on the 1966 aerial photograph, indicating it was constructed between 1958 and 1966. No other significant changes occurred to the structures between 1966 and the present.

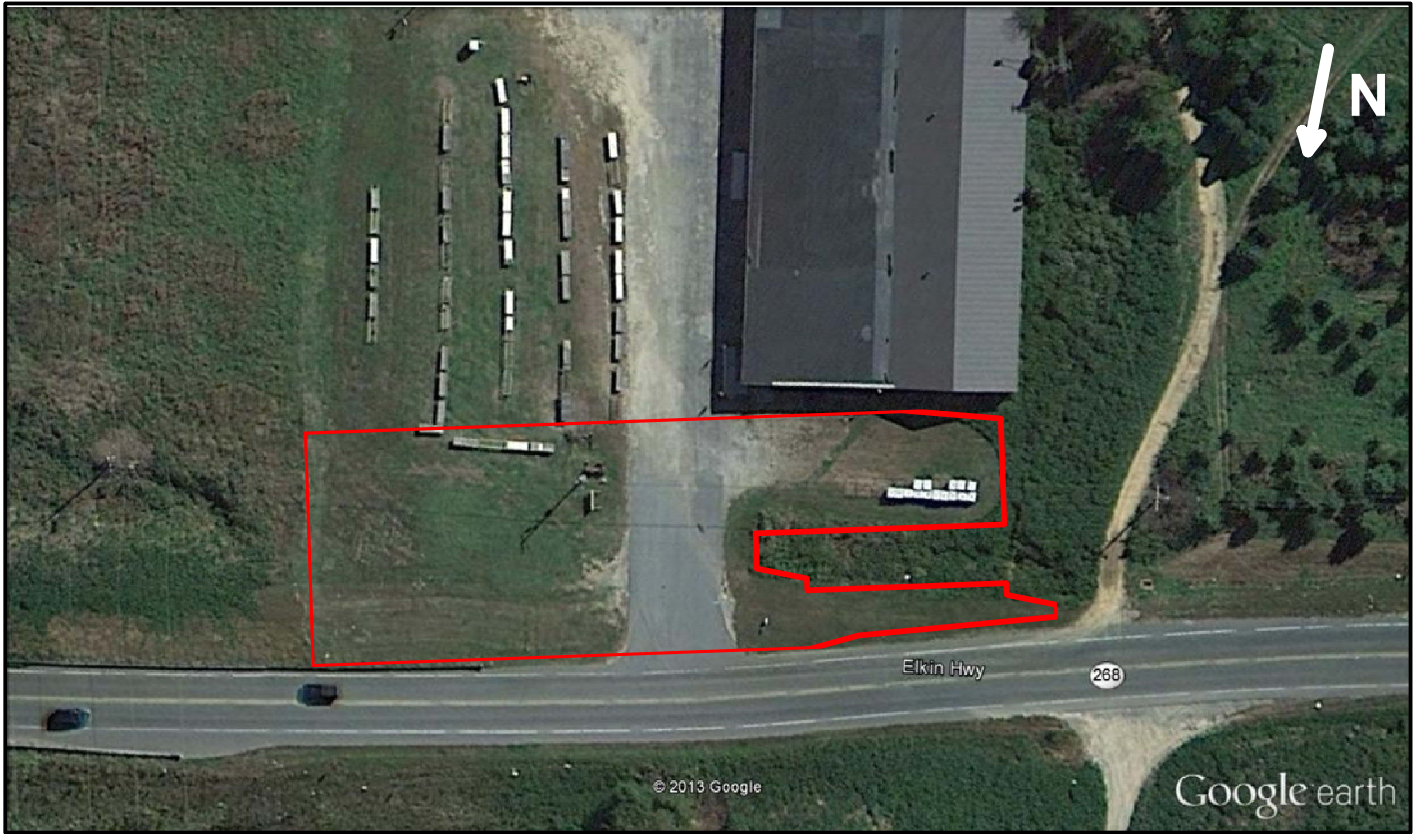
Aerial Photograph Showing Approximate Geophysical Survey Boundaries

The site consisted of a combination of gravel parking space and grassy open areas, as well as an inaccessible drainage ditch and heavily vegetated area to the west of the survey boundaries. Aerial photographs showing the survey area boundaries and ground-level photographs are shown in **Figure 1**.

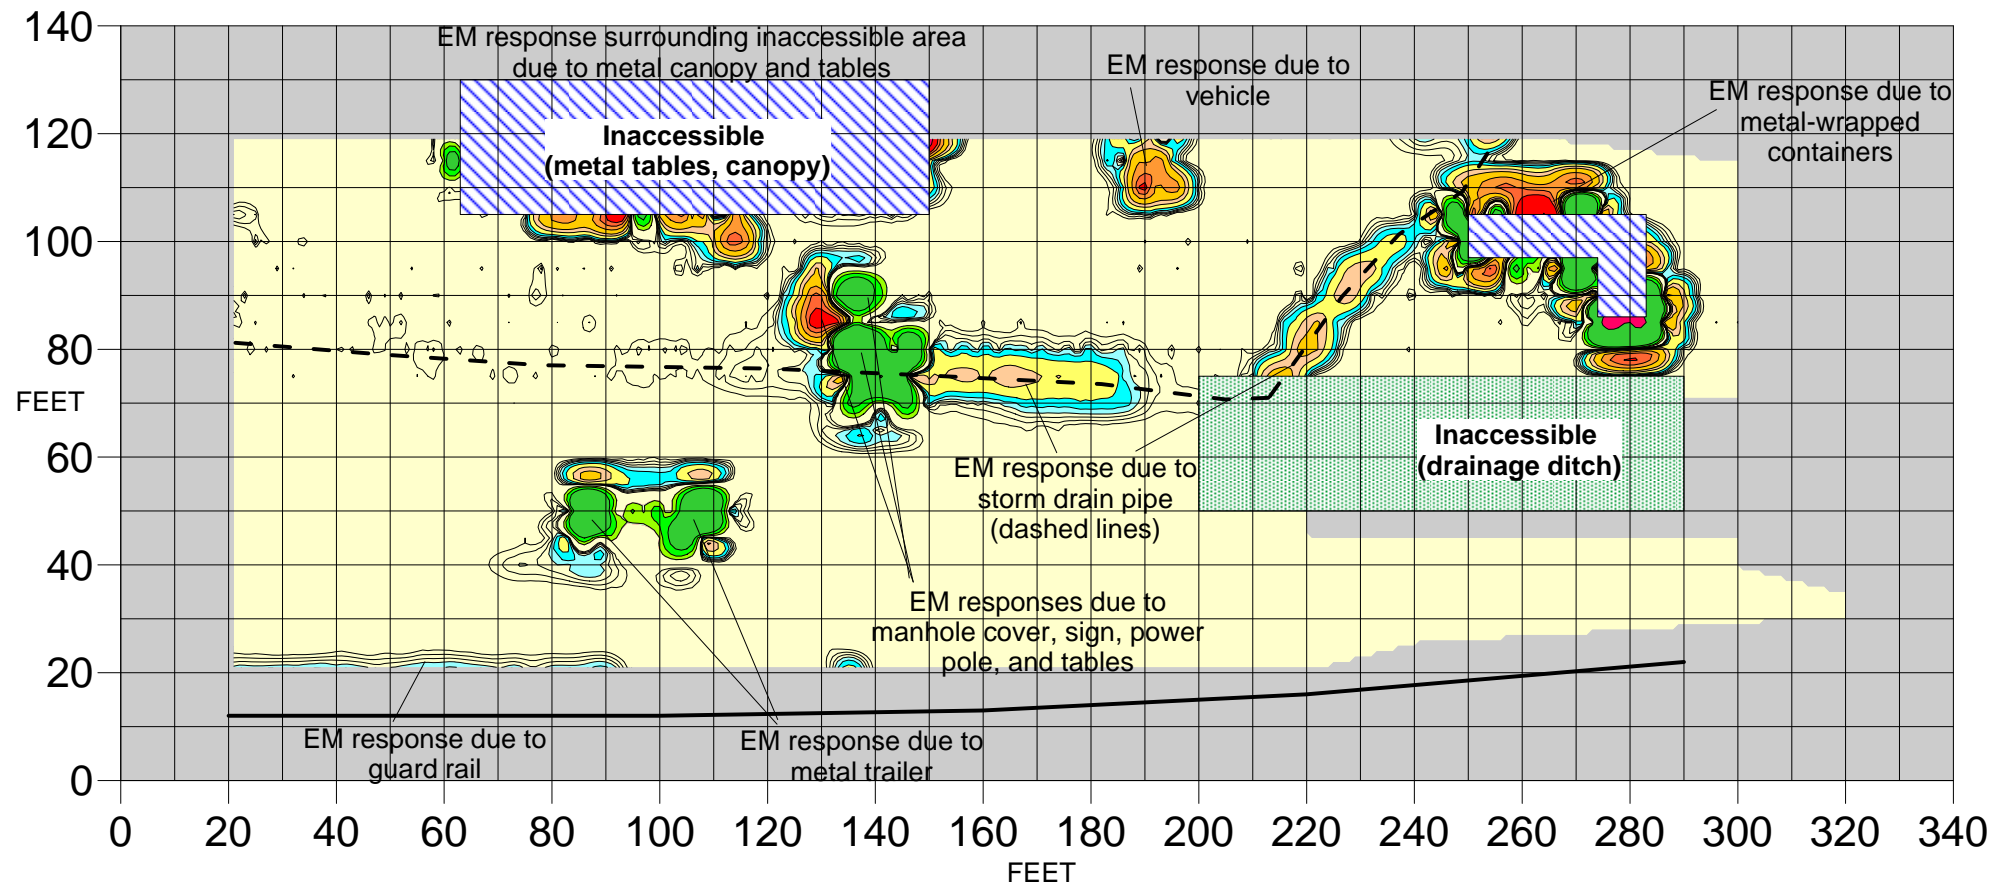
TITLE	PARCEL 78 - EM61 BOTTOM COIL & DIFFERENTIAL RESULTS CONTOUR MAP	
PROJECT	NC DEPARTMENT OF TRANSPORTATION ROW IMPROVEMENT PROJECT N. WILKESBORO, WILKES COUNTY, NC

Contour plots of the EM61 bottom coil and differential results obtained across the survey areas at the property are presented in **Figure 2**. The bottom coil results represent the most sensitive component of the EM61 instrument and detect metal objects regardless of size. The bottom coil response can be used to delineate metal conduits or utility lines, small, isolated metal objects, and areas containing insignificant metal debris. The differential results are obtained from the difference between the top and bottom coils of the EM61 instrument. The differential results focus on the larger metal objects such as drum and UST-size objects and ignore the smaller insignificant metal objects.

The geophysical investigation did not record evidence of metallic USTs within the proposed ROW and/or easement in the accessible areas of the parcel property. It should be noted that the parcel boundaries extended further to the west, however, this area was steeply sloped and heavily vegetated, and was not accessible by the geophysical instruments.

NO EVIDENCE OF METALLIC USTs OBSERVED

The contour plots show the bottom coil (most sensitive) and differential results of the EM61 instrument in millivolts (mV). The bottom coil response shows buried metallic objects regardless of size. The differential response focuses on larger, buried metallic objects such as drums and USTs and ignores smaller miscellaneous buried, metal debris. The EM61 data were collected on May 23, 2013 using a Geonics EM61 instrument. Ground penetrating radar (GPR) data were not required due to all EM anomalies being directly attributed to visible objects at the ground surface and/or utilities.
