PRELIMINARY SITE ASSESSMENT

**622 CAPITAL, LLC (PARCEL #16)
628 Capital Boulevard
Raleigh, North Carolina
State Project: B-5121 & B-5317
WBS Element: 42263.1.1
F&R Project #66T-0097**

Subject: Preliminary Site Assessment
Parcel #16 – 622 Capital, LLC (Pro Auto Repair)
628 Capital Blvd
Raleigh, North Carolina
F&R Project #66T-0097

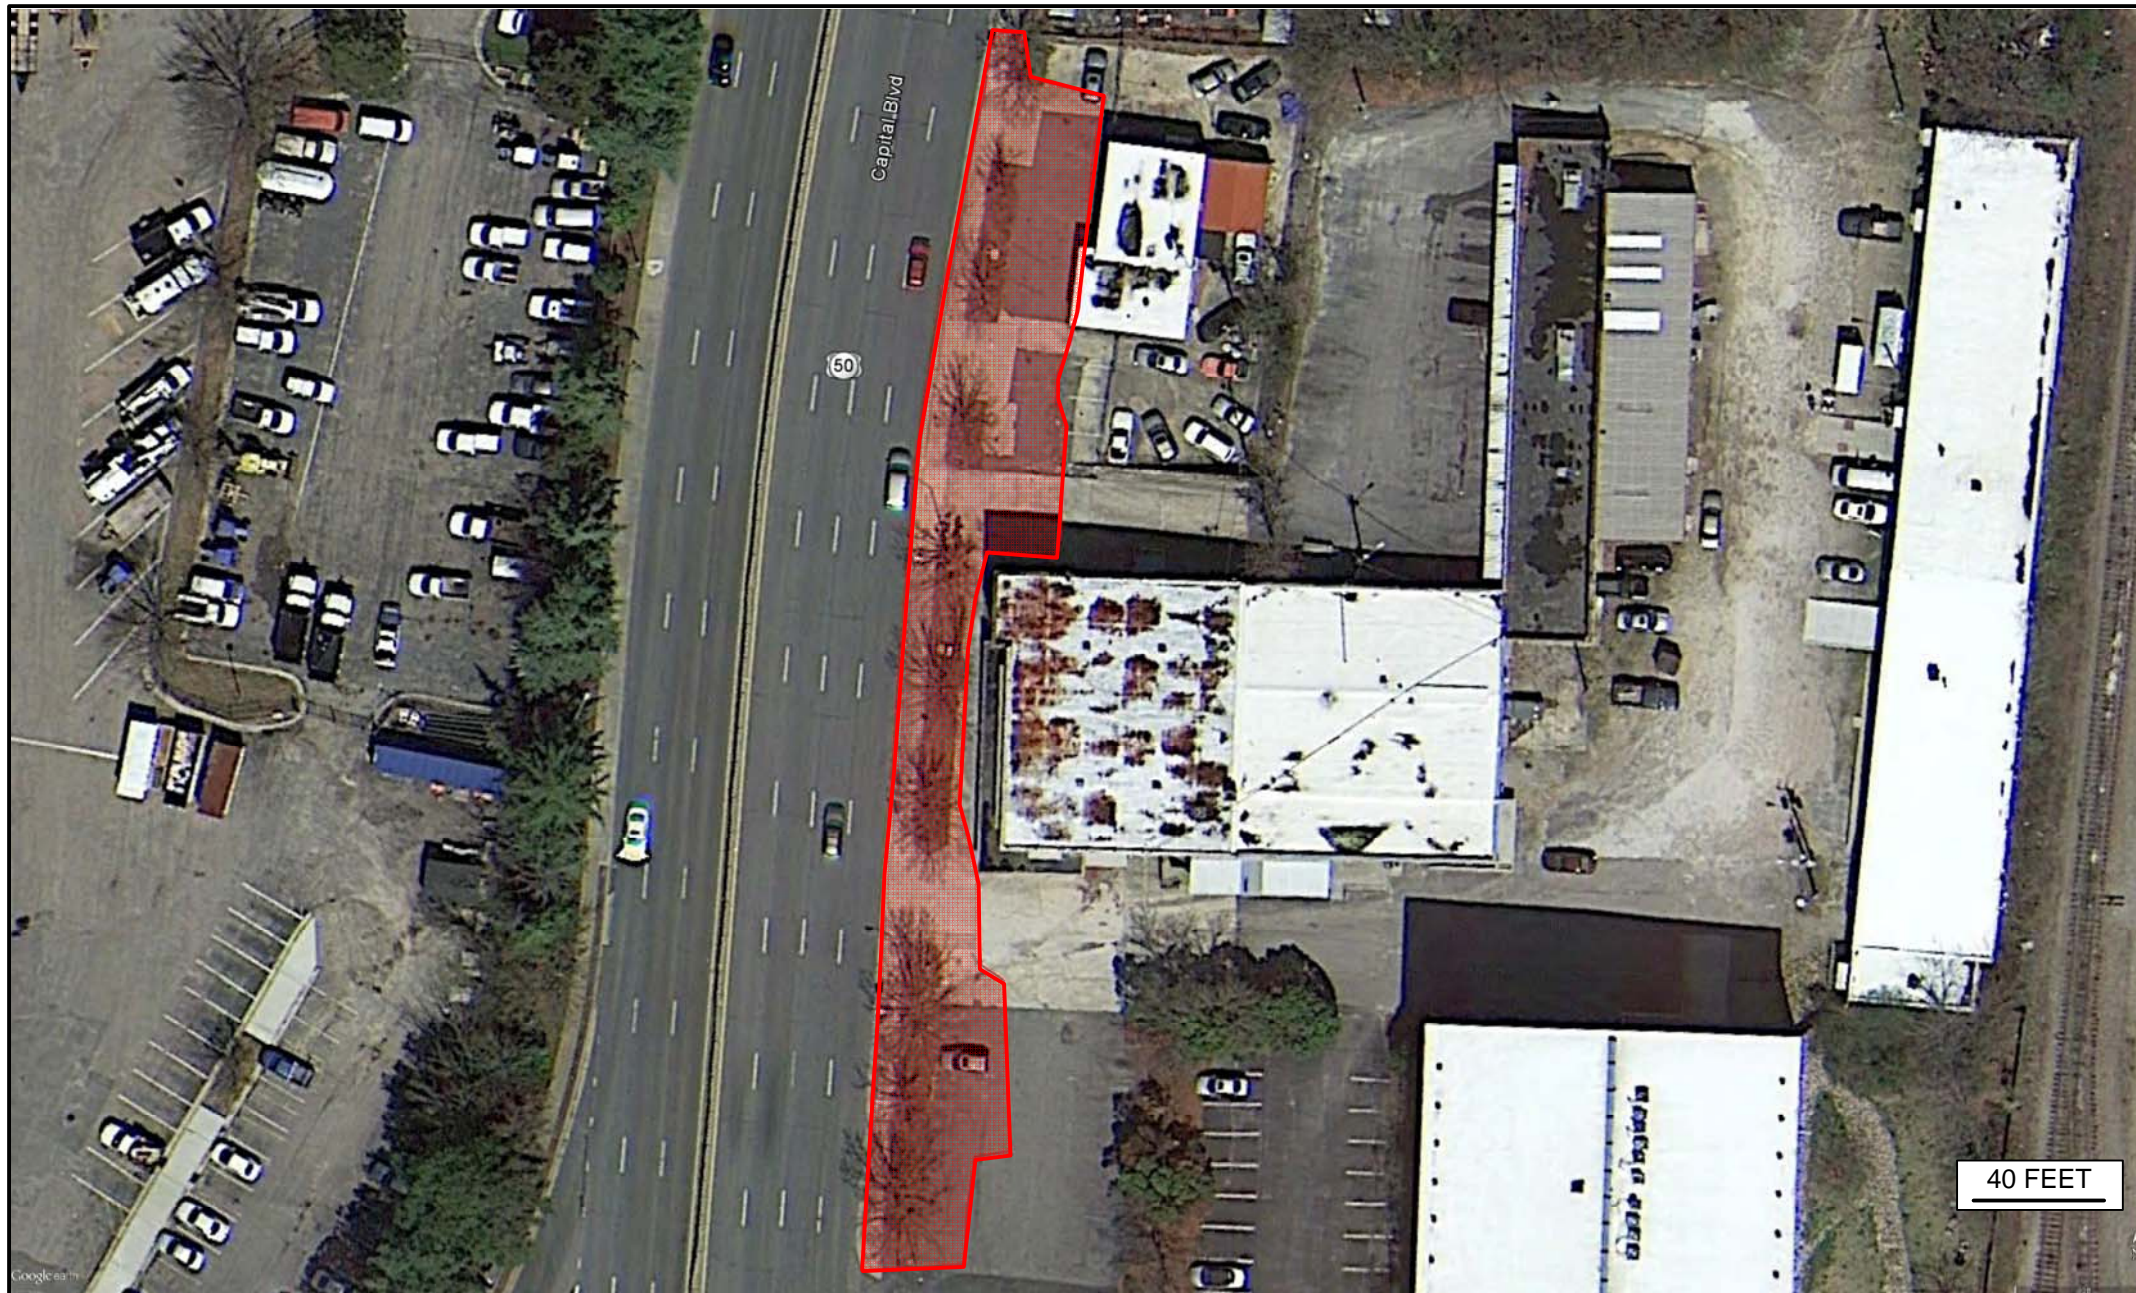
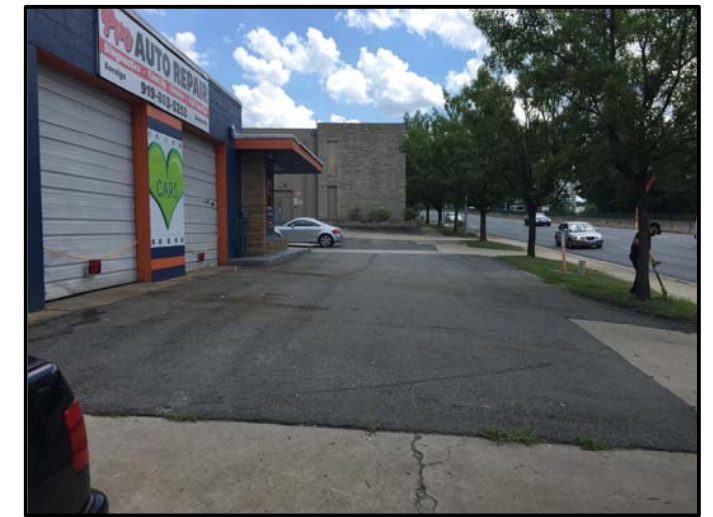
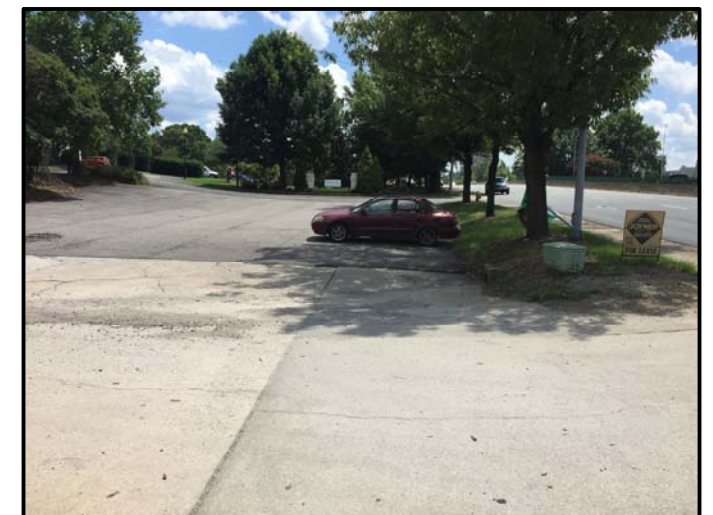
TITLE		PARCEL 16 - 628 CAPITAL BLVD. GEOPHYSICAL SURVEY BOUNDARIES AND SITE PHOTOGRAPHS	
PROJECT		METALLIC UST INVESTIGATION NCDOT B-5121/B-5317, RALEIGH, NC

The site included an auto repair business surrounded by fencing, and an asphalt parking area underlain by reinforced concrete in some areas. The NCDOT site history for Parcel 16 provided to Pyramid by F&R listed two USTs in temporary status located within the parcel. Portions of the survey area were inaccessible due to parked vehicles. Aerial photographs showing the survey area boundaries and ground-level photographs are shown in **Figure 1**.

APPROXIMATE BOUNDARIES OF GEOPHYSICAL SURVEY AREAS.

View of North Survey Area
(Facing Approximately South)

View of South Survey Area
(Facing Approximately South)

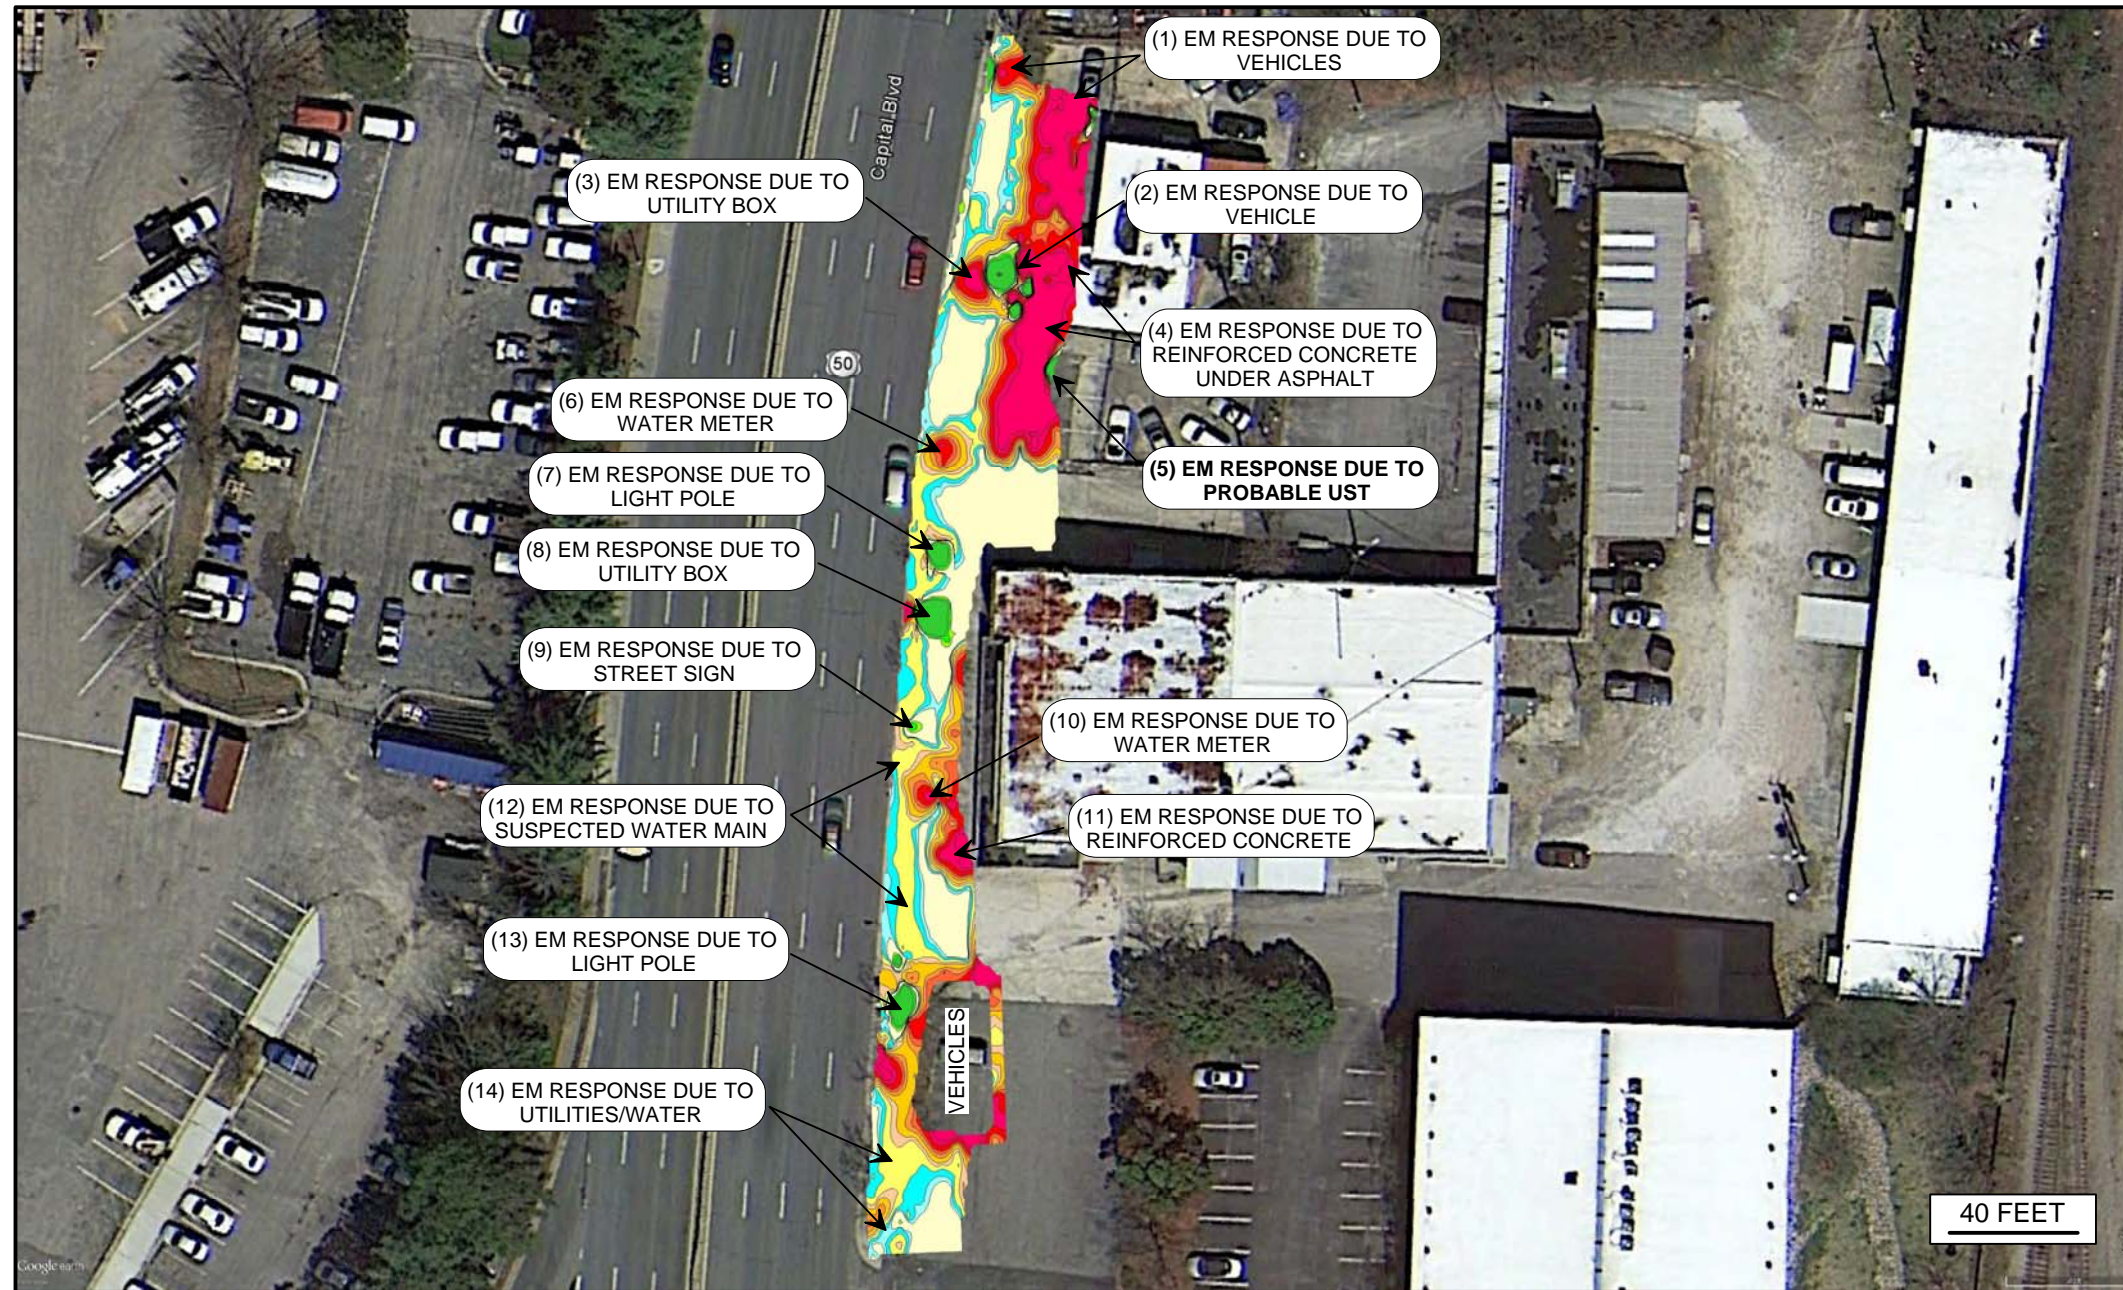
Parcel 16 - EM61 Differential Results

A contour plot of the EM61 results obtained across the survey area at the property is presented in **Figure 2**. Each EM anomaly is numbered for reference to the figure. The following table presents the list of EM anomalies and the cause of the metallic response, if known:

Metallic Anomaly #	Cause of Anomaly	Investigated with GPR
1	Vehicles	
2	Vehicle	
3	Utility Box	
4	Reinforced Concrete Under Asphalt	☑
5	Probable UST	☑
6	Water Meter	
7	Light Pole	
8	Utility Box	
9	Street Sign	
10	Water Meter	
11	Reinforced Concrete	
12	Suspected Water Main	
13	Light Pole	
14	Utilities/Water

The majority of the EM anomalies observed at the site were directly attributed to visible cultural features at the ground surface such as utilities, light poles, signs, fences, and vehicles (see above table and **Figure 2**). However, two areas were investigated further with the GPR. First, the majority of the asphalt in the northern third of the survey area surrounding the auto repair facility was suspected to be underlain by reinforced concrete due to the extensive high amplitude EM response observed at this location. Due to this

Locations of metallic anomalies detected by the EM61 survey. Numbers correspond to descriptive Table in report.

EVIDENCE OF ONE PROBABLE METALLIC UST OBSERVED (OUTSIDE OF ROW)

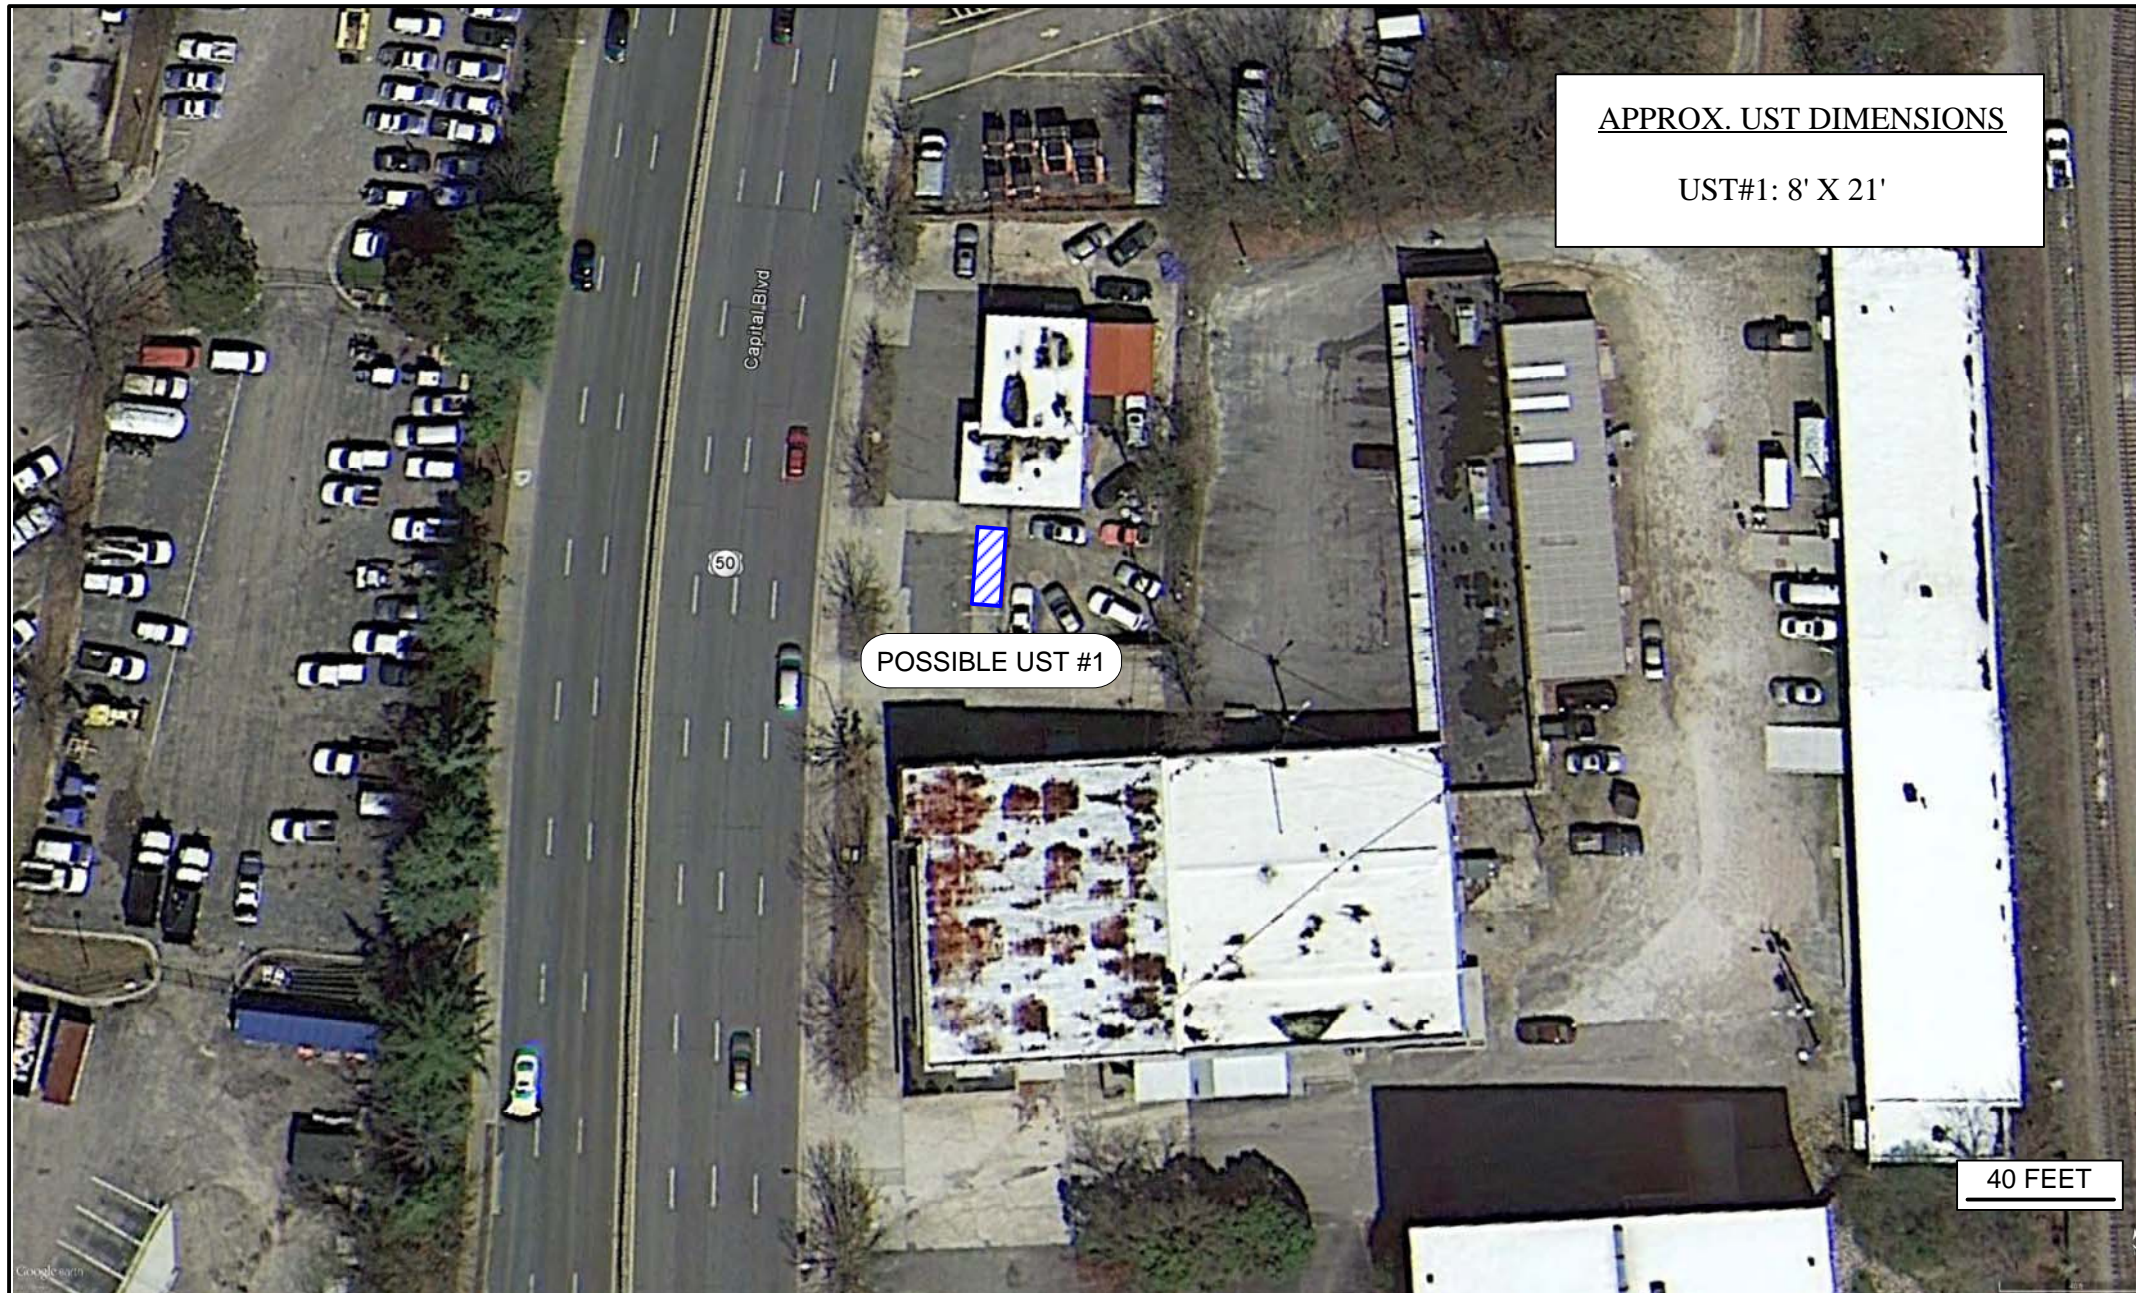
TITLE	PARCEL 16 - 628 CAPITAL BLVD. APPROXIMATE LOCATION OF PROBABLE UST	
PROJECT	METALLIC UST INVESTIGATION NCDOT B-5121/B-5317, RALEIGH, NC

- The probable metallic UST was observed to be approximately 8 feet wide and 21 feet long at a depth of approximately 2.5 feet below the ground surface.

APPROXIMATE LOCATION OF PROBABLE METALLIC UST.

Approximate Location of Probable UST

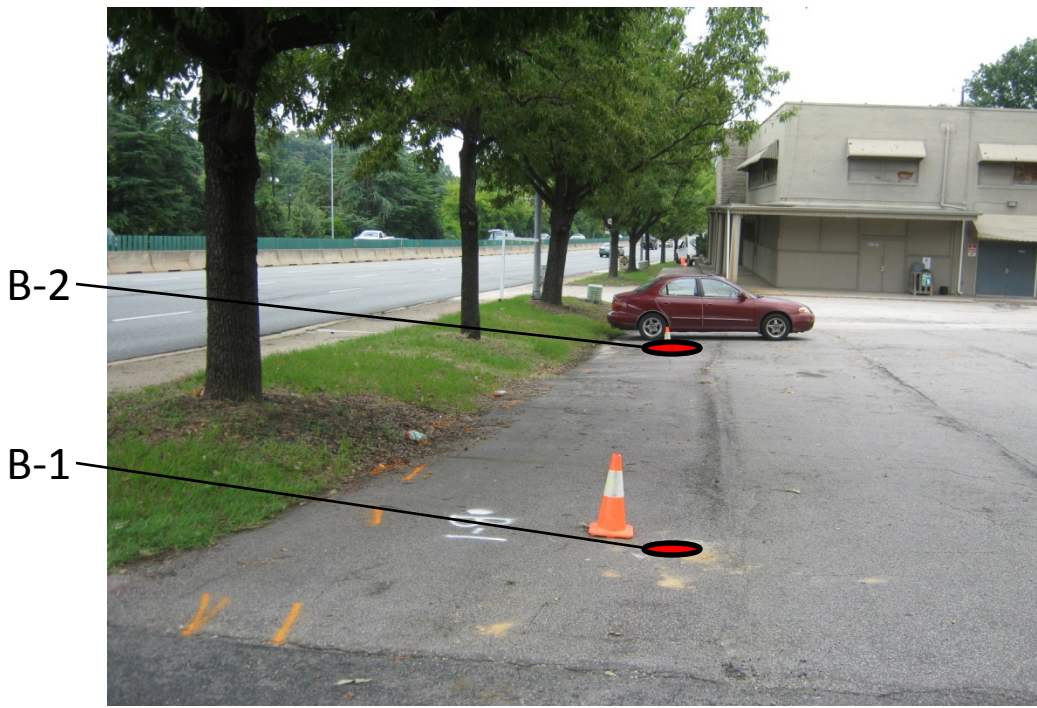
Photo #1: A view of Borings B-1 and B-2, facing north.

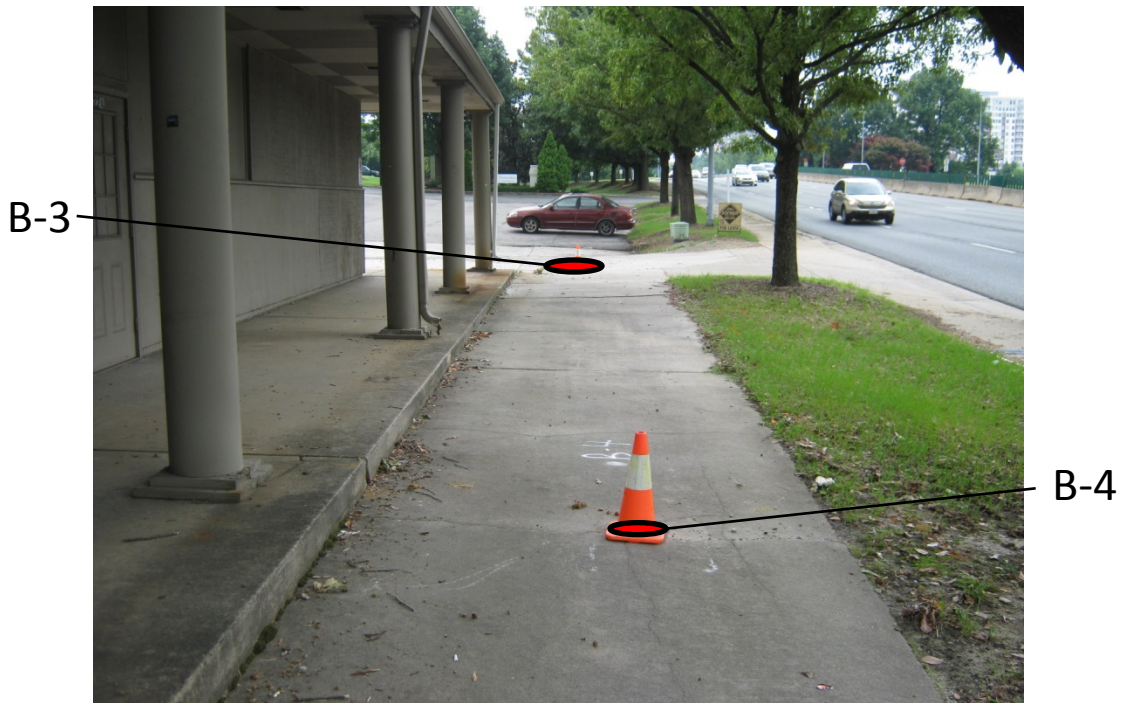
Photo #2: A view of Borings B-3 and B-4, facing south.

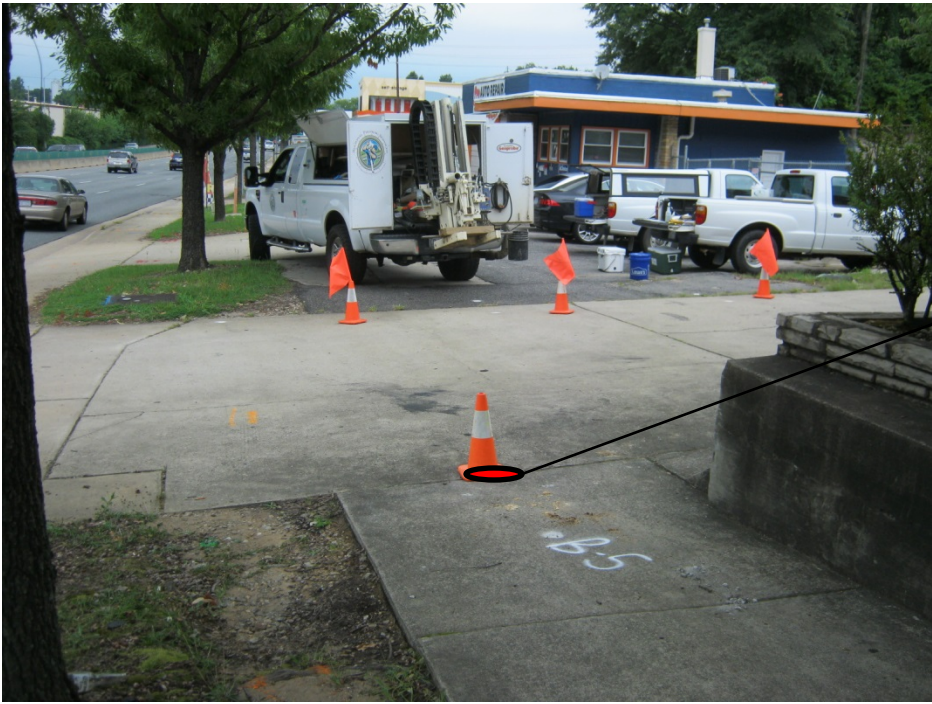
Photo #3: A view of boring location B-5, facing north.

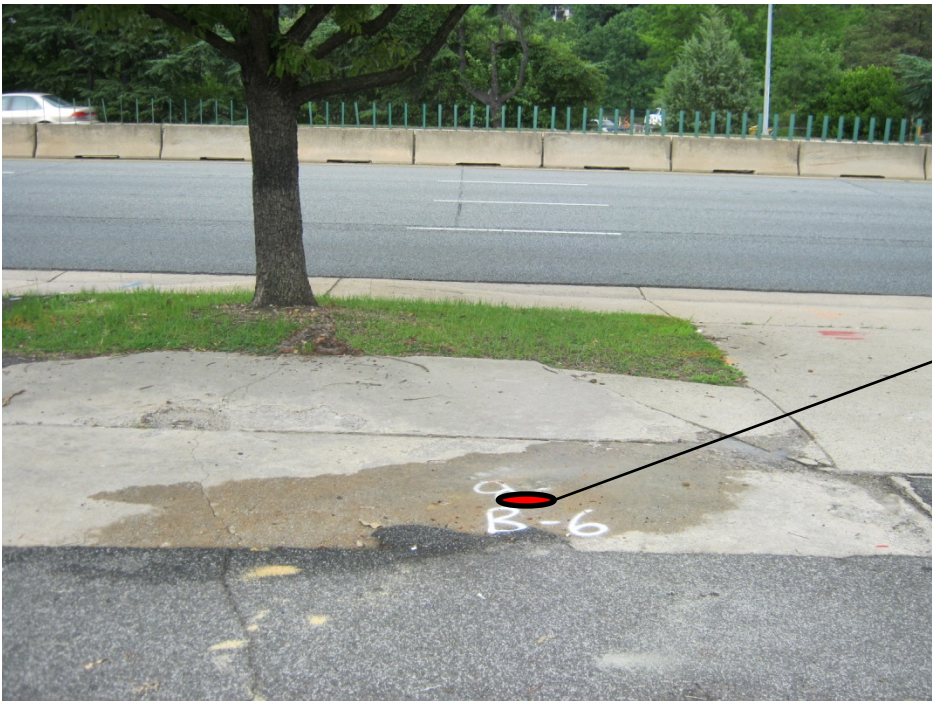
In Boring B-6, F&R notes that well graded sand was observed from just beneath the concrete pavement to 10 feet bgs. The sand was not characteristic of the soils observed in other borings advance at Parcel 16, and appeared to be backfill material. In addition, petroleum odors were noted in this boring from approximately 6 to 10 feet bgs. Based upon these observations, it is possible that this boring was located in a previous UST basin, which may be the location of the second UST that was not found during the geophysical survey.

Photo #4: A view of Boring B-6, facing west.

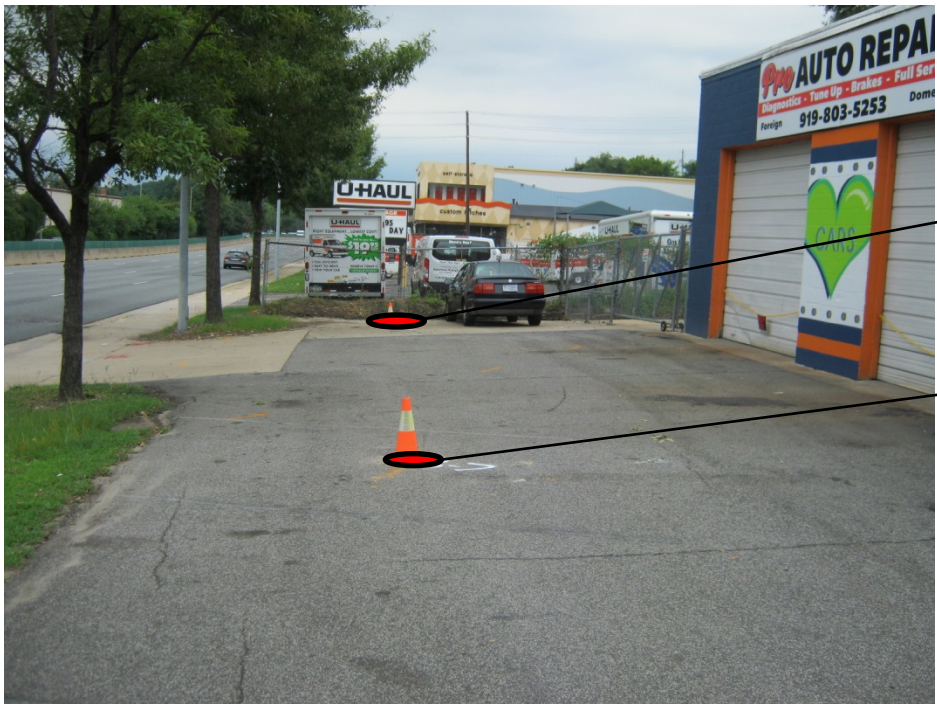
Photo #5: A view of Borings B-7 and B-8, facing north

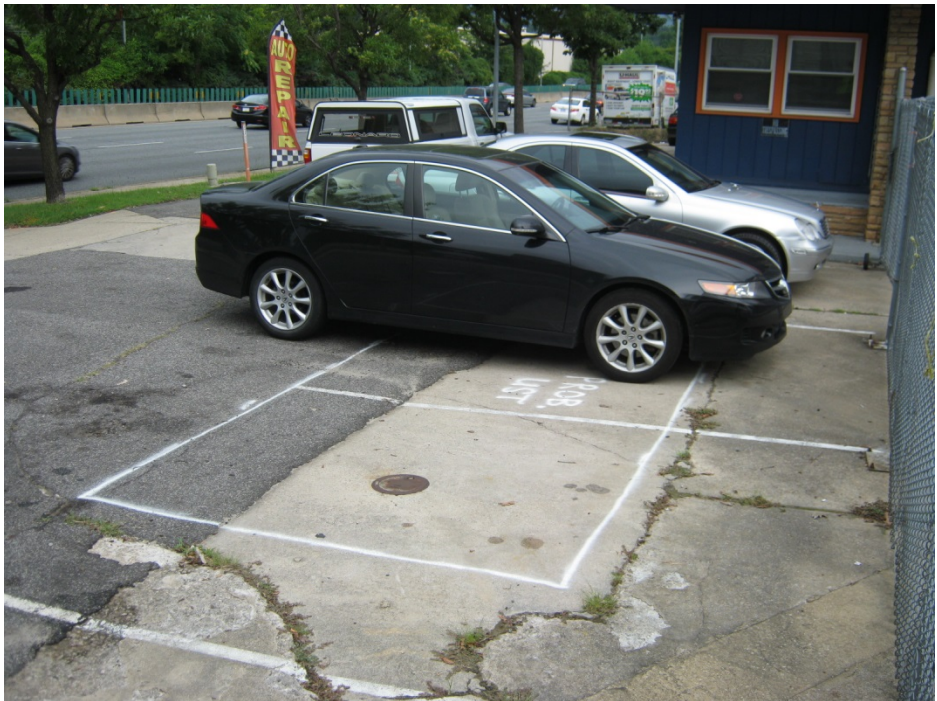
Photo #6: A view of the location of the probable UST located just south of the automotive repair building, facing northwest
