PRELIMINARY SITE ASSESSMENT

**TUMBAPURA 1, LLC (PARCEL #27)
915 Capital Boulevard
Raleigh, North Carolina
State Project: B-5121 & B-5317
WBS Element: 42263.1.1
F&R Project #66T-0097**

**Subject: Preliminary Site Assessment
Parcel #27 – Tumbapura 1, LLC (Atlas Motor & Auto Sales)**
915 Capital Blvd
Raleigh, North Carolina
F&R Project #66T-0097

GEOPHYSICAL INVESTIGATION REPORT
Parcel 27 – Tumbapura 1, LLC
Raleigh, Wake County, North Carolina

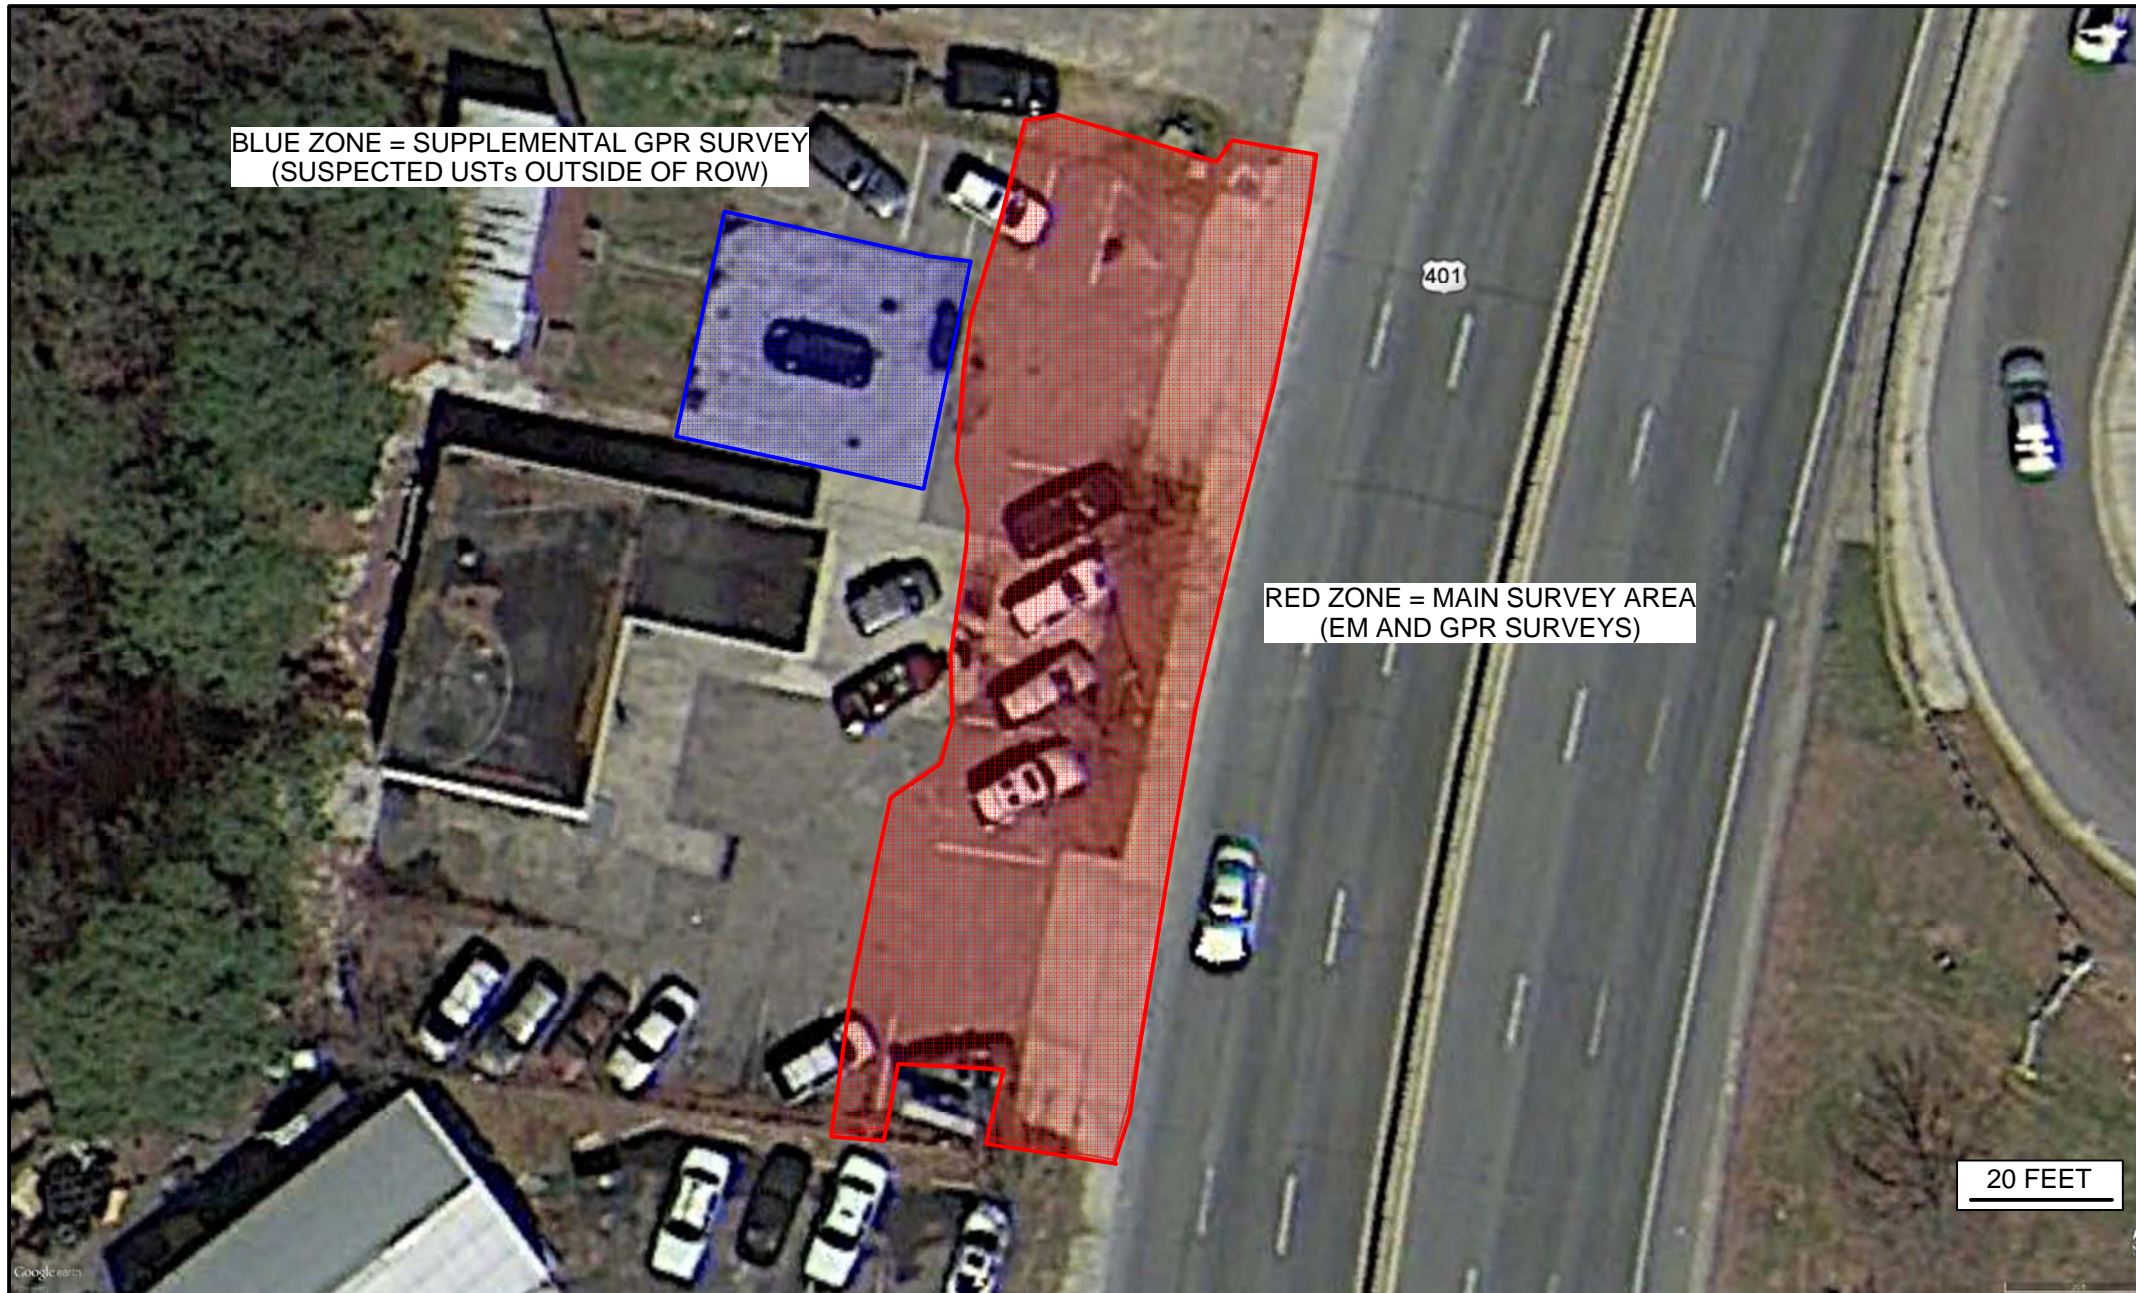
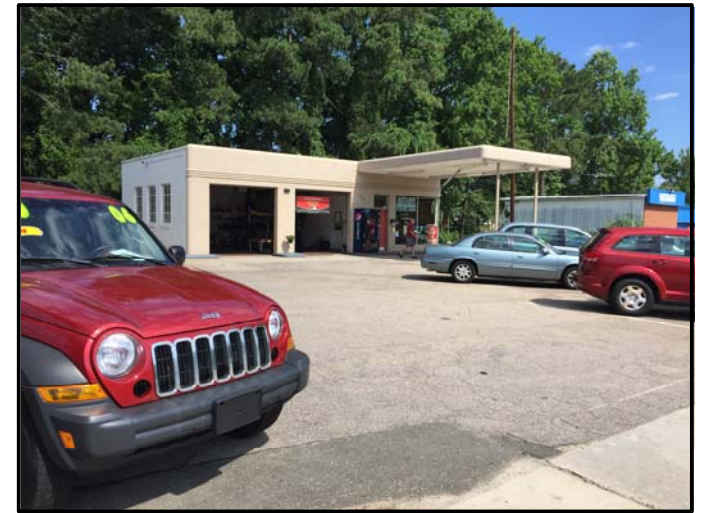
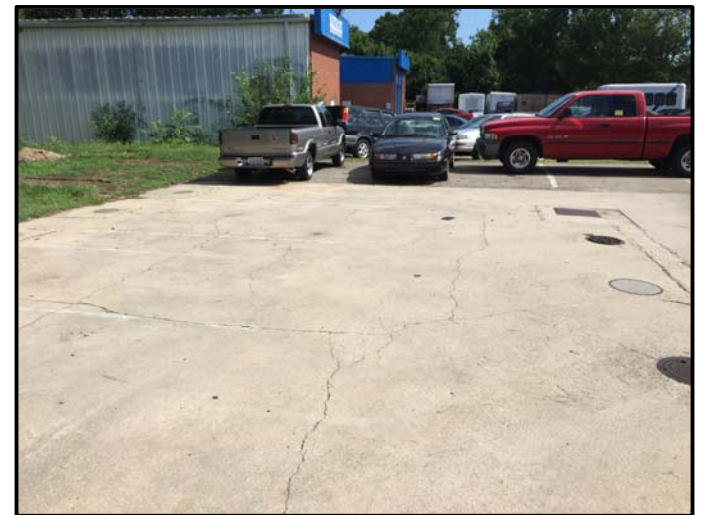
TITLE	PARCEL 27 - 915 CAPITAL BLVD. GEOPHYSICAL SURVEY BOUNDARIES AND SITE PHOTOGRAPHS	
PROJECT	METALLIC UST INVESTIGATION NCDOT B-5121/B-5317, RALEIGH, NC

APPROXIMATE BOUNDARIES OF GEOPHYSICAL SURVEY AREAS.

View of Main Survey Area
(Facing Approximately Northwest)

View of Supplemental Survey Area
(Facing Approximately North)

The site included an automotive sales/repair shop building surrounded by concrete and an asphalt pavement. A significant portion of the center of the survey area was inaccessible due to the number of parked vehicles. A series of apparent fill ports were observed directly adjacent to the northwest boundary of the survey area, outside of the proposed ROW/easements. Documentation provided by the NCDOT indicated that the owner of the property stated that three USTs were located on the parcel. Pyramid included a GPR survey of this area regardless of its location outside of the proposed ROW due to its proximity to the NCDOT roadwork plans. Aerial photographs showing the survey area boundaries and ground-level photographs are shown in **Figure 1**.

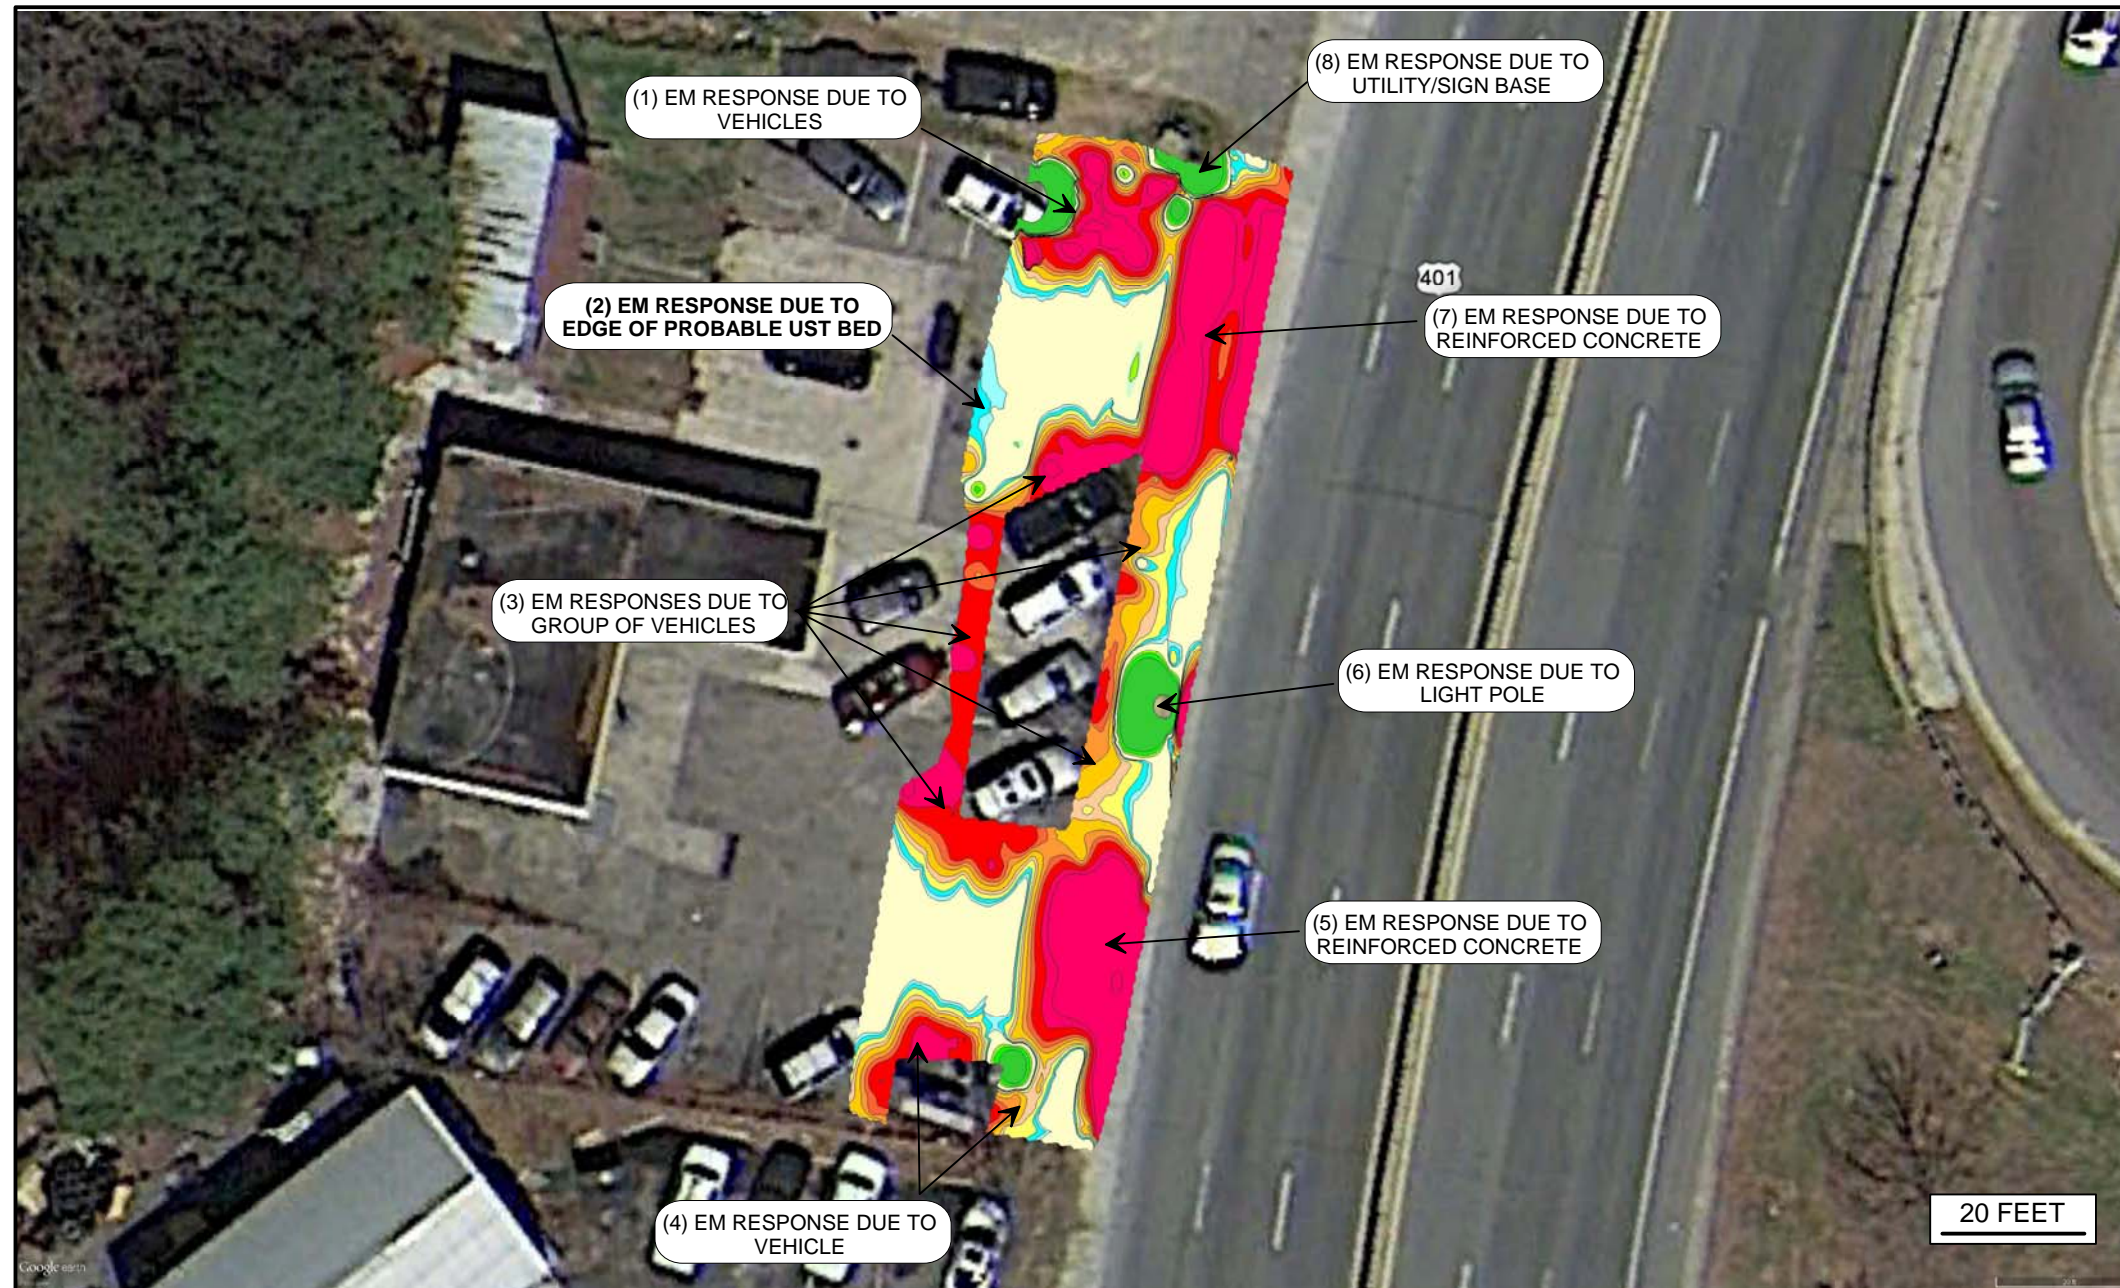
503 INDUSTRIAL AVENUE GREENSBORO, NC 27460 (336) 335-3174 (p) (336) 691-0648 (f) License # C1251 Eng. / License # C257 Geology	
DATE	7/6/2015	CLIENT FROEHLING & ROBERTSON
PYRAMID PROJECT #:	2015-176	FIGURE 2

Metallic Anomaly #	Cause of Anomaly	Investigated with GPR
1	Vehicles	
2	Probable UST Bed	☑
3	Group of vehicles	
4	Vehicle	
5	Reinforced Concrete	☑
6	Light pole	
7	Reinforced Concrete	☑
8	Utility/sign base

Locations of metallic anomalies detected by the EM61 survey. Numbers correspond to descriptive Table in report.

EVIDENCE OF THREE PROBABLE METALLIC USTs OBSERVED (OUTSIDE OF ROW)

A contour plot of the EM61 results obtained across the survey area at the property is presented in **Figure 2**. Each EM anomaly is numbered for reference to the figure. The following table presents the list of EM anomalies and the cause of the metallic response, if known:

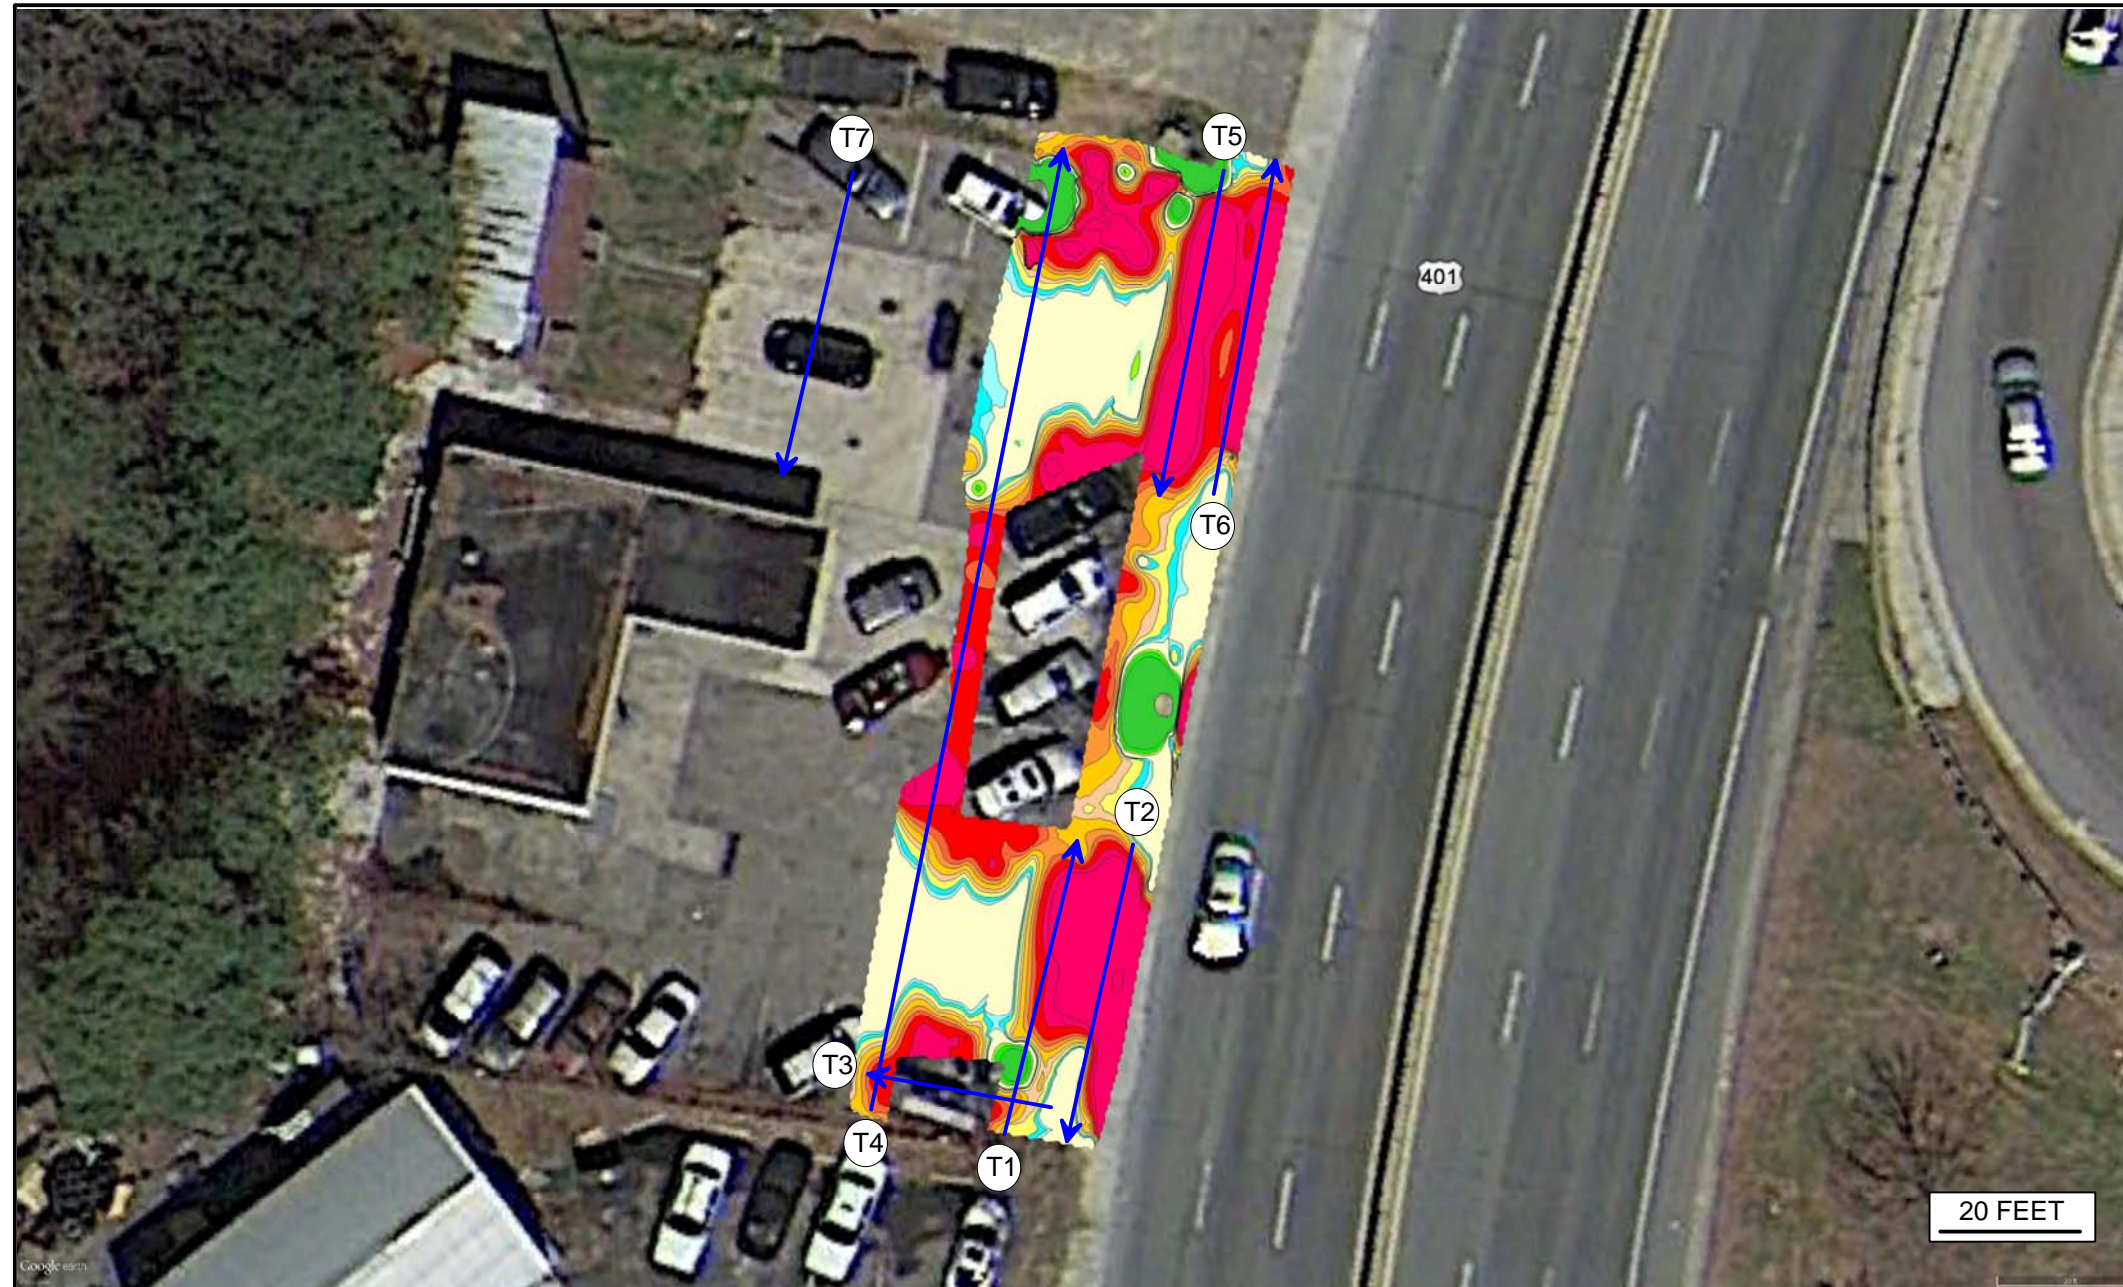
TITLE	PARCEL 27 - 915 CAPITAL BLVD. GPR TRANSECT LOCATIONS AND SELECT IMAGES	
PROJECT	METALLIC UST INVESTIGATION NCDOT PROJECT B-5121/B-5317 (42263.1.1)

GPR TRANSECT 7 (T7)

GPR TRANSECT 1 (T1)

GPR TRANSECT 5 (T5)

- GPR scans verified the presence of reinforcement within the concrete on the east side of the property.
- The GPR survey recorded evidence of three probable metallic USTs in the area where the fill ports were observed to the northwest of the survey area.

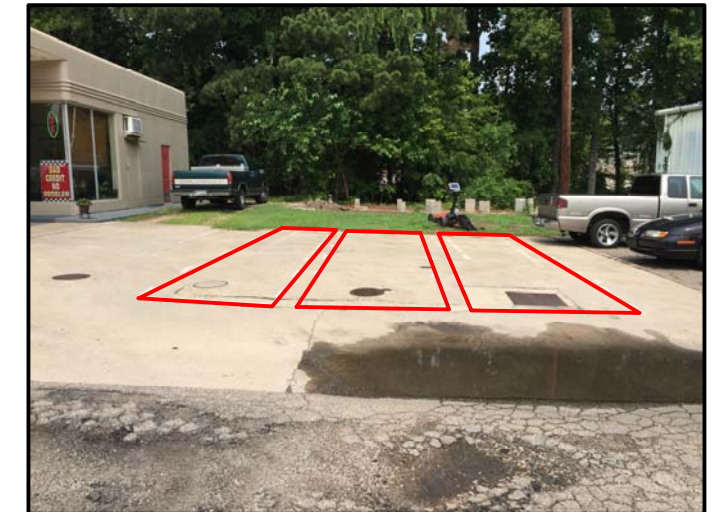
503 INDUSTRIAL AVENUE GREENSBORO, NC 27460 (336) 335-3174 (p) (336) 691-0648 (f) License # C1251 Eng. / License # C257 Geology	
DATE	7/6/2015	CLIENT FROEHLING & ROBERTSON
PYRAMID PROJECT #:	2015-176	FIGURE 4

PROBABLE USTs
#1, #2 AND #3

APPROXIMATE LOCATIONS OF PROBABLE METALLIC USTs.

Approximate Locations of Probable USTs

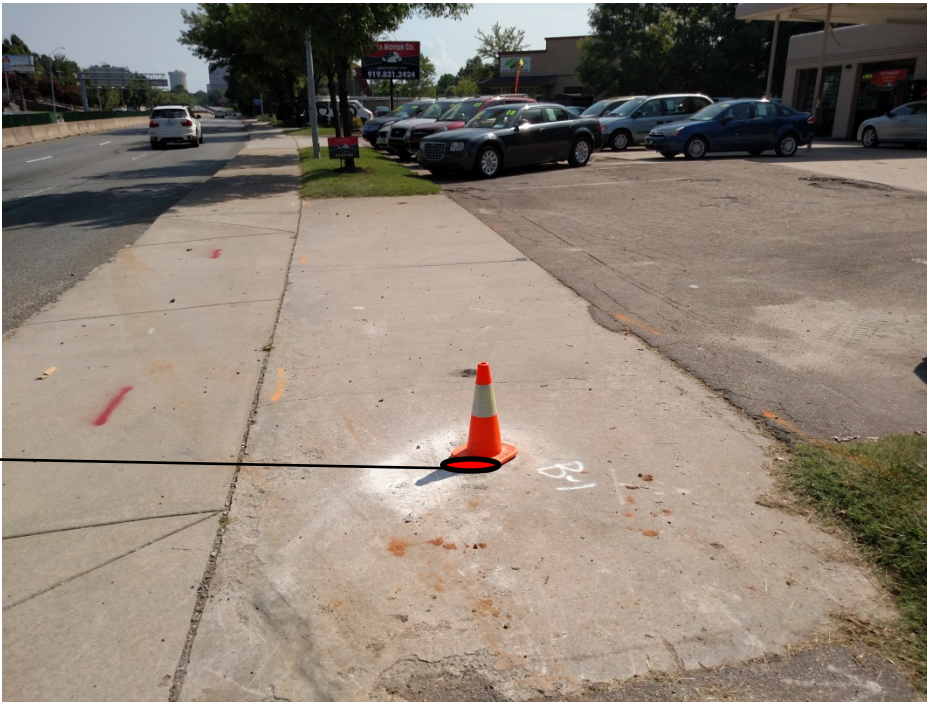
B-1

Photo #1: A view of Boring B-1, facing south from the northern property boundary.

F&R also encountered a void beneath the sidewalk at Boring B-1, extending from just beneath the sidewalk to a depth of approximately 1.5 feet bgs.

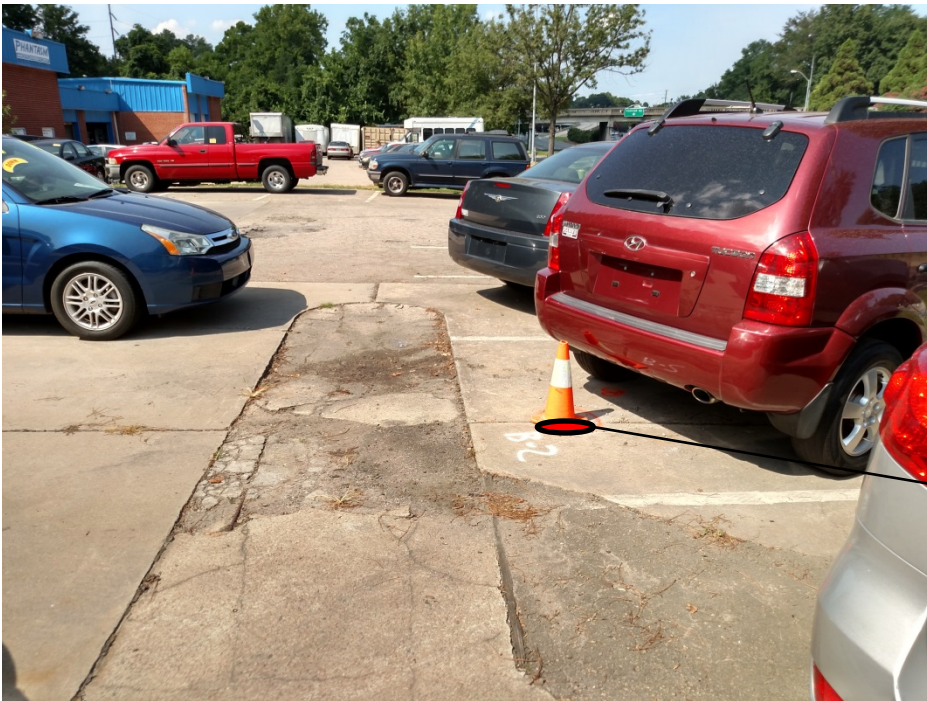
Photo #2: A view of Boring B-2 and the former pump island footprint, facing north.

Petroleum odors were observed in Boring B-2 from 2 to 10 feet bgs. In addition, wet soils were observed in Boring B-2 from 6 to 10 feet bgs, and B-3 from 8 to 10 feet bgs. Based upon the proximity of Pigeon House Branch, it is possible these wet soils may be indicative of the groundwater table elevation at the site.

Of the samples screened, PID readings generally did not exceed 0.9 ppm; however, elevated PID readings were recorded in Boring B-2 from 2 to 10 feet bgs.

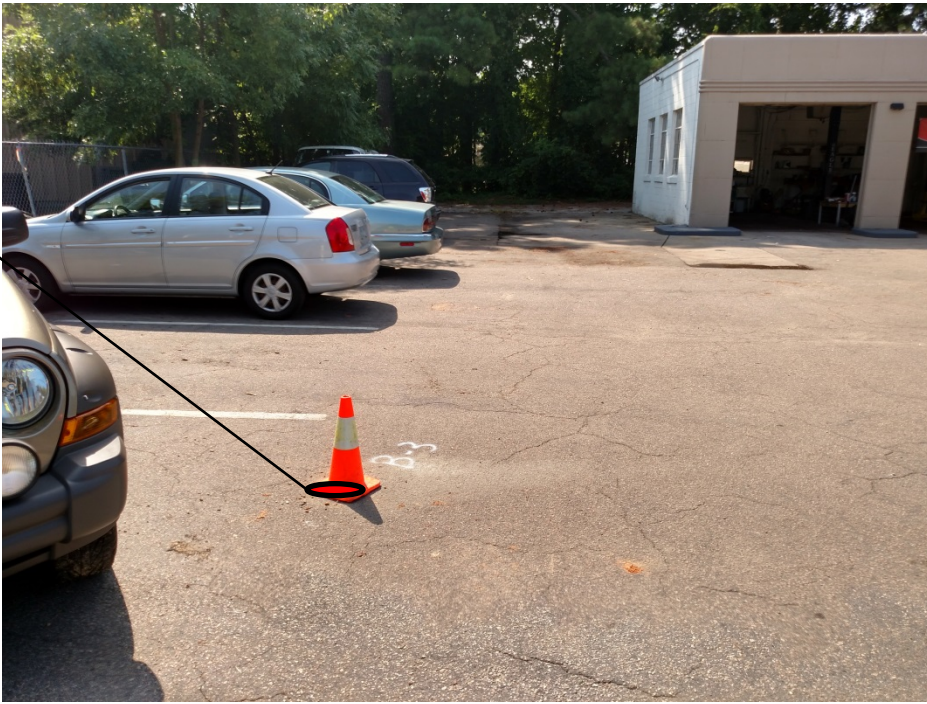
B-3

Photo #3: Boring location B-3, facing west.

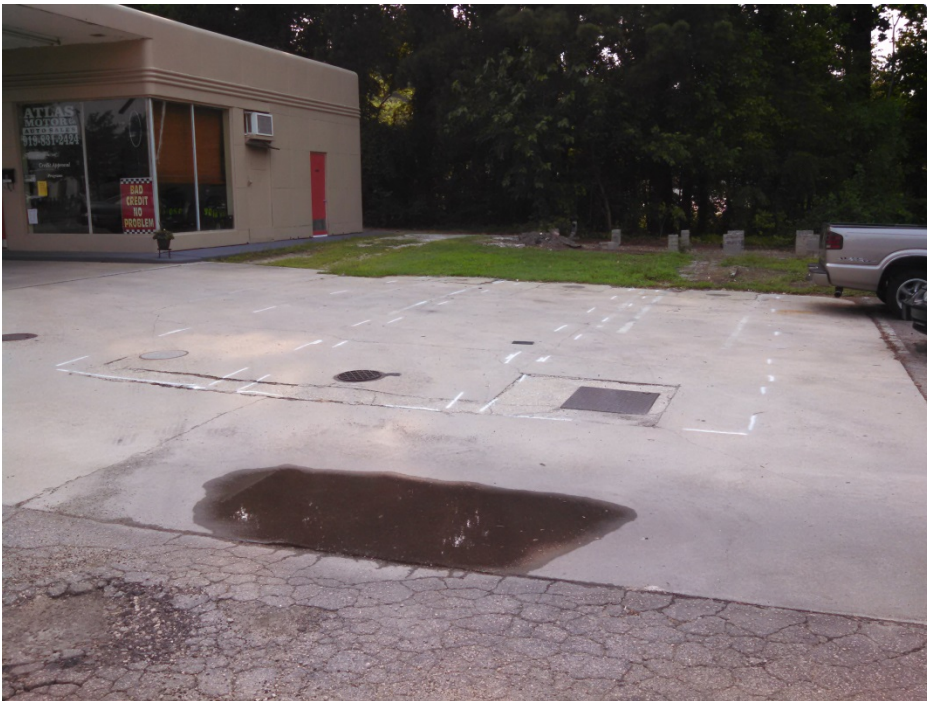
Photo #4: A view of the UST bed identified during the GPR survey, facing west.
