PRELIMINARY SITE ASSESSMENT REPORT

6556 NC HWY. 107

**Anthony L. Pate and Shari L. Pate Property
Parcel 006**

State Project R-4753

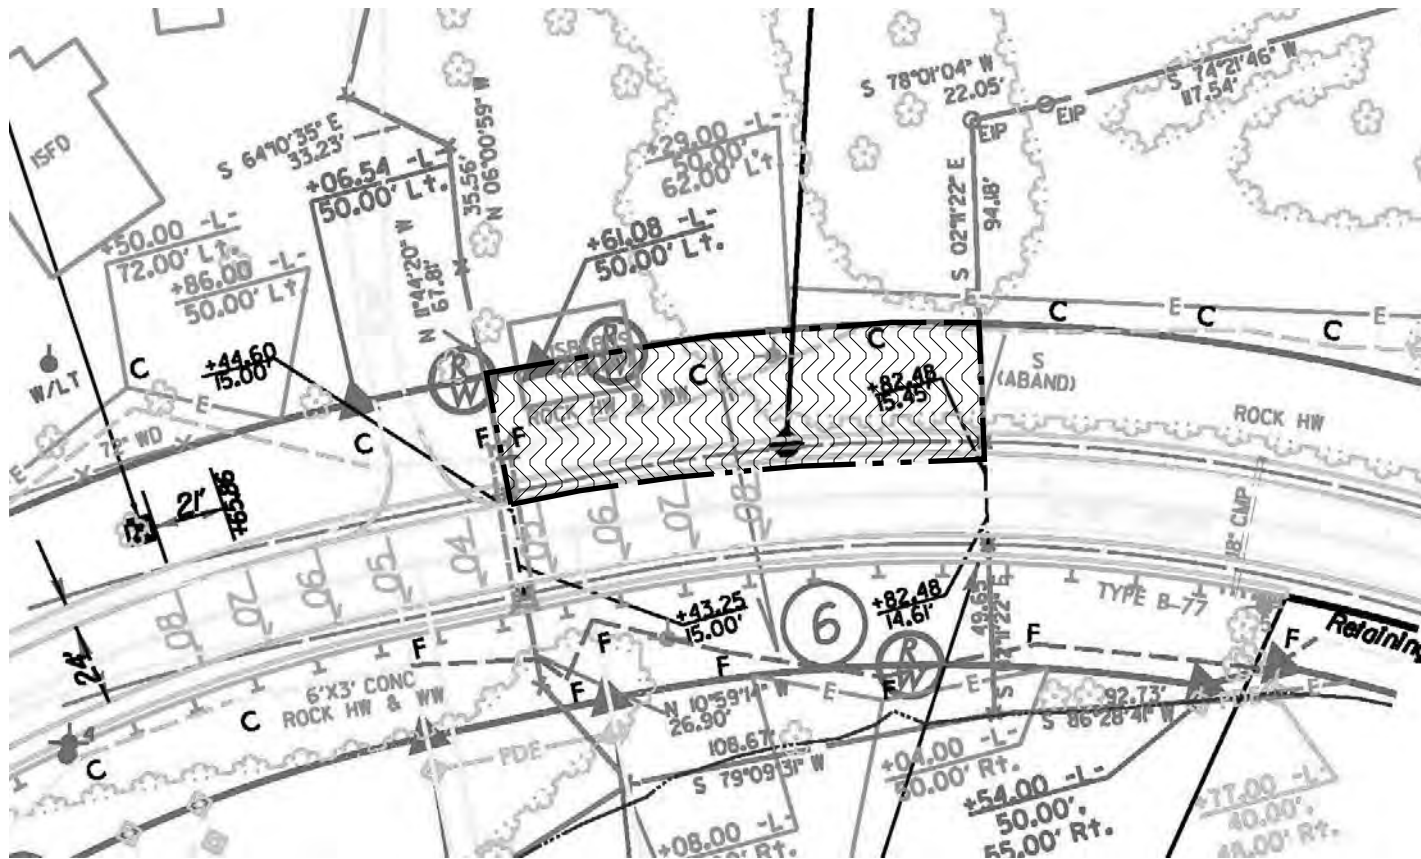
PROJECT: ncd01513			
PRELIMINARY SITE ASSESSMENT		DESIGNATED INVESTIGATION AREA FOR PARCEL 006	FIGURE 2
PARCEL 006 JACKSON COUNTY, NORTH CAROLINA TIP NO. R-4753, WBS ELEMENT NO. 39999.1.1			
DATE: May 5, 2014	DRAWN BY: ADE

PARCEL 006
INVESTIGATION AREA

NCDOT is planning road improvements to the area in the vicinity of NC Hwy. 107 in Jackson County, North Carolina. NCDOT wanted to assess the area in the existing and proposed ROW and easements on the north side of NC Hwy 107 fronting Parcel 006 to evaluate the presence or absence of USTs and soil contamination related to the current and/or former on-site operations, and the impact (if any) of these operations on the proposed road improvements. Figures 2 through 4 show the general site layout for Parcel 006.

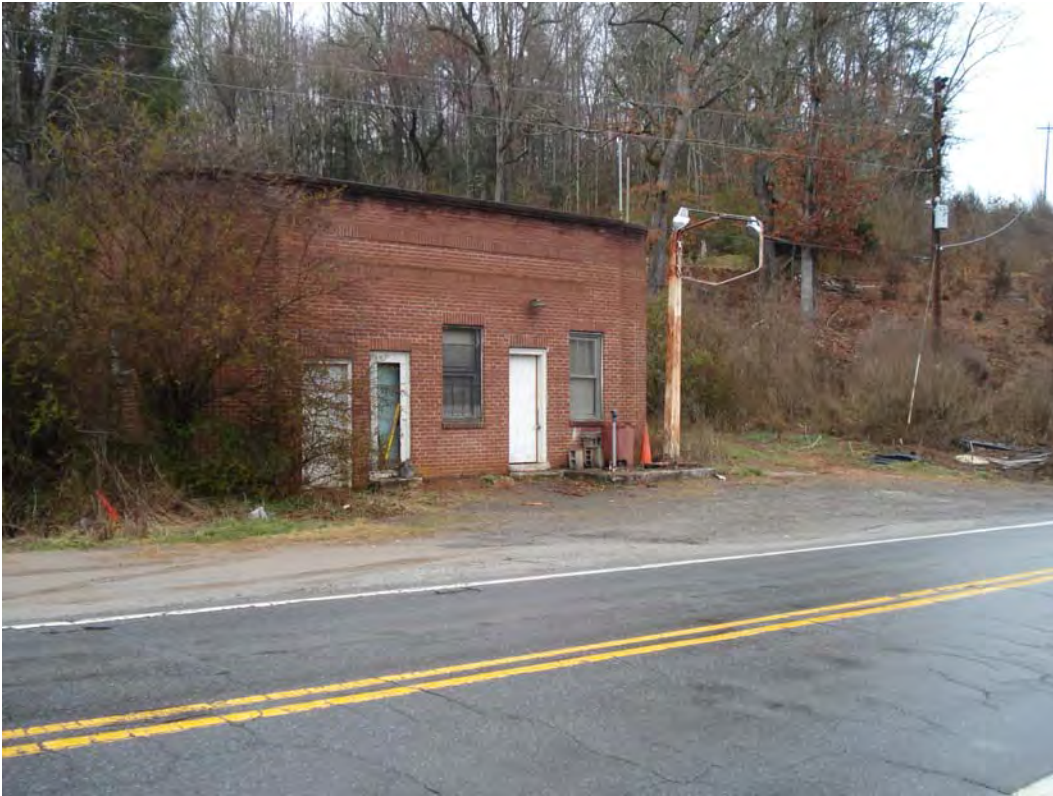
Photograph 1: View looking northeast at onsite structure. Former location of pump island is at concrete slab at east corner of building.

Parcel 006 contains a one-story brick building that formerly operated as a service station, as shown in Photographs 1 and 2 in Appendix I. The site location is shown on Figure 1, an excerpt from the United States Geological Survey (USGS) 7.5-minute quadrangle map of Sylva South and Tuckasegee, North Carolina. The preliminary site assessment was conducted by GEL Engineering of NC, Inc. (GEL) in accordance with the Notice to Proceed issued by NCDOT on February 5, 2014.

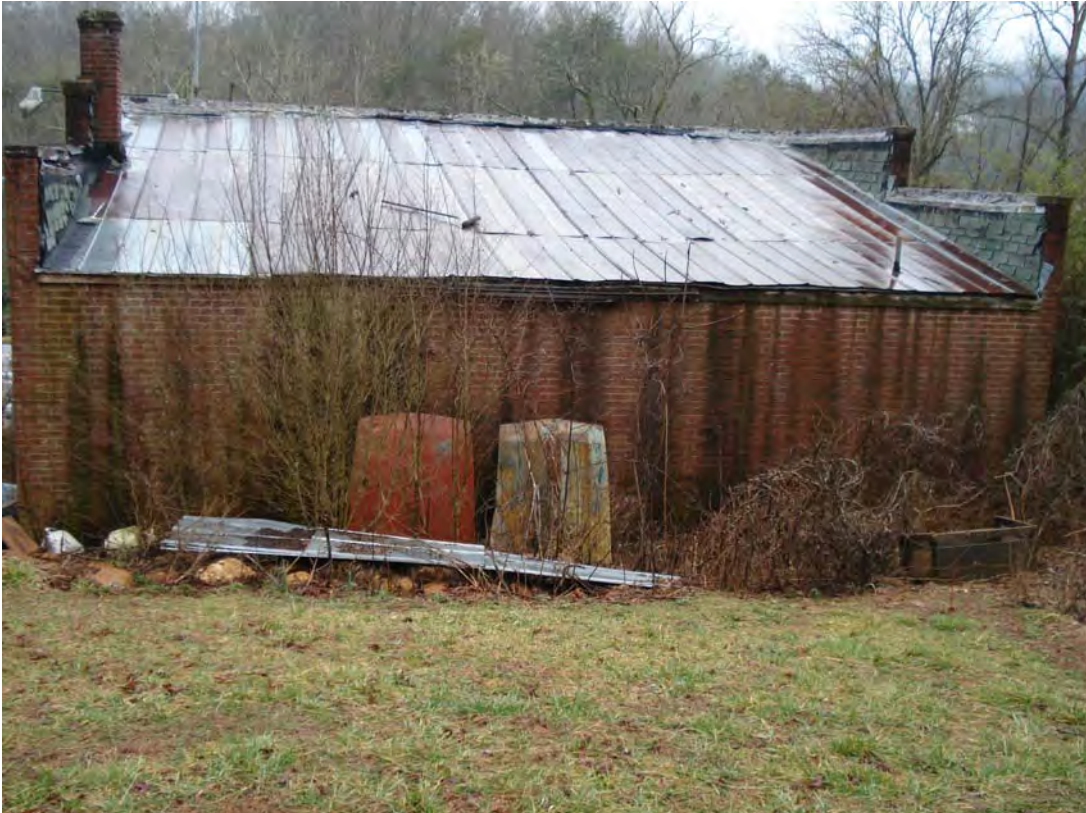
Photograph 2: View looking south at rear of former service station. No entrances or evidence of former bay doors, were observed.

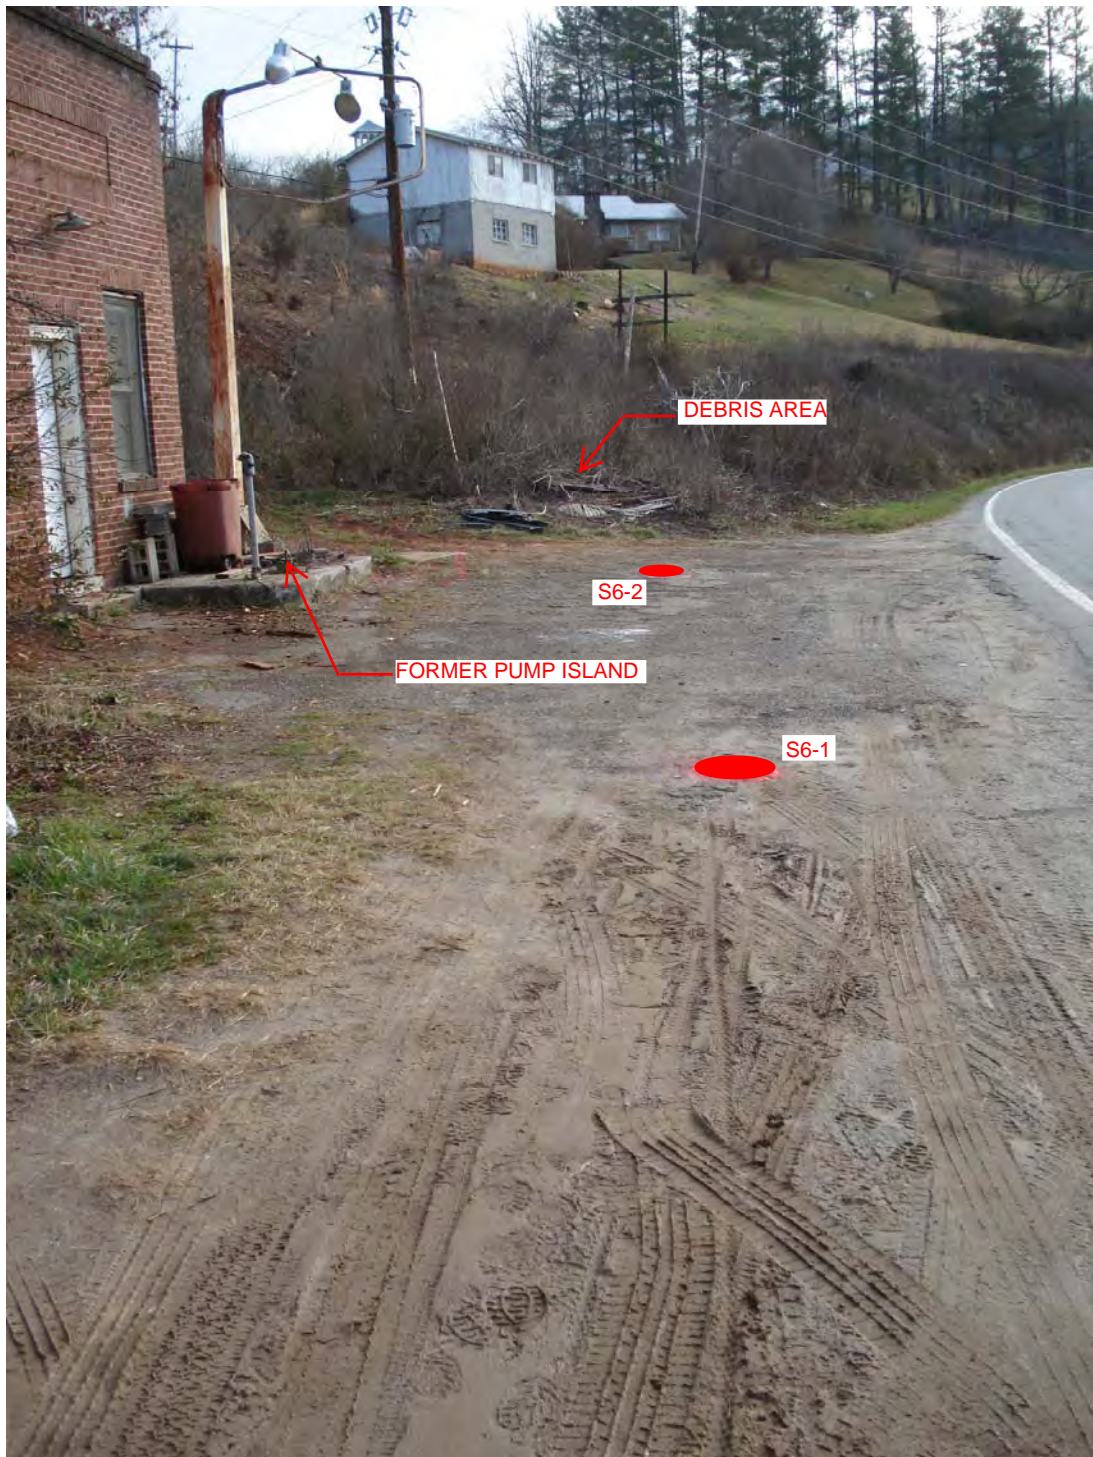
Photograph 3: View looking east at locations of soil borings S6-1 and S6-2. Former pump island is shown at left of photograph, and debris area identified during geophysical investigation is shown in background.

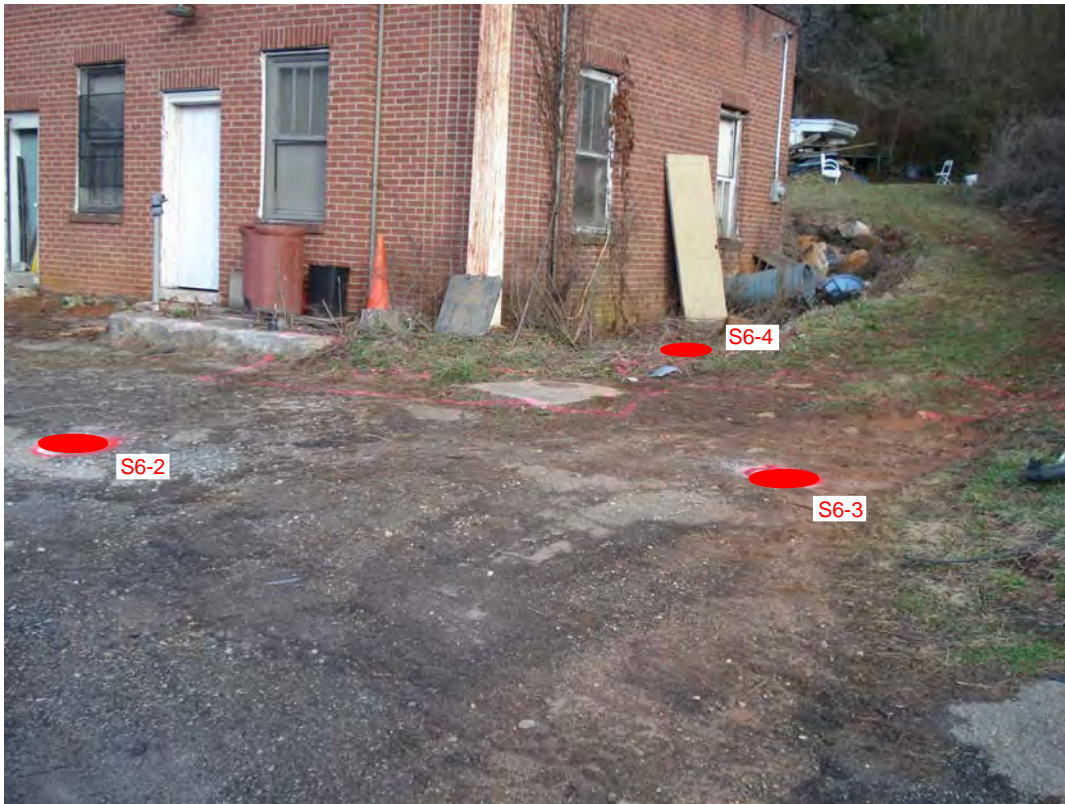
Photograph 4: View looking northwest at locations of soil boring S6-2, S6-3, and S6-4. Two “Known USTs” are located between the building and borings S6-2 and S6-3.

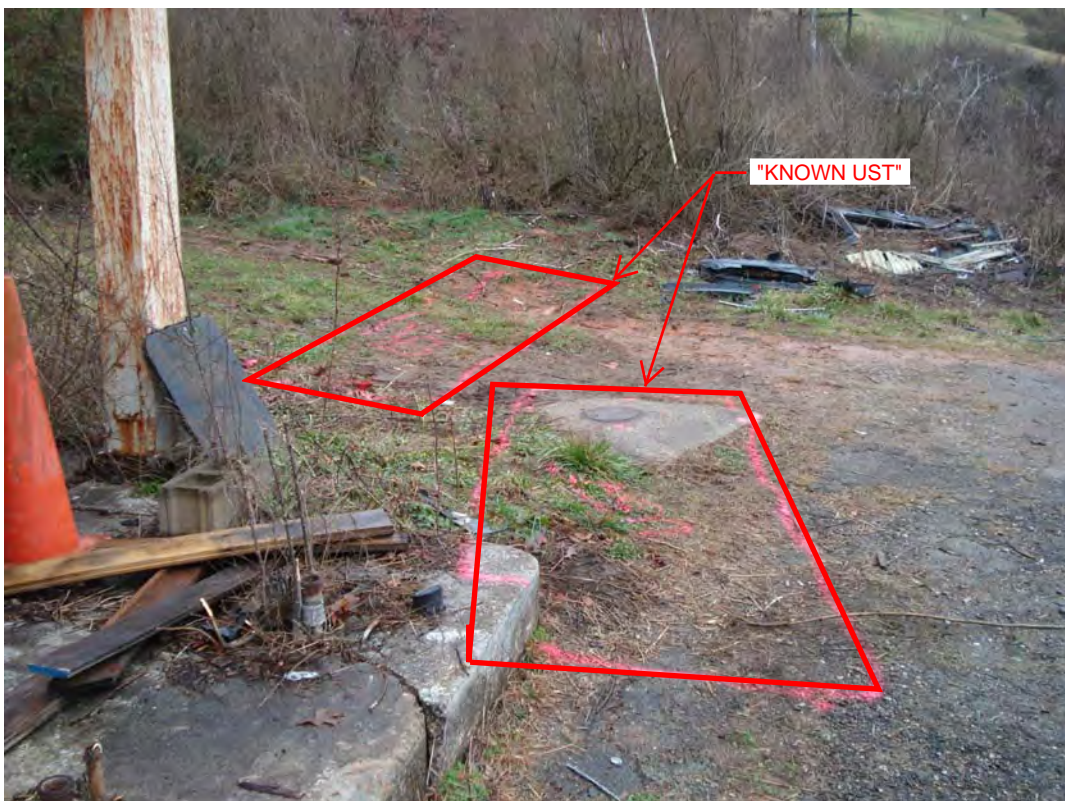
Two USTs and the base of a former pump island were observed near the east corner of the building, as shown in the photographs in Appendix I. Following removal of the manhole covers over the fill ports of the USTs, GEL encountered water in both USTs at a depth of approximately 4 feet below ground surface (bgs). No petroleum or petroleum odors were observed. The tops of the tanks are approximately 2 feet bgs, and the estimated capacity of each tank is 1000 gallons.

Photograph 5: View looking northeast at locations of two “Known USTs” identified during geophysical investigation.

No additional environmental investigation of the soil at the site by NCDOT is recommended at this time. However, it is recommended the two “Known USTs” be removed prior to NCDOT construction activities in accordance with NCDENR UST closure guidance.

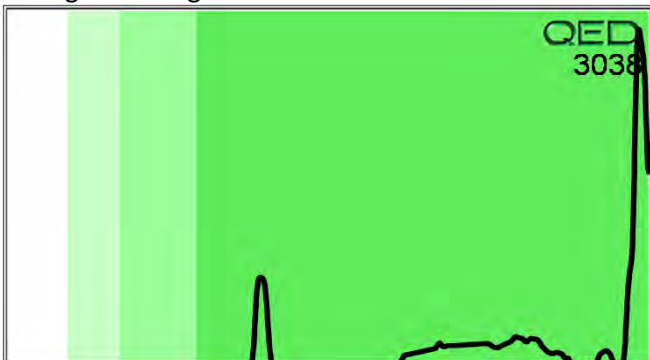
Background Organics S6-1

Results generated by a QED HC-1 analyser. Concentration values in mg/kg for soil samples and mg/L for water samples. Soil values are not corrected for moisture or stone content
 Fingerprints provide a tentative hydrocarbon identification. The abbreviations are:- FCM = Results calculated using Fundamental Calibration Mode : % = confidence for sample fingerprint match to library
 (SBS) or (LBS) = Site Specific or Library Background Subtraction applied to result : (PFM) = Poor Fingerprint Match : (T) = Turbid : (P) = Particulate present
