STATE OF NORTH CAROLINA  
DEPARTMENT OF TRANSPORTATION  
DIVISION OF HIGHWAYS  
GEOTECHNICAL ENGINEERING UNIT

STRUCTURE  
SUBSURFACE INVESTIGATION

COUNTY Cleveland  
PROJECT DESCRIPTION US 74 (Shelby Bypass) from West  
of NC 226 to West of NC 150

SITE DESCRIPTION Bridge Nos. 0466 & 0467 over First  
Broad River on Highway US 74 Bypass Between SR 1005  
and SR 1827

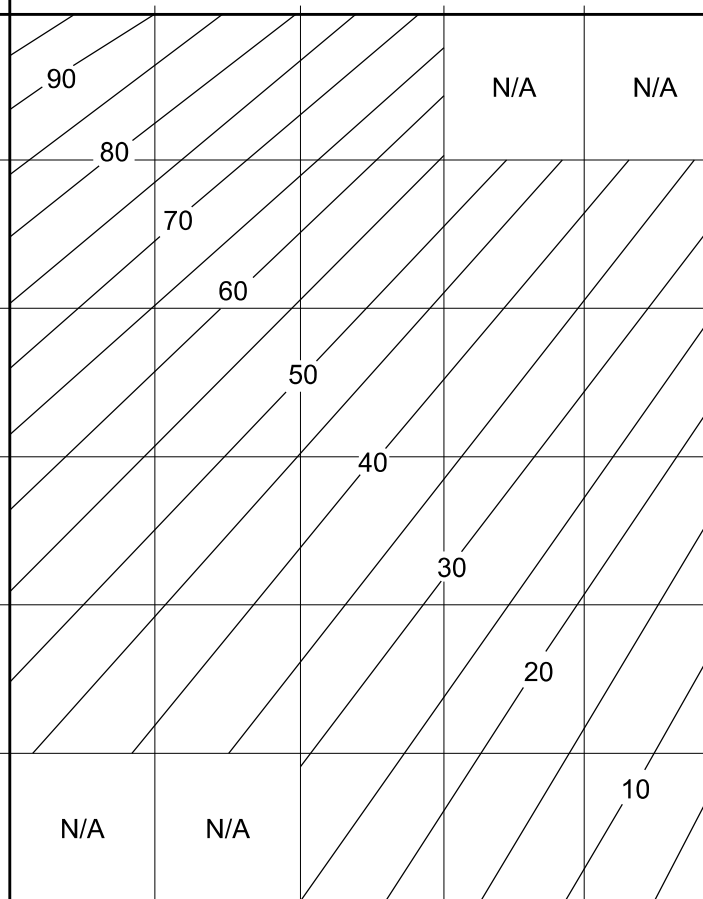
AASHTO LRFD Figure 10.4.6.4-1 — Determination of GSI for Jointed Rock Mass (Marinos and Hoek, 2000)

AASHTO LRFD Figure 10.4.6.4-2 — Determination of GSI for Tectonically Deformed Heterogeneous Rock Masses (Marinos and Hoek, 2000)

**GEOLOGICAL STRENGTH INDEX (GSI) FOR JOINTED ROCKS (Hoek and Marinos, 2000)**

From the lithology, structure and surface conditions of the discontinuities, estimate the average value of GSI. Do not try to be too precise. Quoting a range from 33 to 37 is more realistic than stating that GSI = 35. Note that the table does not apply to structurally controlled failures. Where weak planar structural planes are present in an unfavorable orientation with respect to the excavation face, these will dominate the rock mass behaviour. The shear strength of surfaces in rocks that are prone to deterioration as a result of changes in moisture content will be reduced if water is present. When working with rocks in the fair to very poor categories, a shift to the right may be made for wet conditions. Water pressure is dealt with by effective stress analysis.

**GSI FOR HETEROGENEOUS ROCK MASSES SUCH AS FLYSCH (Marinos, P and Hoek E., 2000)**

From a description of the lithology, structure and surface conditions (particularly of the bedding planes), choose a box in the chart. Locate the position in the box that corresponds to the condition of the discontinuities and estimate the average value of GSI from the contours. Do not attempt to be too precise. Quoting a range from 33 to 37 is more realistic than giving GSI = 35. Note that the Hoek-Brown criterion does not apply to structurally controlled failures. Where unfavourably oriented continuous weak planar discontinuities are present, these will dominate the behaviour of the rock mass. The strength of some rock masses is reduced by the presence of groundwater and this can be allowed for by a slight shift to the right in the columns for fair, poor and very poor conditions. Water pressure does not change the value of GSI and it is dealt with by using effective stress analysis.

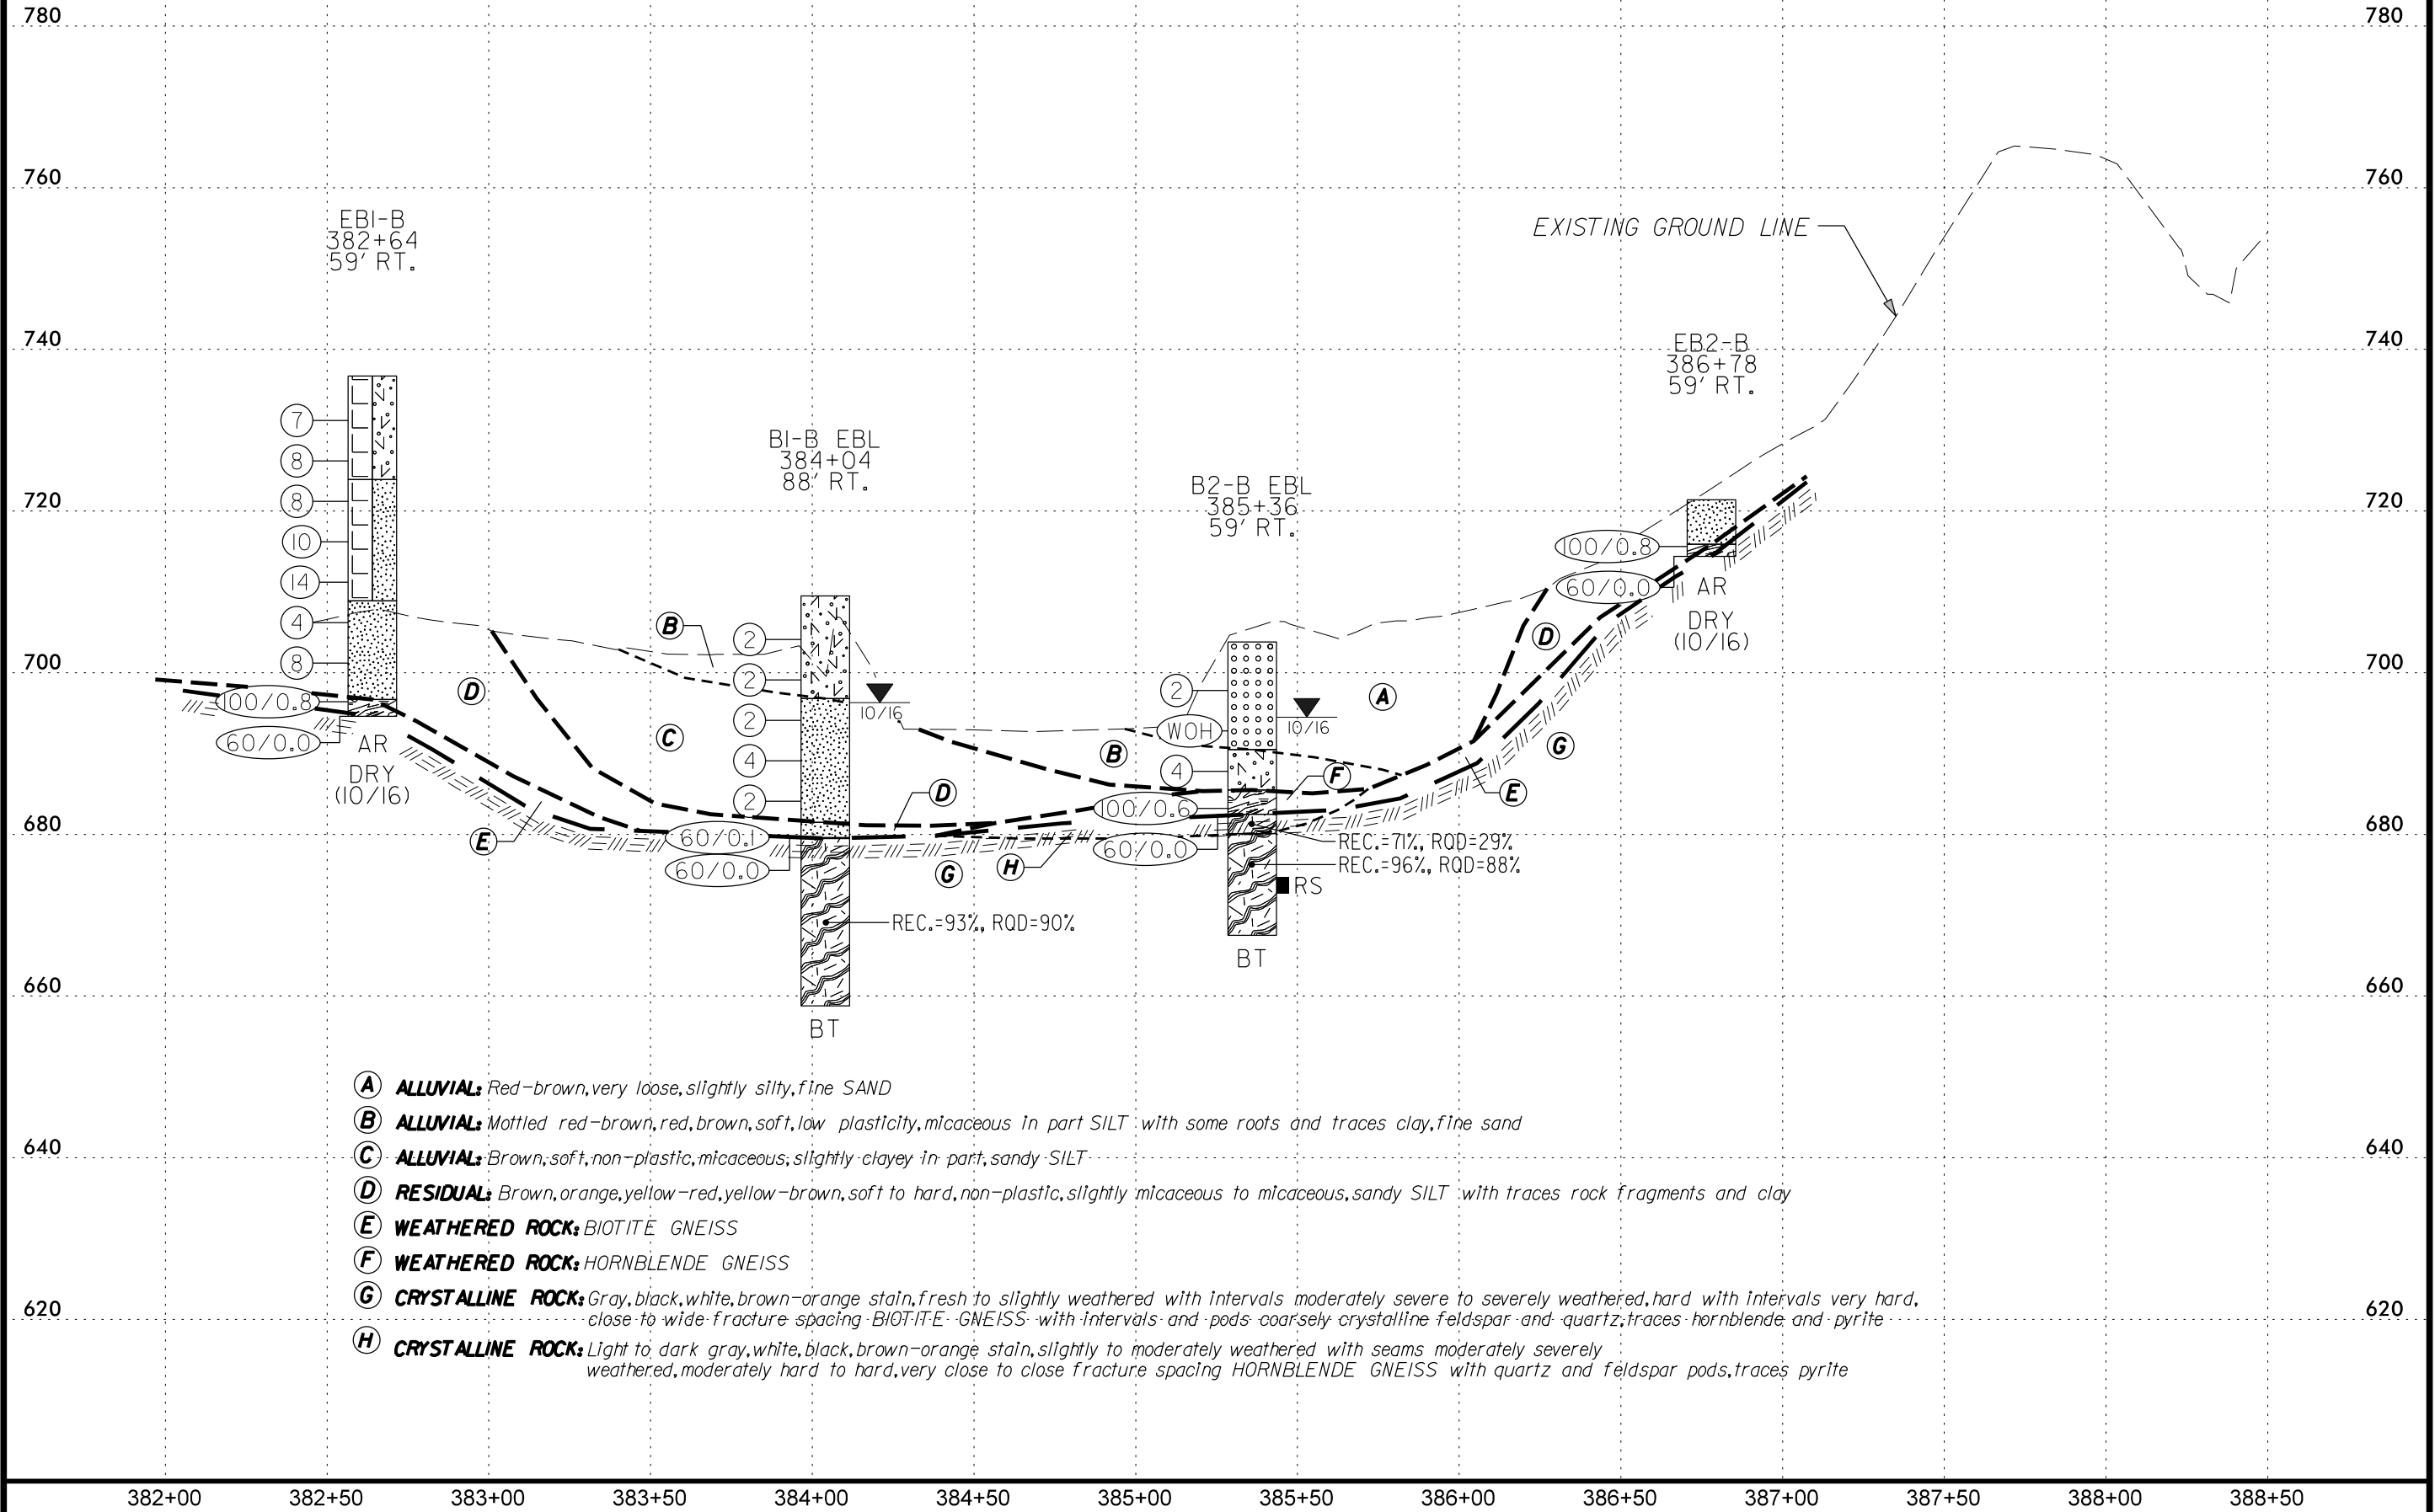
PROJECT REFERENCE NO.	SHEET NO.
R-2707C	5
BRIDGE NO. 467 PROFILE 59' RT. OF -L-

GROUNDLINE PROFILE CREATED FROM r2707c\_ls\_tin.tin FILE RECEIVED FROM NCDOT DATED 11-16-2016  
 INFERRED STRATIGRAPHY IS DRAWN AT THE PROFILE OFFSET WITH THE BORINGS PROJECTED ONTO THE PROFILE  
 TIN FILE PROVIDED DOES NOT DISPLAY THE CURRENT EMBANKMENT AT END BENT 1

- (A) **ALLUVIAL:** Red-brown, very loose, slightly silty, fine SAND
- (B) **ALLUVIAL:** Mottled red-brown, red, brown, soft, low plasticity, micaceous in part SILT with some roots and traces clay, fine sand

- (C) **ALLUVIAL:** Brown, soft, non-plastic, micaceous, slightly clayey in part, sandy SILT
- (D) **RESIDUAL:** Brown, orange, yellow-red, yellow-brown, soft to hard, non-plastic, slightly micaceous to micaceous, sandy SILT with traces rock fragments and clay

- (E) **WEATHERED ROCK:** BIOTITE GNEISS
- (F) **WEATHERED ROCK:** HORNBLLENDE GNEISS
- (G) **CRYSTALLINE ROCK:** Gray, black, white, brown-orange stain, fresh to slightly weathered with intervals moderately severe to severely weathered, hard with intervals very hard, close to wide fracture spacing BIOTITE GNEISS with intervals and pods coarsely crystalline feldspar and quartz, traces hornblende and pyrite

- (H) **CRYSTALLINE ROCK:** Light to dark gray, white, black, brown-orange stain, slightly to moderately weathered with seams moderately severely weathered, moderately hard to hard, very close to close fracture spacing HORNBLLENDE GNEISS with quartz and feldspar pods, traces pyrite

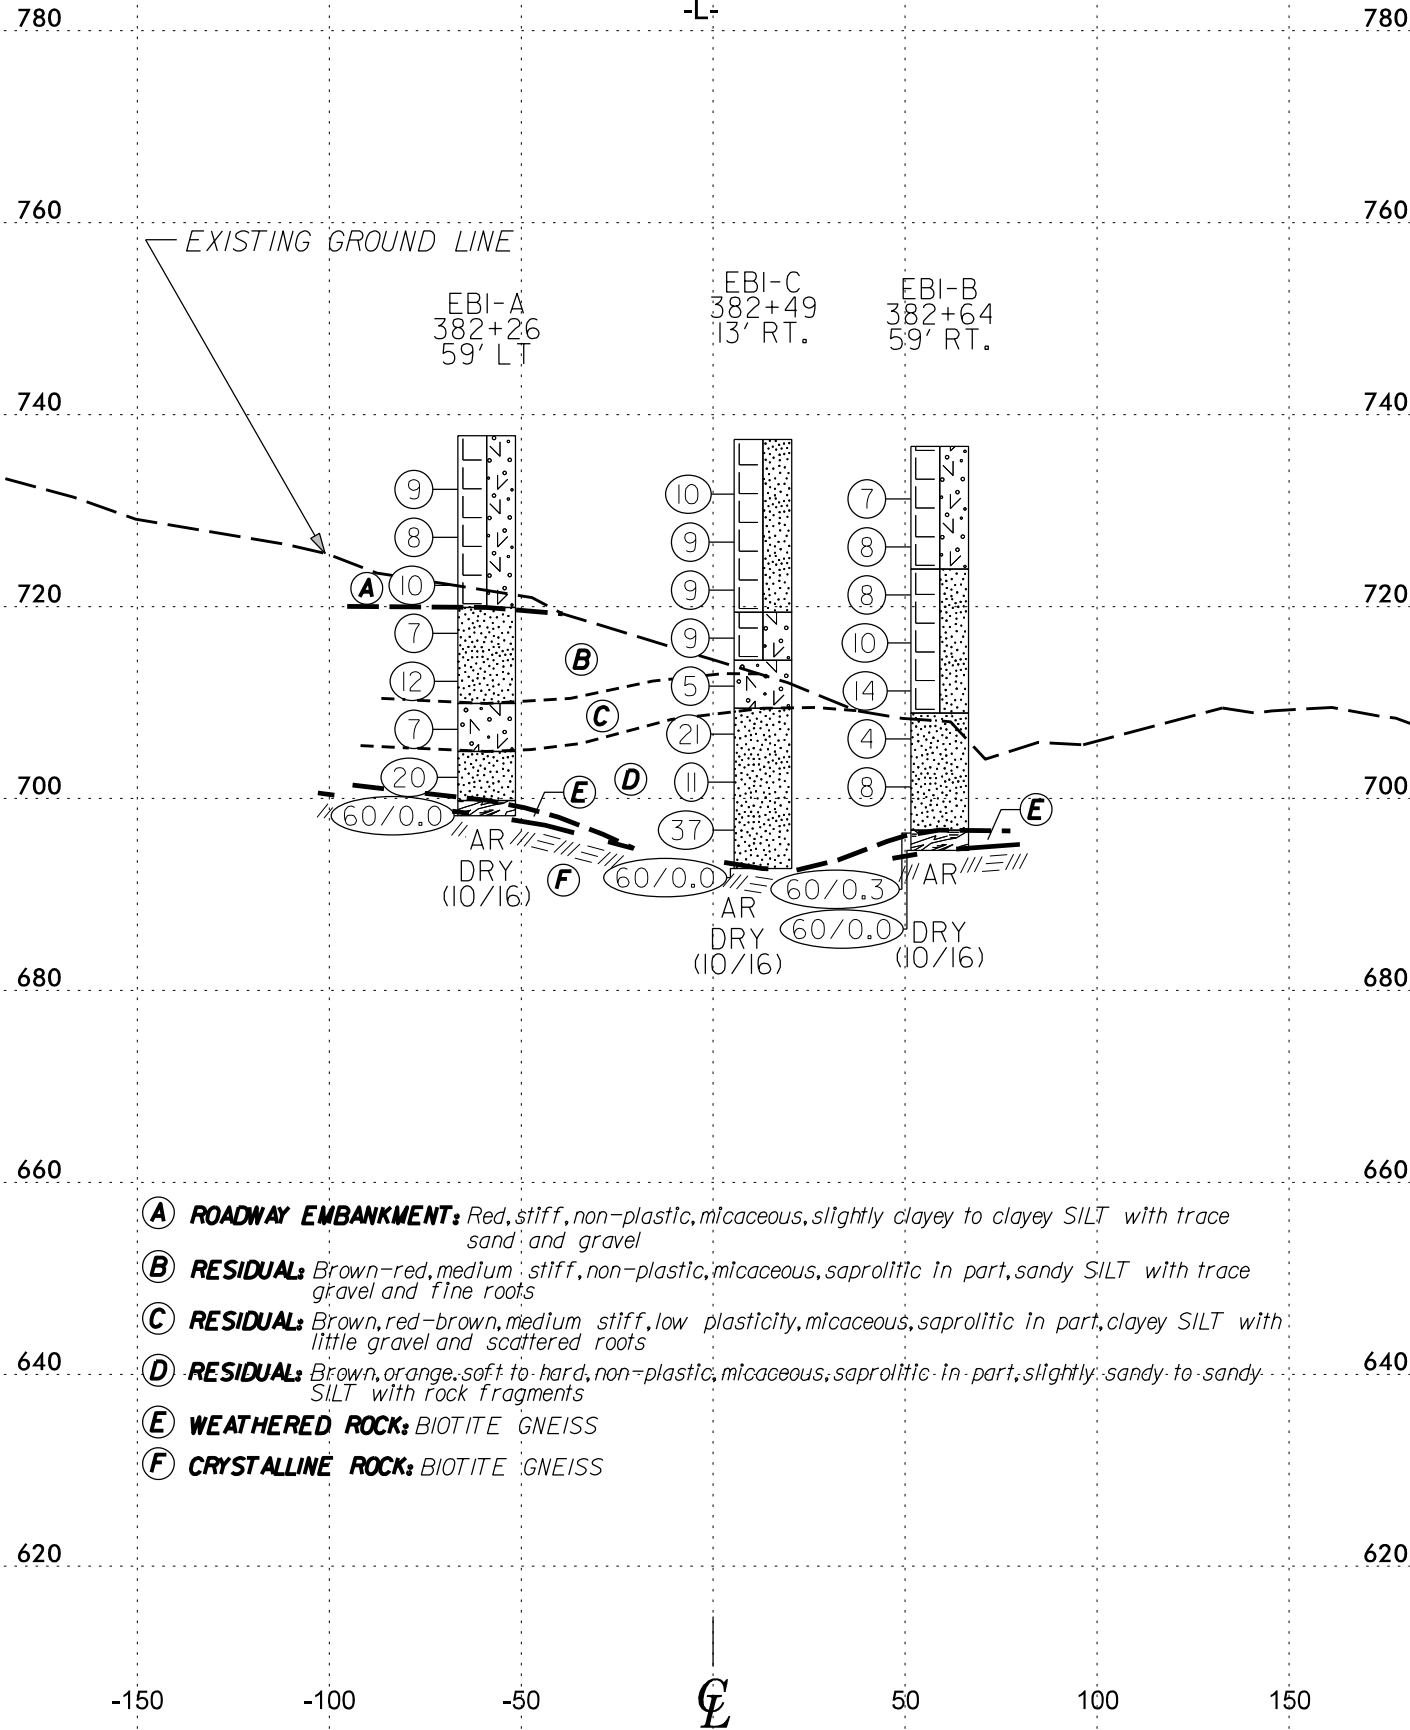
**END BENT 1 - CROSS SECTION  
 STA. 382+45**

CROSS SECTION CREATED FROM r2707c\_ls\_tin.tin FILE DATED 11-16-2016  
 TIN FILE PROVIDED DOES NOT DISPLAY THE CURRENT EMBANKMENT  
 108° SKEW  
 -L-

- (A) **ROADWAY EMBANKMENT:** Red, stiff, non-plastic, micaceous, slightly clayey to clayey SILT with trace sand and gravel
- (B) **RESIDUAL:** Brown-red, medium stiff, non-plastic, micaceous, saprolitic in part, sandy SILT with trace gravel and fine roots
- (C) **RESIDUAL:** Brown, red-brown, medium stiff, low plasticity, micaceous, saprolitic in part, clayey SILT with little gravel and scattered roots
- (D) **RESIDUAL:** Brown, orange, soft to hard, non-plastic, micaceous, saprolitic in part, slightly sandy to sandy SILT with rock fragments
- (E) **WEATHERED ROCK:** BIOTITE GNEISS
- (F) **CRYSTALLINE ROCK:** BIOTITE GNEISS

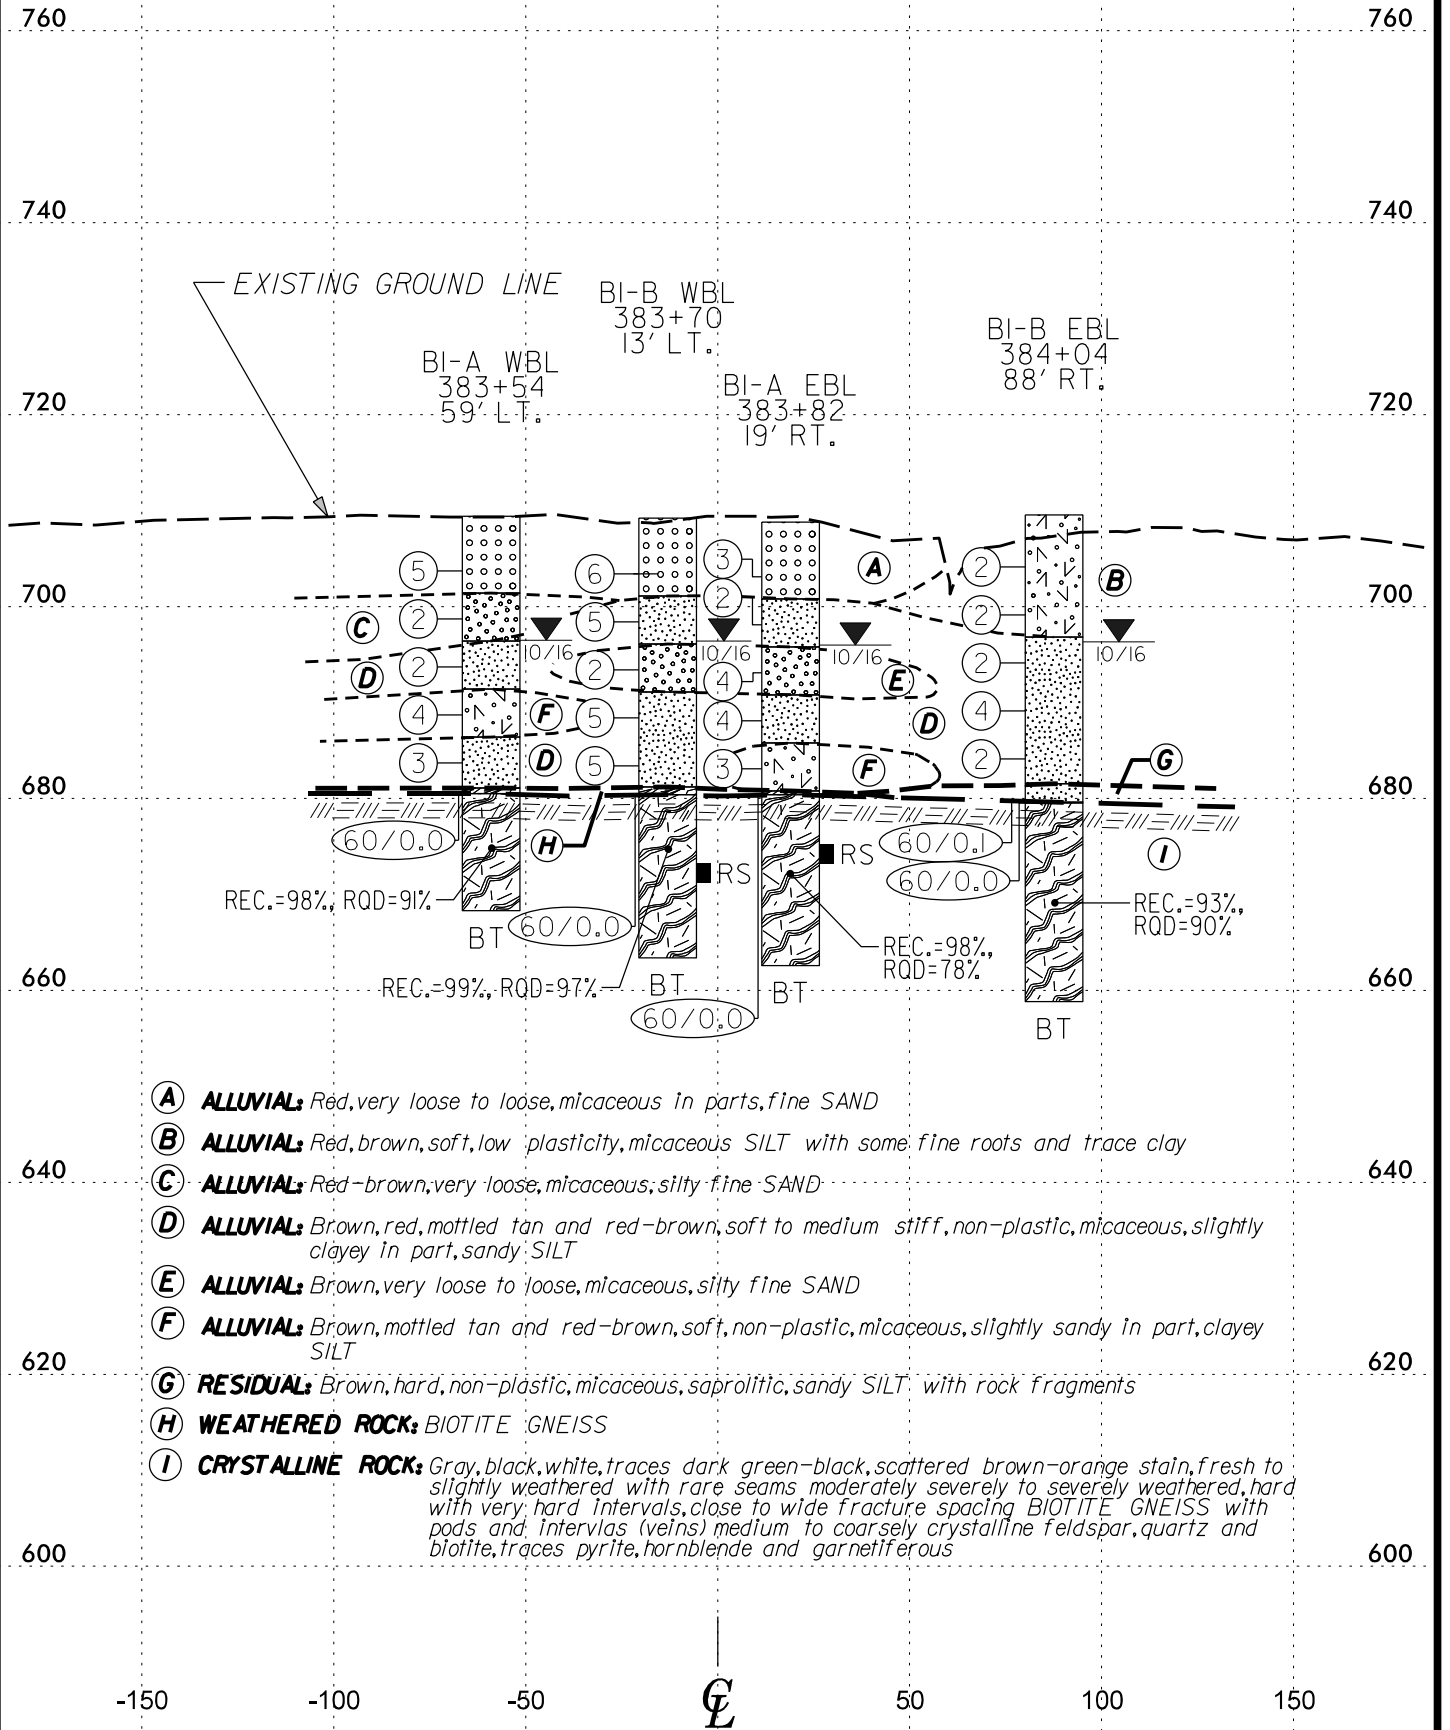
**BENT 1 - CROSS SECTION  
 STA. 383+75**

CROSS SECTION CREATED FROM r2707c\_ls\_tin.tin FILE DATED 11-16-2016  
 110° SKEW  
 -L-

- (A) **ALLUVIAL:** Red, very loose to loose, micaceous in parts, fine SAND
- (B) **ALLUVIAL:** Red, brown, soft, low plasticity, micaceous SILT with some fine roots and trace clay

- (C) **ALLUVIAL:** Red-brown, very loose, micaceous, silty fine SAND
- (D) **ALLUVIAL:** Brown, red, mottled tan and red-brown, soft to medium stiff, non-plastic, micaceous, slightly clayey in part, sandy SILT

- (E) **ALLUVIAL:** Brown, very loose to loose, micaceous, silty fine SAND
- (F) **ALLUVIAL:** Brown, mottled tan and red-brown, soft, non-plastic, micaceous, slightly sandy in part, clayey SILT

- (G) **RESIDUAL:** Brown, hard, non-plastic, micaceous, saprolitic, sandy SILT with rock fragments
- (H) **WEATHERED ROCK:** BIOTITE GNEISS
- (I) **CRYSTALLINE ROCK:** Gray, black, white, traces dark green-black, scattered brown-orange stain, fresh to slightly weathered with rare seams moderately severely to severely weathered, hard with very hard intervals, close to wide fracture spacing BIOTITE GNEISS with pods and intervals (veins) medium to coarsely crystalline feldspar, quartz and biotite, traces pyrite, hornblende and garnetiferous

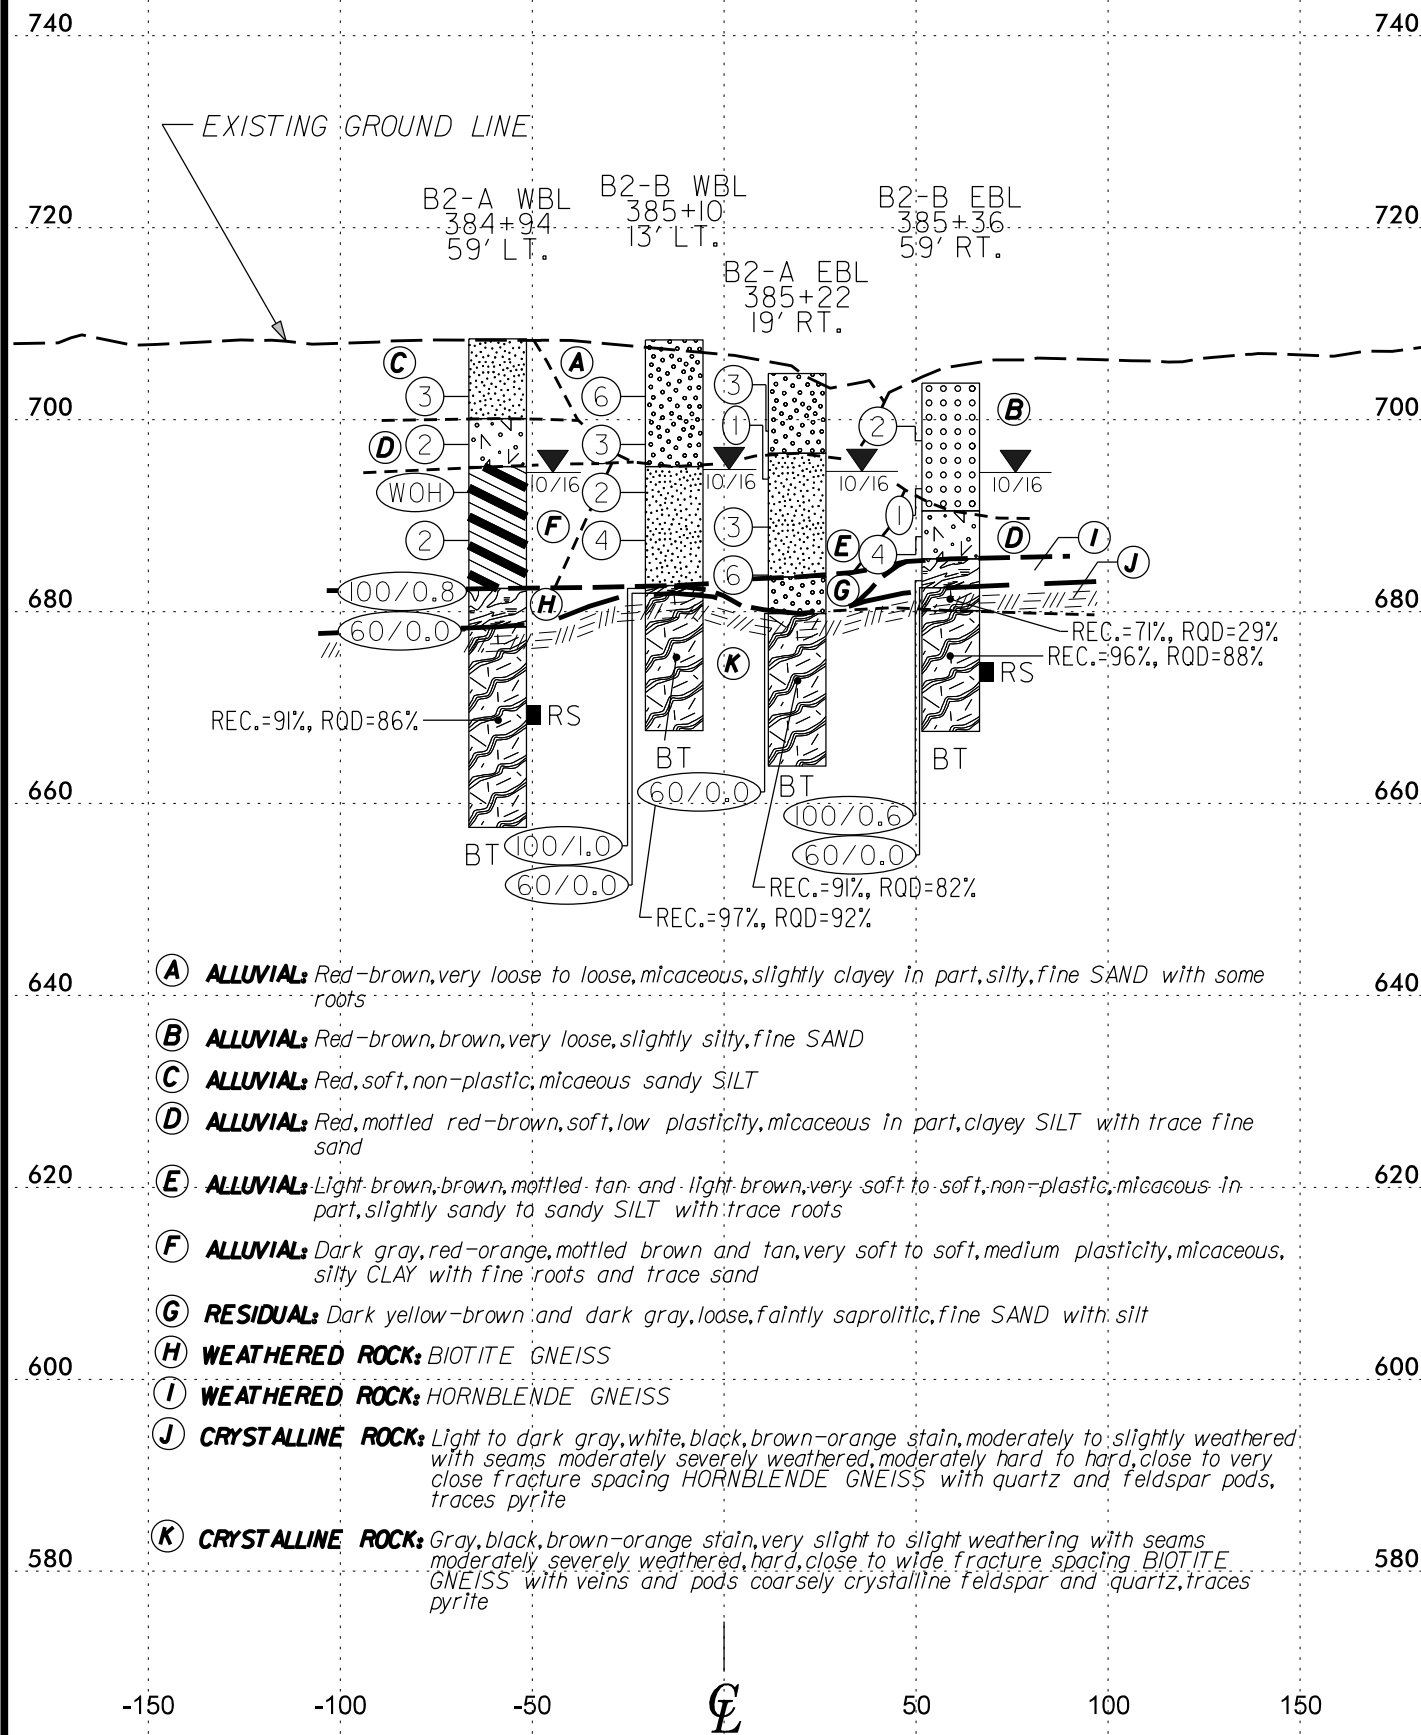
HORIZ. SCALE 0 50 100 (FEET) VE = 2.5:1 **BENT 2 - CROSS SECTION STA. 385+15**

CROSS SECTION CREATED FROM r2707c\_ls\_fin.tin FILE DATED 11-16-2016  
110° SKEW  
-L-

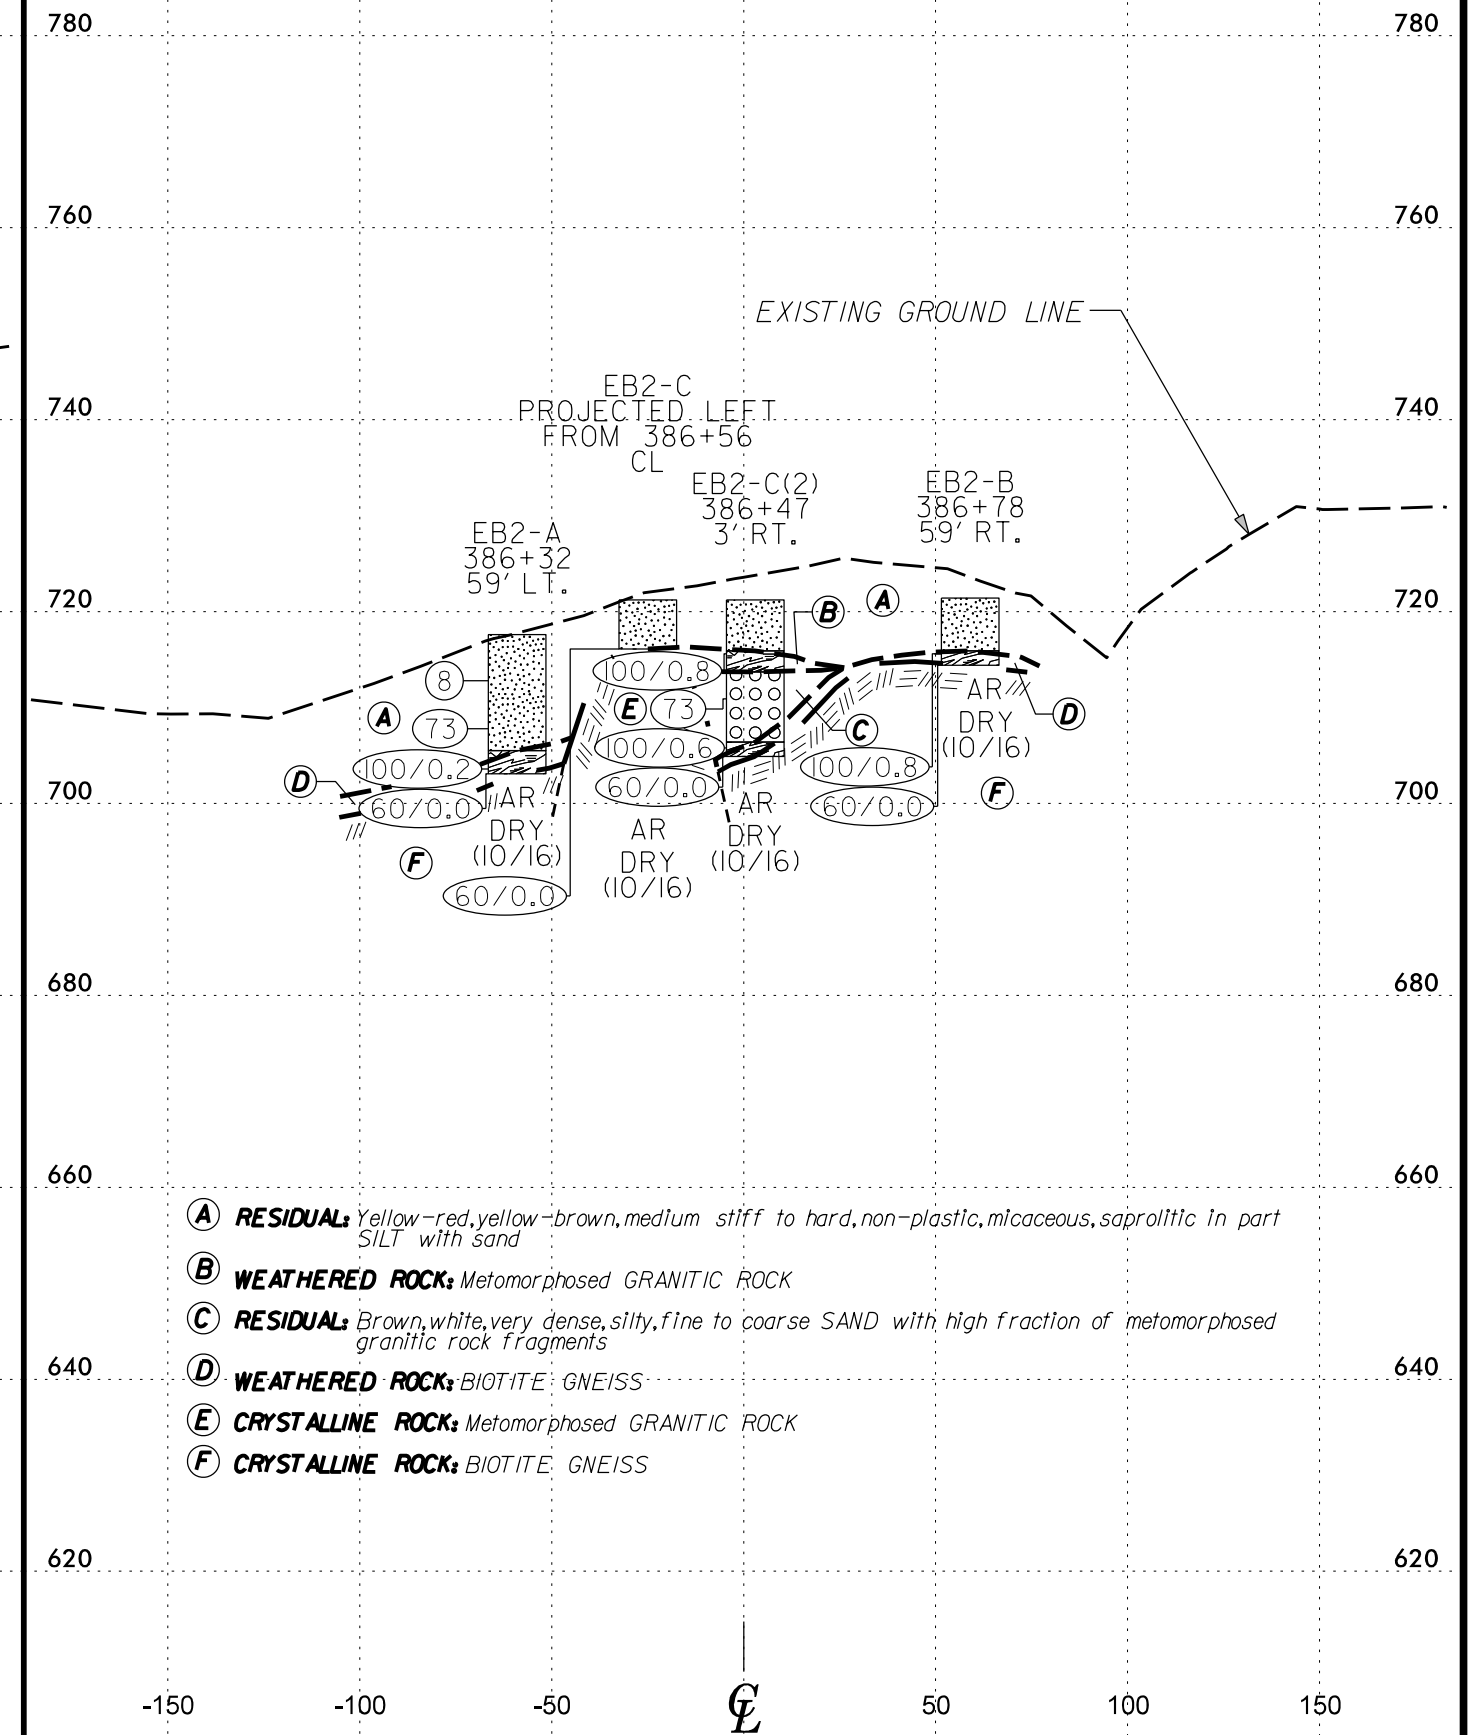
HORIZ. SCALE 0 20 40 (FEET) VE = 2.5:1 **END BENT 2 - CROSS SECTION STA. 386+55**

CROSS SECTION CREATED FROM r2707c\_ls\_fin.tin FILE DATED 11-16-2016  
111° SKEW  
-L-

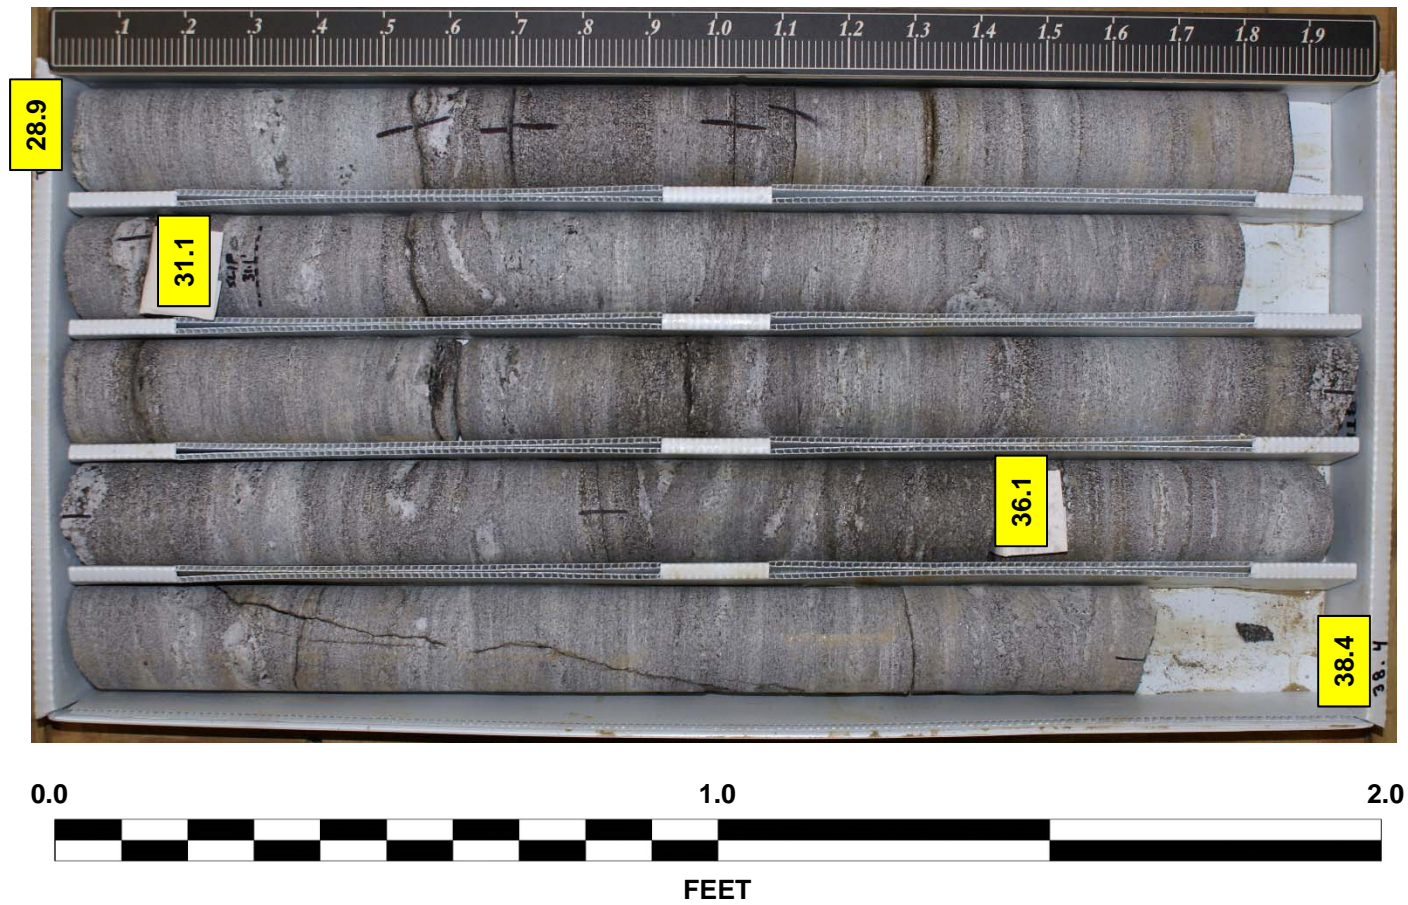
**B1-A WBL**  
**STA. 383+54 @ 59' LT.**  
**Box 1 of 2: 28.9 – 38.4 FEET**

680.5	680.5	28.9	2.2	1:35/0.2	(2.2)	(2.0)	(12.0)	(11.1)		Begin Coring @ 28.9 ft <b>CRYSTALLINE ROCK</b> Gray, black, fresh to very slightly weathered, hard, close to moderately close fracture spacing. <b>BIOTITE GNEISS</b> with small pods and veins medium to coarse crystalline feldspar and quartz. 12 0°-15° joints, some with faint iron oxide stain; 1 80° joint at 36.9'-37.8', with some calcite infill, no stain, partially healed to healed GSI=75	28.9
675	678.3	31.1	5.0	1:44 1:49	100%	91%	98%	91%			680.5
670	673.3	36.1	5.0	1:53 2:09 2:07	(5.0)	(4.7)					668.3
670	668.3	41.1	5.0	1:59 1:45	(4.8)	(4.4)					668.3

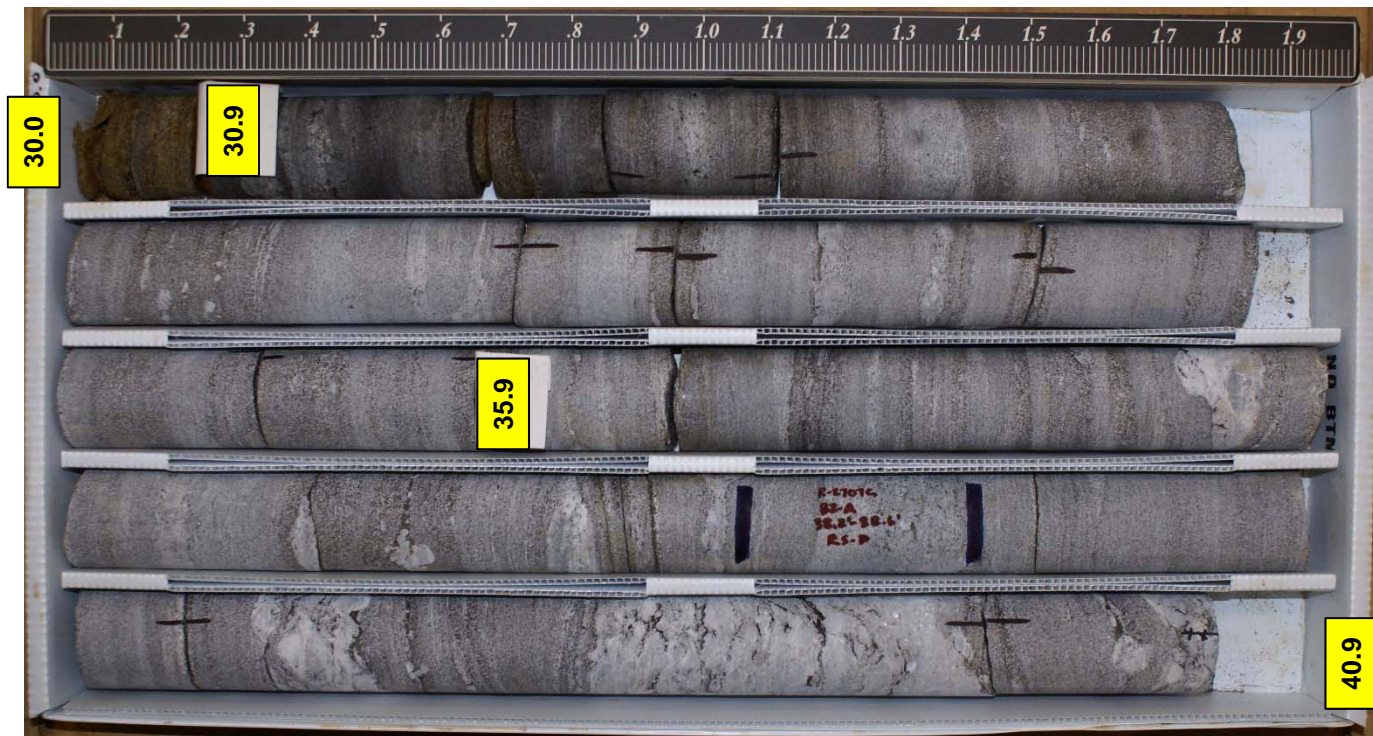
**B2-A WBL**  
**STA. 384+94 @ 59' LT.**  
**Box 1 of 2: 30.0 – 40.9 FEET**

678.4	678.4	30.0	0.9	0:53/0.9	(0.2)	(0.0)	(19.1)	(17.9)		<p style="text-align: center;">Begin Coring @ 30.0 ft</p> <p style="text-align: center;"><b>CRYSTALLINE ROCK</b></p> <p>Gray, black, very slight weathering with seam moderately severely weathered at 30.0'-31.6', hard, close to wide fracture spacing, <b>BIOTITE GNEISS</b> with coarsely crystalline quartz and feldspar veins, traces pyrite.</p> <p>18 0°-10° joints, some with heavy iron oxide stain; 1 25° joint with muscovite &lt;1mm; 1 45° joint healed; 2 90° joints healed</p> <p>UCS=14,262 PSI, GSI=69</p>	30.0		
675	677.5	30.9	5.0	0:56 1:05 1:31 1:50 2:05	(0.2) (4.1) 82%	(0.0) (4.0) 80%	91%	86%					
670	672.5	35.9	5.0	1:55 2:08 2:02	(5.0) 100%	(4.6) 92%							
665	667.5	40.9	5.0	1:57 2:24									
660	662.5	45.9	5.0	1:50 1:45 1:48 1:40 1:36	(5.0) 100%	(4.5) 90%							
	660

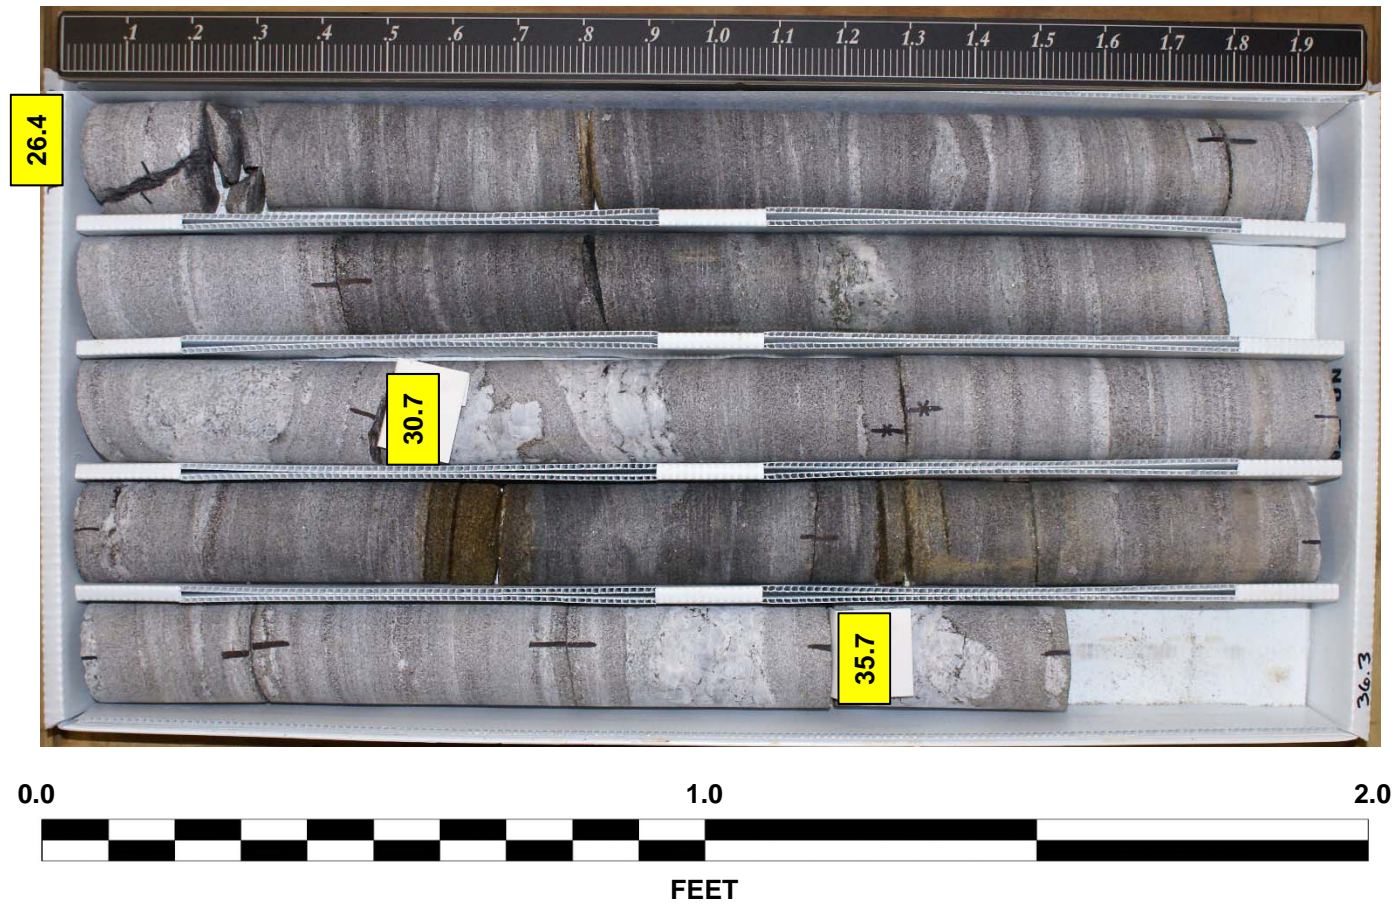
**B2-B WBL**  
**STA. 385+10 @ 13' LT.**  
**Box 1 of 2: 26.4 – 36.3 FEET**

681.9	681.9	26.4	4.3	1:37/0.3	(4.2)	(3.9)	(13.8)	(13.2)		Begin Coring @ 26.4 ft <b>CRYSTALLINE ROCK</b> Gray, black, scattered brown-orange stain, very slight to slight weathering with seam moderately severely weathered 32.7'-32.9', hard, close to wide fracture spacing. <b>BIOTITE GNEISS</b> with pods and veins coarsely crystalline feldspar and quartz. 16 0°-15° joints, some with iron oxide stain GSI=76	26.4
680				1:30	98%	91%

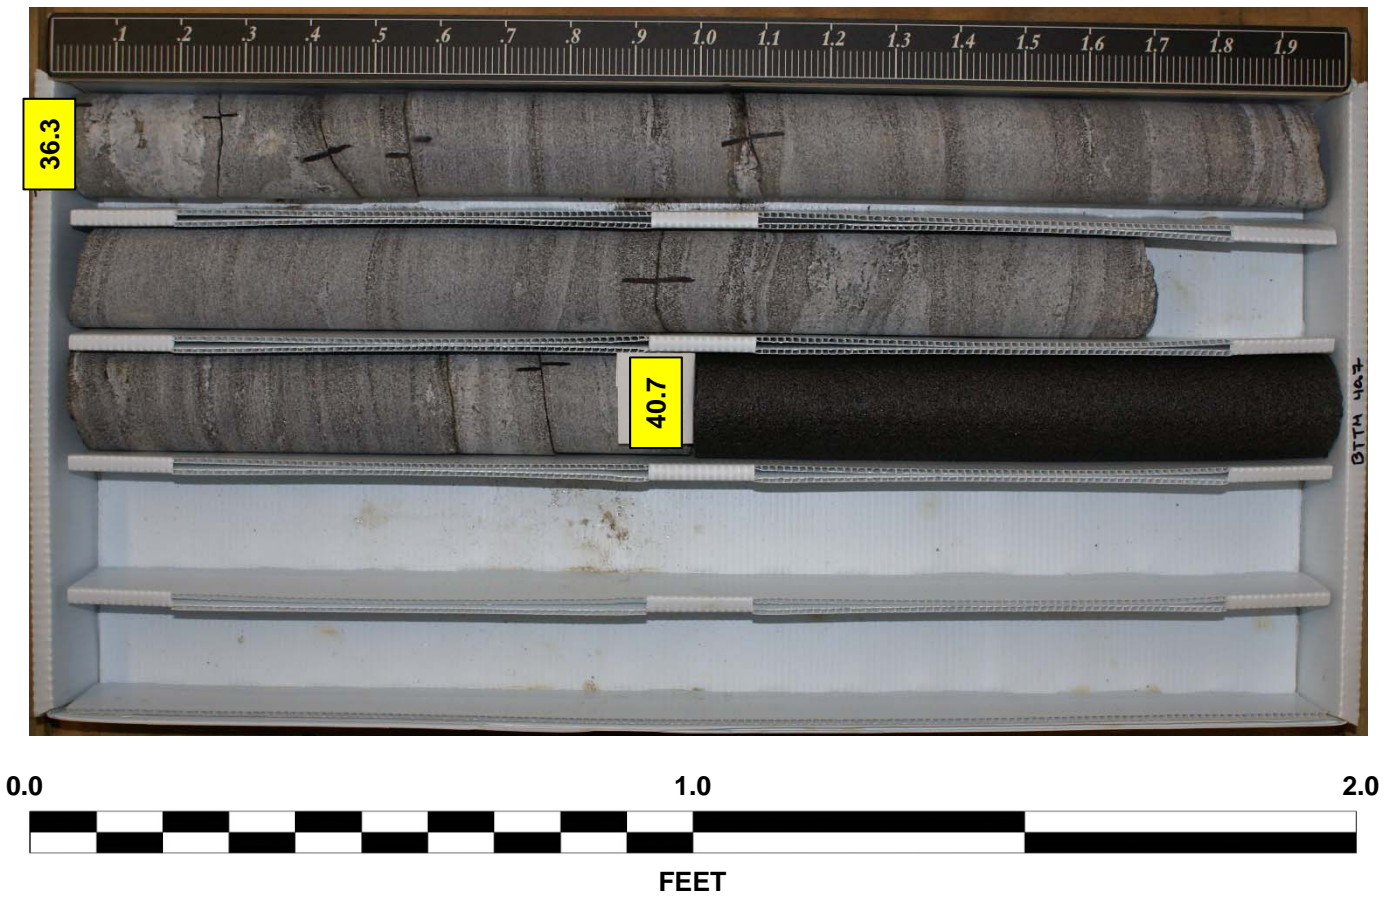
**B2-B WBL**  
**STA. 385+10 @ 13' LT.**  
**Box 2 of 2: 36.3 – 40.7 FEET**

677.6	30.7		1:28							
675			5.0	1:31	(4.6)	(4.3)					
	672.6	35.7		1:20	92%	86%					
670			5.0	1:04	(5.0)	(5.0)					
	667.6	40.7		1:53	100%	100%				40.7	
Boring Terminated at Elevation 667.6 ft in Crystalline Rock (Biotite Gneiss).

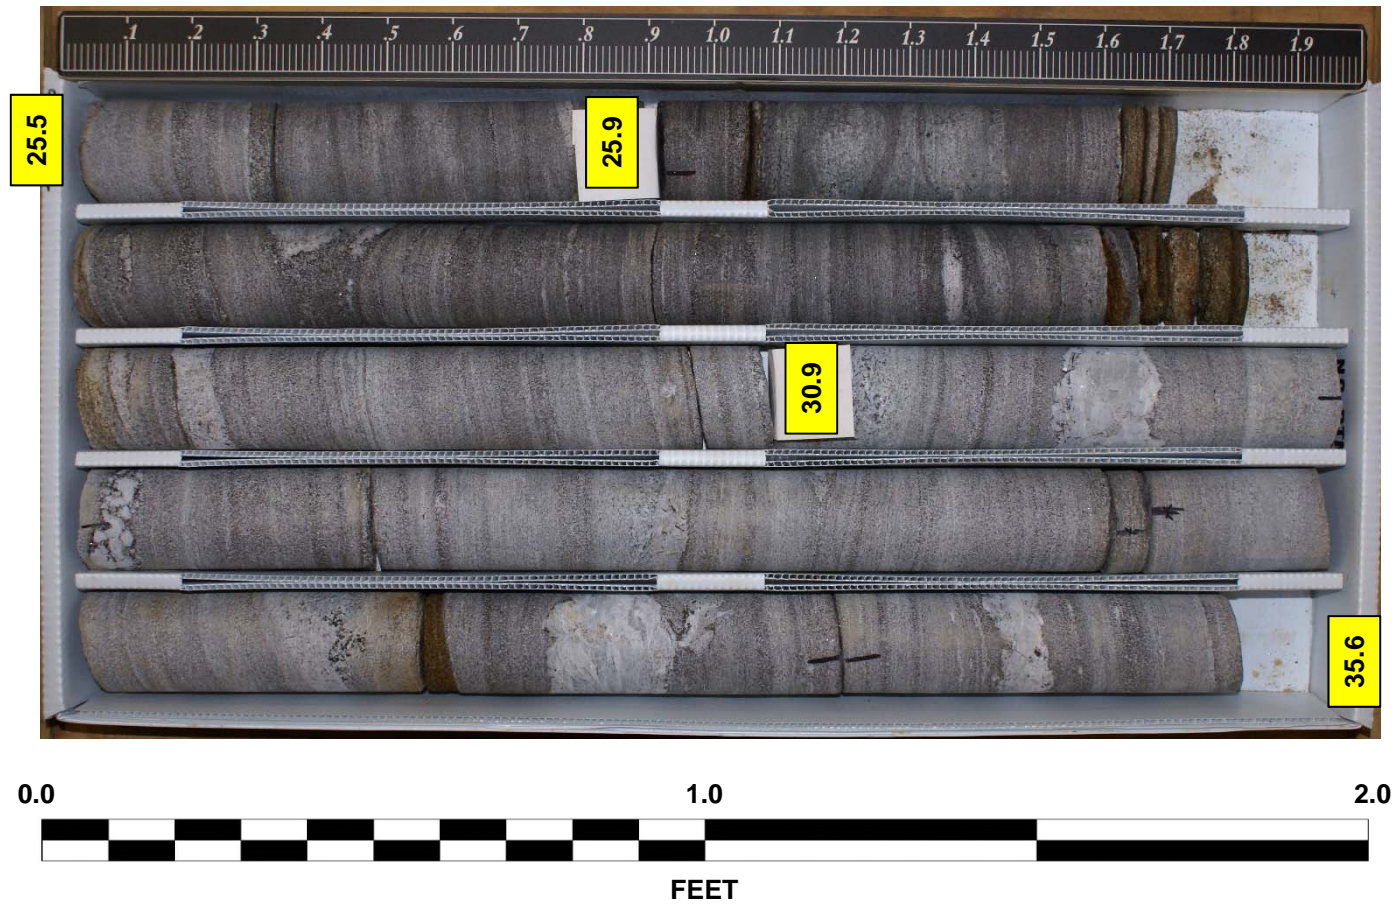
**B2-A EBL**  
**STA. 385+22 @ 19' RT.**  
**Box 1 of 2: 25.0 – 35.6 FEET**

679.8	679.8	25.0	0.9	1:23/0.9	(0.9)	(0.6)	(14.5)	(13.0)		<p style="text-align: center;">Begin Coring @ 25.0 ft</p> <p style="text-align: center;"><b>CRYSTALLINE ROCK</b></p> <p>Gray, black, brown-orange stain, very slight weathering with seams moderately severely weathered 26.6'-27.3', 28.9'-29.8' and 34.2'-34.3', hard, close to moderately close fracture spacing, <b>BIOTITE GNEISS</b> with veins and pods coarsely crystalline feldspar and quartz. 23 0°-15° joints, some with iron oxide stain, some with muscovite &lt;1mm GSI=65</p>	25.0
