STATE OF NORTH CAROLINA  
DEPARTMENT OF TRANSPORTATION  
DIVISION OF HIGHWAYS  
GEOTECHNICAL ENGINEERING UNIT

STRUCTURE  
SUBSURFACE INVESTIGATION

COUNTY Cleveland  
PROJECT DESCRIPTION US 74 (Shelby Bypass) from West  
of NC 226 to West of NC 150

SITE DESCRIPTION Bridge Nos. 0466 & 0467 over First  
Broad River on Highway US 74 Bypass Between SR 1005  
and SR 1827

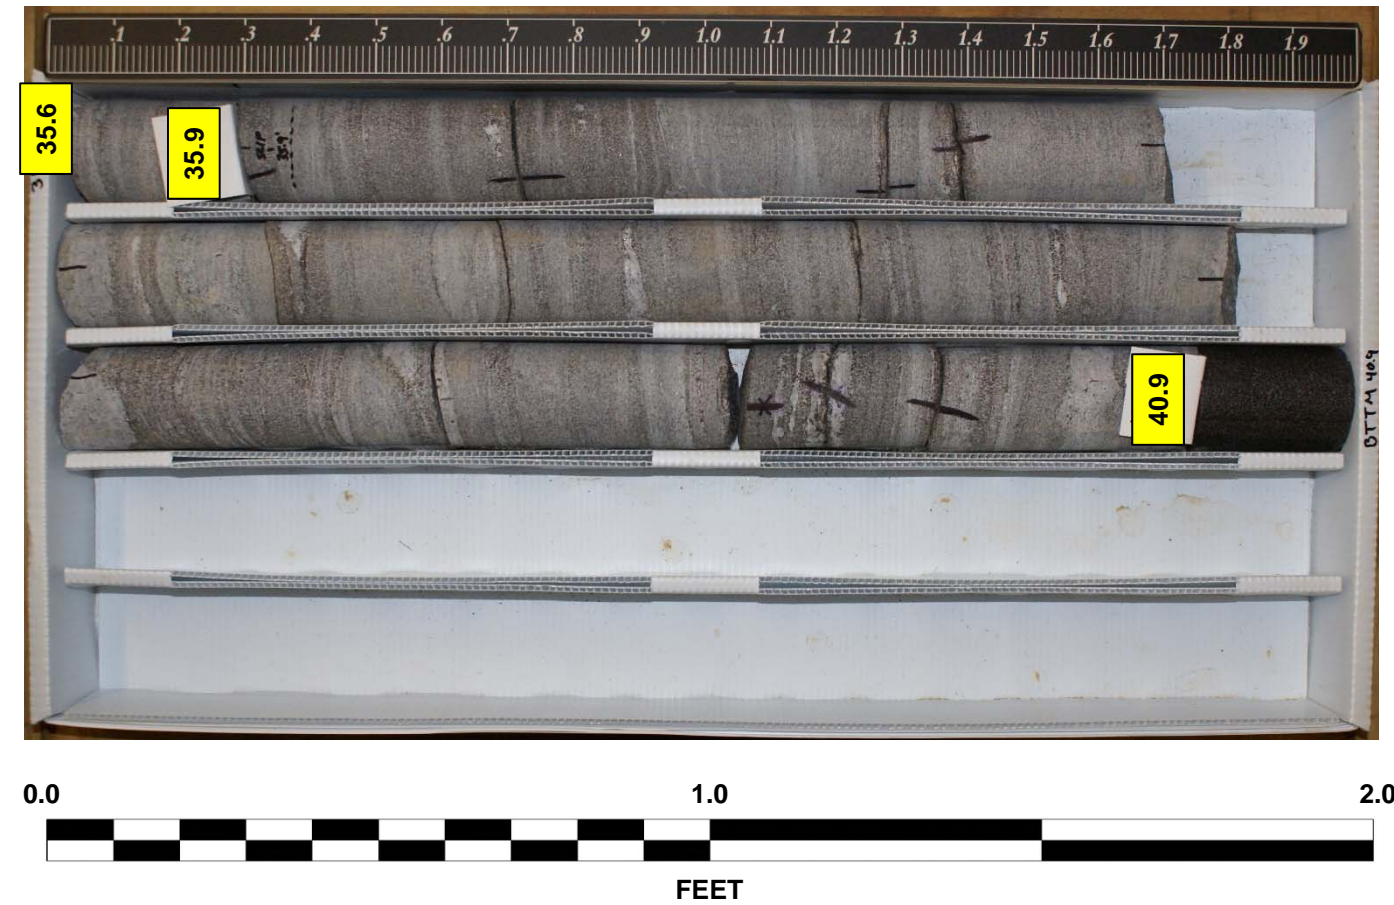
**B2-A EBL**  
**STA. 385+22 @ 19' RT.**  
**Box 2 of 2: 35.6 – 40.9 FEET**

678.9	678.9	25.9	5.0	1:26	100%	67%						
675	675			1:17 1:17 0:42 1:51	(3.8) 76%	(3.2) 64%						
670	670	30.9	5.0	2:07 2:03 2:05 1:47 1:55	(4.9) 98%	(4.3) 86%						
665	665	35.9	5.0	1:58 1:48 1:58 2:10 1:58	(4.9) 98%	(4.9) 98%

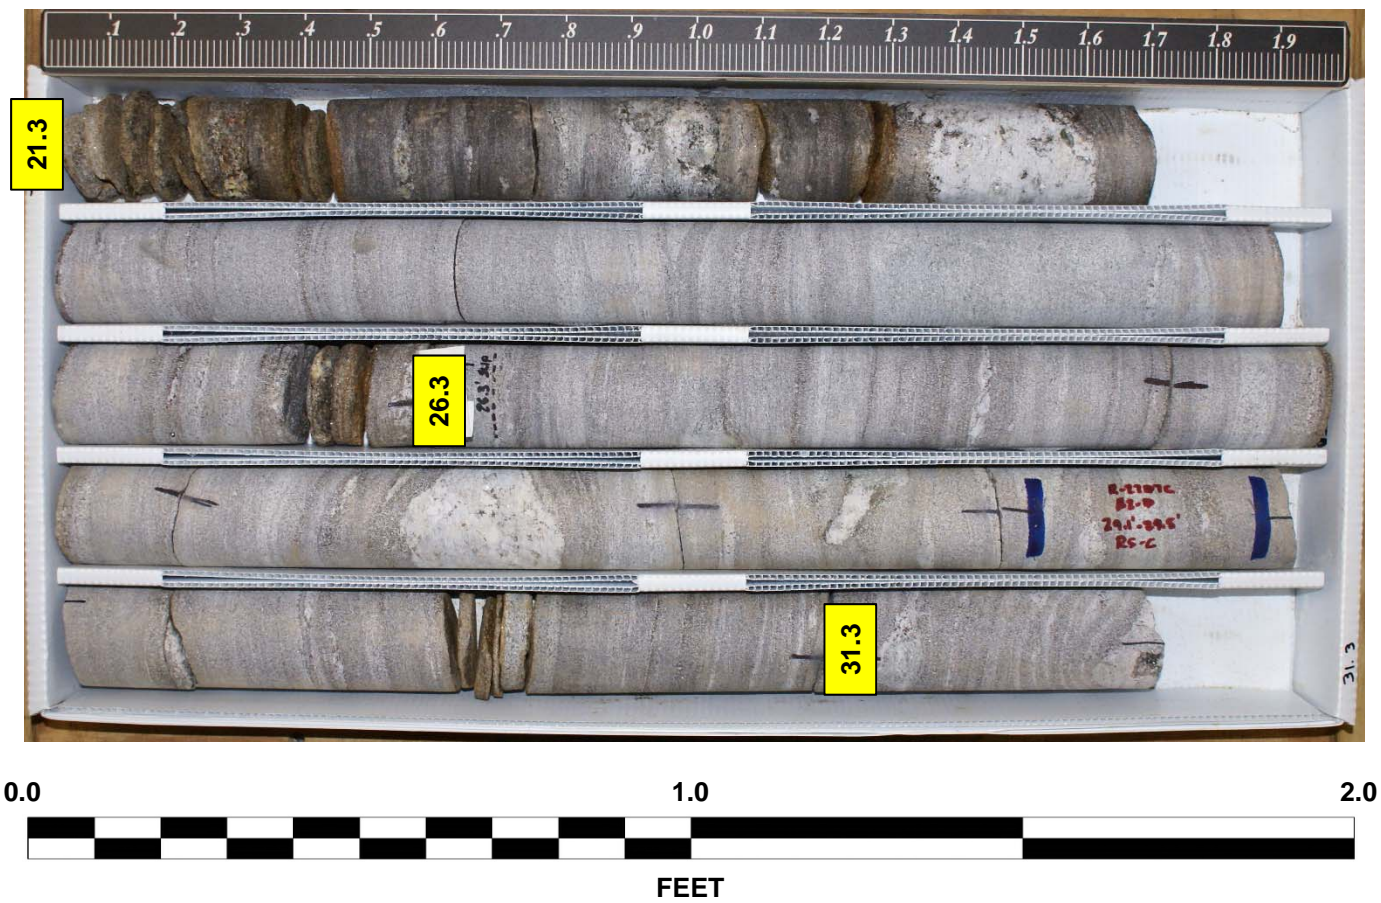
**B2-B EBL**  
**STA. 385+36 @ 59' RT.**  
**Box 1 of 2: 21.3 – 31.3 FEET**

682.5	682.5	21.3	5.0	1:17	(4.3)	(3.0)	(1.7)	(0.7)		Begin Coring @ 21.3 ft	21.3	
680	682.5			1:20	86%	60%	71%	29%		680.1	Light to dark gray, white, black, brown-orange stain, moderately to slightly weathered with seams moderately severely weathered, moderately hard to hard, close to very close fracture spacing,	23.7

677.5	26.3		1:44			(12.1)	(11.1)			<b>HORNBLLENDE GNEISS</b> with quartz and feldspar pods, traces pyrite.	
			5.0	1:45			96%	88%			12 0°-5° joints with iron oxide stain	
675				1:51							GSI=29	
	675			1:58	(5.0)	(4.9)					Gray, black, brown-orange stain, very slight weathering with seams moderately severely weathered, hard, close to wide fracture spacing

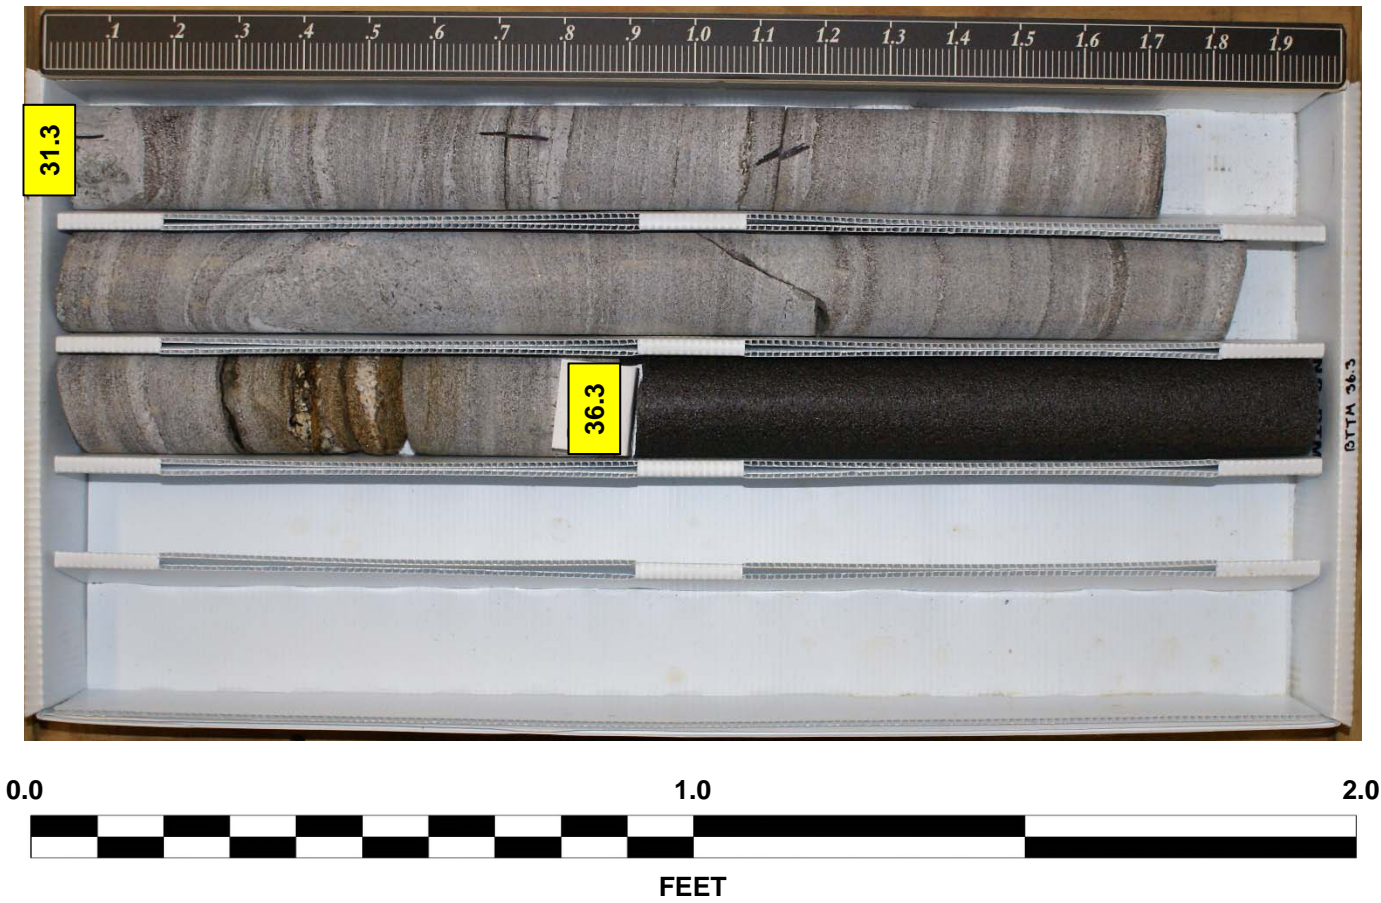
**B2-B EBL**  
**STA. 385+36 @ 59' RT.**  
**Box 2 of 2: 31.3 – 36.3 FEET**

1:46	100%	98%					<b>BIOTITE GNEISS</b>	
	672.5	31.3		2:02							17 0°-15° joints, some with iron oxide stain and/or clay <1mm; 1 60° joint with slightly rough walls

5.0	1:59	(4.5)	(3.9)					UCS=11,848 PSI, GSI=71	
670				1:41								
	670			1:52								
				1:59								
	667.5	36.3		1:57								
				1:46								
				1:29								
										Boring Terminated at Elevation 667.5 ft in Crystalline Rock (Biotite Gneiss).
