## Preliminary Site Assessment Report

Medlin Brothers Body Shop, Inc.

Parcel # 45

TIP Number: U-3330

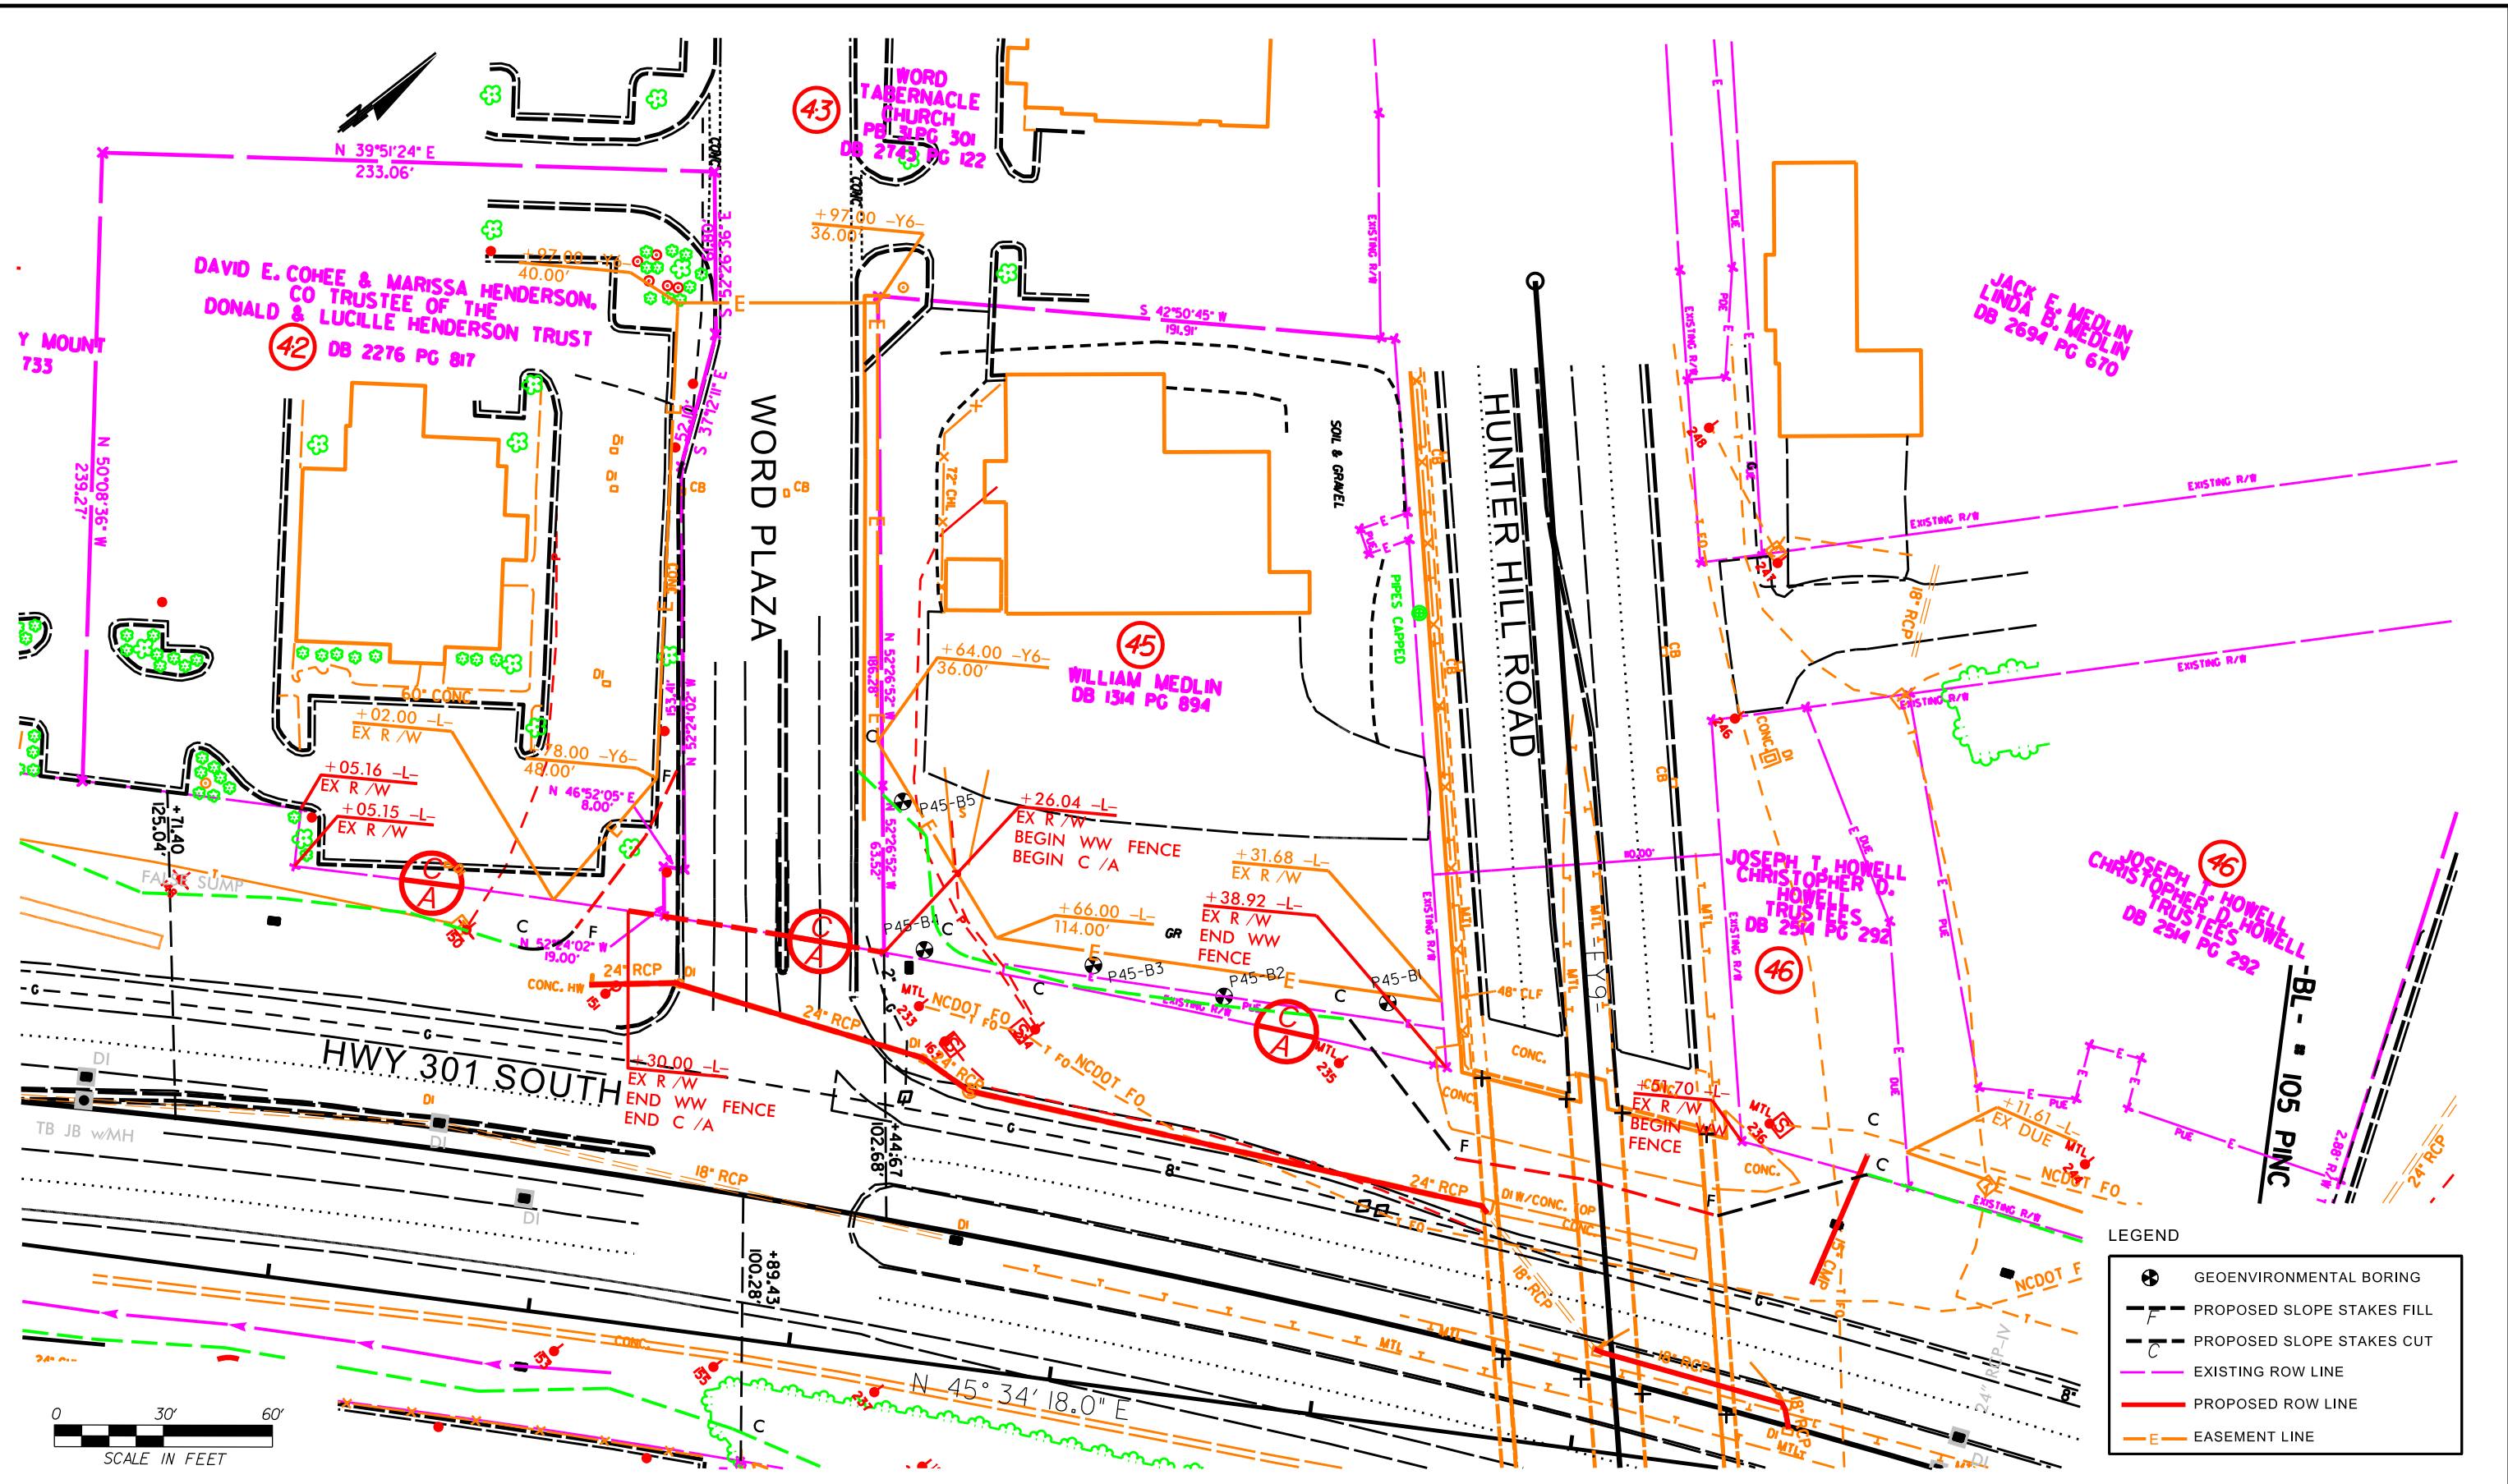
**FIGURE 2  
PARCEL 45  
SITE MAP WITH  
SOIL BORING LOCATIONS**

Site geology was observed through the drilling and sampling of five direct push probe soil borings onsite. **Figure 2** presents the boring locations and site layout. Borings did not exceed a total depth of ten feet below ground surface (bgs) since that depth was the maximum excavation depth for proposed drainage features. Soil consisting predominantly of orange to an orange and tan marbled clayey silt was observed across the parcel. Soil displayed varying degrees of moisture. Groundwater was not encountered during the assessment of this parcel. Boring logs are presented in **Appendix B**.

Apex conducted drilling activities at the site on July 27, 2015. Apex drilling subcontractor Regional Probing Services advanced five direct push soil borings within the proposed expanded NCDOT ROW. These five boring locations were placed in a pattern to maximize the likelihood of intercepting potential soil contamination. **Figure 2** presents the Site Map with boring locations and identifications.

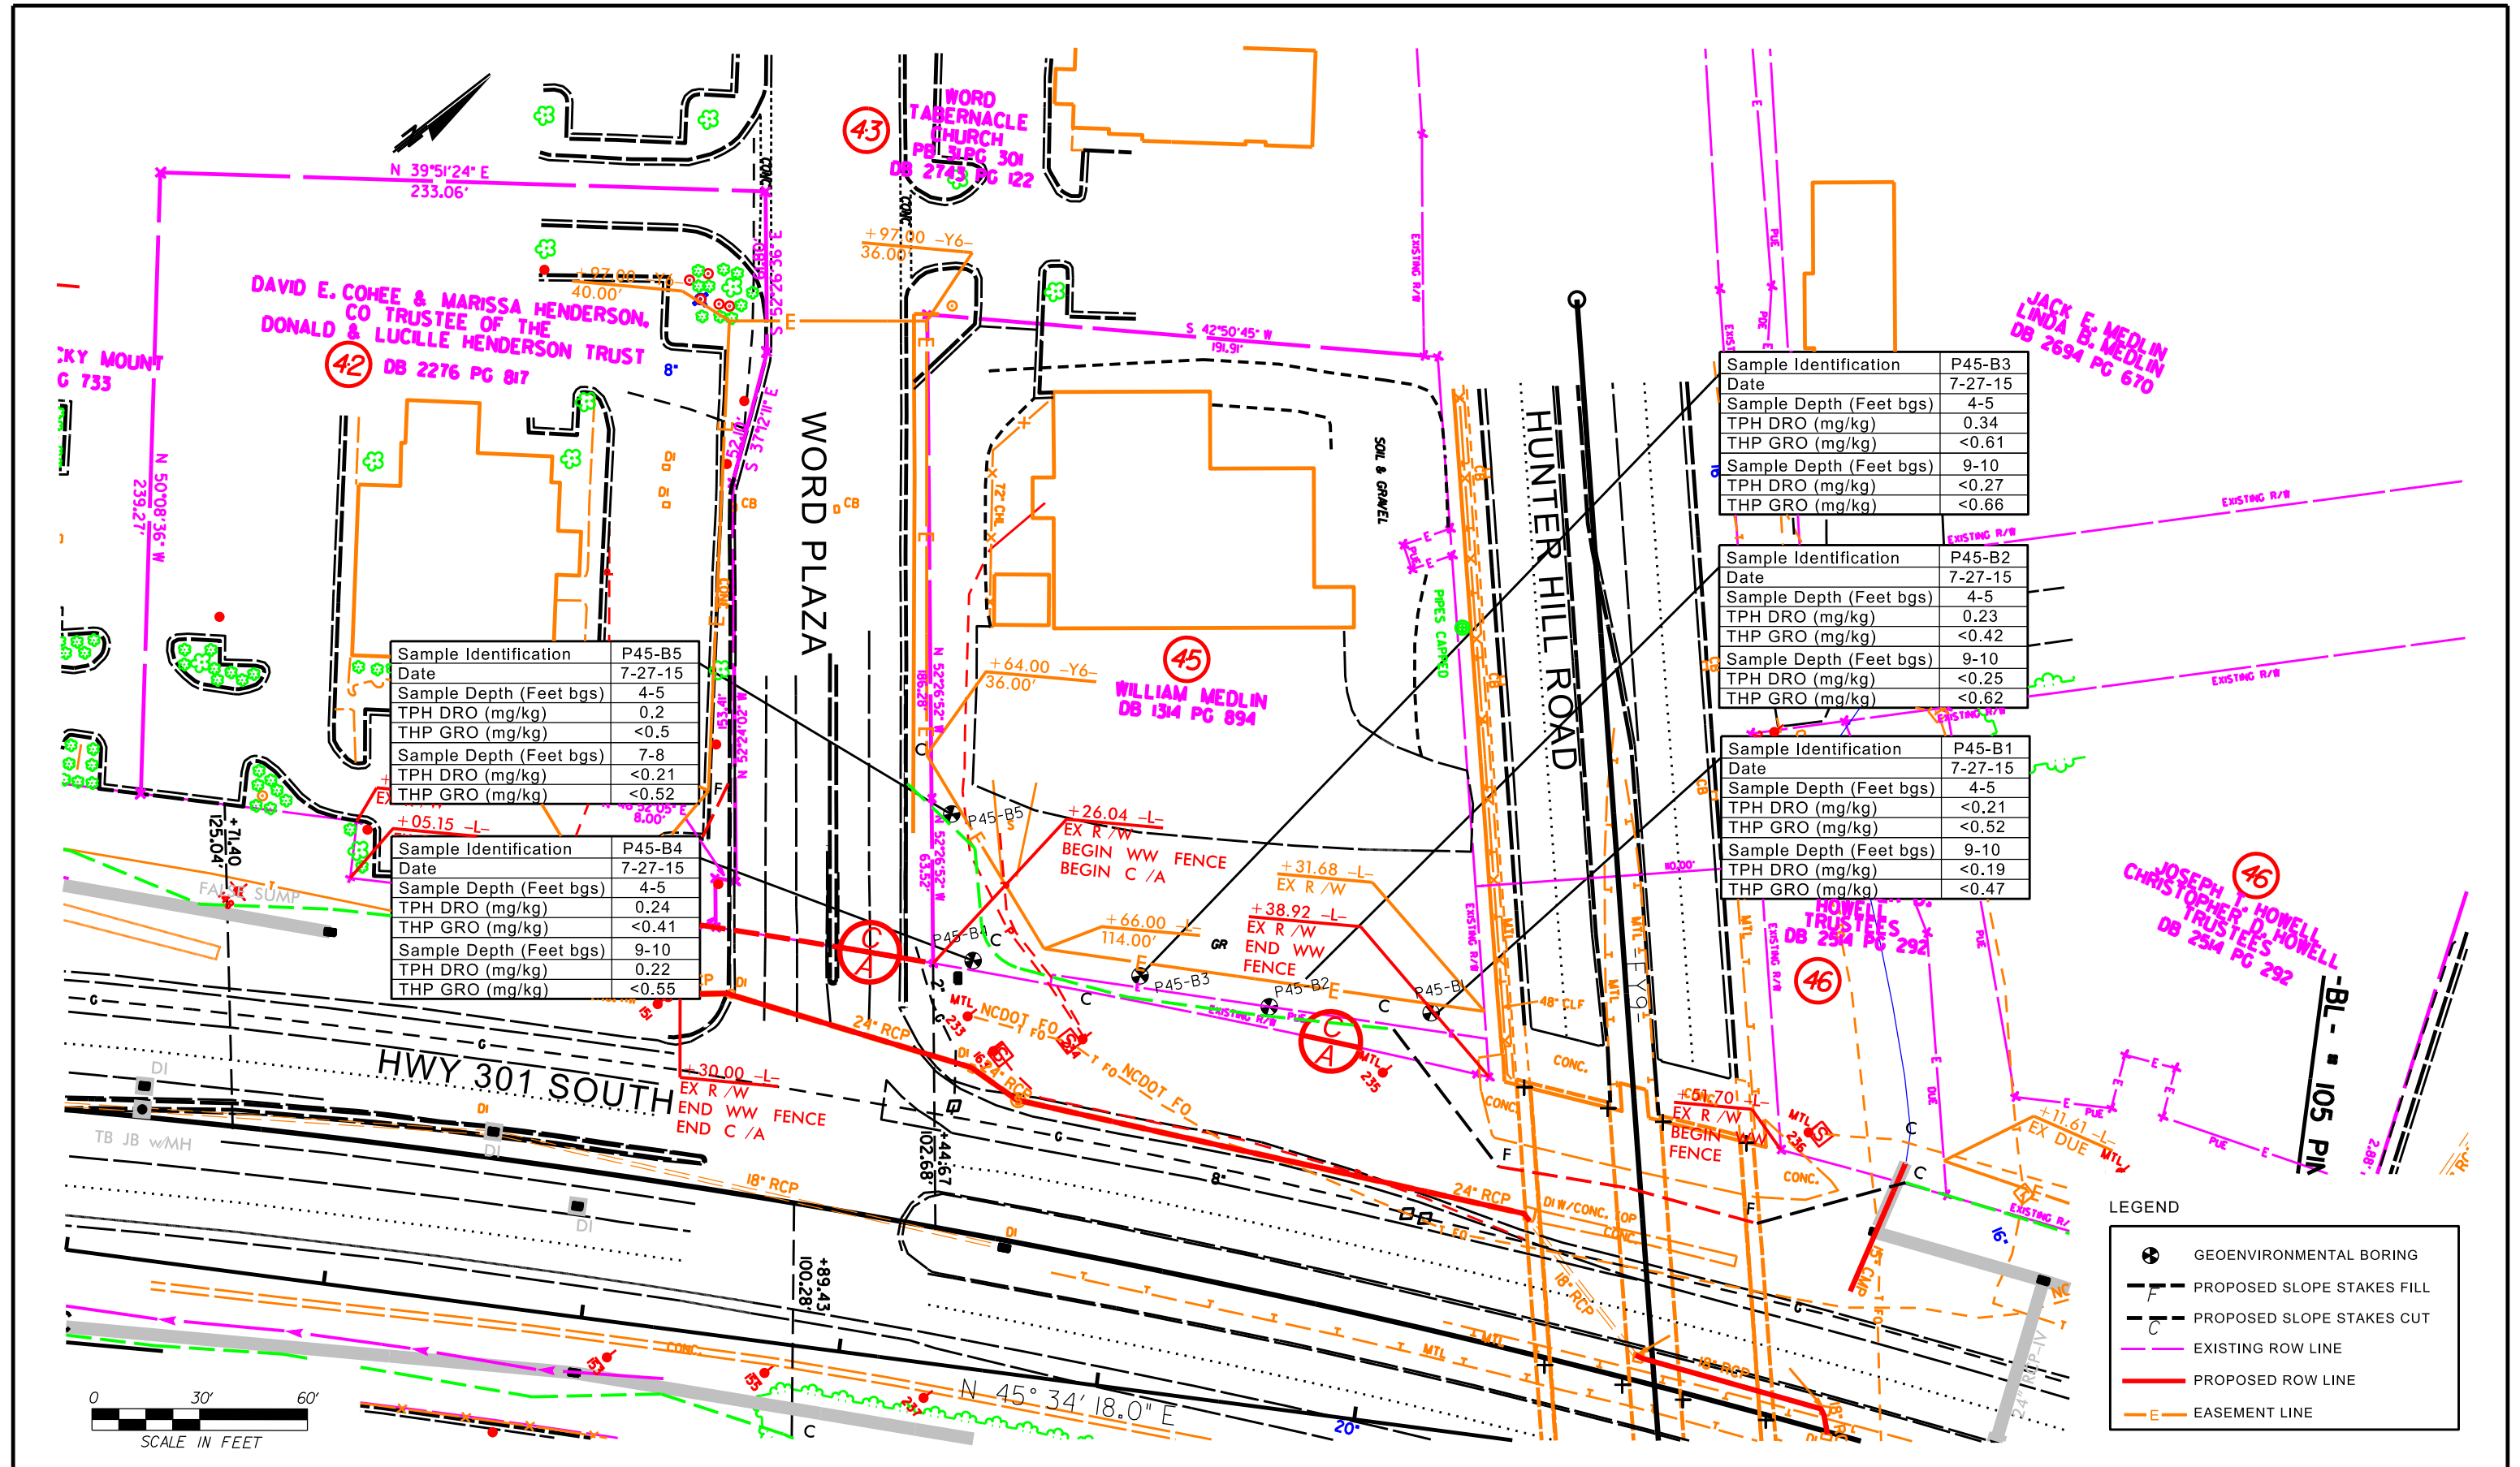
**FIGURE 3  
 PARCEL 45  
 ONSITE UVF HYDROCARBON  
 ANALYSIS RESULTS**

TPH gasoline range organics (GRO) and diesel range organics (DRO) measured using the onsite UVF unit are presented in **Table 1**, with instrument generated tables and chromatographs in **Appendix D**. **Figure 3** presents the GRO and DRO results at each boring.

Based on the UVF analyses GRO was not detected above the instrument reporting limits. DRO concentrations were identified on Parcel 45, however the concentrations do not exceed the regulatory action level of 10 milligram per kilogram (mg/kg).

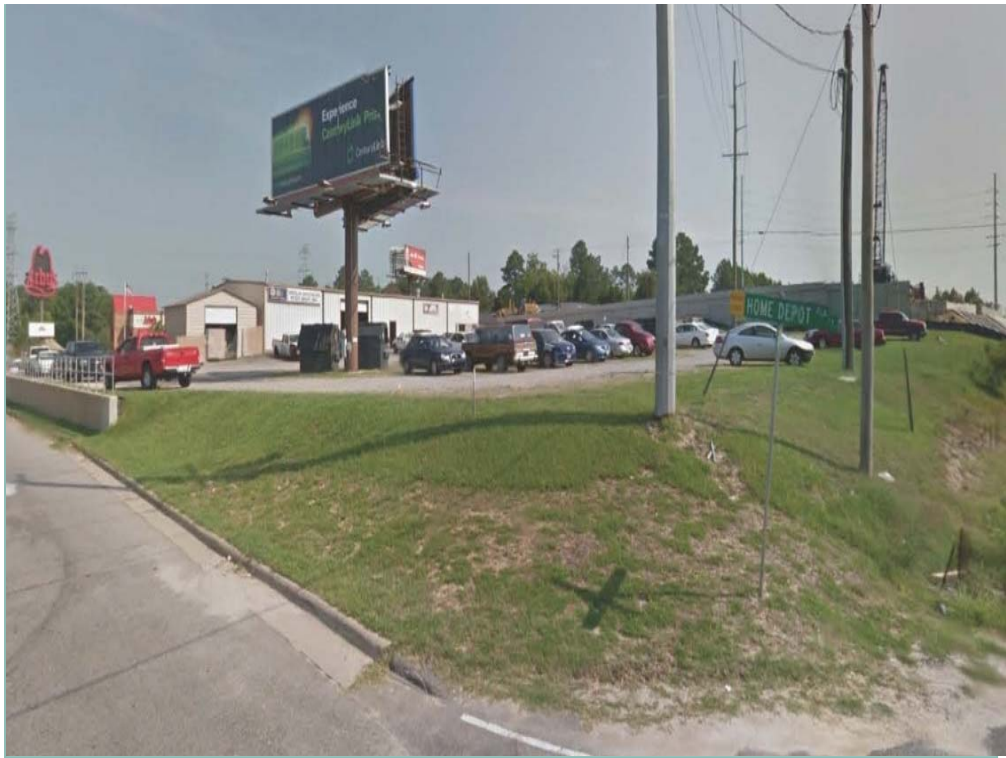
**Photo 1**

Viewing Parcel 45 Prior to Drilling Activities.

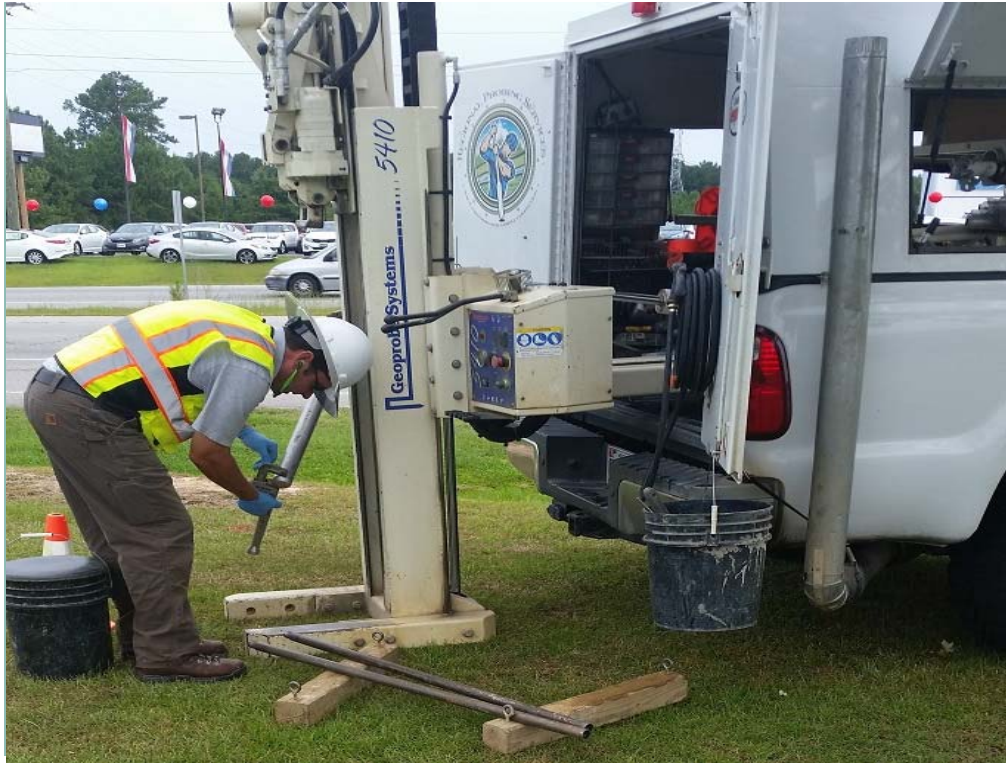
**Photo 2**

Removing the liner from a macro core.

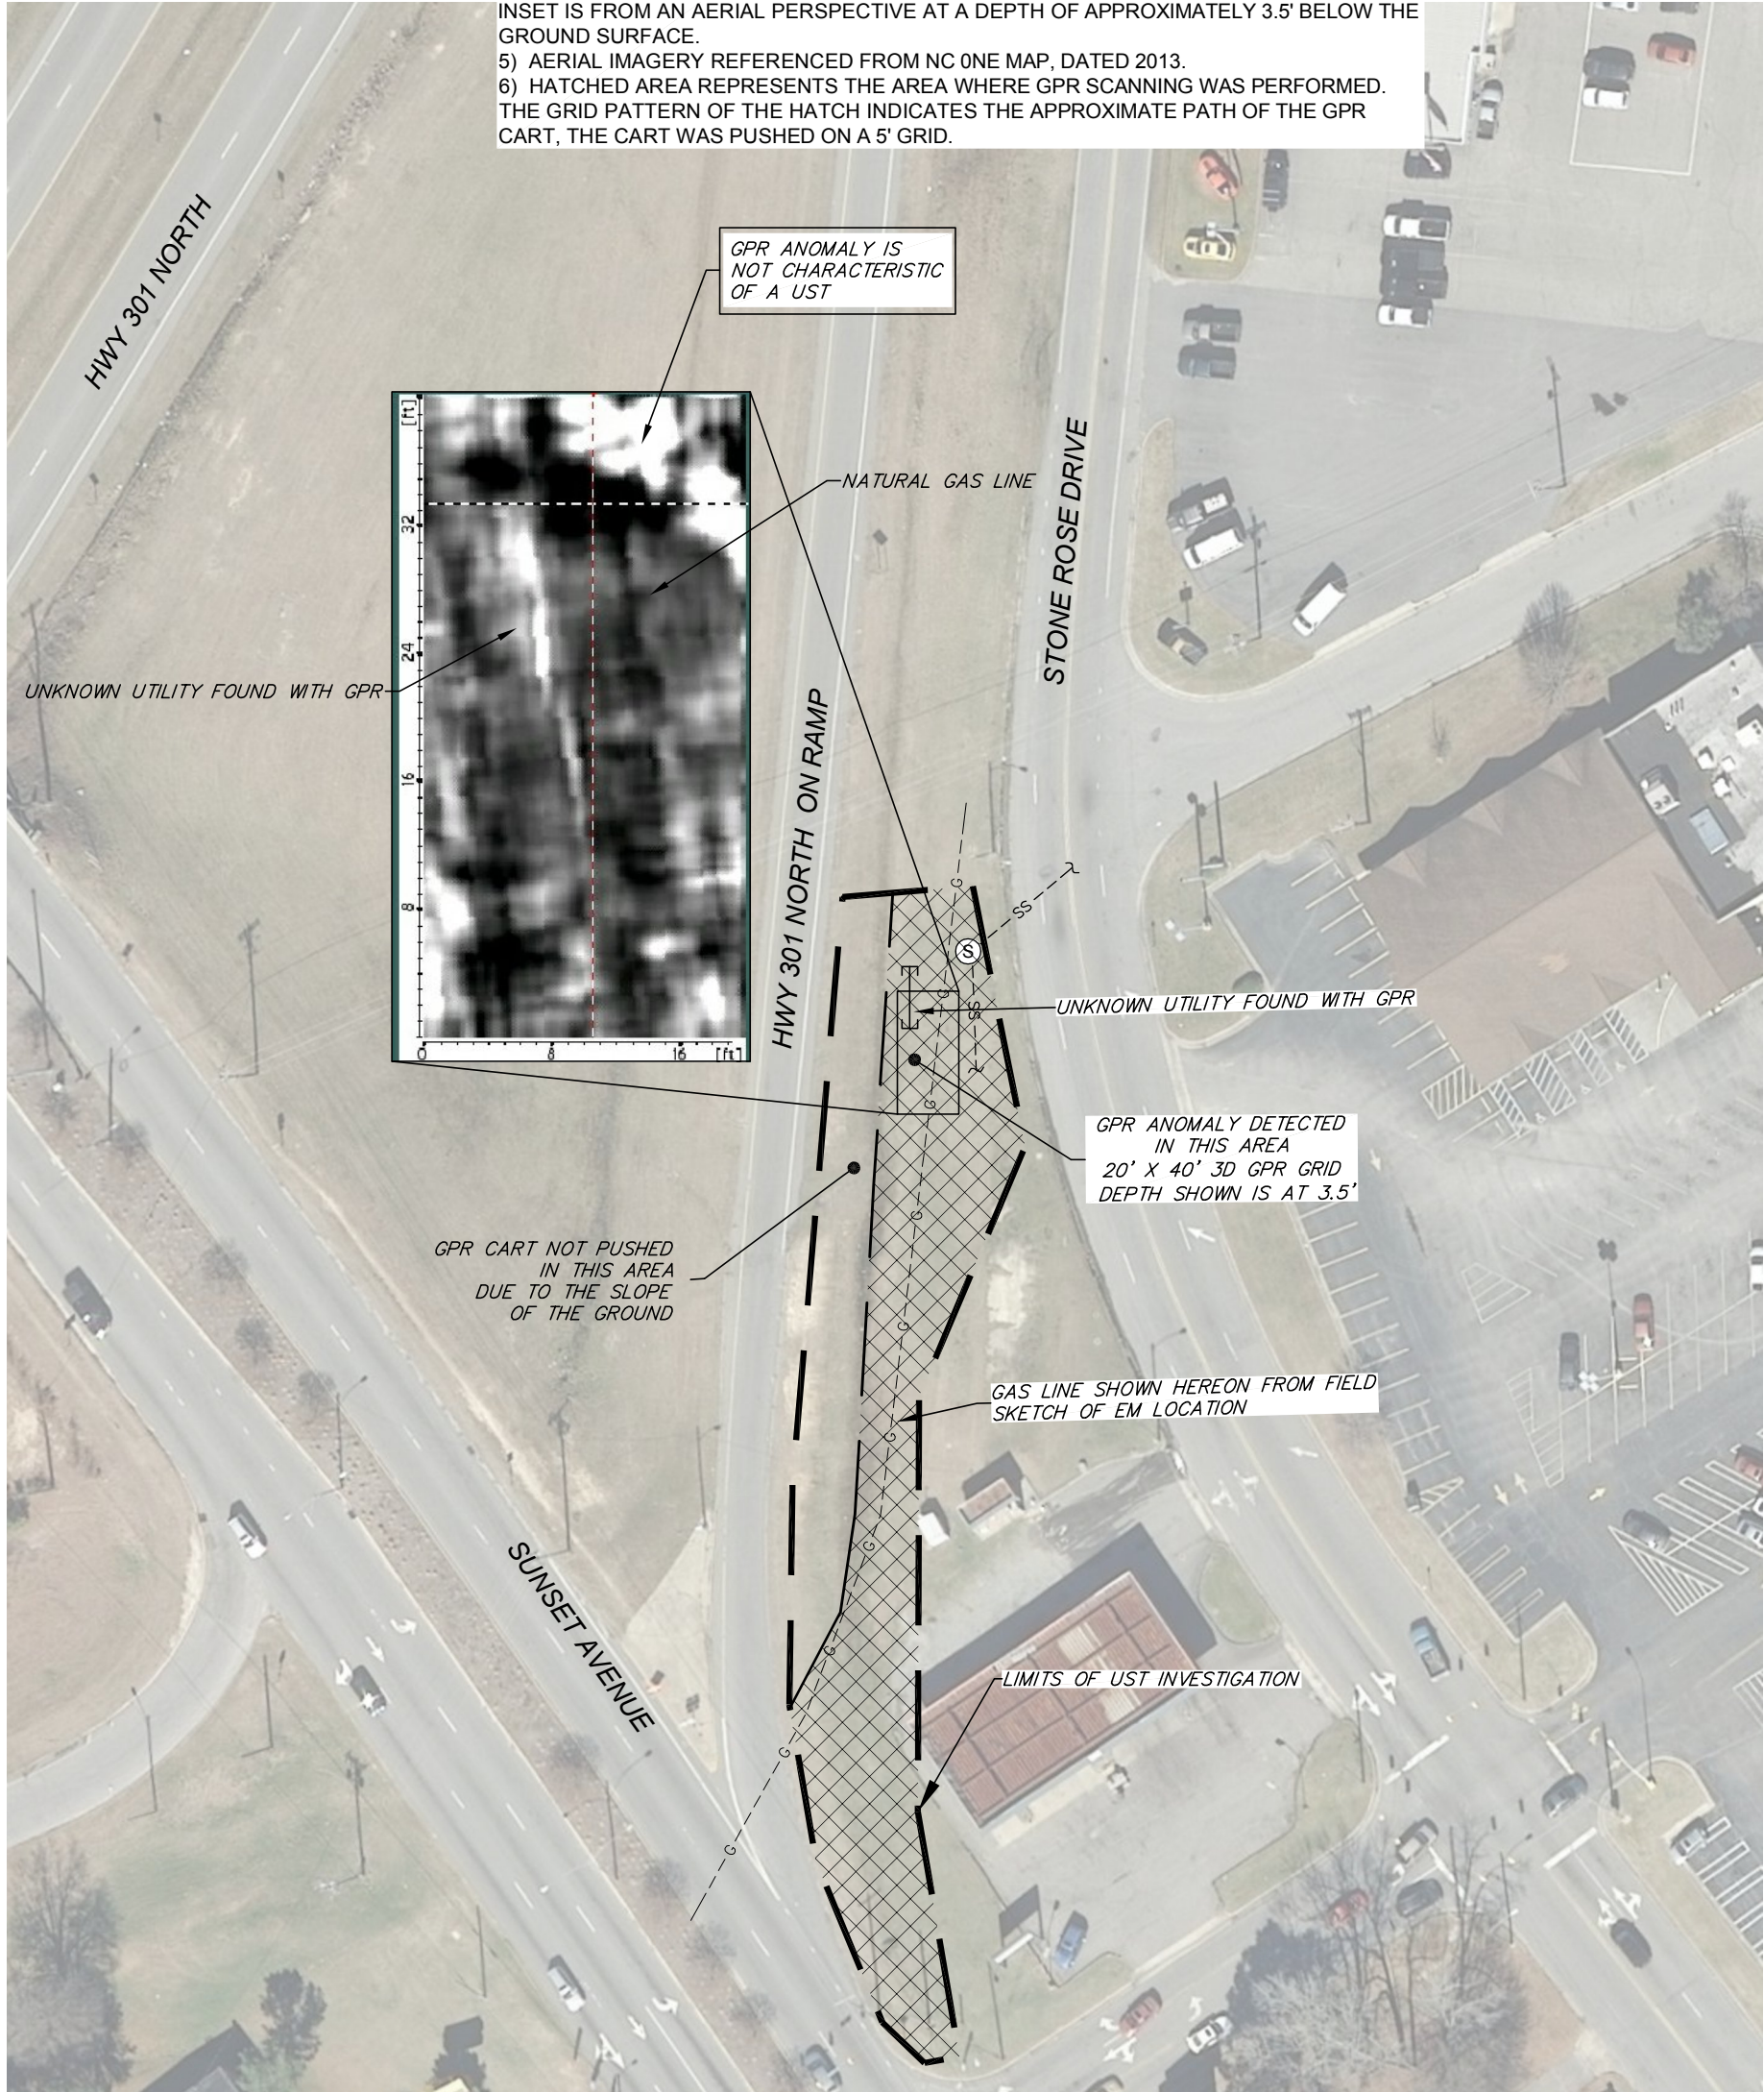
REVISIONS:	DATE OF SURVEY:	07/13/2015
	SCALE:	1" = 60'
	DRAWN BY:	J.REYNOLDS
	CHECKED BY:	C. HOWARD PLS
	PROJECT:	70668.5002.00
FIGURE #:	1	SHEET: 1 / 1

Parcel 20 (refer to Figure 1) is the only parcel where the GPR detected an anomaly. The anomaly was not characteristic of a UST and has been duly noted that way on the Figure.

- 4) THERE WAS ONE AREA WITHIN THE LIMITS, THAT THE GPR FOUND AN ANOMALY. THE INSET IS FROM AN AERIAL PERSPECTIVE AT A DEPTH OF APPROXIMATELY 3.5' BELOW THE GROUND SURFACE.

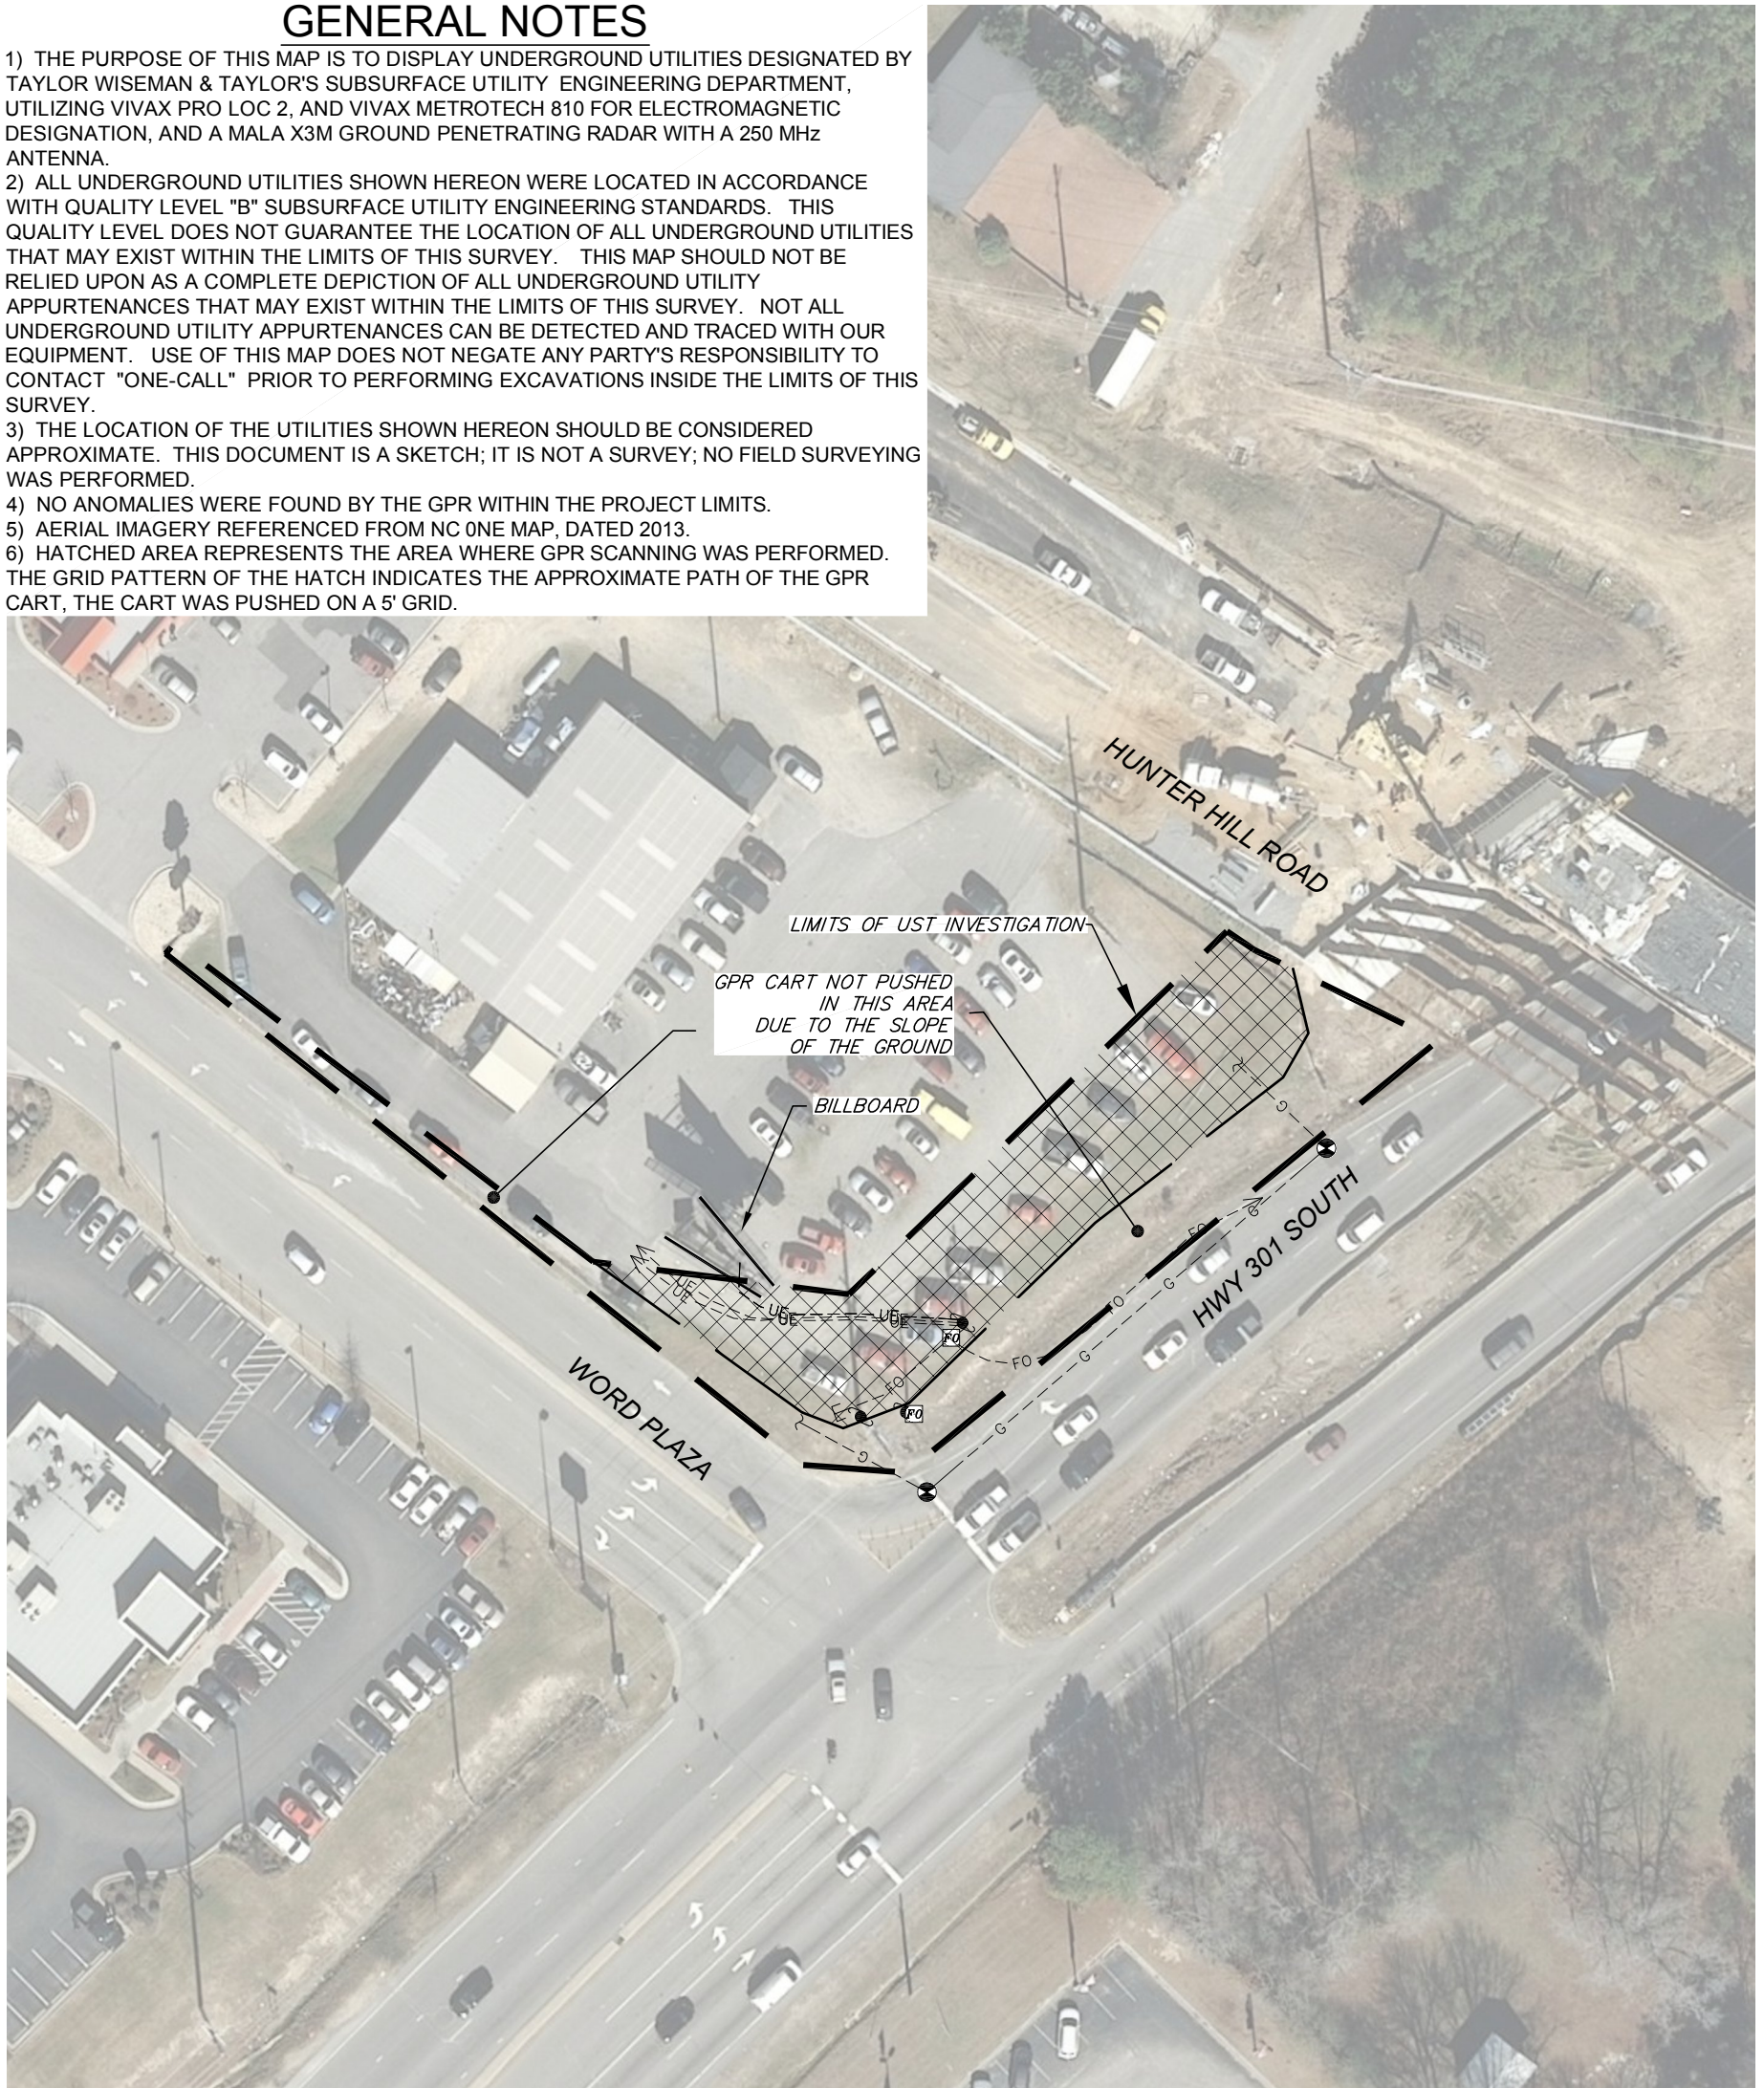
REVISIONS:	DATE OF SURVEY:	07/13/2015
	SCALE:	1" = 60'
	DRAWN BY:	J.REYNOLDS
	CHECKED BY:	C. HOWARD PLS
	PROJECT:	70668.5002.00
FIGURE #:	<b>3</b>	SHEET: <b>1 / 1</b>

The geophysical survey of the site occurred the week of July 13<sup>th</sup>, 2015. TWT performed an electromagnetic (EM) survey followed by ground penetrating radar (GPR) survey. Their Geophysical Report is presented in **Appendix C**. No unknown EM features were identified.

- 4) NO ANOMALIES WERE FOUND BY THE GPR WITHIN THE PROJECT LIMITS.
- 5) AERIAL IMAGERY REFERENCED FROM NC ONE MAP, DATED 2013.
- 6) HATCHED AREA REPRESENTS THE AREA WHERE GPR SCANNING WAS PERFORMED. THE GRID PATTERN OF THE HATCH INDICATES THE APPROXIMATE PATH OF THE GPR CART, THE CART WAS PUSHED ON A 5' GRID.
