Preliminary Site Assessment Report

Bishop Partners Property (Golden Corral) Parcel # 49 921 N Wesleyan Blvd (aka 921 S Wesleyan Blvd) Rocky Mount, Nash County, North Carolina Rocky Mounty –US 301 Bypass from NC 43-48 (Benvenue Rd.) to SR 1836 TIP Number: U-3330 WBS Element: 36596.1.1

October 2, 2015

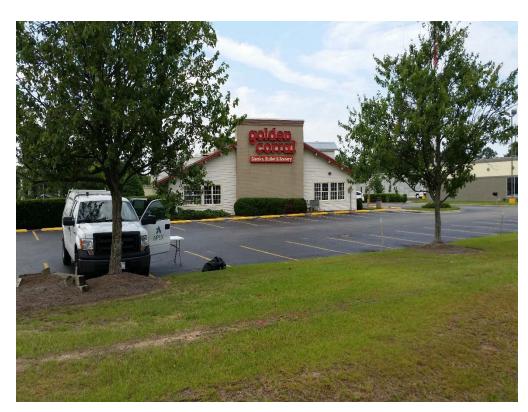
Photo 1

Viewing Parcel 49 Prior to Drilling Activities.

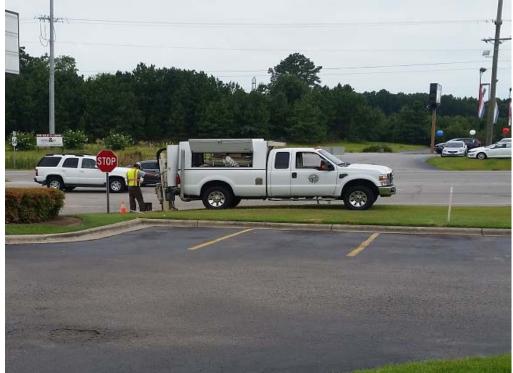
Photo 2

Viewing truck mounted geoprobe as drilling activities begin.

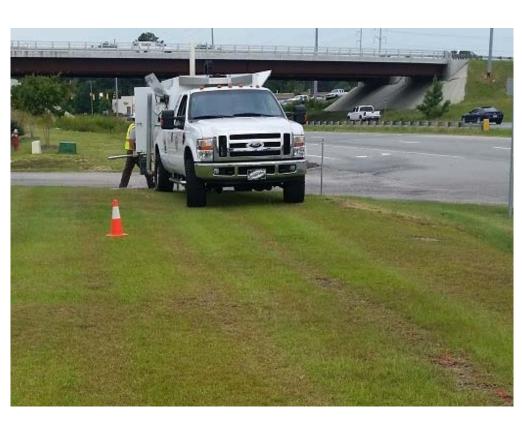
Photo 3

Viewing a portion of the investigation area. Cone is placed on a predetermined boring location.

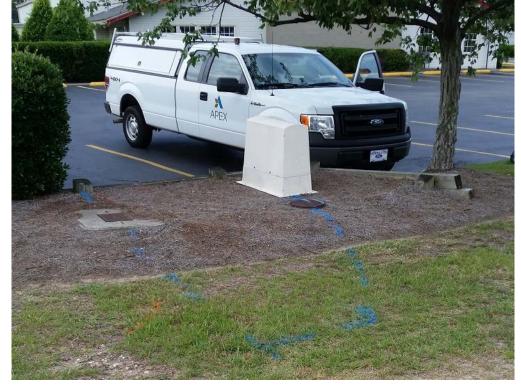
Photo 4

Photo is of utilities which cross the proposed drainage feature.
