Preliminary Site Assessment Report

State Project: B-5864

Brown's Creek Baptist Church Property

Parcel #012

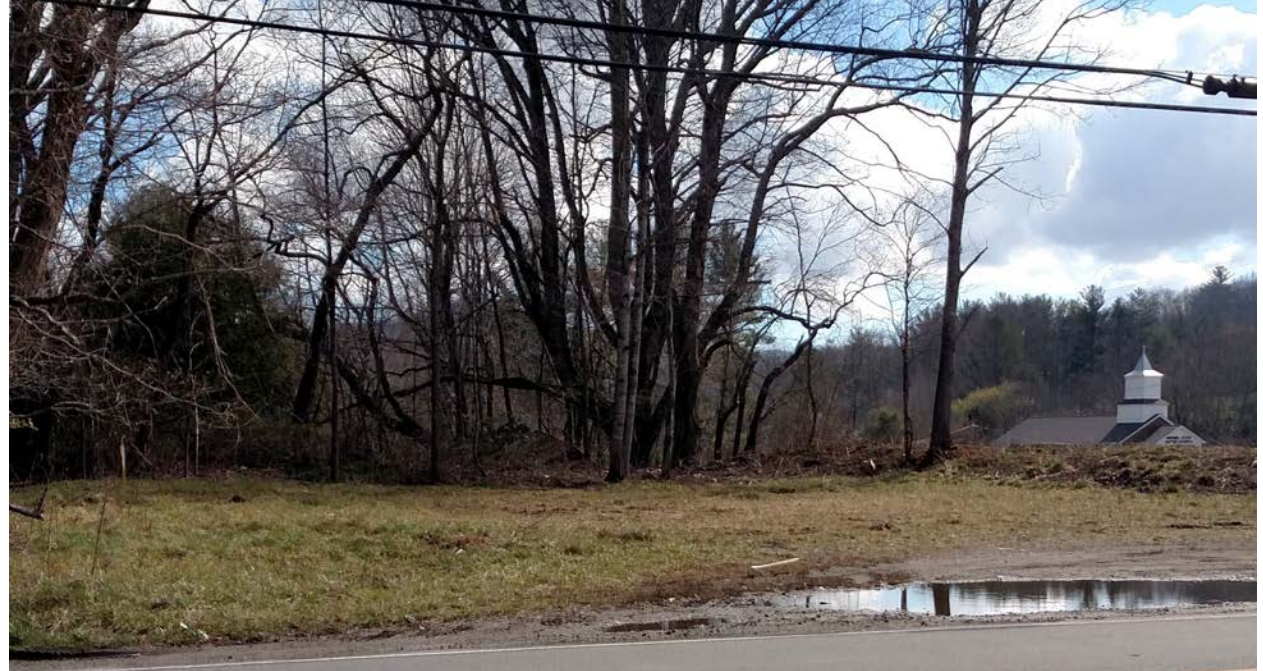
View to the east showing empty lot and gravel drive at Parcel #012.

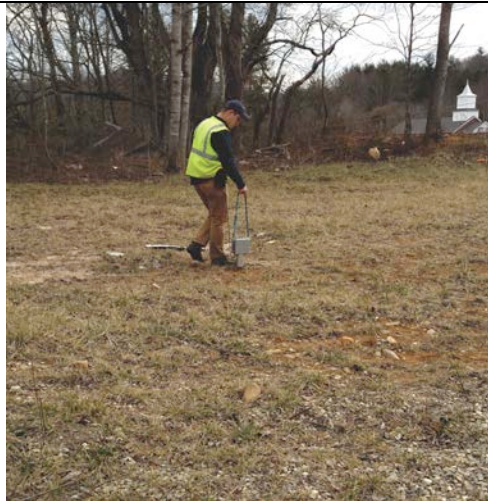
Magnetometer data collection in Grid 1 across the footprint of the former building.

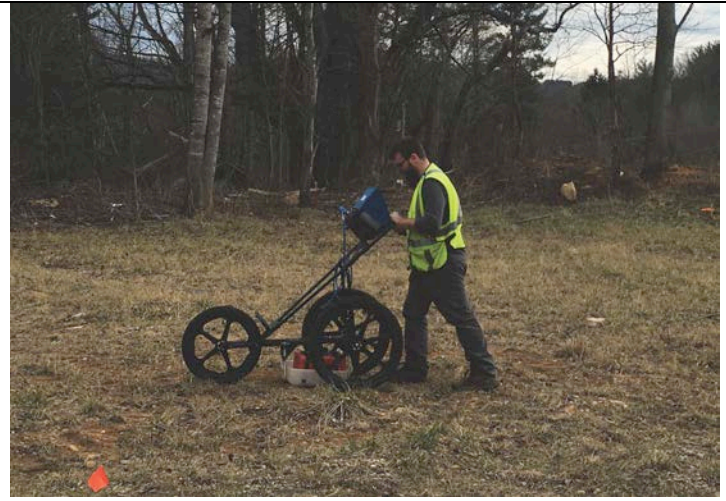
GPR data collection in Grid 1 across the footprint of the former building.
