**RE: PRELIMINARY SITE ASSESSMENT OF PARCEL 20
ESP Project No. CS34.358**

WBS: 38389.1.1
TIP: B-4491
County: Cumberland
Description: Replace Bridge 22 over I-95B/US 301 on NC 59
Parcel No.: 20
Address: 4933B S. Main St., Hope Mills, NC 28348

**FIGURE 1 – PARCEL 20
SITE VICINITY MAP**

**B-4491, REPLACE BRIDGE 22 OVER I-95B/US 301 ON NC 59
CUMBERLAND COUNTY, NORTH CAROLINA**

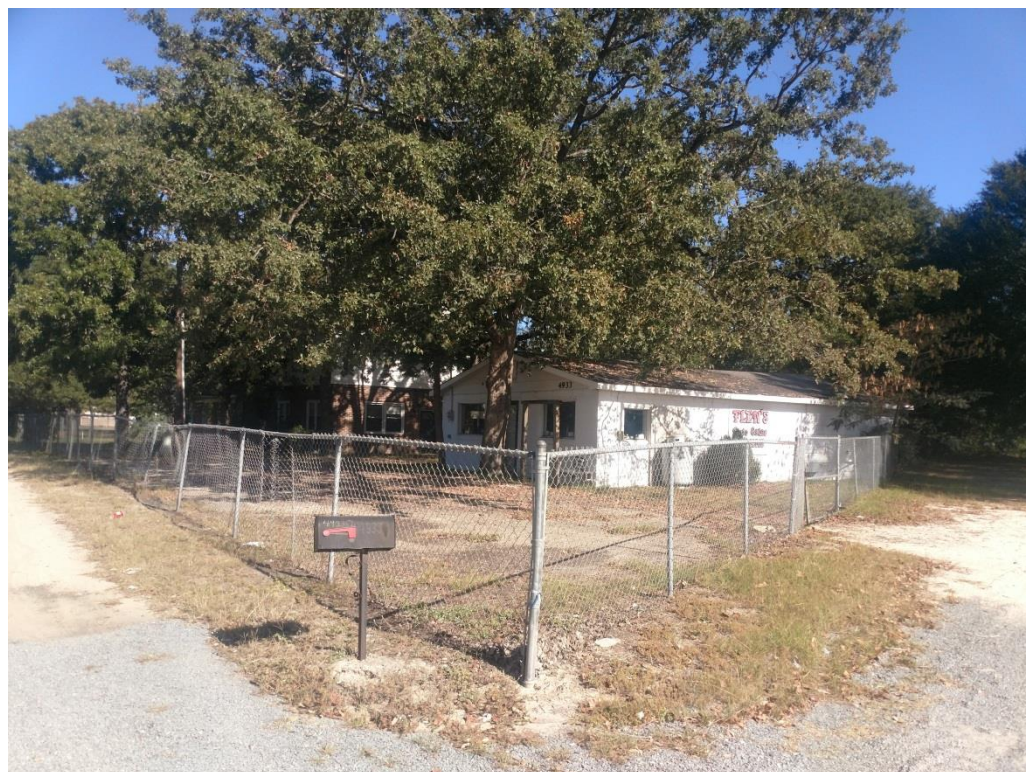
During our October 2017 field work, the site was operating as a vacant used car lot (Figure 2). The ground in the study area was covered by gravel and grass.

a. Photo from southeast side of site looking northwest.

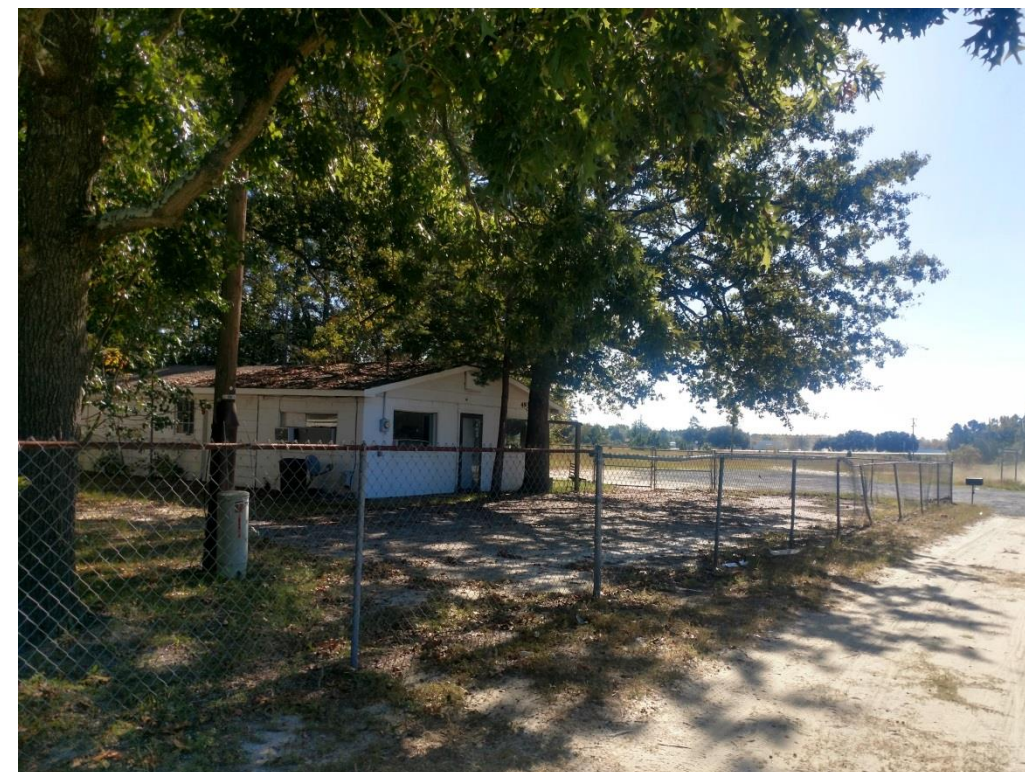
b. Photo from west side of site looking east.

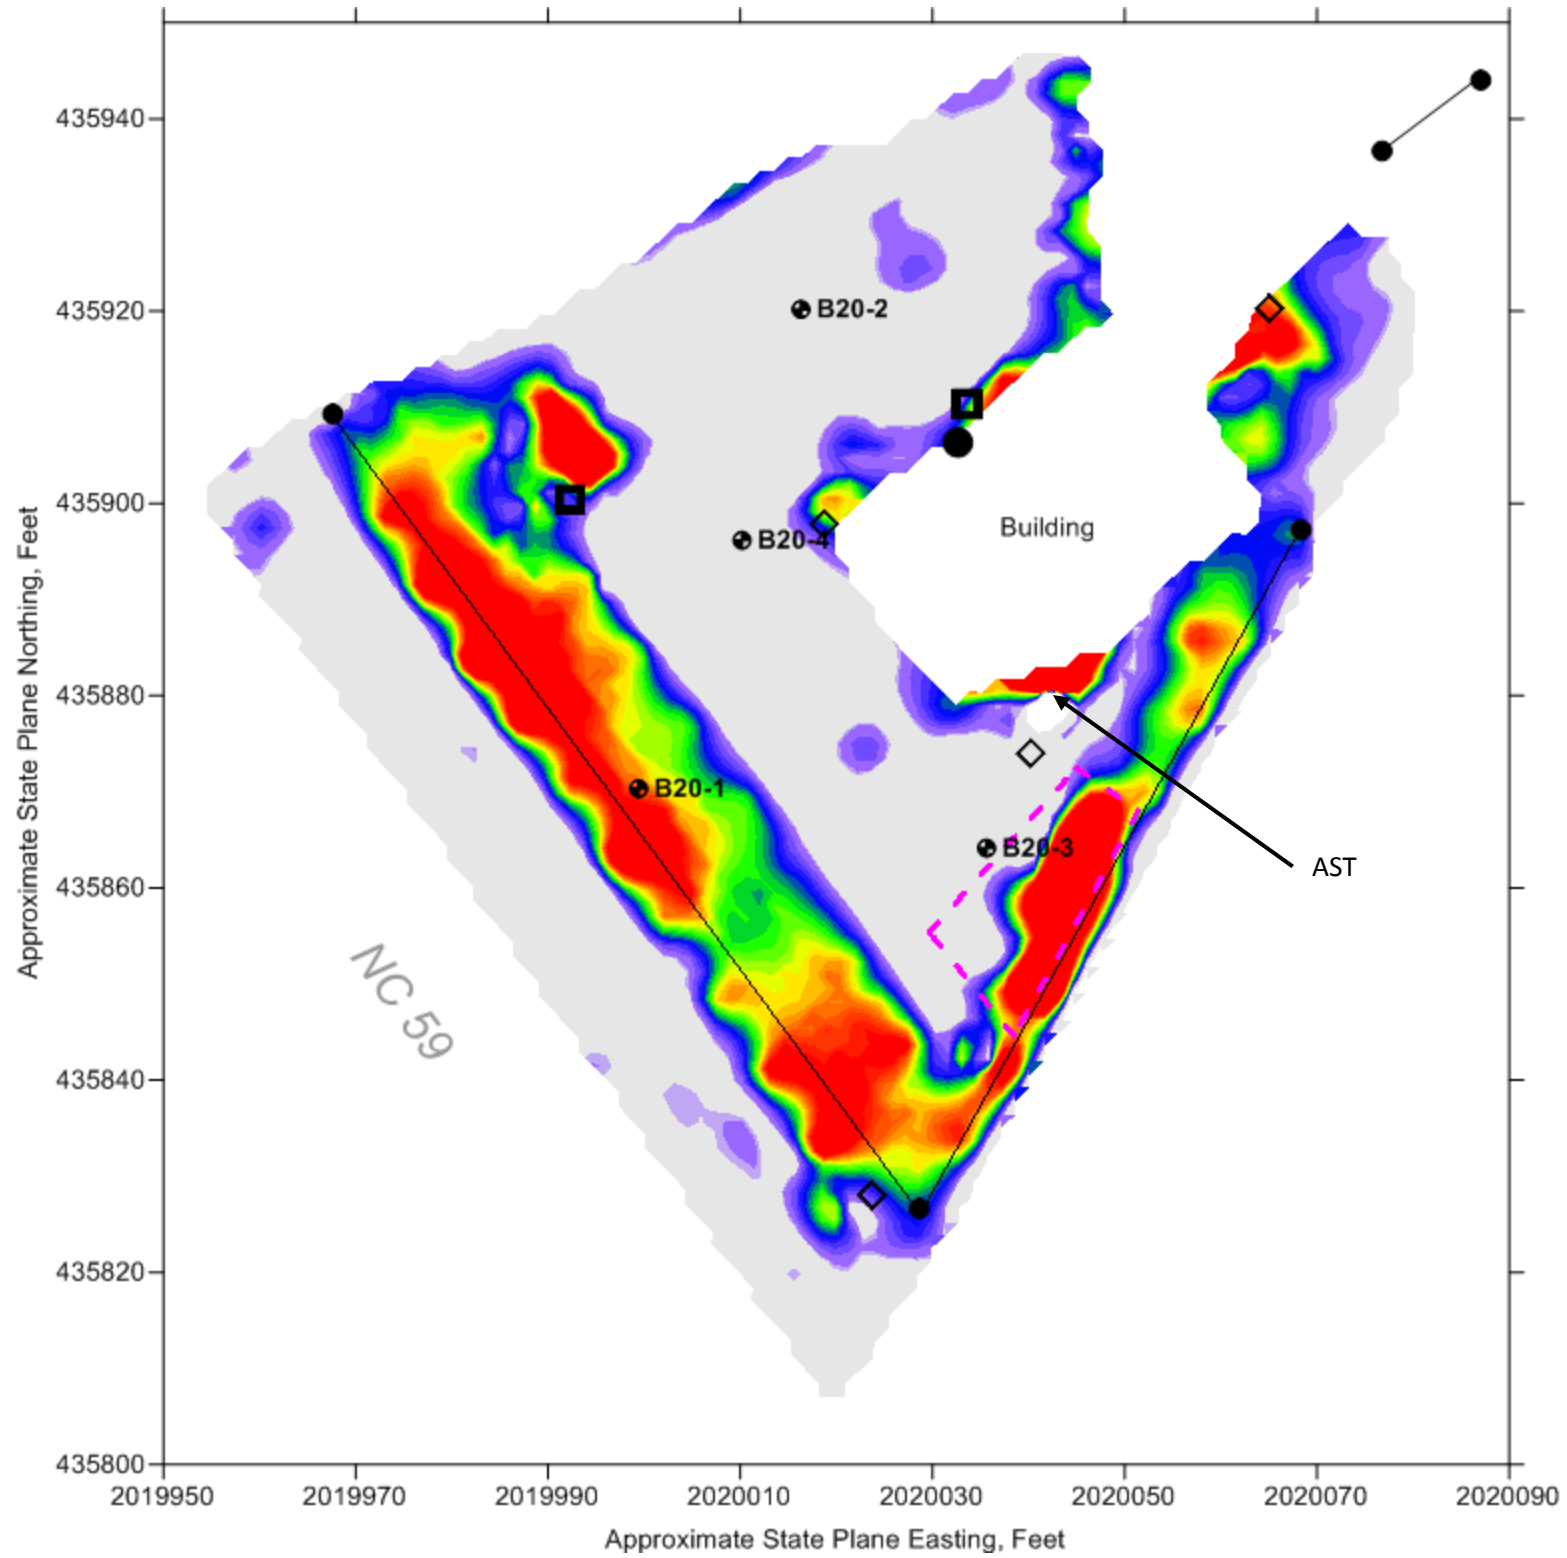
FIGURE 3 – PARCEL 20
EM61 EARLY TIME GATE RESPONSE
B-4491, REPLACE BRIDGE 22 OVER I-95B/US 301 ON NC 59
CUMBERLAND COUNTY, NORTH CAROLINA

ESP performed a metal detector study over the accessible areas of the site using a Geonics EM61 MK2 with a line spacing of about three feet (Figures 3 and 4). Location control was provided in real-time using a sub-meter differential global positioning system (DGPS). We collected ground-penetrating radar (GPR) data over EM61 anomalies using our Sensors and Software Noggin 250 GPR system. The GPR data were collected using a line spacing of one to two feet.

The EM61 early time gate data show the response from both shallow and deeper metallic objects (Figure 3). The differential response reduces the effect of shallow anomalies and emphasizes anomalies from larger and more deeply buried metallic objects, such as USTs (Figure 4). The EM61 differential results indicated one anomaly (response above background) that could represent a buried UST(s).

GPR data were collected over the EM61 anomaly. The GPR data collected did not indicate the presence of unknown USTs within the study area.

The geophysical data do not indicate the presence of abandoned USTs.
