**RE: PRELIMINARY SITE ASSESSMENT OF PARCEL 27
ESP Project No. CS34.358**

WBS: 38389.1.1
TIP: B-4491
County: Cumberland
Description: Replace Bridge 22 over I-95B/US 301 on NC 59
Parcel No.: 27
Address: 5211 Red Maple Ln., Hope Mills, NC 28348

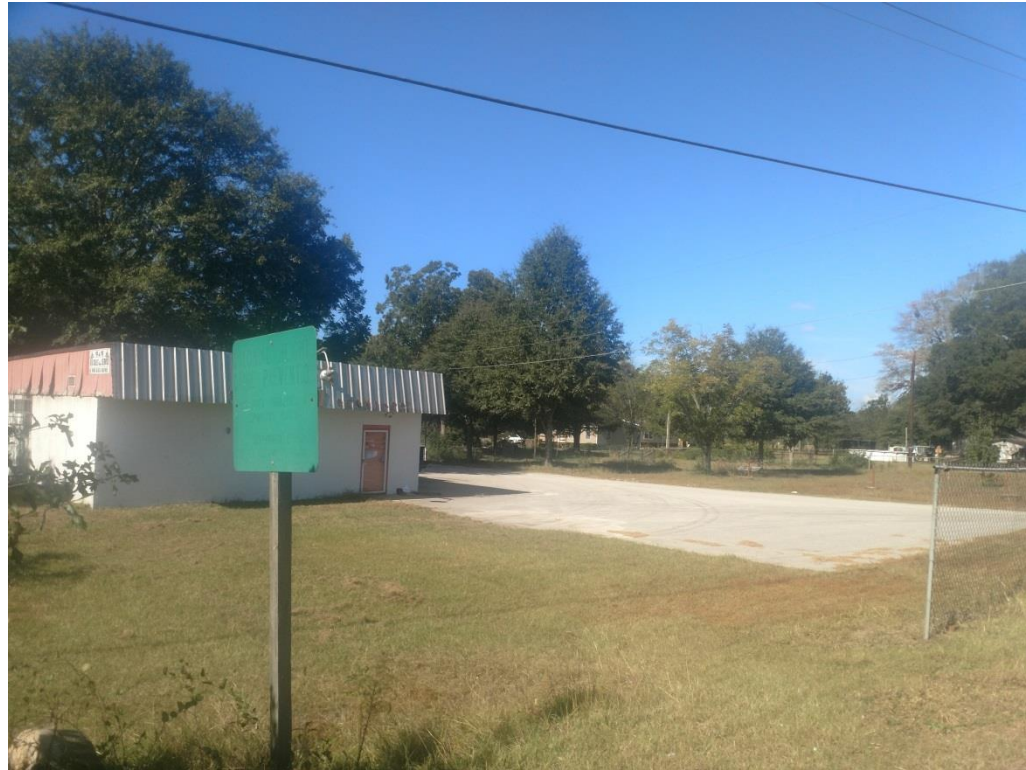
During our October 2017 field work, the site was operating as a vacant motorcycle repair shop (Figure 2). The ground in the study area was covered by asphalt and grass.

a. Photo from east side of site looking west.

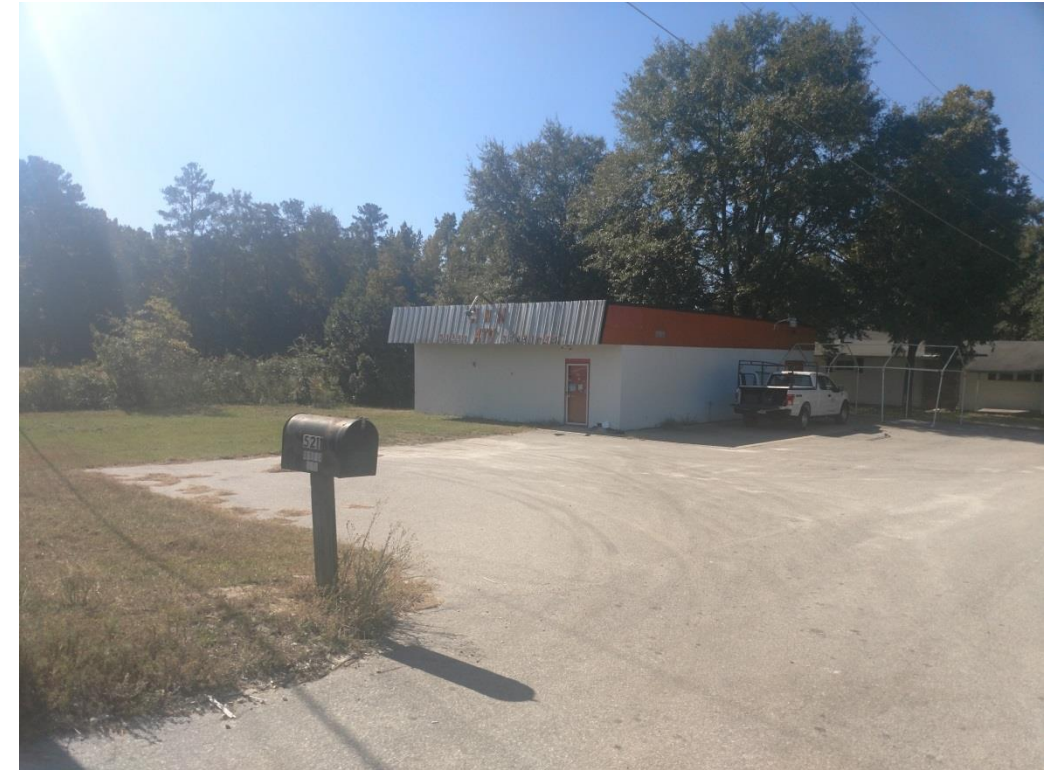
b. Photo from north side of site looking south.

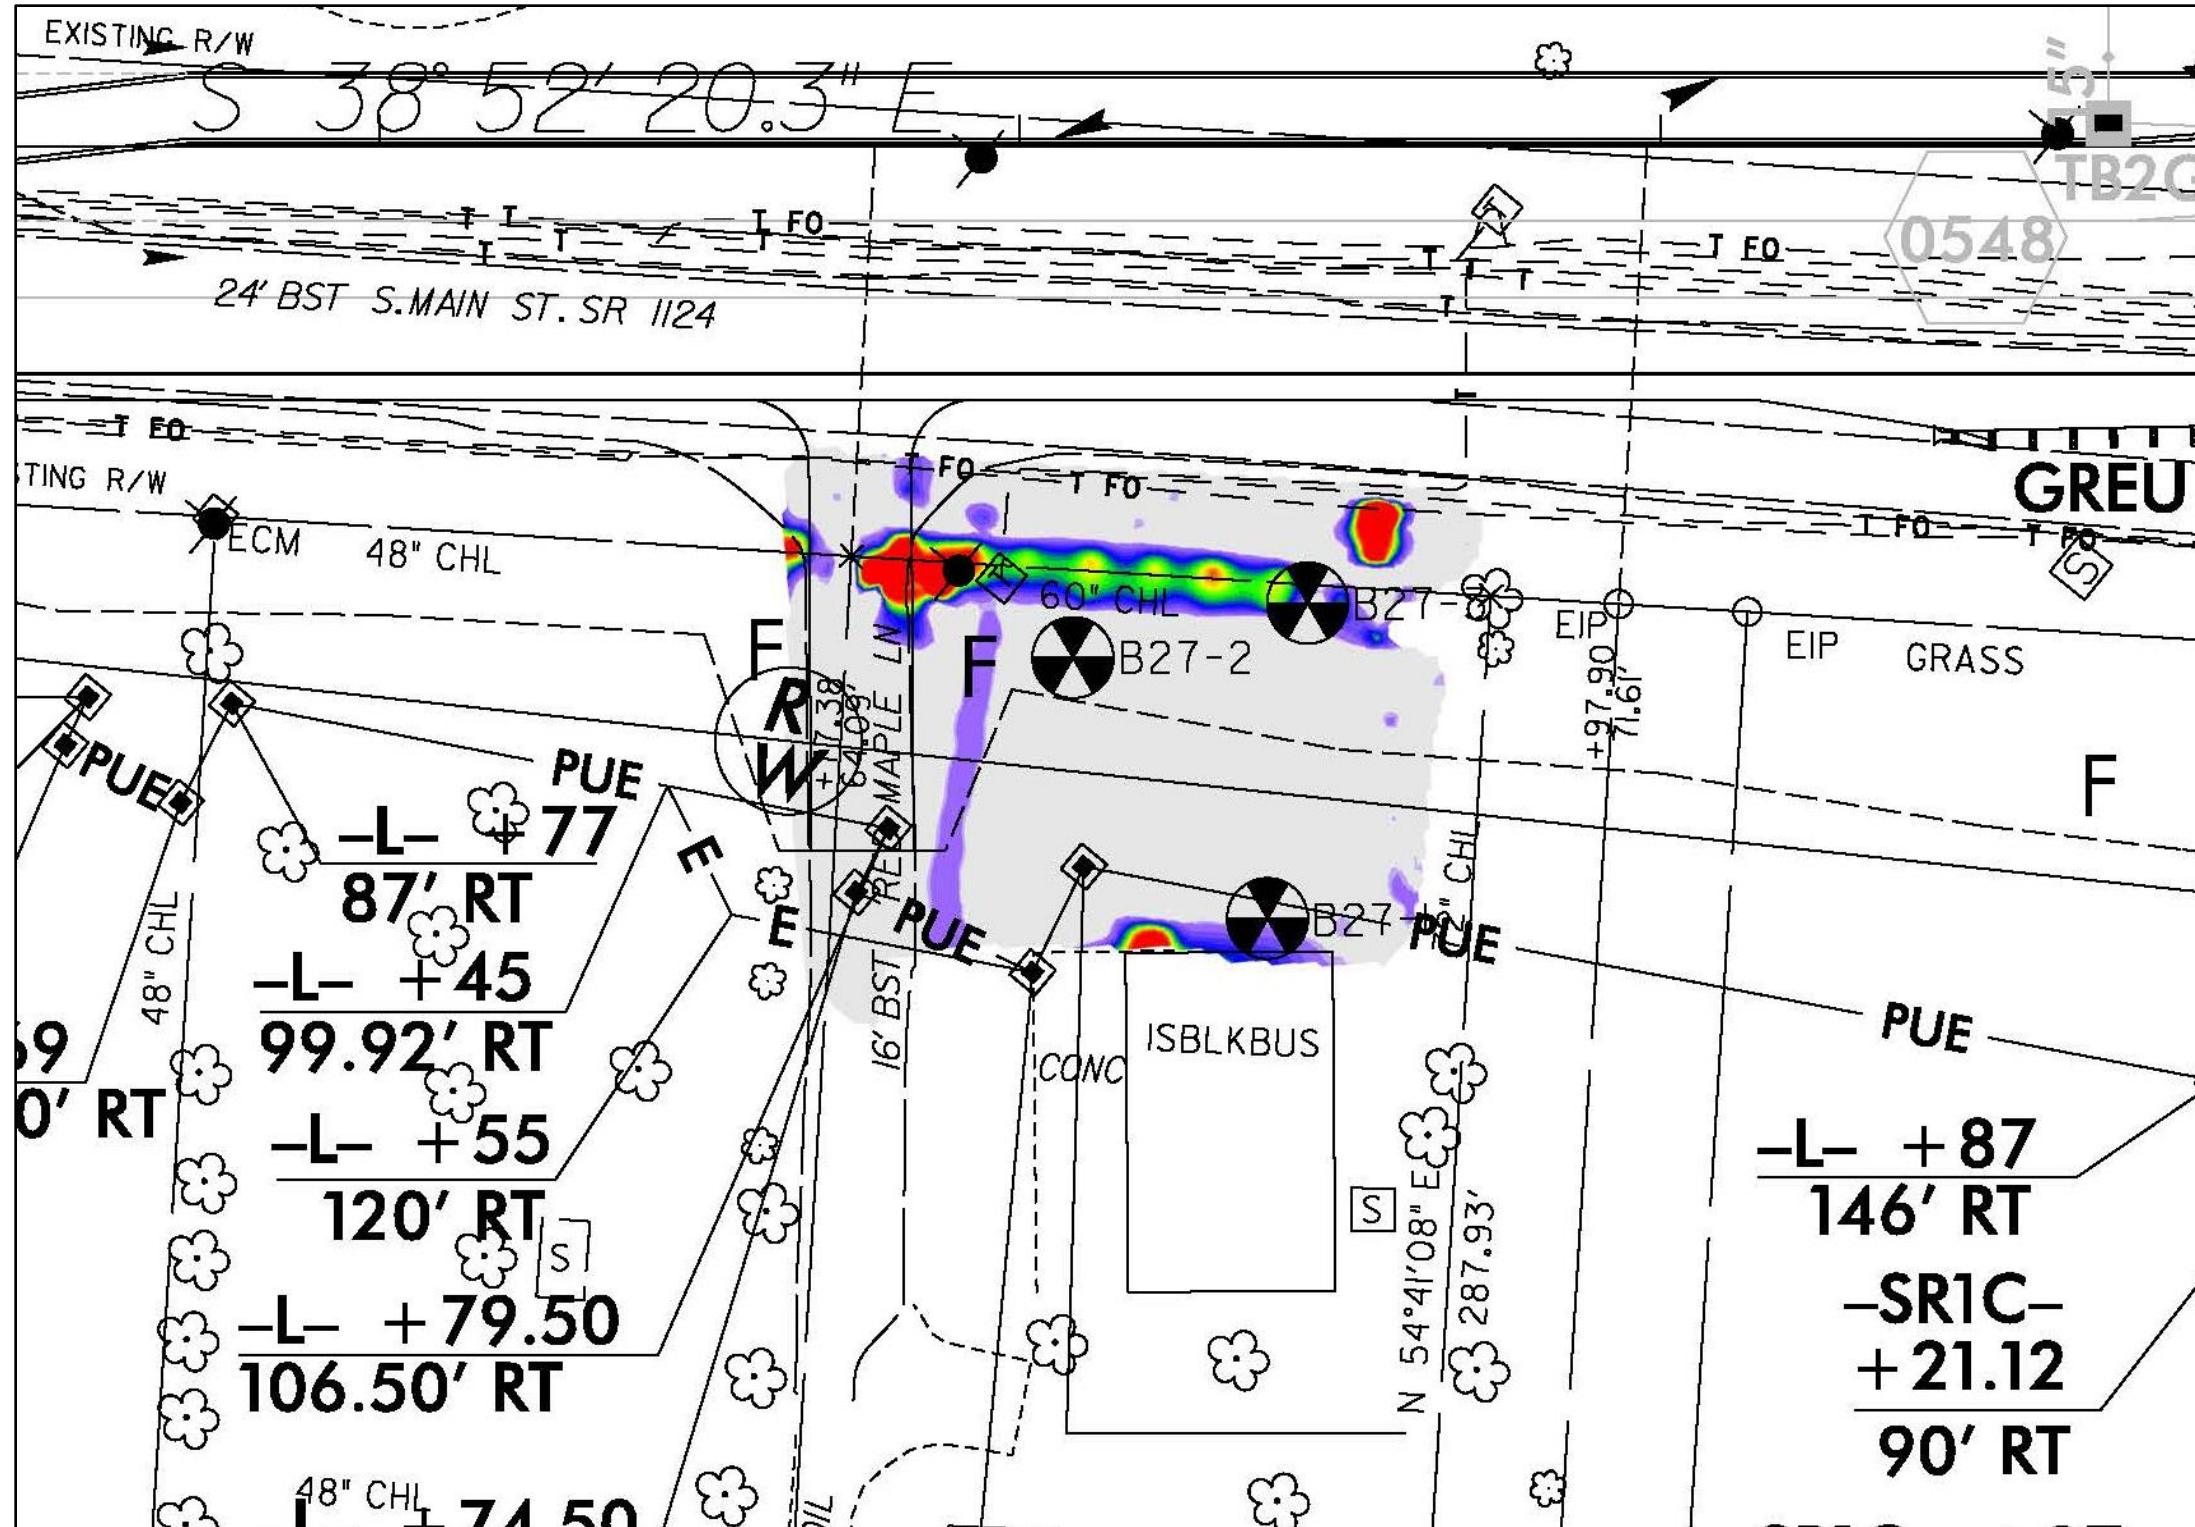
FIGURE 5 – PARCEL 27	
EM61 EARLY TIME GATE RESPONSE ON PLAN SHEET	
B-4491, REPLACE BRIDGE 22 OVER I-95B/US 301 ON NC 59	
CUMBERLAND COUNTY, NORTH CAROLINA

The EM61 early time gate response and differential response are shown on the plan sheet on Figures 5 and 6, respectively.
