Pyramid Environmental & Engineering, P.C. Project # 2013-278
Preliminary Site Assessment (PSA) – Parcel 33, Fast Track Properties, Inc.

PRELIMINARY SITE ASSESSMENT
PARCEL 33, FAST TRACK PROPERTIES, INC.
2015 U.S. HIGHWAY 1 NORTH
ROCKINGHAM, RICHMOND COUNTY, NORTH CAROLINA
STATE PROJECT: R-2501C
WBS ELEMENT: 34437.1.1
JANUARY 21, 2014

PARCEL 033 – FAST TRACK PROPERTIES
2015 N. US 1
NCDOT PROJECT R-2501C (34437.1.1)

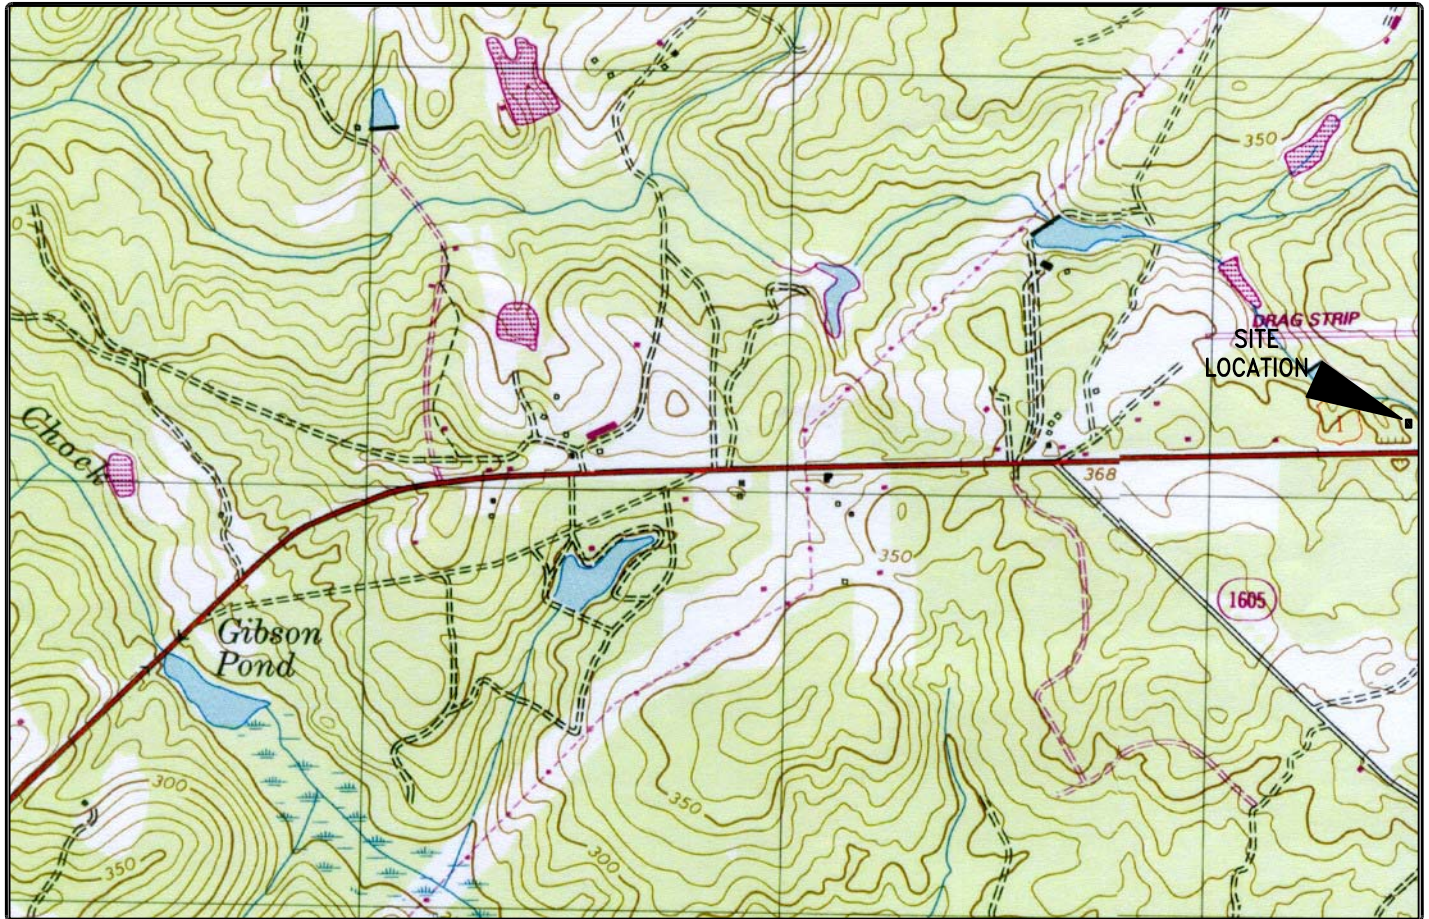
FIGURE NUMBER:
 1

The purpose of this assessment was to determine the presence or absence of underground storage tanks (USTs) and the potential for impacted soils at the subject properties within the proposed ROW and/or easement and edge of pavement (State Project R-2501C). The location of the subject site is shown on **Figure 1**.

TITLE: TOPOGRAPHIC MAP

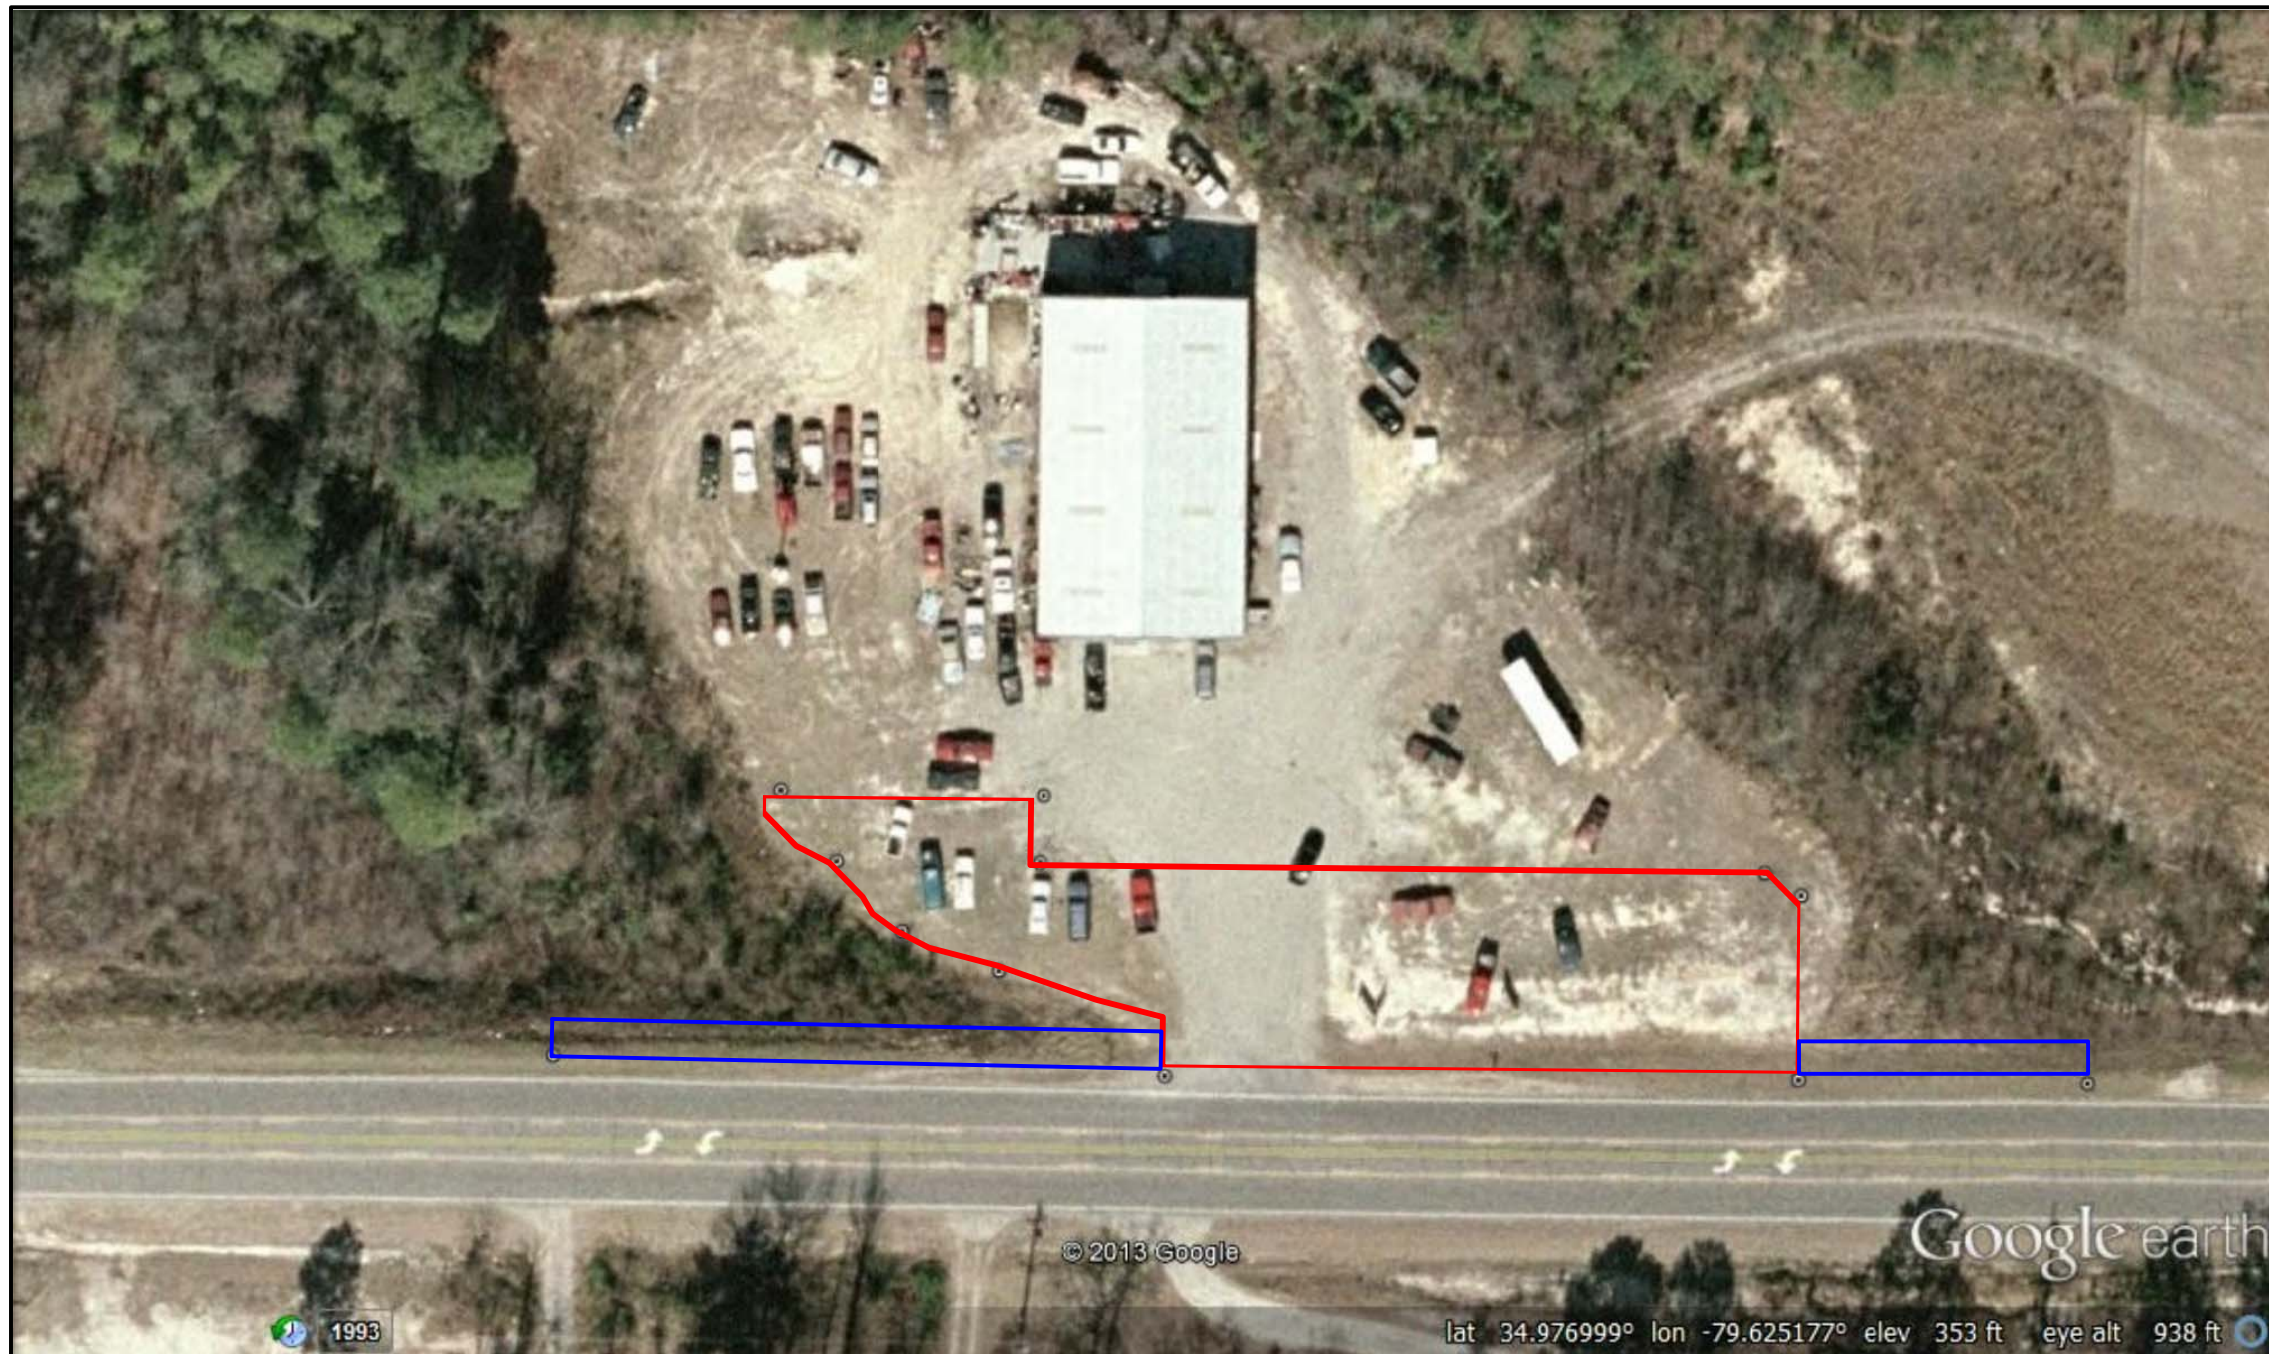
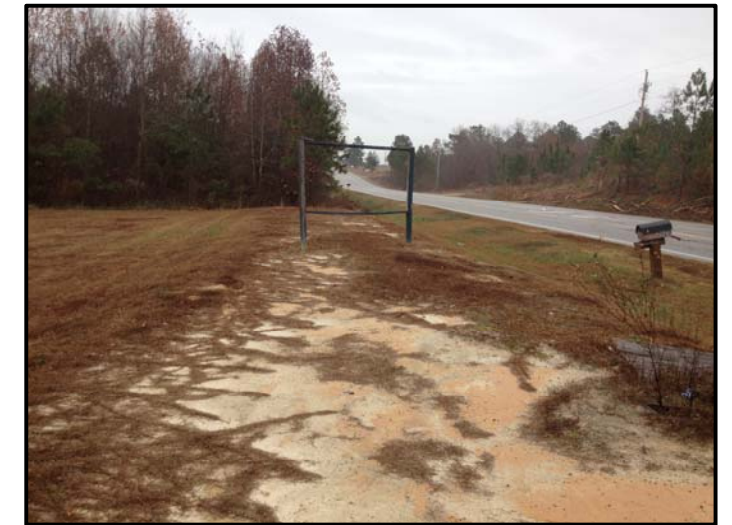
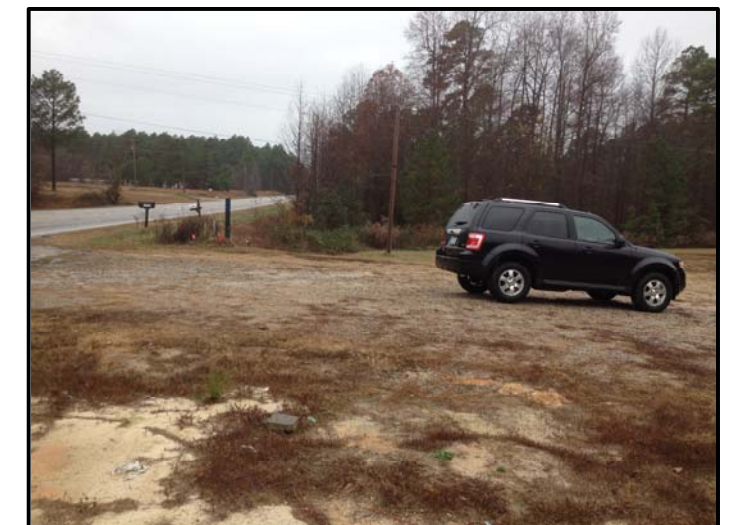
TITLE		PARCEL 033: GEOPHYSICAL SURVEY BOUNDARIES AND SITE PHOTOGRAPHS	
PROJECT		NCDOT PROJECT R-2501C (34437.1.1) ROCKINGHAM, RICHMOND COUNTY, NC

The site contained a vacant warehouse building, and otherwise consisted primarily of open grassy areas. It should be noted that an area of dense vegetation was present on the west side of the survey, limiting access for the geophysical instruments. Aerial photographs showing the survey area boundaries and ground-level photographs are shown in **Figure 1**.

Approximate Boundaries of the Geophysical Survey Area

View of East Portion of Survey Area
(Facing Approximately East)

View of West Portion of Survey Area
(Facing Approximately West)

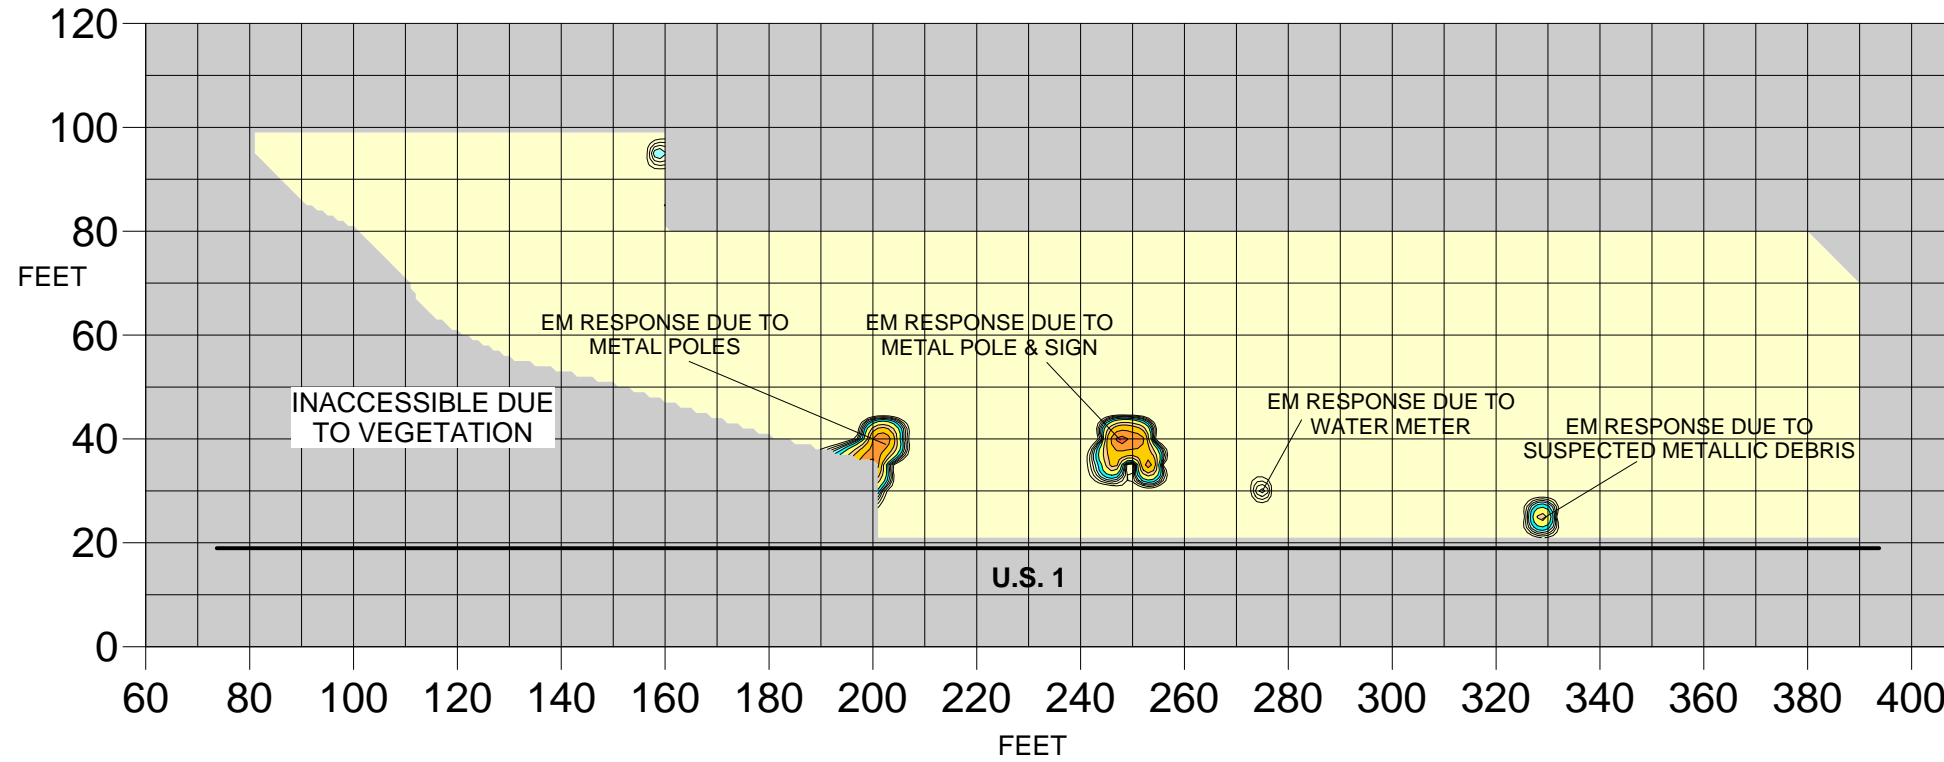
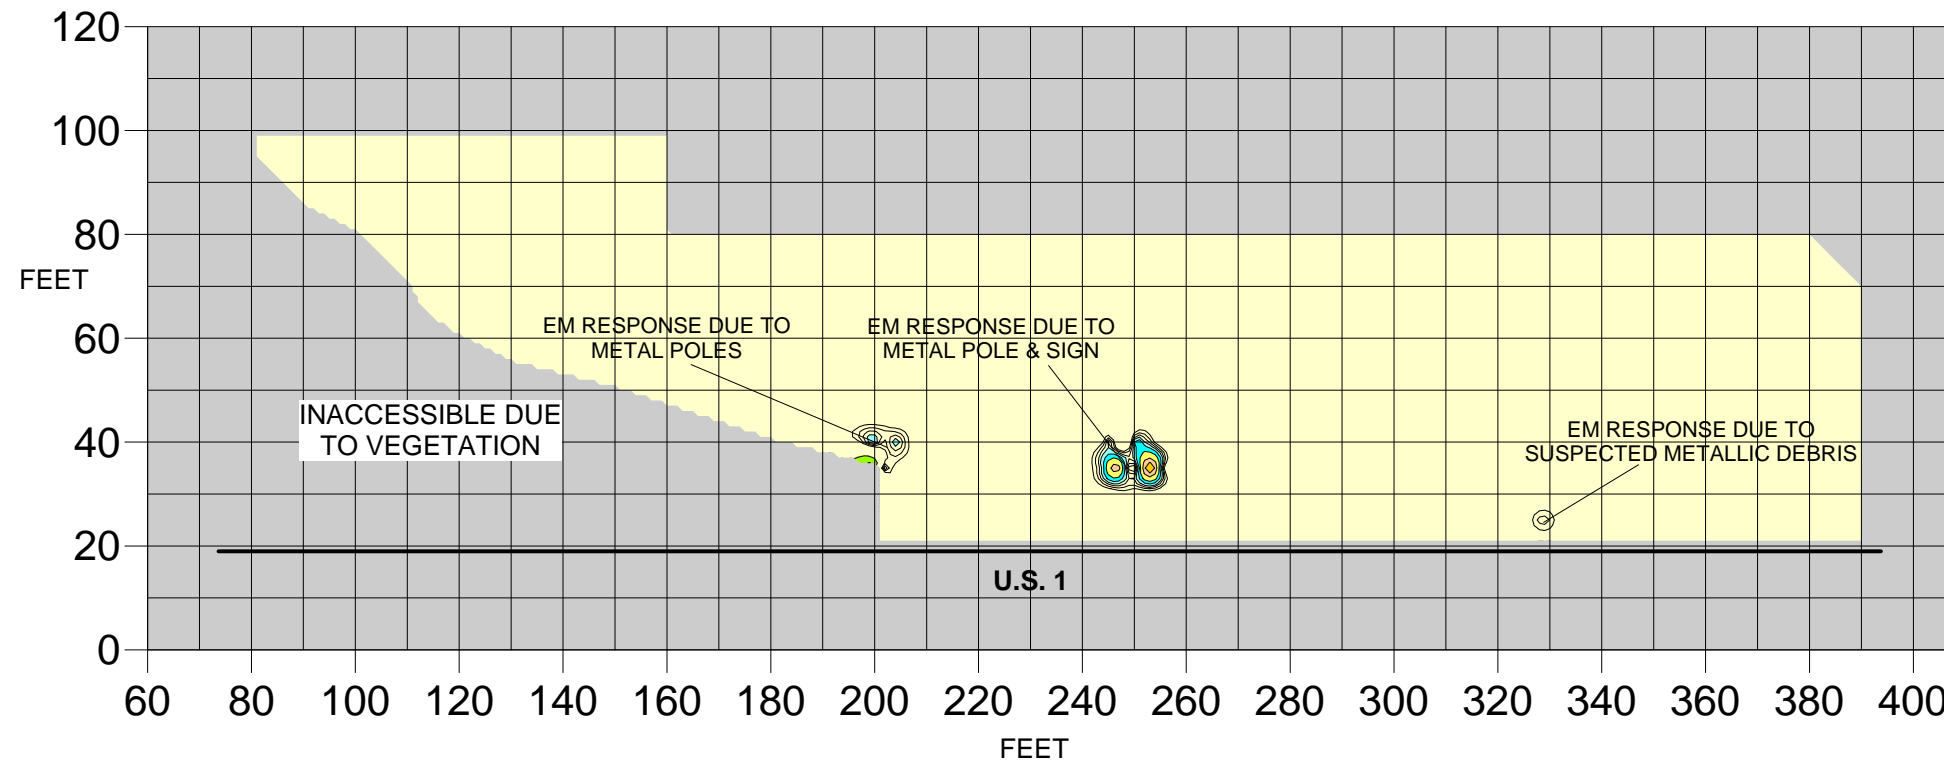
503 INDUSTRIAL AVENUE GREENSBORO, NC 27460 (336) 335-3174 (p) (336) 691-0648 (f) License # C1251 Eng. / License # C257 Geology	
	DATE	1/6/2014
	CLIENT	NCDOT
PYRAMID PROJECT #:	2013-278	FIGURE 2

EM61 Bottom Coil Results

NO EVIDENCE OF METALLIC USTs OBSERVED

The contour plots show the bottom coil (most sensitive) and differential results of the EM61 instrument in millivolts (mV). The bottom coil response shows buried metallic objects regardless of size. The differential response focuses on larger, buried metallic objects such as drums and USTs and ignores smaller miscellaneous buried, metal debris. The EM61 data were collected on December 4, 2013 using a Geonics EM61 instrument. Ground penetrating radar (GPR) data were collected on December 9, 2013, using a GSSI SIR 2000 unit coupled to a 400 MHz antennae.

EM61 Differential Results

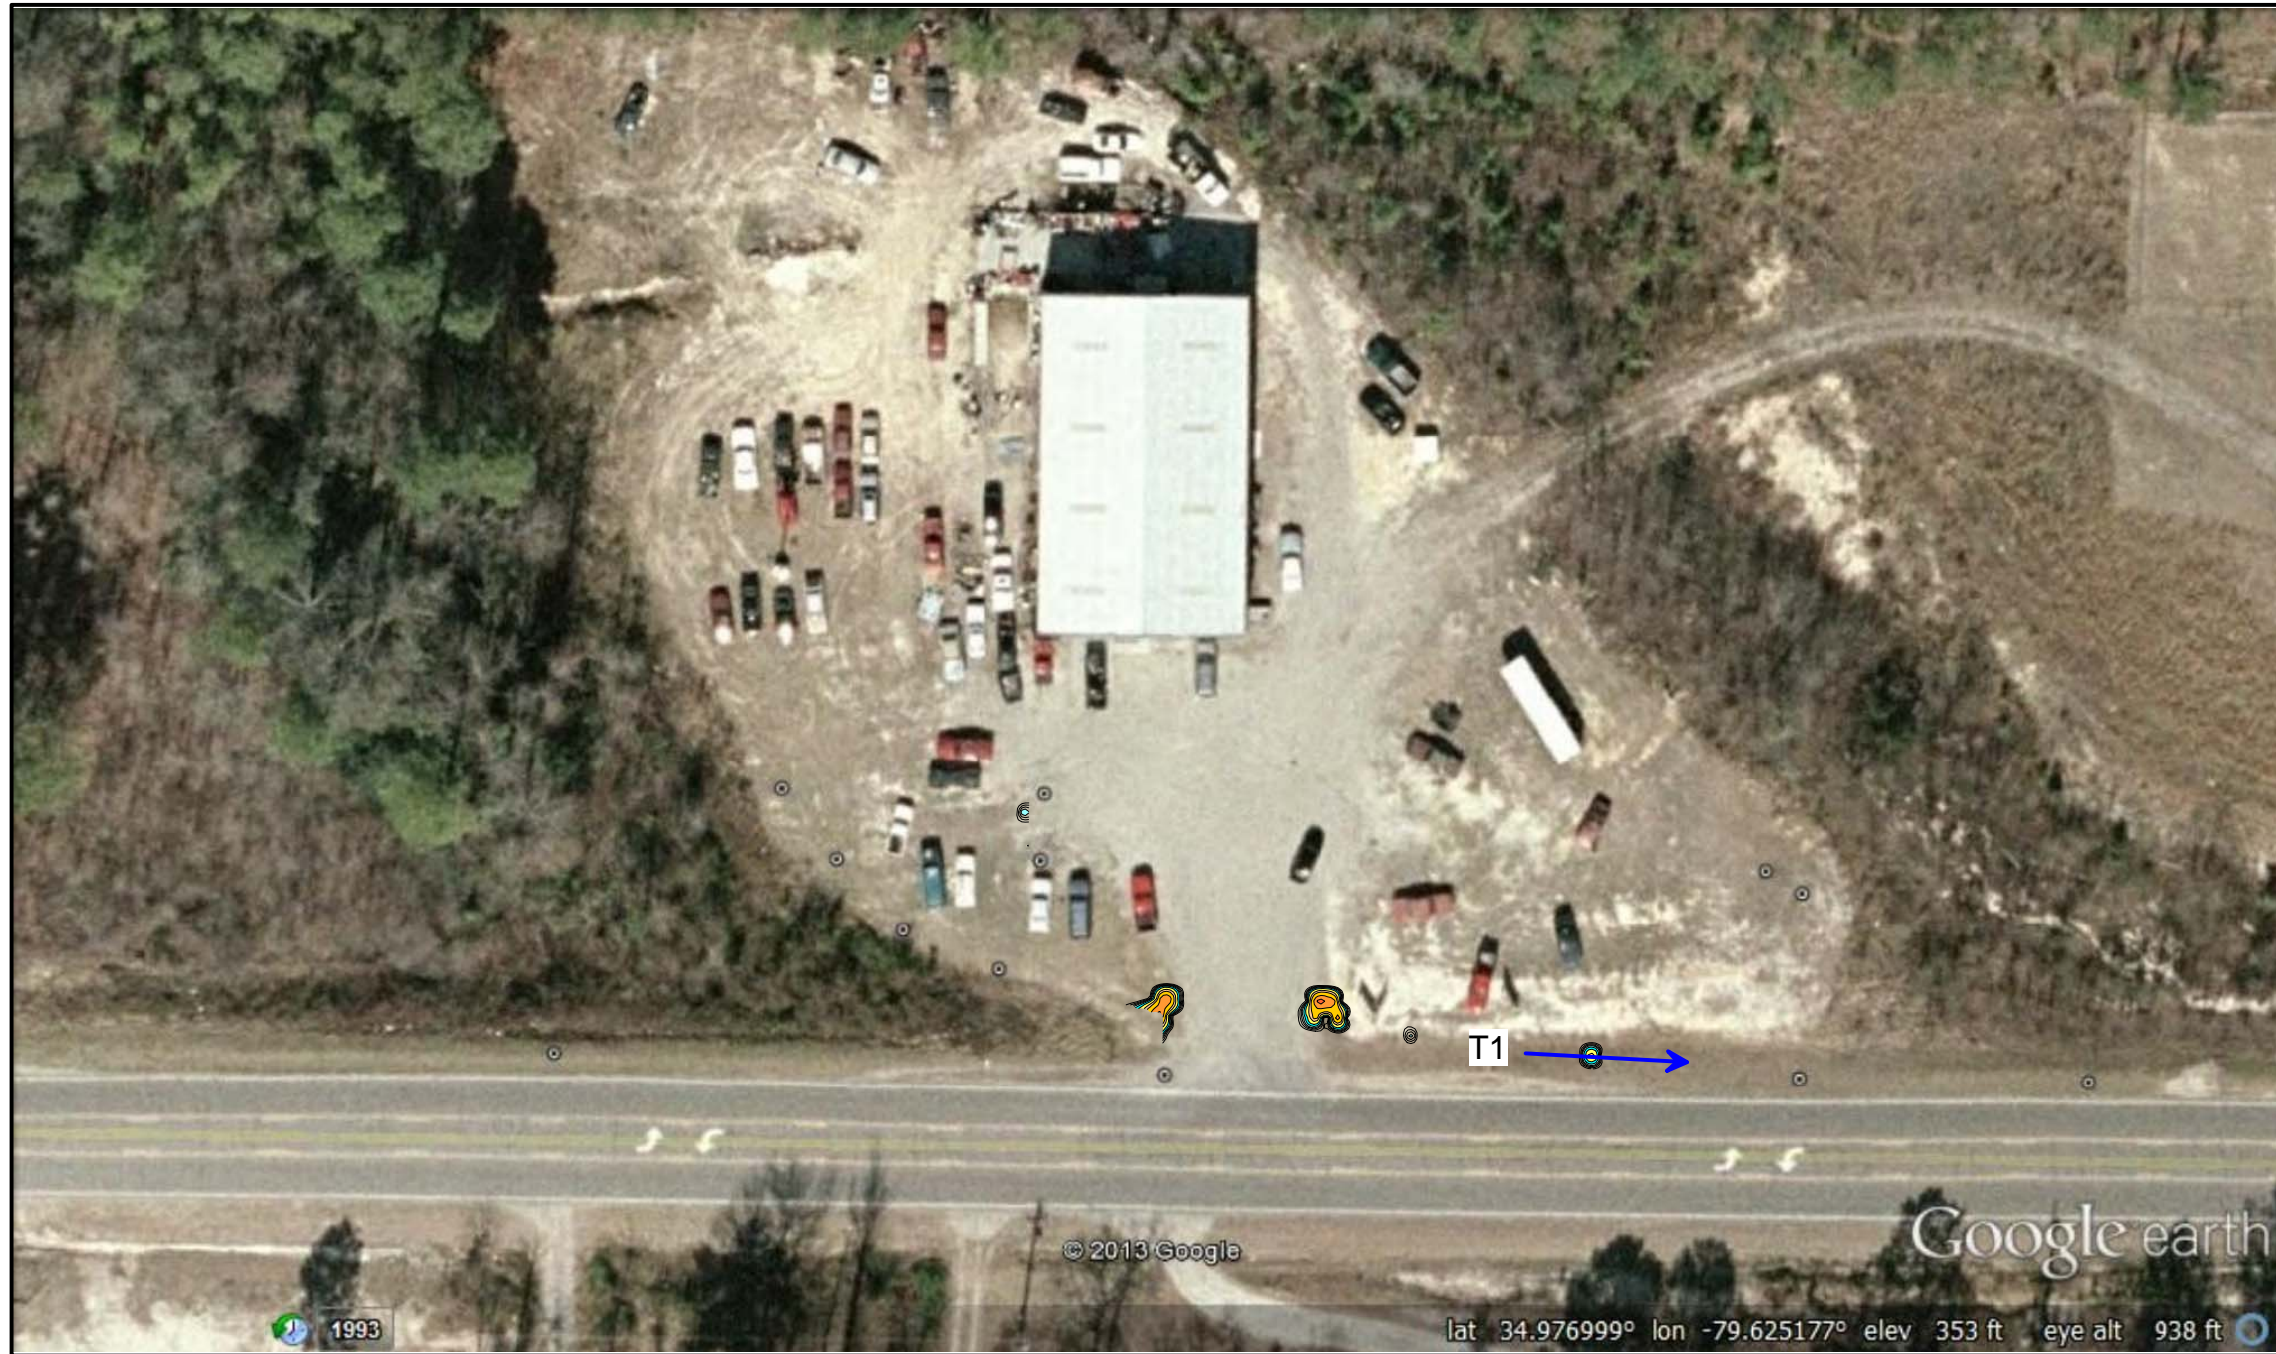
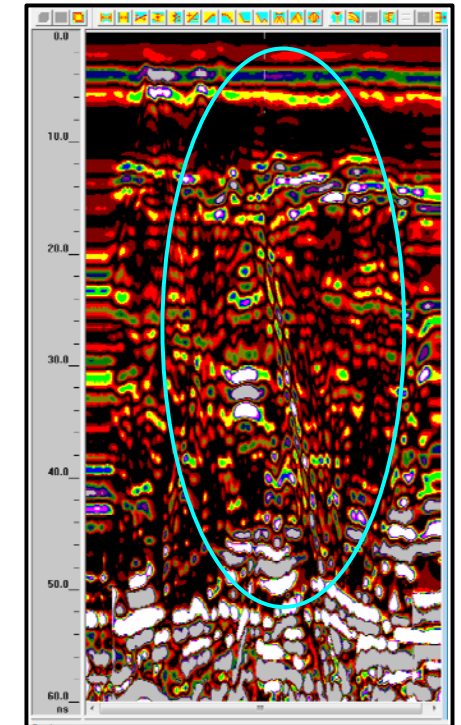
TITLE	PARCEL 033: GPR TRANSECT LOCATION AND IMAGE	
PROJECT	NCDOT PROJECT R-2501C (34437.1.1) ROCKINGHAM, RICHMOND COUNTY, NC

Approximate Location of GPR Transect

GPR Transect 1
Possible Metallic Debris
