Pyramid Environmental & Engineering, P.C. Project # 2013-278
Preliminary Site Assessment (PSA) – Parcel 42, Bradley G. McInnis

PRELIMINARY SITE ASSESSMENT
PARCEL 42, BRADLEY G. MCINNIS
2050 U.S. HIGHWAY 1 NORTH
ROCKINGHAM, RICHMOND COUNTY, NORTH CAROLINA
STATE PROJECT: R-2501C
WBS ELEMENT: 34437.1.1
JANUARY 21, 2014

**PRELIMINARY SITE ASSESSMENT
PARCEL 42, BRADLEY G. MCINNIS
2050 N. US 1
ROCKINGHAM, RICHMOND COUNTY, NORTH CAROLINA**

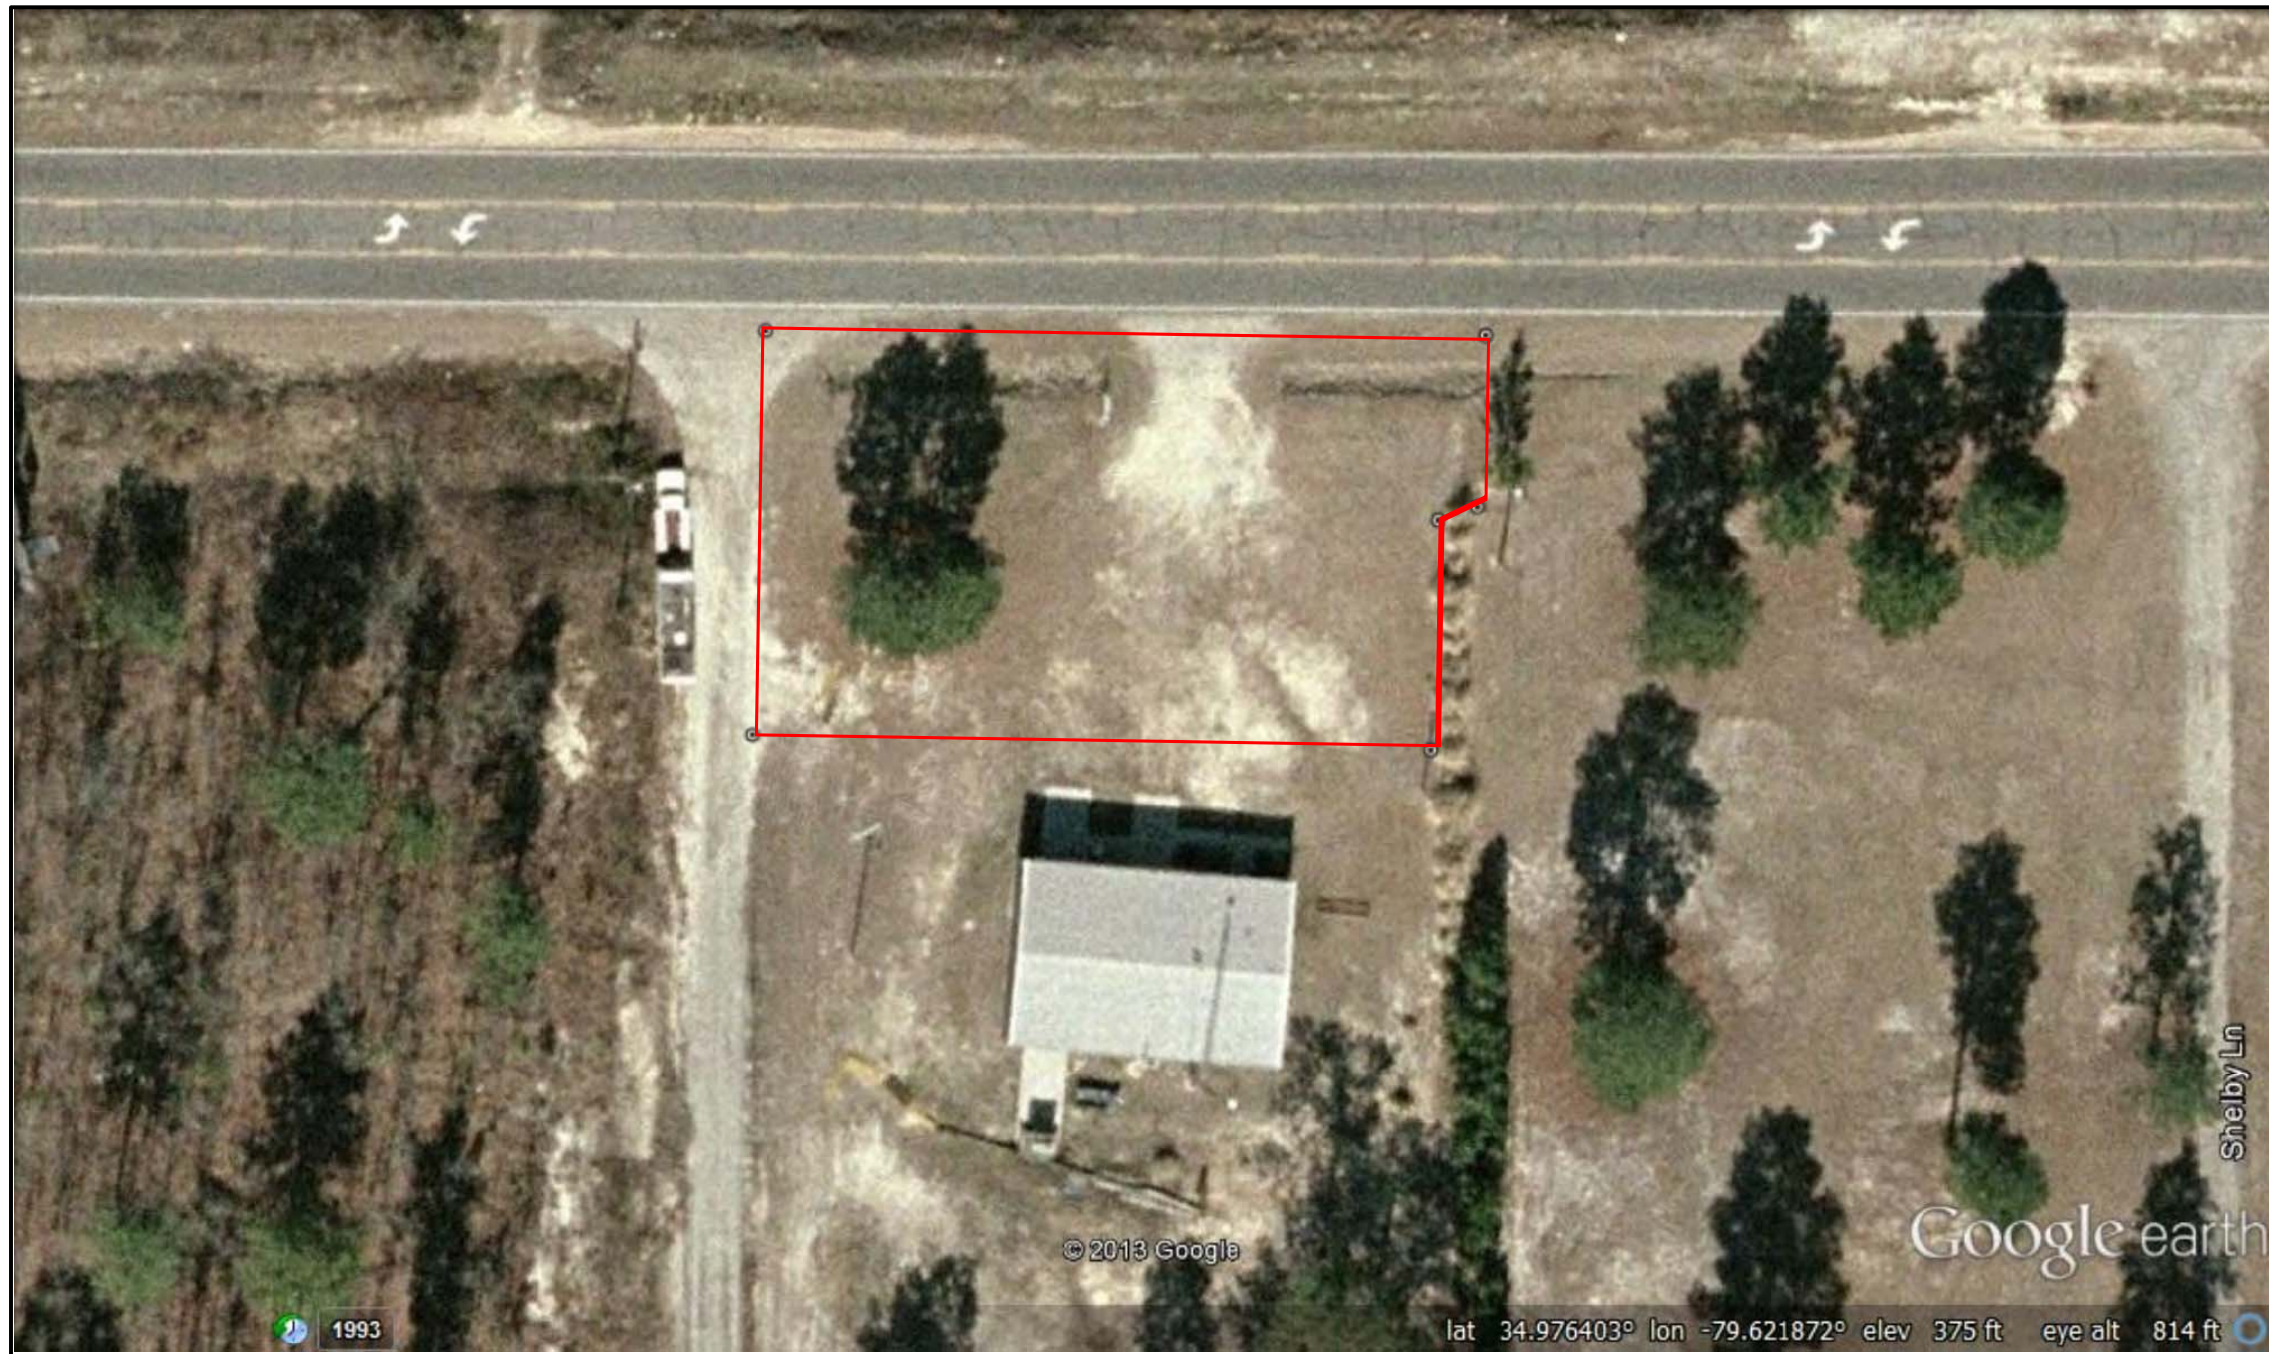
Approximate Boundaries of the Geophysical Survey Area

Pyramid performed a electromagnetic (EM) and ground penetrating radar (GPR) surveys across the accessible portions of the Parcel. The majority of the EM61 anomalies detected could be attributed to visible objects at the ground surface such as signs, culverts, and other cultural features. A suspected water line was observed to extend from north to south across the survey area at X=160. All remaining anomalies investigated by the GPR were attributed to utilities or metallic debris.

The geophysical investigation did not record evidence of any metallic USTs at the property.

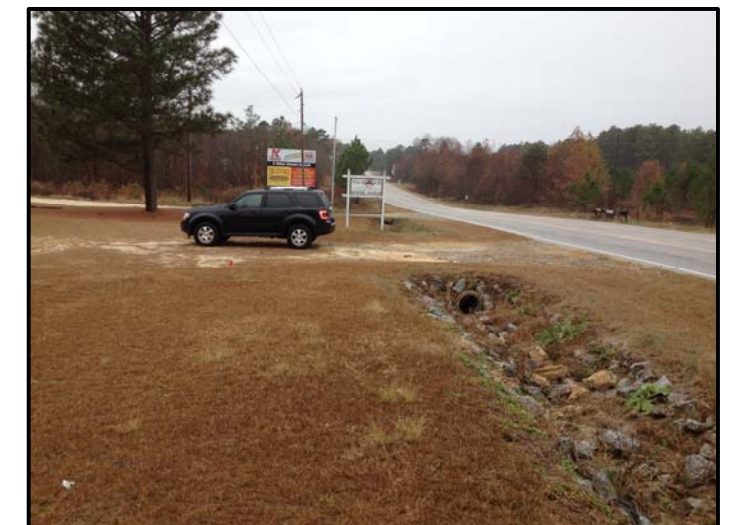
View of Geophysical Survey Area
(Facing Approximately West)

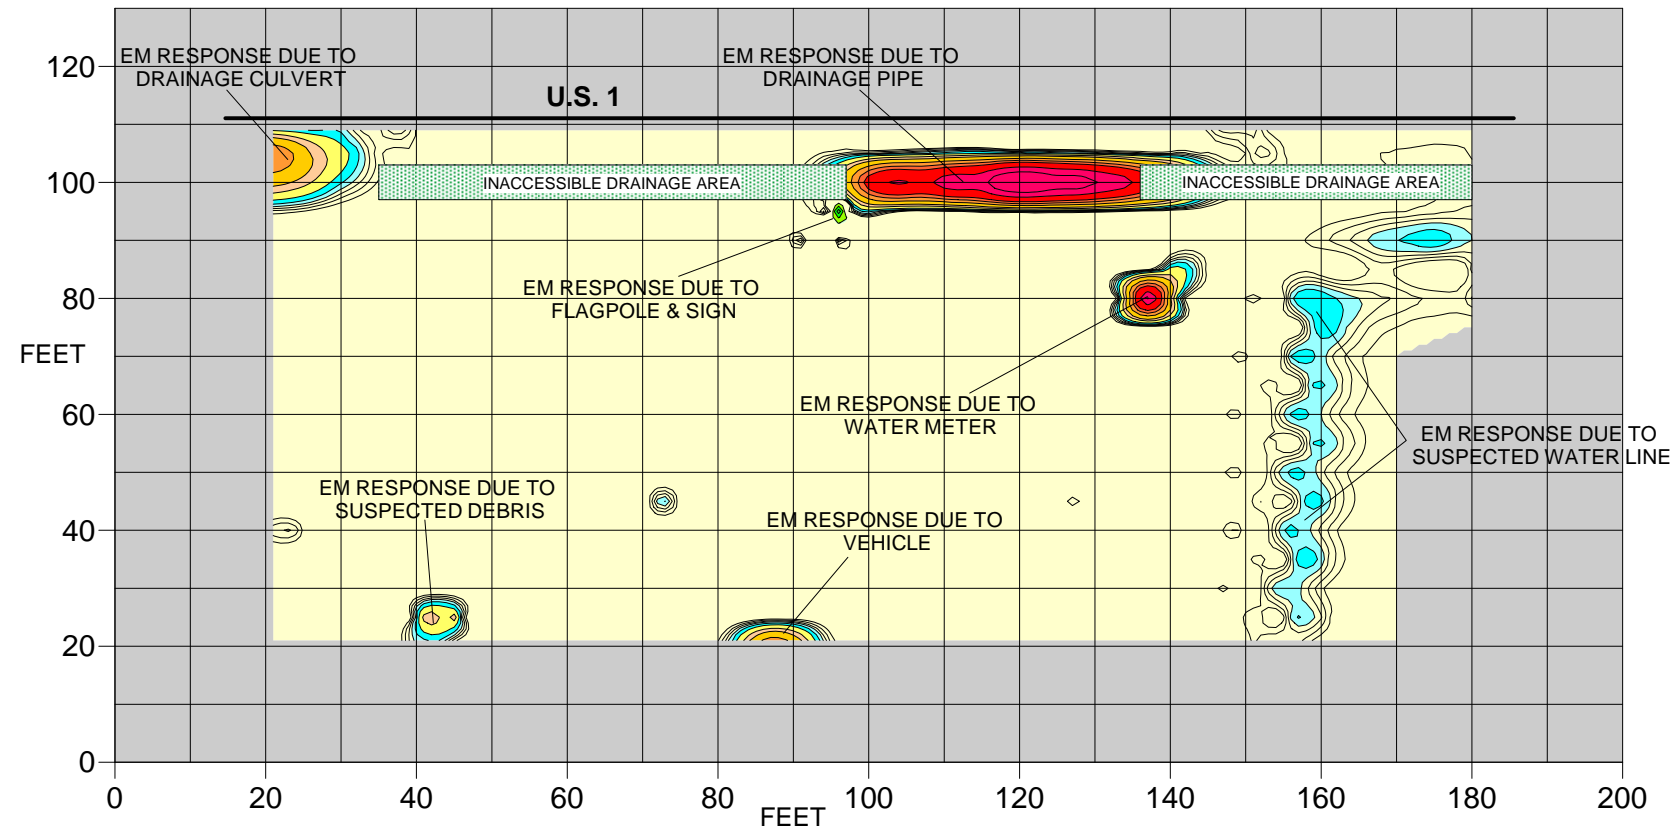
EM61 Bottom Coil Results

NO EVIDENCE OF METALLIC USTs OBSERVED

The contour plots show the bottom coil (most sensitive) and differential results of the EM61 instrument in millivolts (mV). The bottom coil response shows buried metallic objects regardless of size. The differential response focuses on larger, buried metallic objects such as drums and USTs and ignores smaller miscellaneous buried, metal debris. The EM61 data were collected on December 4, 2013 using a Geonics EM61 instrument. Ground penetrating radar (GPR) data were collected on December 9, 2013, using a GSSI SIR 2000 unit coupled to a 400 MHz antennae.
