Pyramid Environmental & Engineering, P.C. Project # 2013-278
Preliminary Site Assessment (PSA) – Parcel 49, Martha Robbins

PRELIMINARY SITE ASSESSMENT
PARCEL 49, MARTHA ROBBINS
2259 U.S. HIGHWAY 1 NORTH
ROCKINGHAM, RICHMOND COUNTY, NORTH CAROLINA
STATE PROJECT: R-2501C
WBS ELEMENT: 34437.1.1
JANUARY 21, 2014

**PRELIMINARY SITE ASSESSMENT
PARCEL 49, MARTHA ROBBINS
2259 N. US 1
ROCKINGHAM, RICHMOND COUNTY, NORTH CAROLINA**

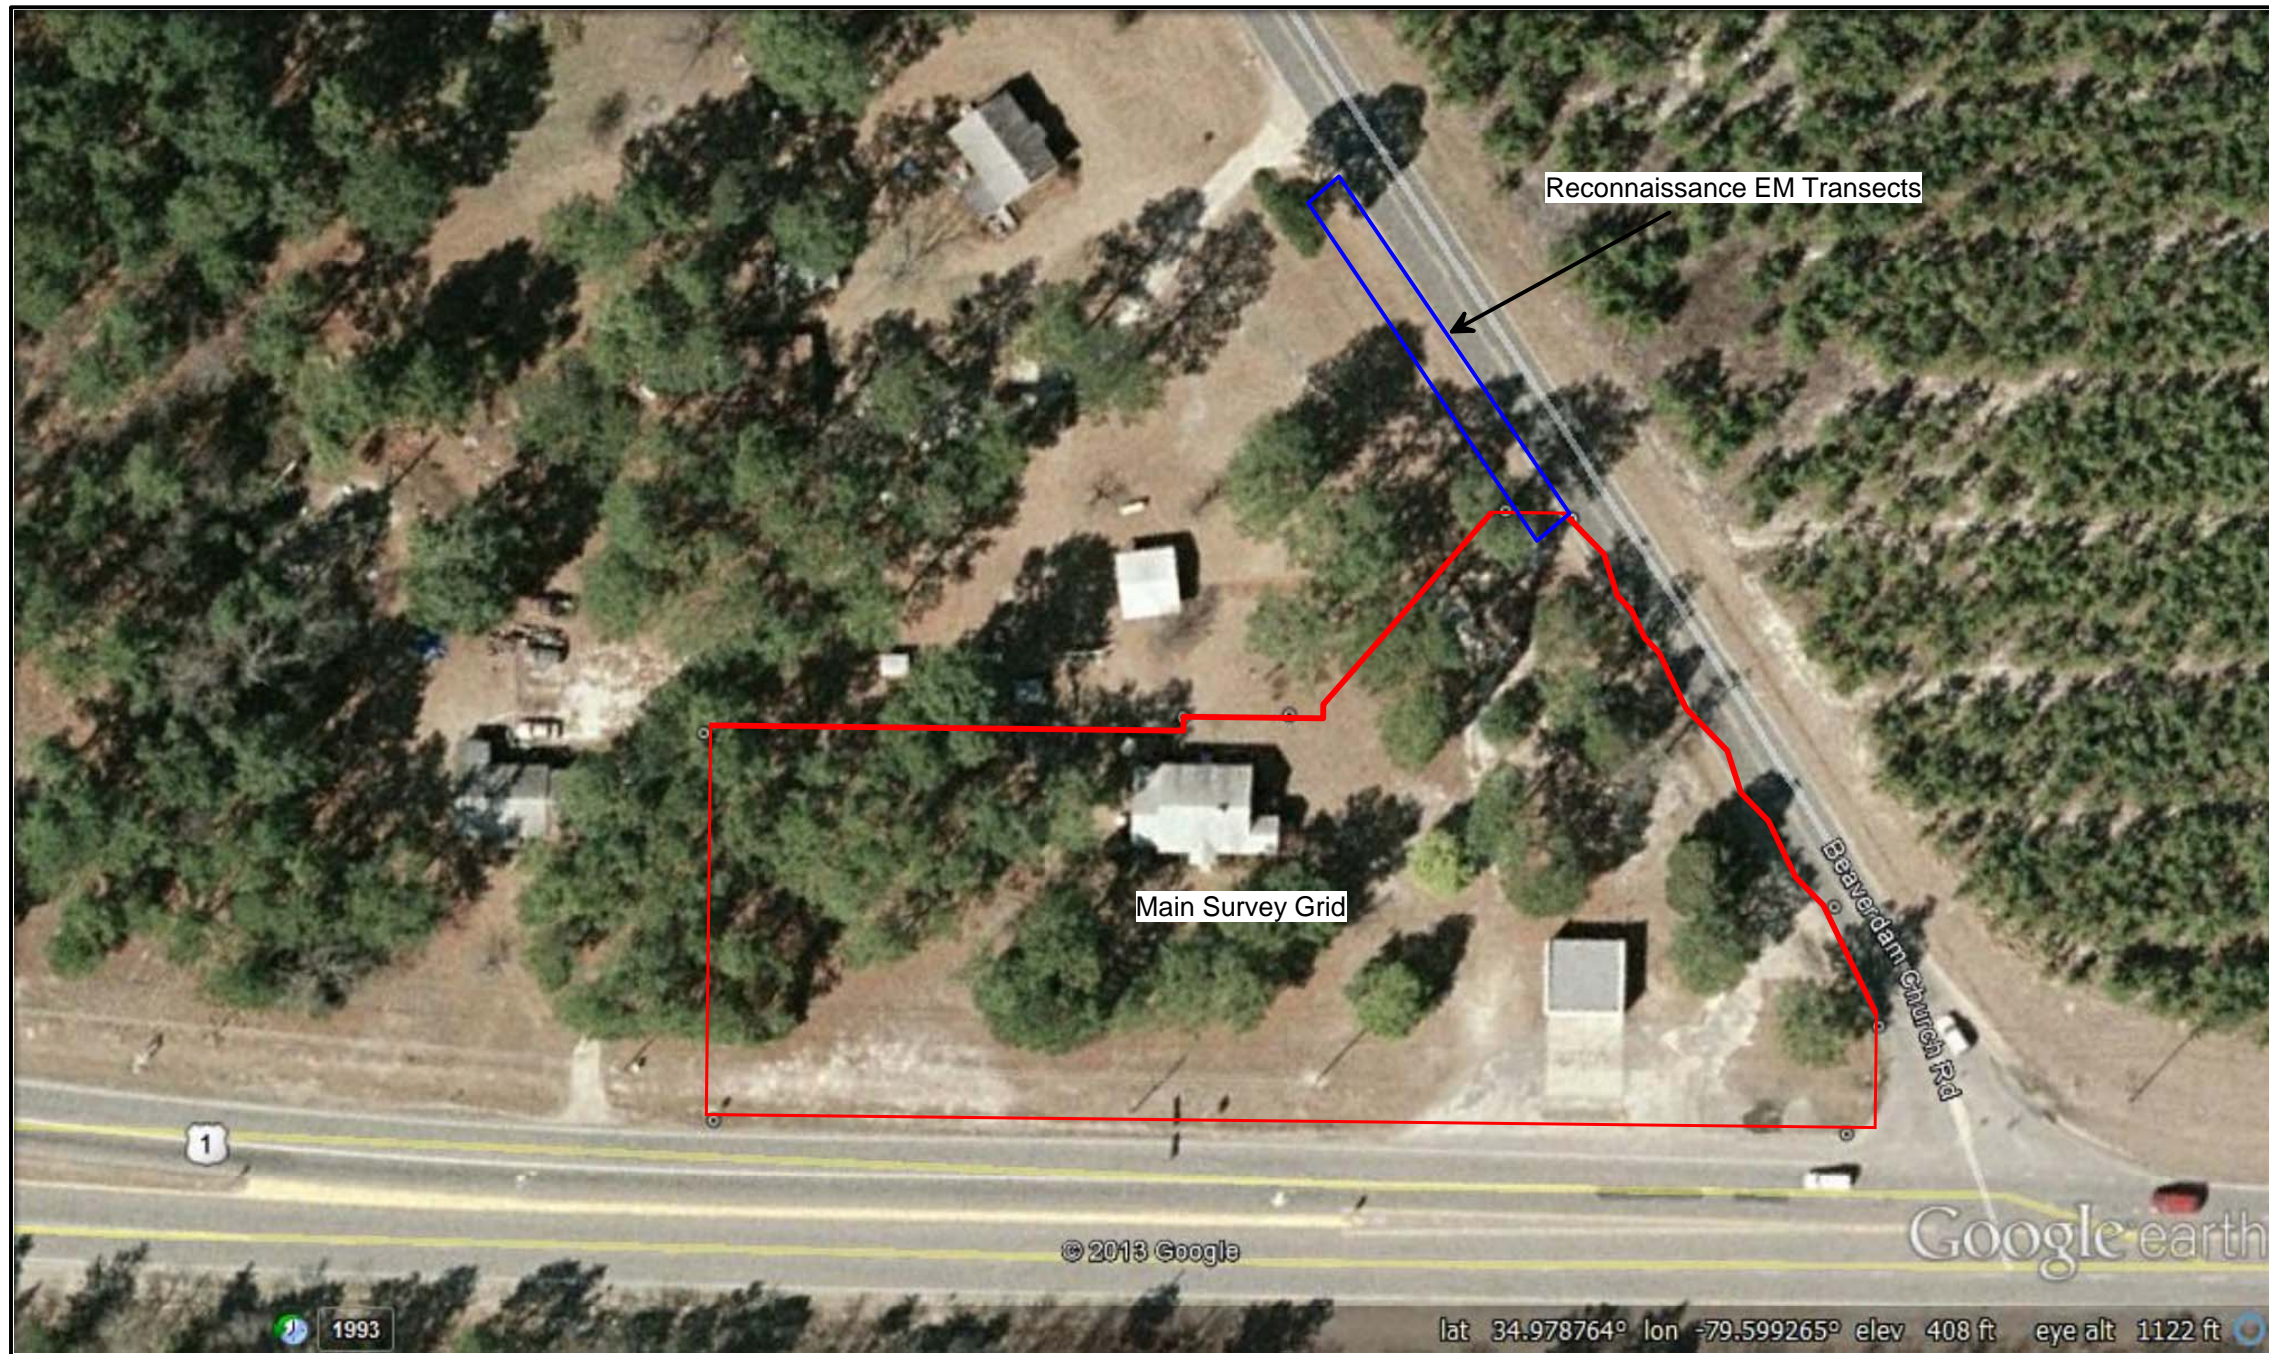
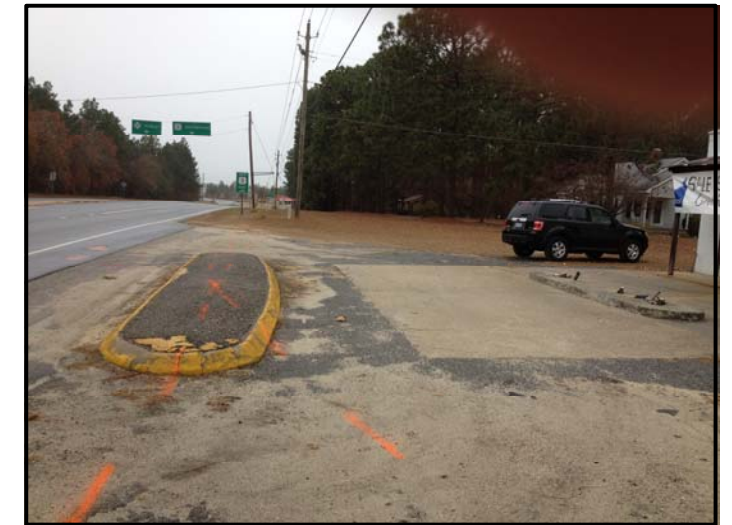
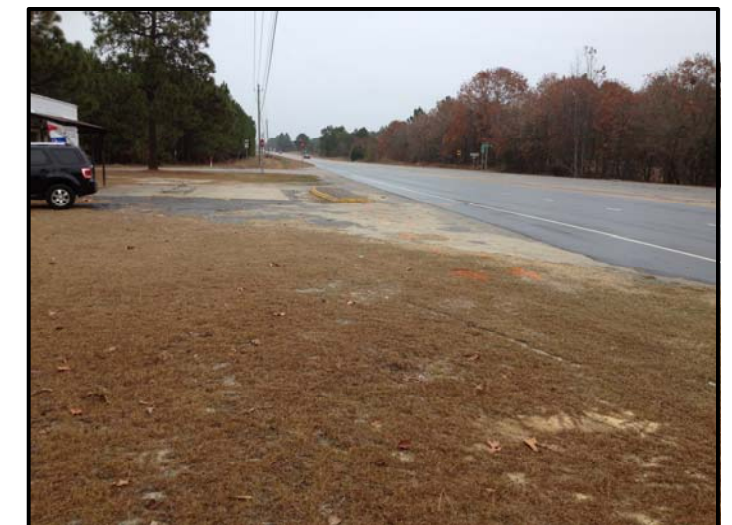
TITLE		PARCEL 049: GEOPHYSICAL SURVEY BOUNDARIES AND SITE PHOTOGRAPHS	
PROJECT		NCDOT PROJECT R-2501C (34437.1.1) ROCKINGHAM, RICHMOND COUNTY, NC

Approximate Boundaries of the Geophysical Survey Area

View of West Portion of Survey Area
(Facing Approximately West)

View of East Portion of Survey Area
(Facing Approximately East)

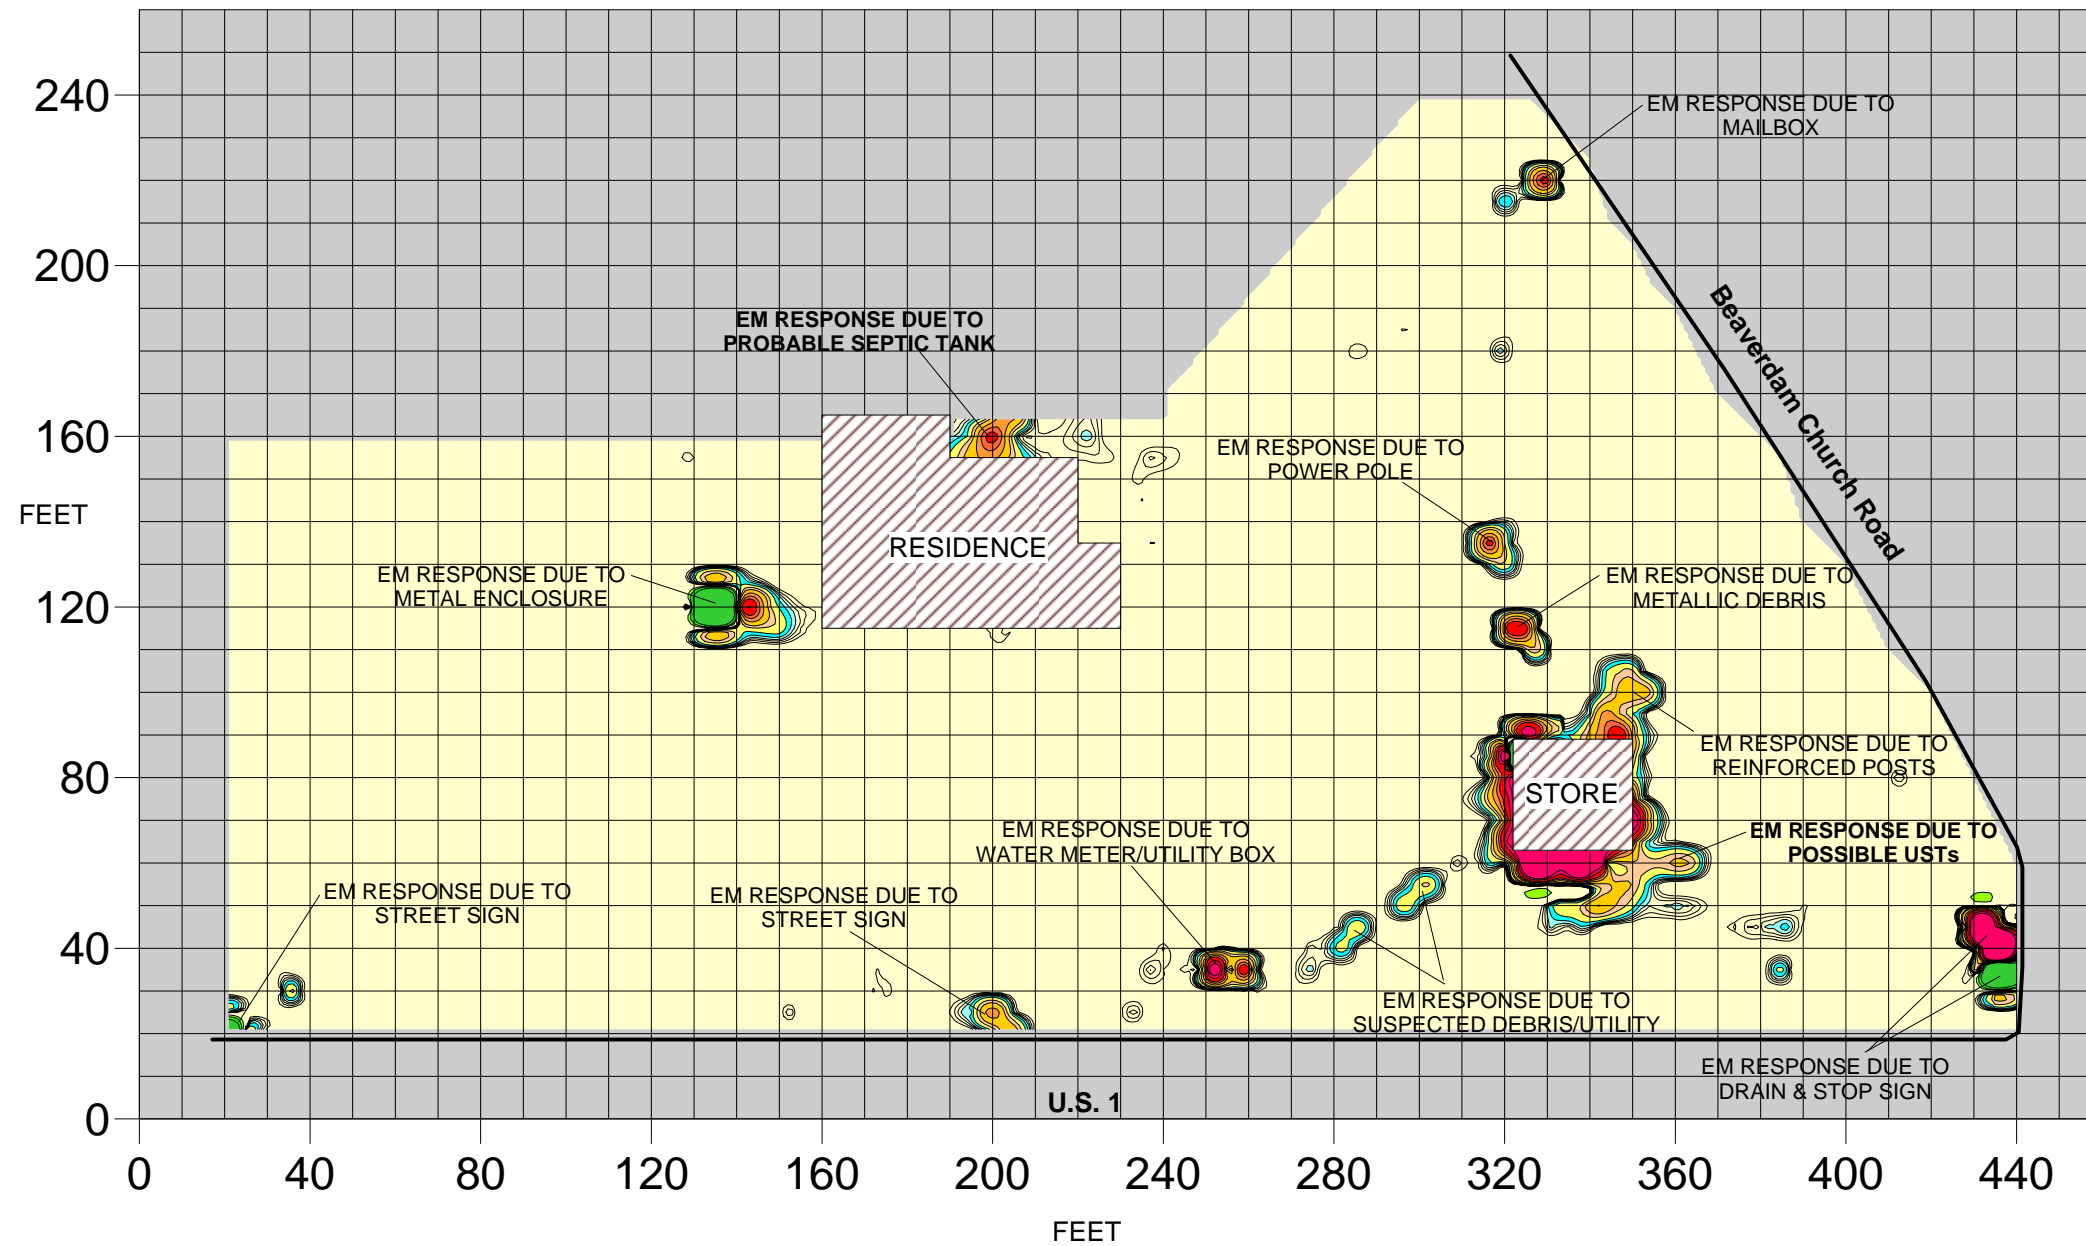
EM61 Bottom Coil Results

EVIDENCE OF ONE PROBABLE & TWO POSSIBLE METALLIC USTs OBSERVED

The contour plot shows the bottom coil (most sensitive) results of the EM61 instrument in millivolts (mV). The bottom coil response shows buried metallic objects regardless of size. The EM61 data were collected on December 4, 2013 using a Geonics EM61 instrument. Ground penetrating radar (GPR) data were collected on December 9, 2013, using a GSSI SIR 2000 unit coupled to a 400 MHz antennae.

The GPR survey recorded evidence of one probable metallic UST directly to the north of the residential building on the property which is most likely a septic tank. The GPR survey recorded evidence of two possible metallic USTs adjacent to the southeast corner of the vacant store building. These possible USTs measured approximately 12 feet long and 7 feet wide. GPR transects indicated former product lines directly to the north of the former pump island on the south side of the vacant store building.

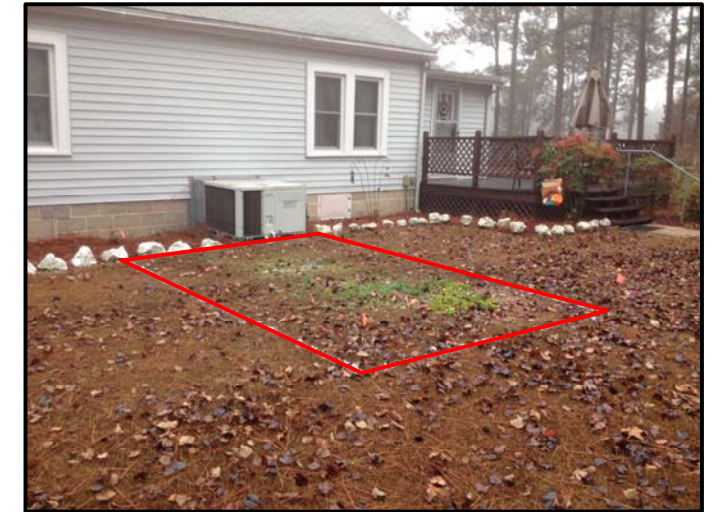
Area containing probable UST (suspected septic tank)

No petroleum-impacted soils above 10 mg/kg were encountered during the PSA investigation at Parcel 49. Therefore, no recommendations are necessary for the treatment or disposal of such materials. Pyramid would recommend that the former pump islands and apparent former product lines detected by the geophysical survey be removed and properly disposed of. Congruently, it is recommended that verification of the two possible USTs be made, and should these features be USTs, it is recommended that they also be removed and properly disposed of.

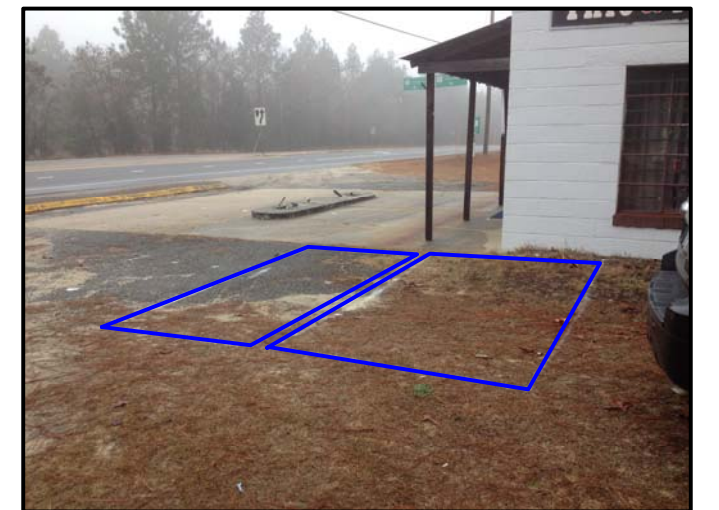
Area containing two possible USTs
