Pyramid Environmental & Engineering, P.C. Project # 2013-278  
Preliminary Site Assessment (PSA) – Parcel 63, Lonnie Walker

**PRELIMINARY SITE ASSESSMENT**  
**PARCEL 63, LONNIE WALKER**  
**2210 U.S. HIGHWAY 1 NORTH**  
**ROCKINGHAM, RICHMOND COUNTY, NORTH CAROLINA**  
**STATE PROJECT: R-2501C**  
**WBS ELEMENT: 34437.1.1**  
**JANUARY 21, 2014**

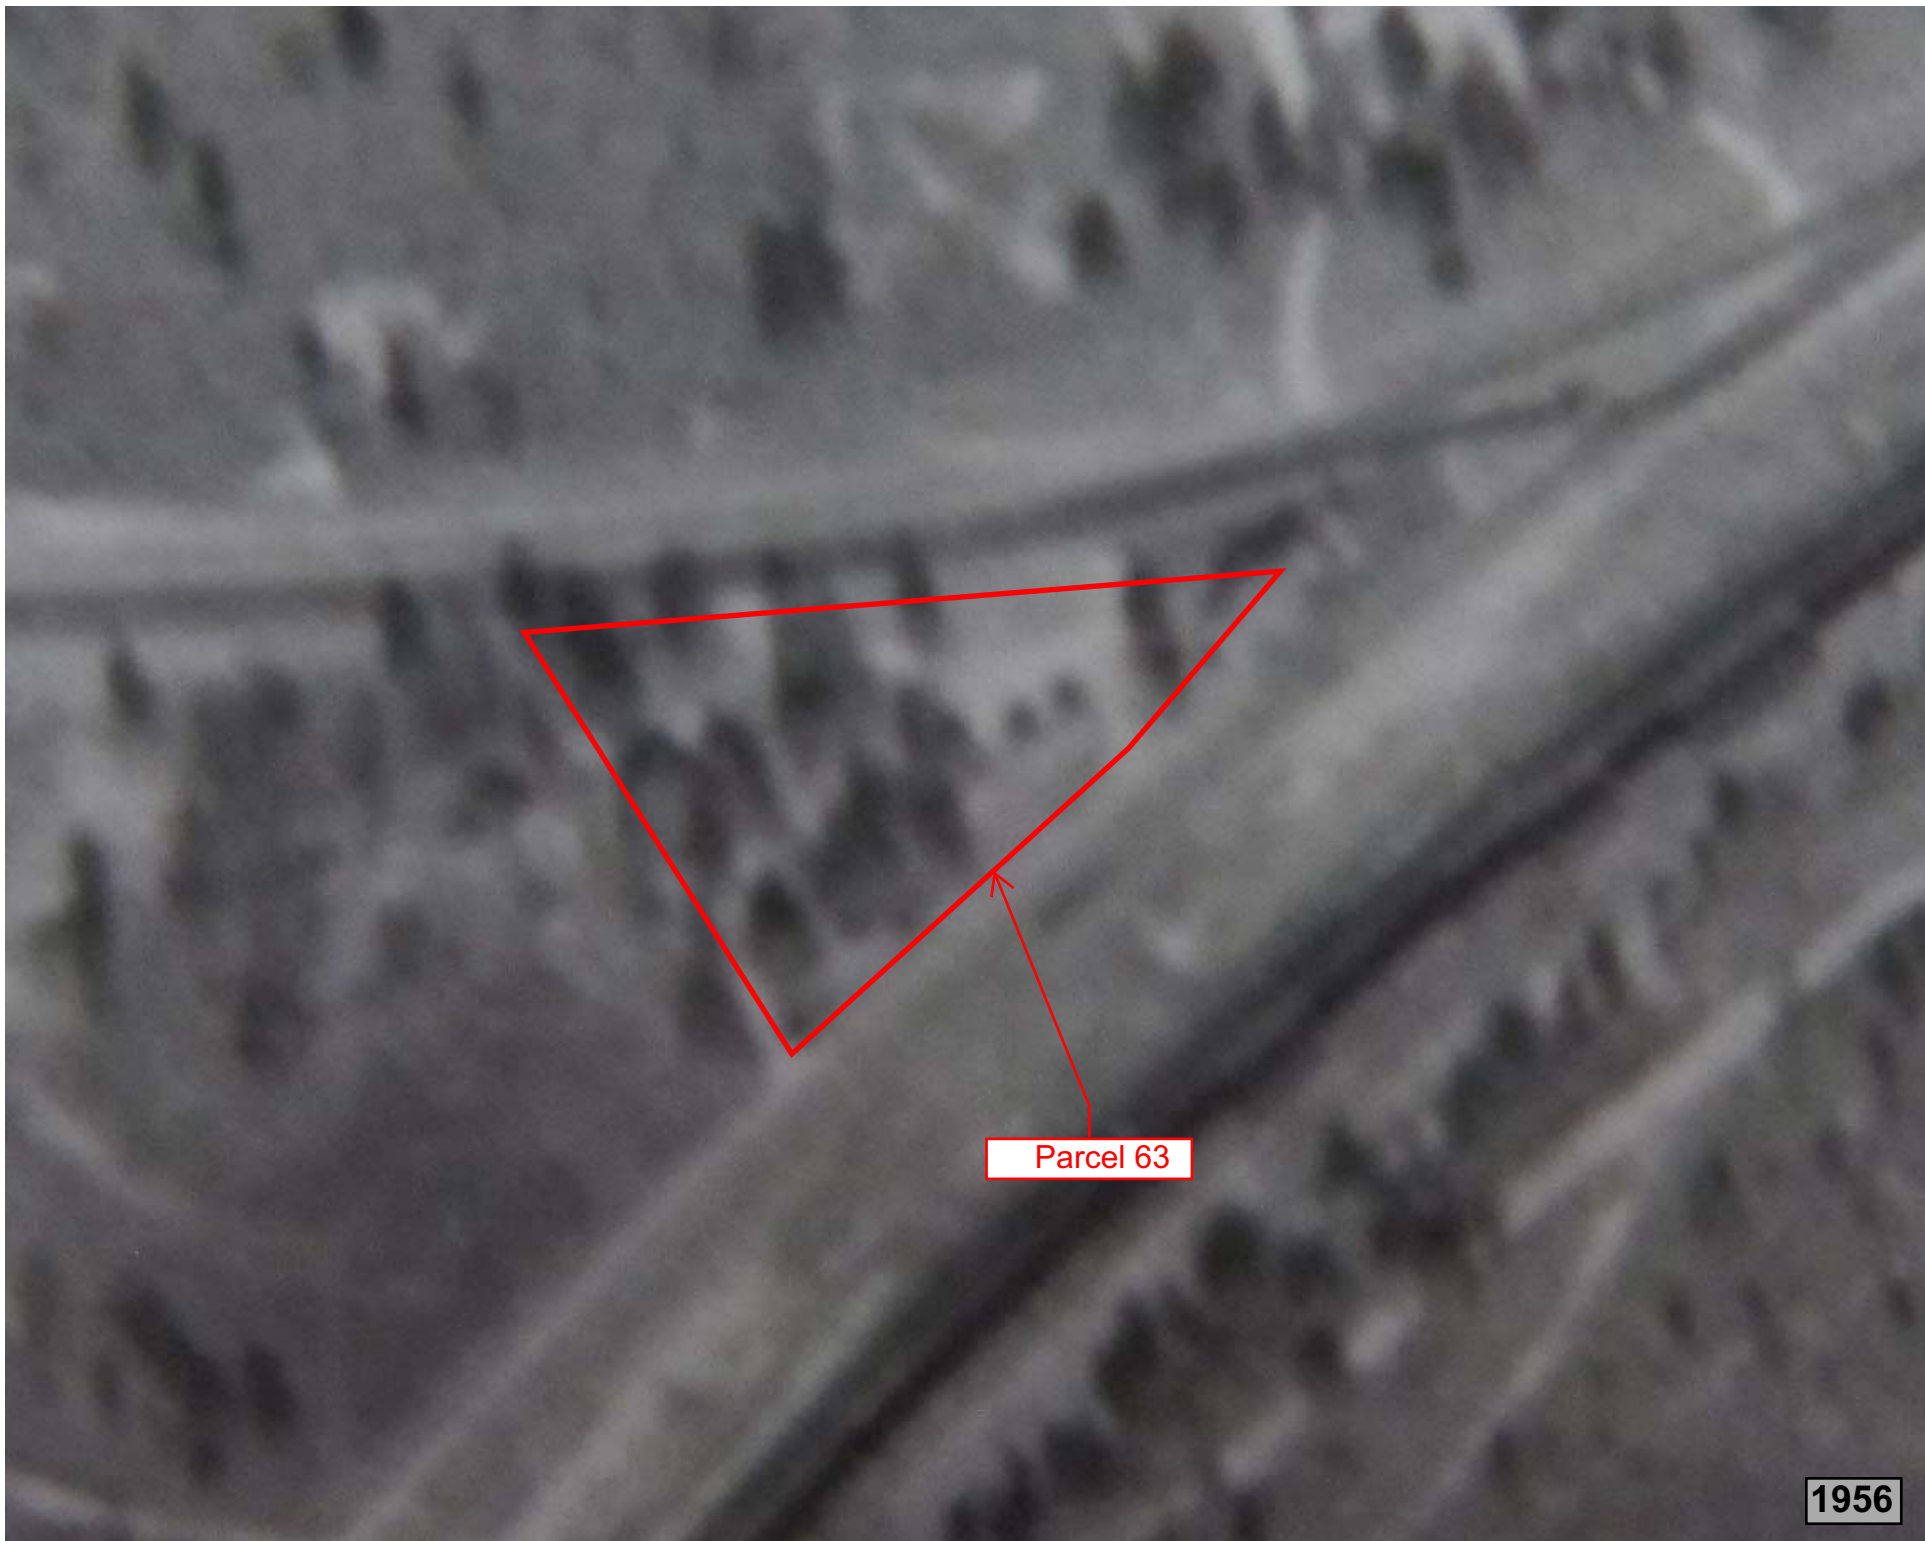
1975

Parcel 63

Pyramid completed a records review of the parcel, interviewed DENR personnel, interviewed property owners, and reviewed aerial photographs to assess past uses of the property. Pyramid reviewed historical aerial photographs dating back to 1938 available from the Richmond County Soil and Water Conservation office in Rockingham and on Google Earth. The 1938, 1956, 1975, 1993, 1999, 2005, 2008, 2011, and 2013 aerial photographs are included in **Appendix A**. Historical information reviewed as part of the PSA indicated that the building appears to have been constructed between 1938 and 1956. The earliest aerial to show the building appears to be the 1956 aerial. The 1938 aerial shows the property to be undeveloped land.

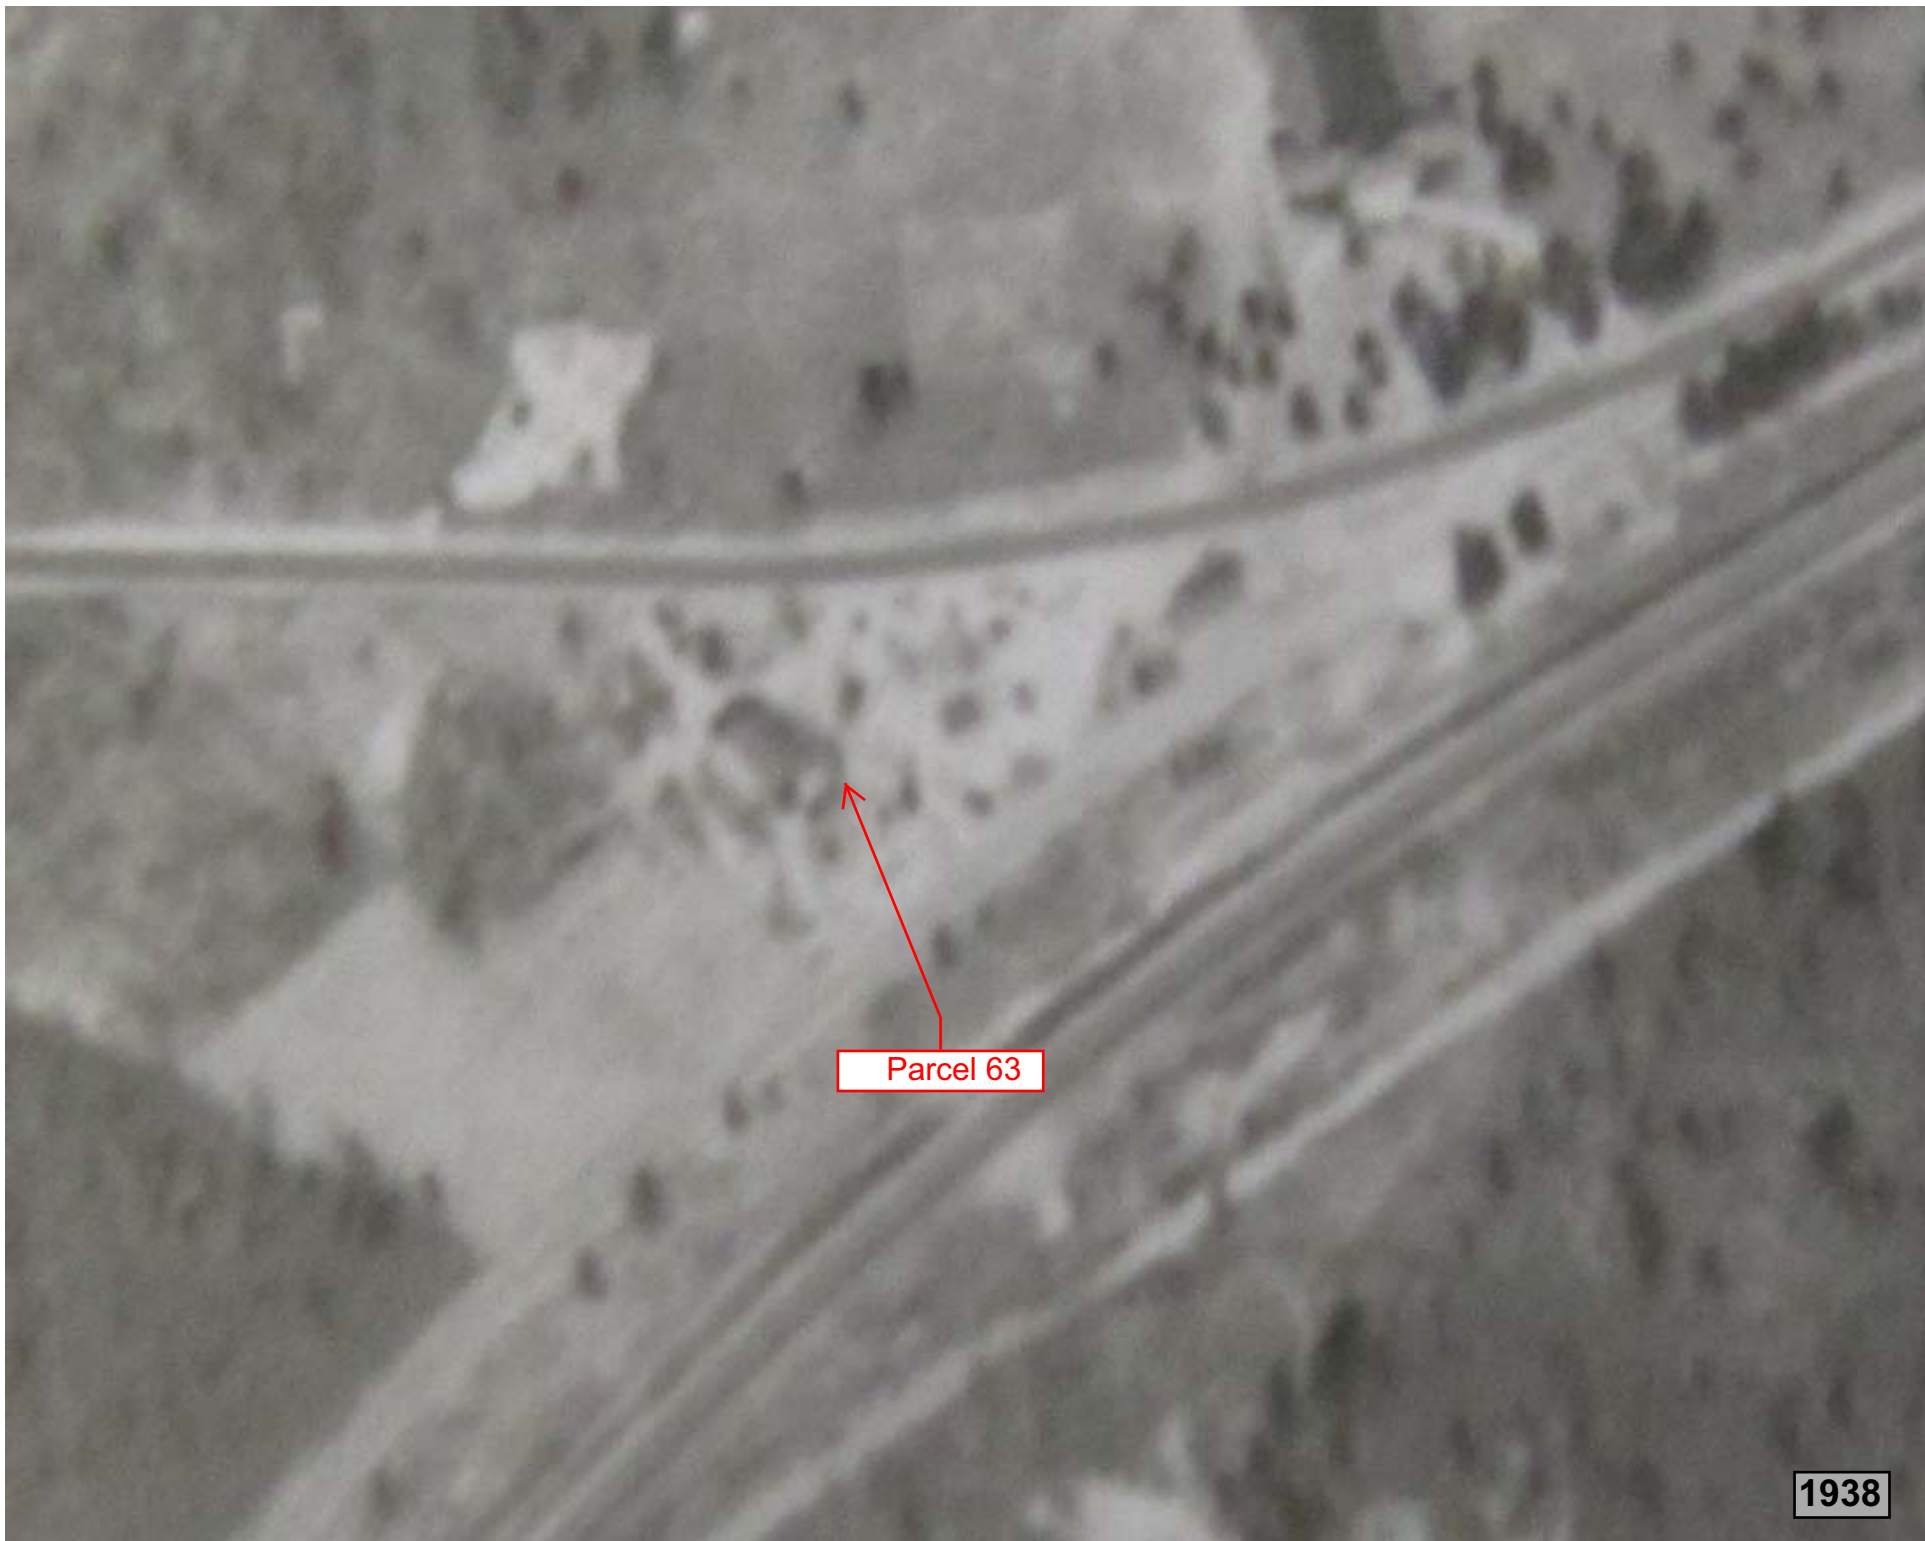
1956

Parcel 63

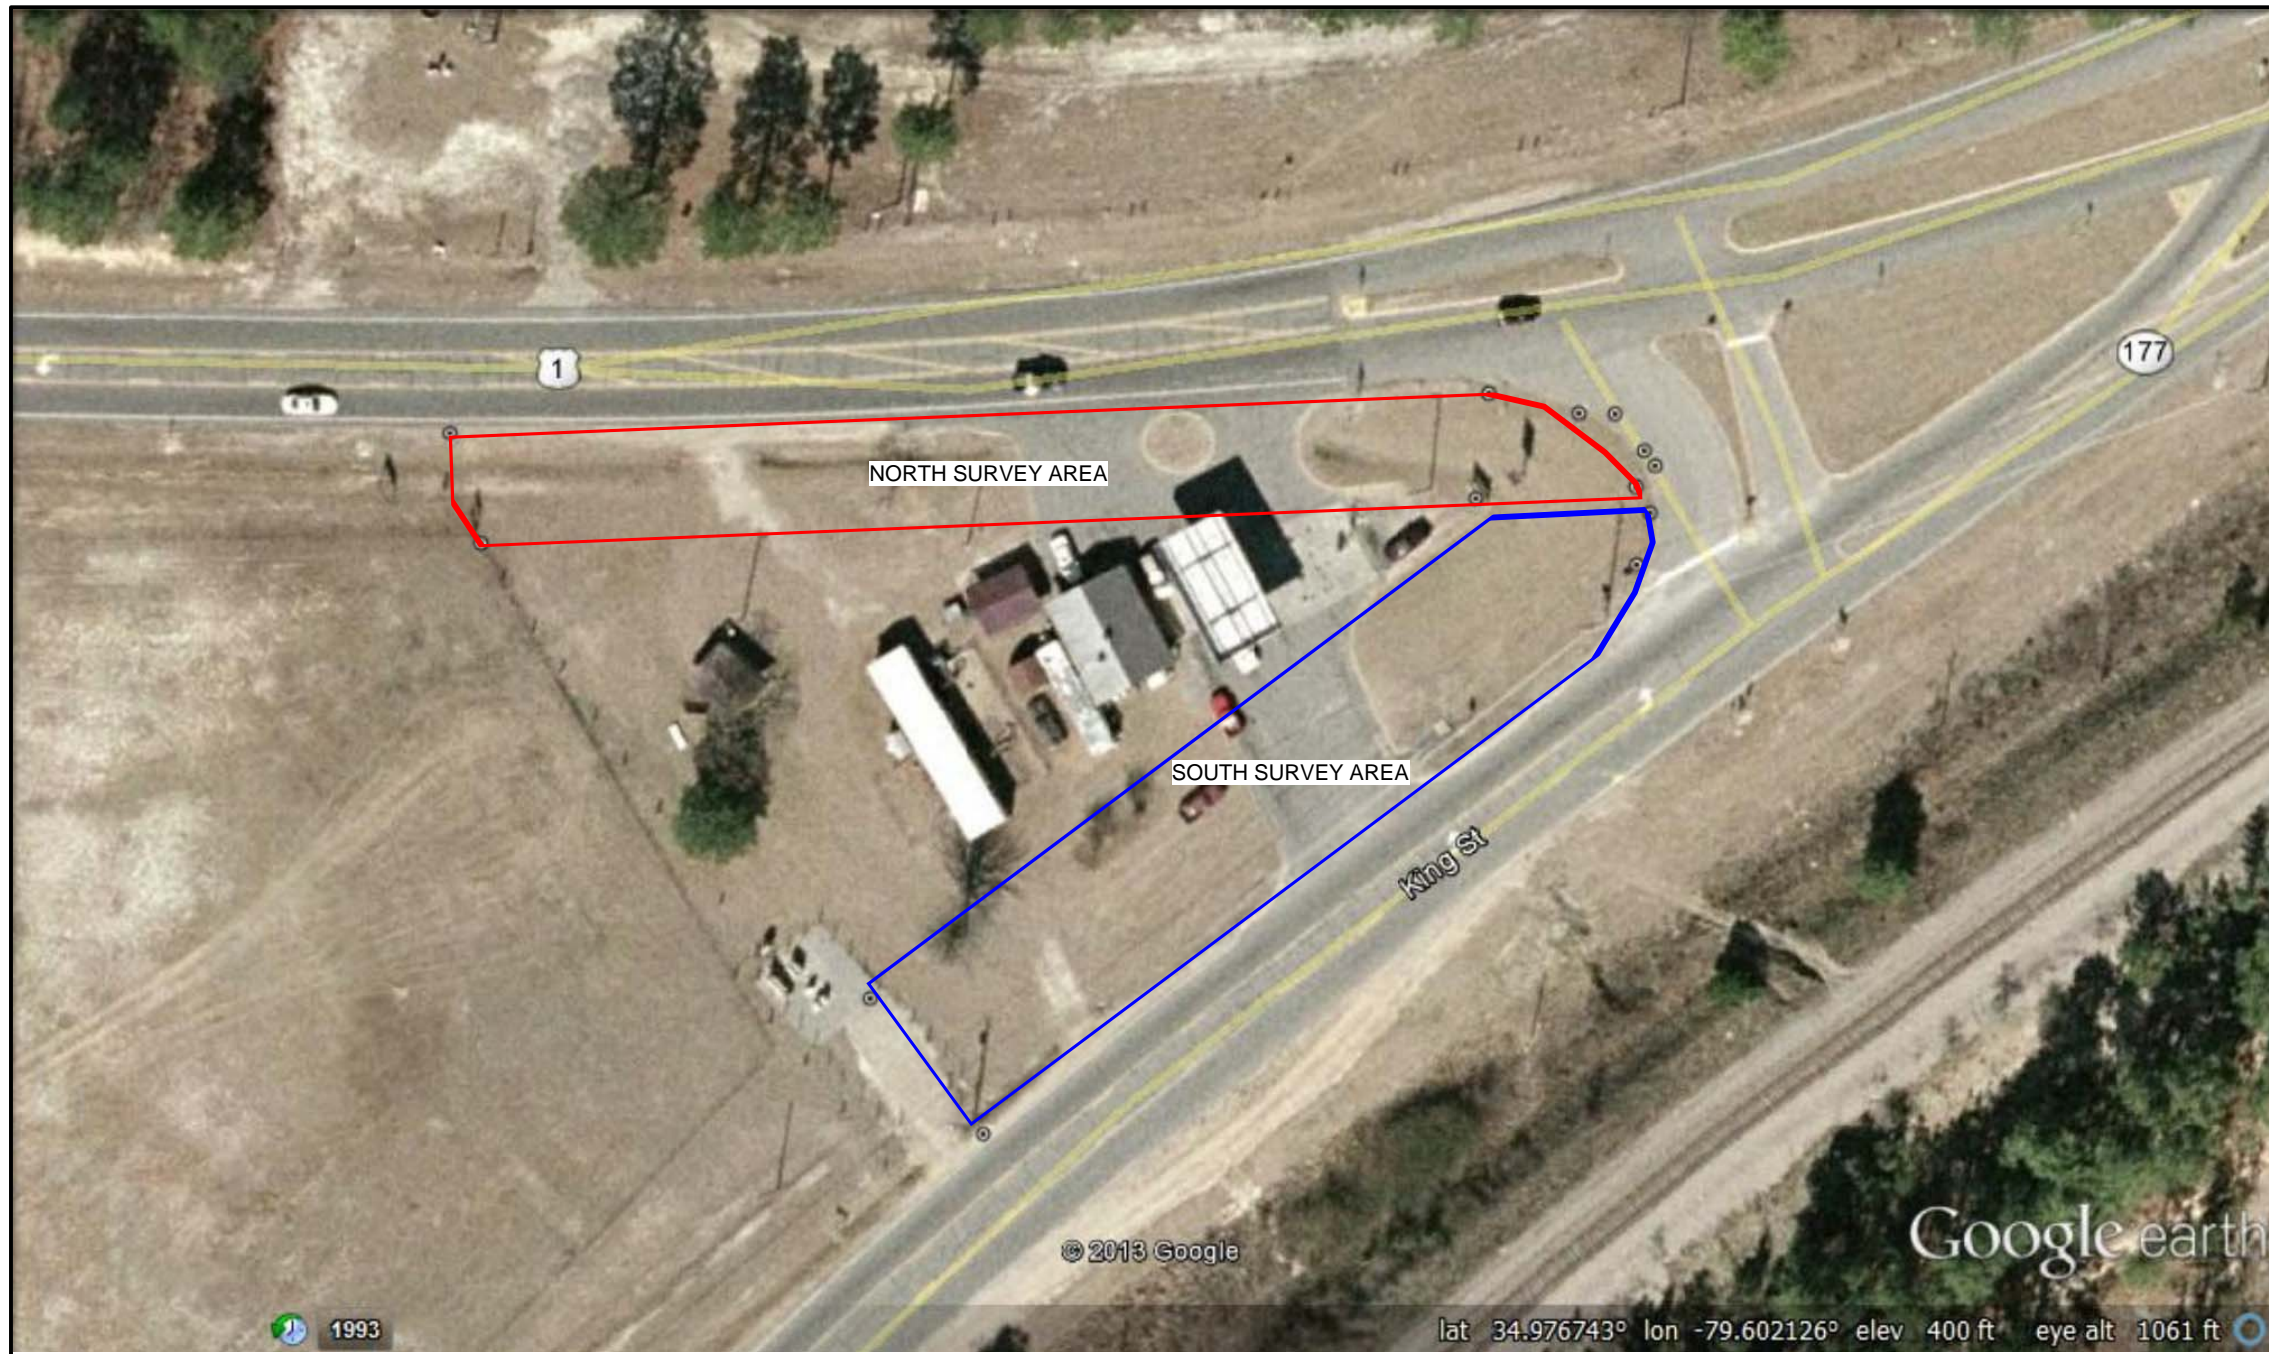
Approximate Boundaries of the Geophysical Survey Area

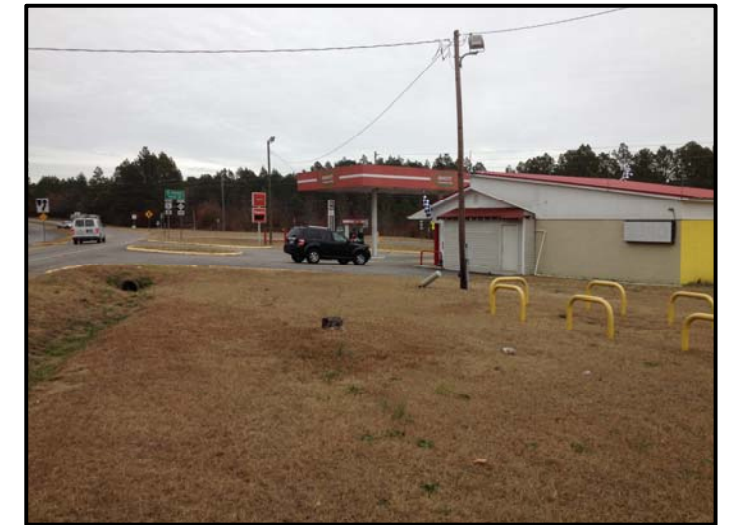
View of North Survey Area  
(Facing Approximately East)

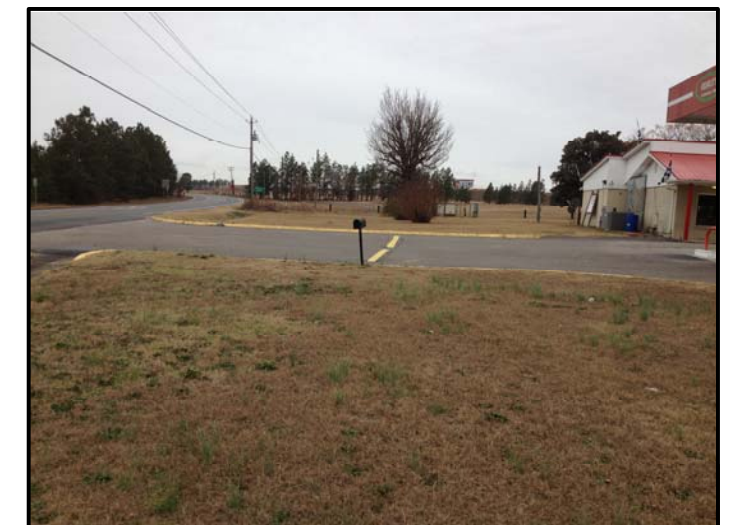
View of South Survey Area  
(Facing Approximately West)

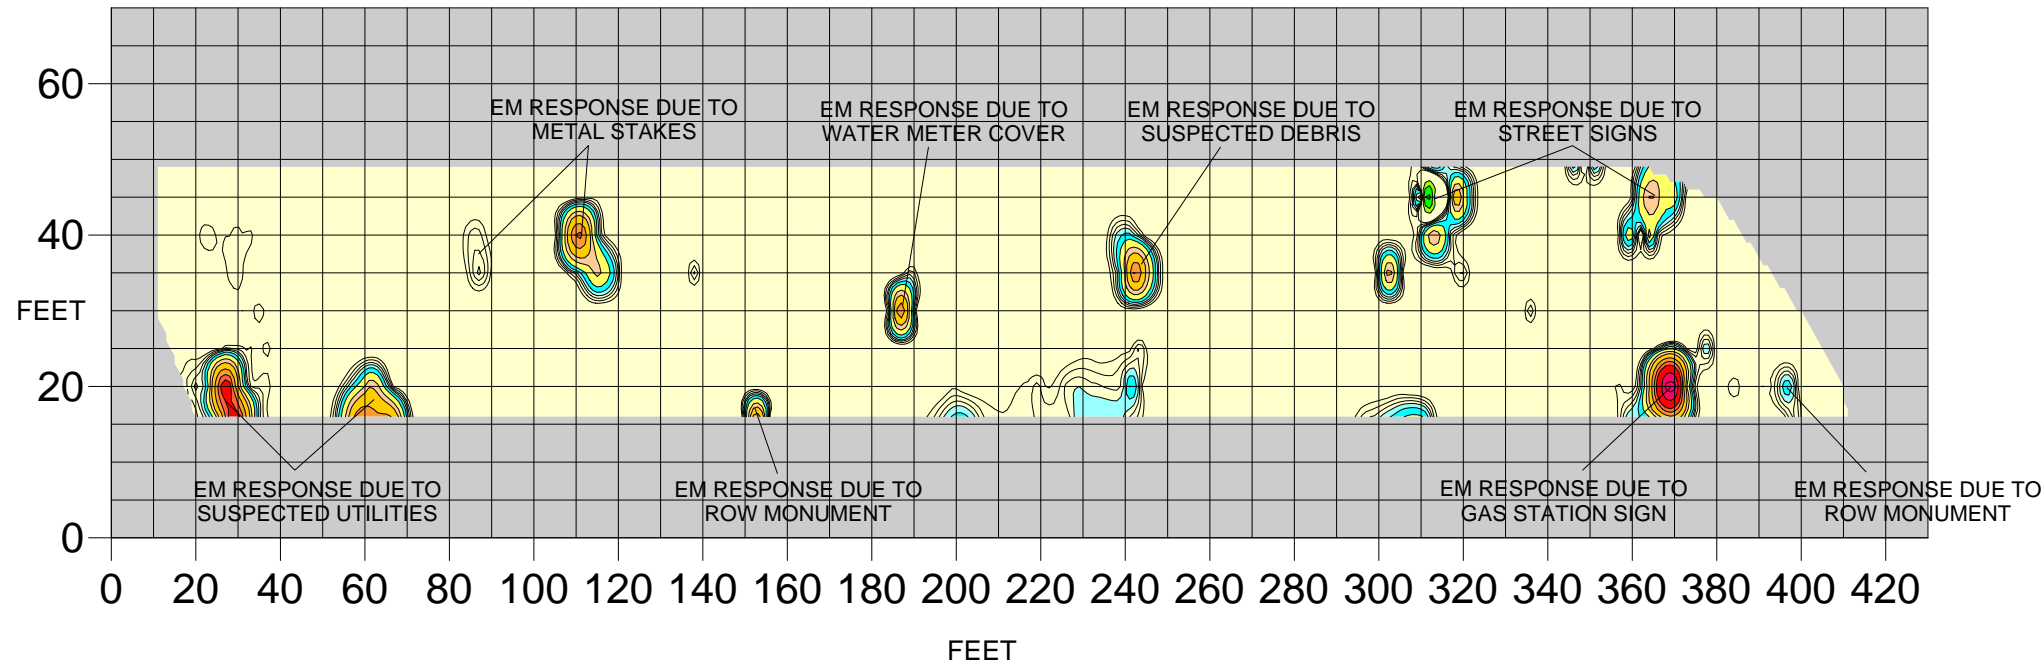
### EM61 Bottom Coil Results (North Grid Area)

### NO EVIDENCE OF METALLIC USTs OBSERVED

The contour plots show the bottom coil (most sensitive) and differential results of the EM61 instrument in millivolts (mV). The bottom coil response shows buried metallic objects regardless of size. The differential response focuses on larger, buried metallic objects such as drums and USTs and ignores smaller miscellaneous buried, metal debris. The EM61 data were collected on December 5, 2013 using a Geonics EM61 instrument. Ground penetrating radar (GPR) data were collected on December 9, 2013, using a GSSI SIR 2000 unit coupled to a 400 MHz antennae.

Pyramid performed an electromagnetic (EM) survey across the accessible portions of the Parcel. The majority of the EM61 anomalies in the north survey area could be attributed to visible objects at the ground surface such as signs, culverts, and other cultural features. All of the EM61 anomalies in the south survey area could be attributed to visible objects at the ground surface such as signs, culverts, and other cultural features, or were too minor to be considered USTs. GPR surveys performed across the two anomalies at the southwest boundary of the north survey area recorded evidence of possible utilities or other structures. The lack of significant definition to these structures resulted in classifying them as “no confidence” in terms of metallic USTs.
