GEOTECHNICAL DEC 06 2001

PRELIMINARY SITE ASSESSMENT  
APPROXIMATELY 4.29 ACRES ALONG  
NORFOLK SOUTHERN RAILROAD  
MECKLENBURG COUNTY, NORTH CAROLINA  
STATE PROJECT NO. 9.9081000 (P-3800)

Prepared for:  
NCDOT Geotechnical Unit  
1589 Mail Service Center  
Raleigh, North Carolina 27699-1589

Prepared by:  
Solutions Industrial & Environmental Services, Inc.  
3722 Benson Drive  
Raleigh, North Carolina 27609

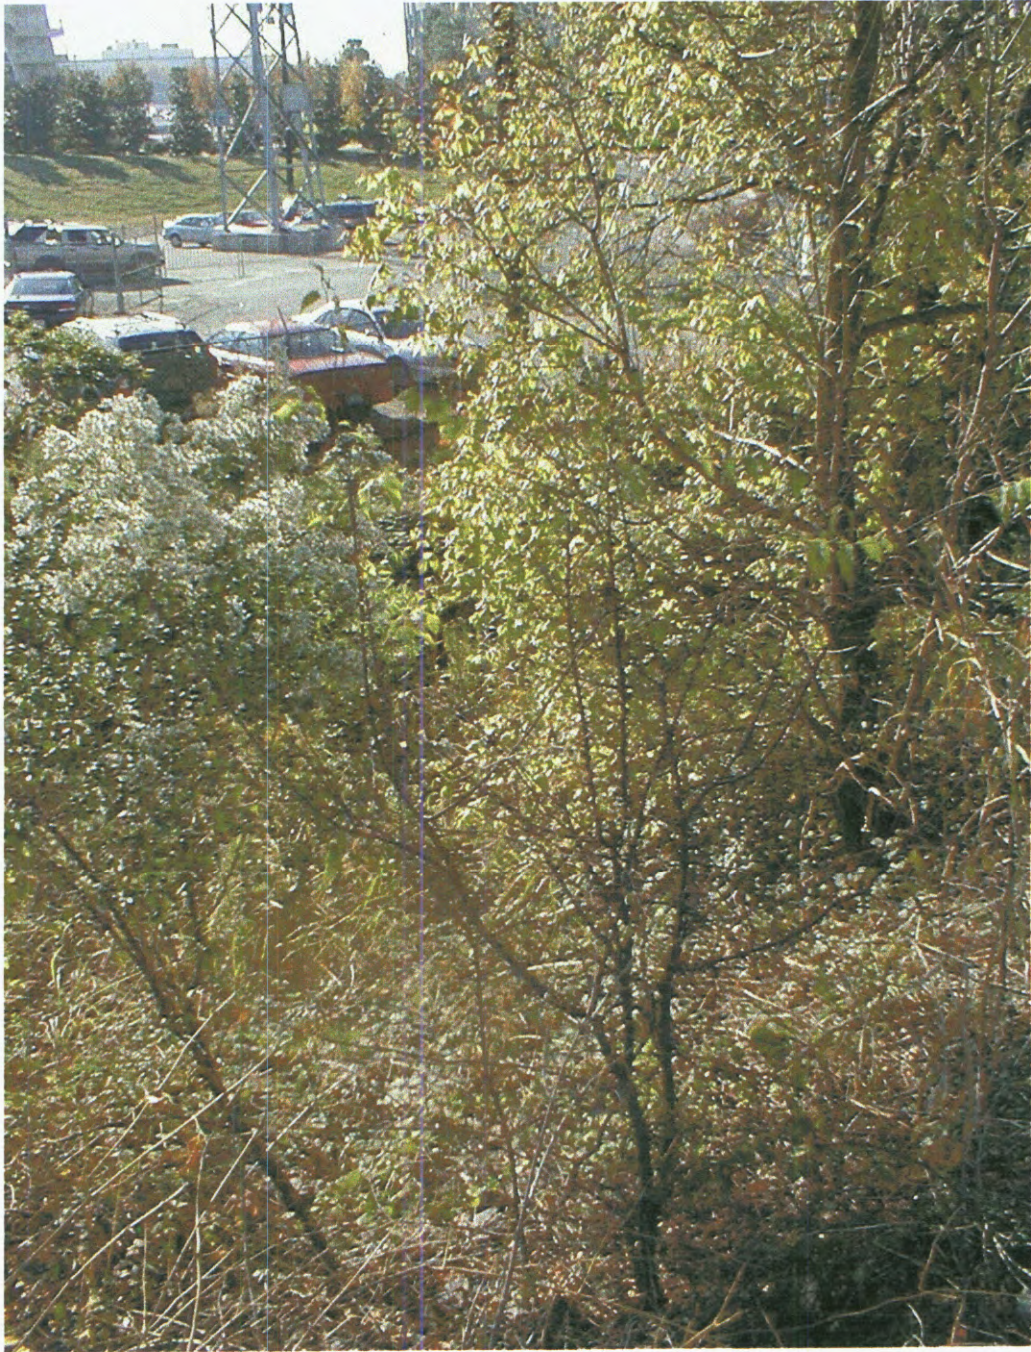
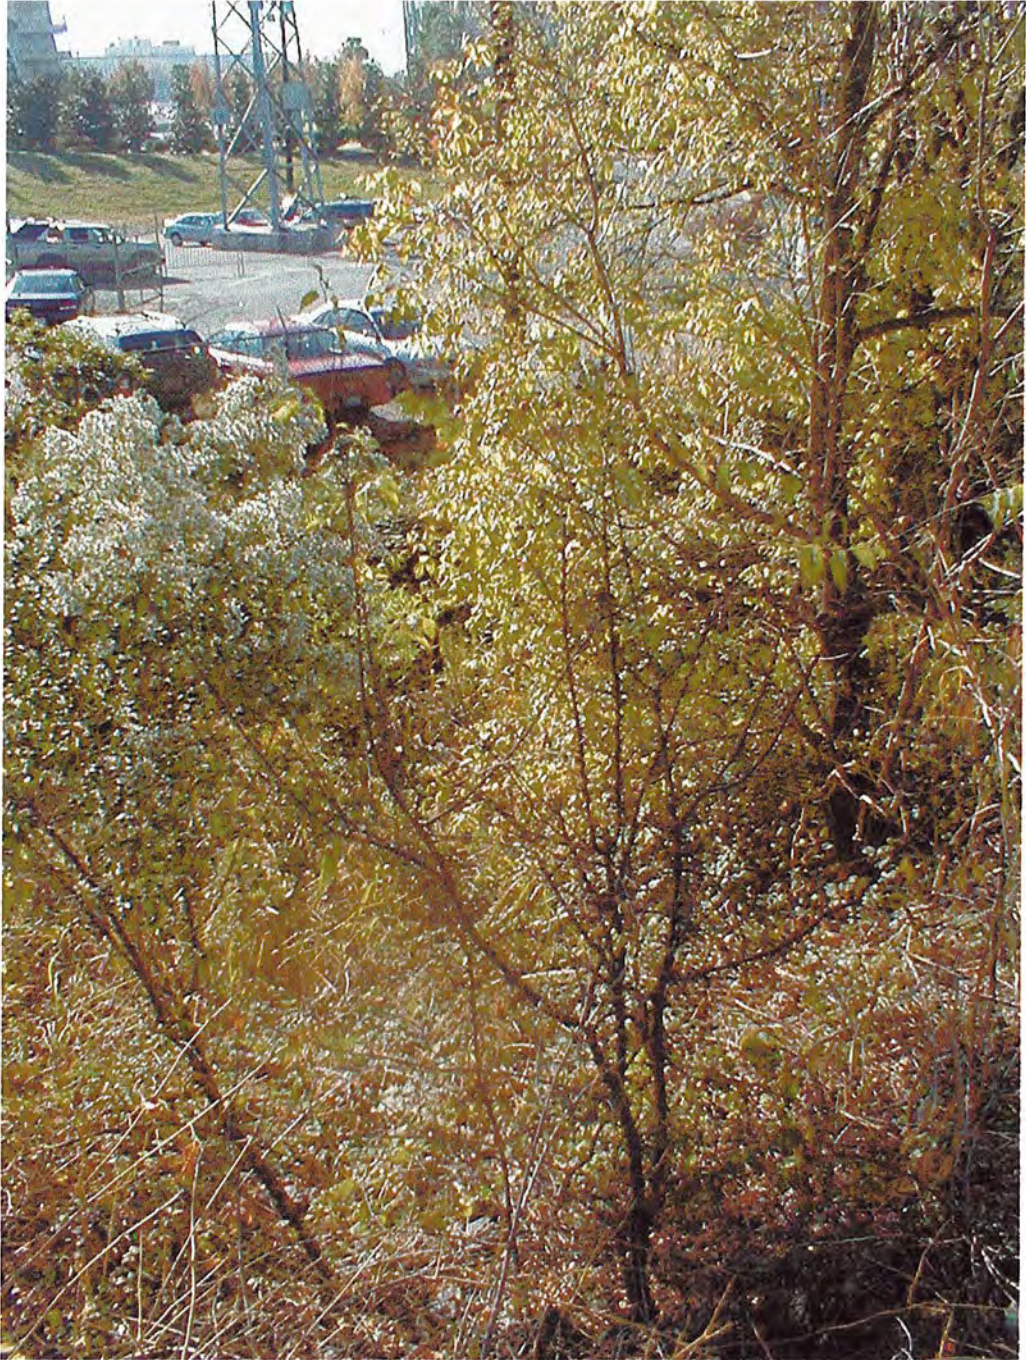
**Photograph 1 Approximate location of SB-1**

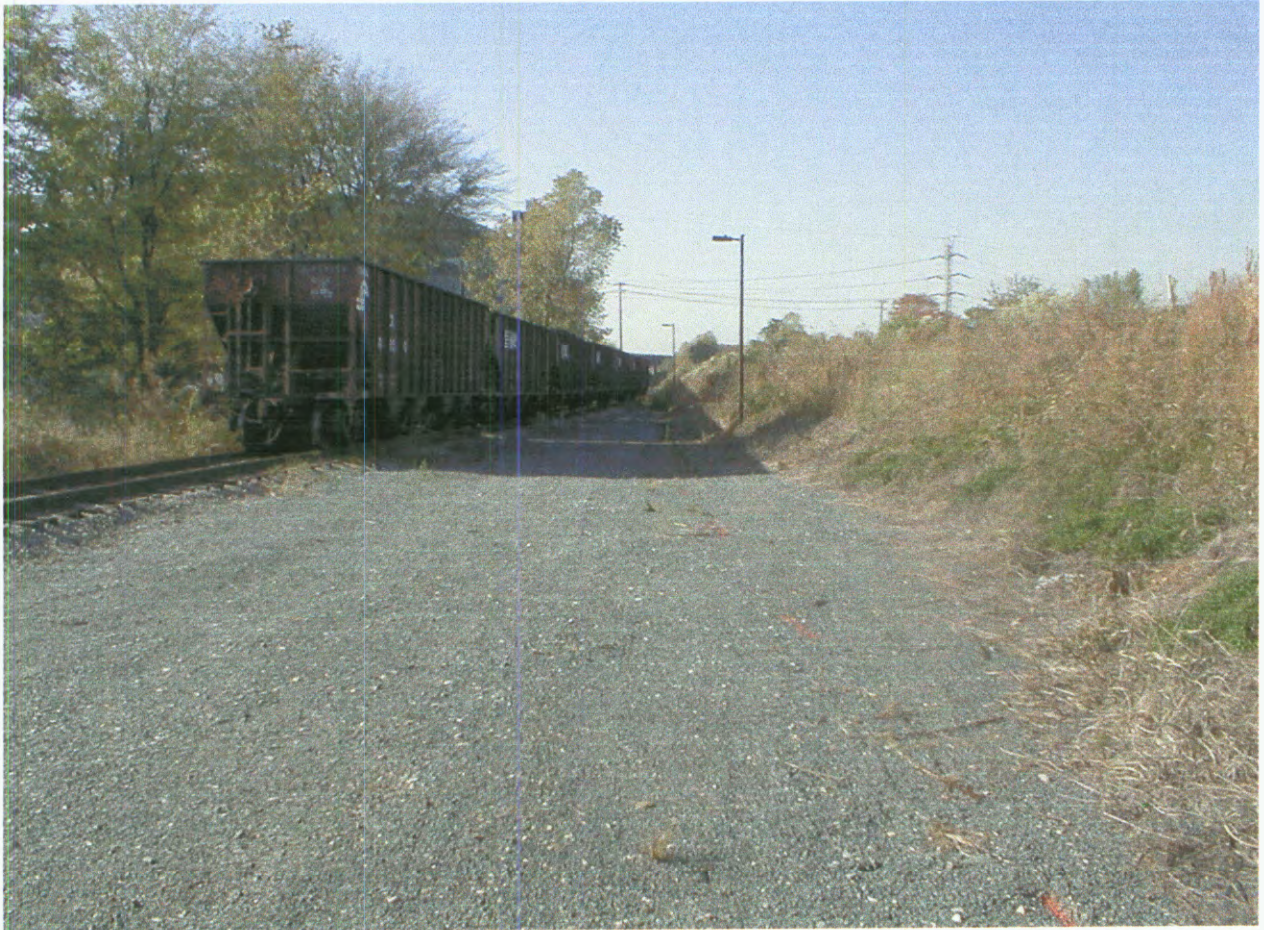
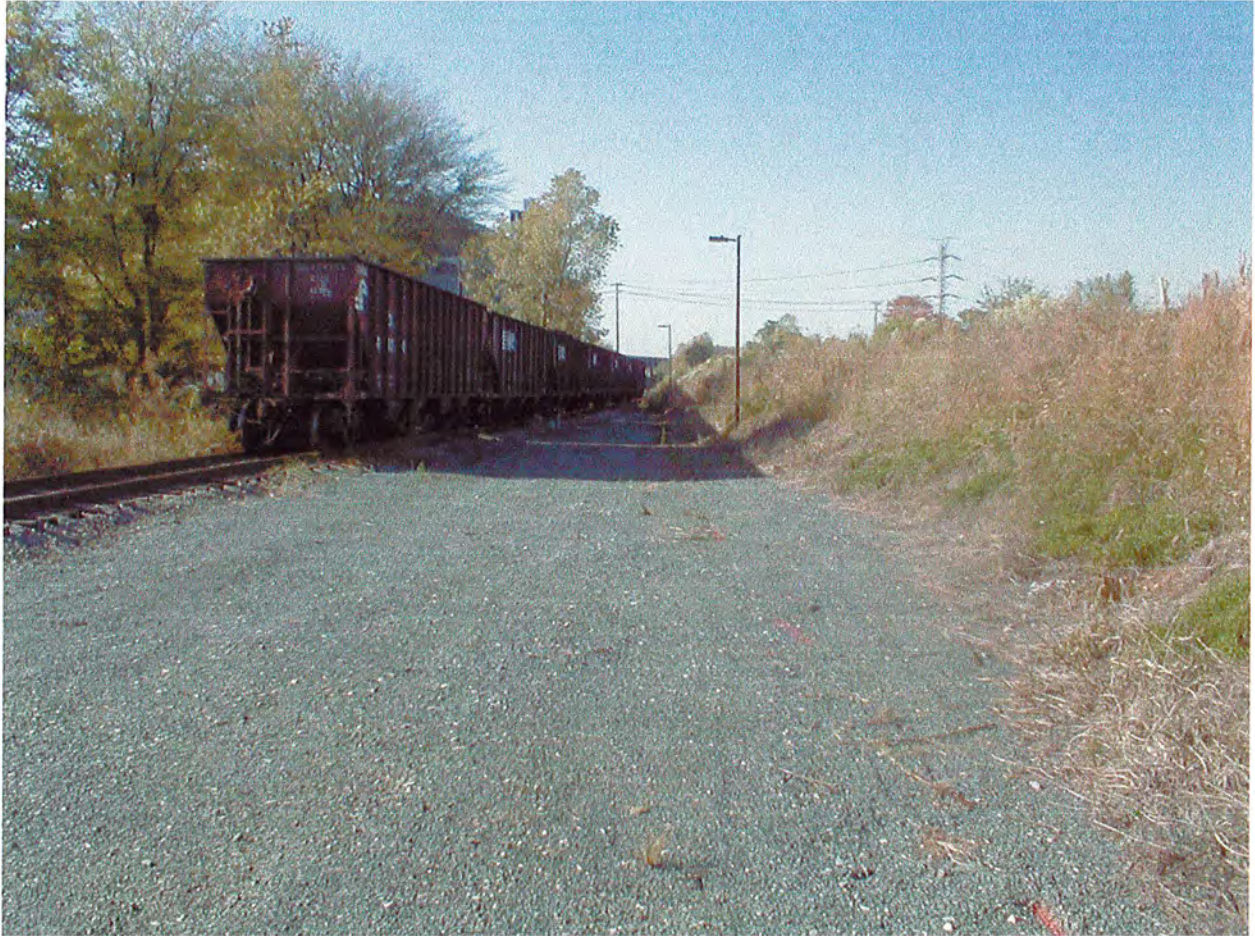
Within Parcel 2, the main line tracks are elevated on embankment fill. The fill slopes are vegetated and the portion of the property located east of the embankment slope is at street grade (10 to 15 feet below the mainline rail elevation (Photograph 1) and covered with gravel. There is an existing spur line, identified in the Feasibility Study as the "Old Team Track", extending through the parcel. Judging from the rusty rails, the spur line appears to be rarely used (Photographs 2 and 3). Parcel 2 is the largest of the four properties evaluated and encompasses approximately 3 acres. Parcel 2 was found to contain several underground utilities, including high voltage electric, cable television, and fiber optic telephone lines.

**Photograph 2 Parcel #2 facing southwest. Active railroad lines are on right.**

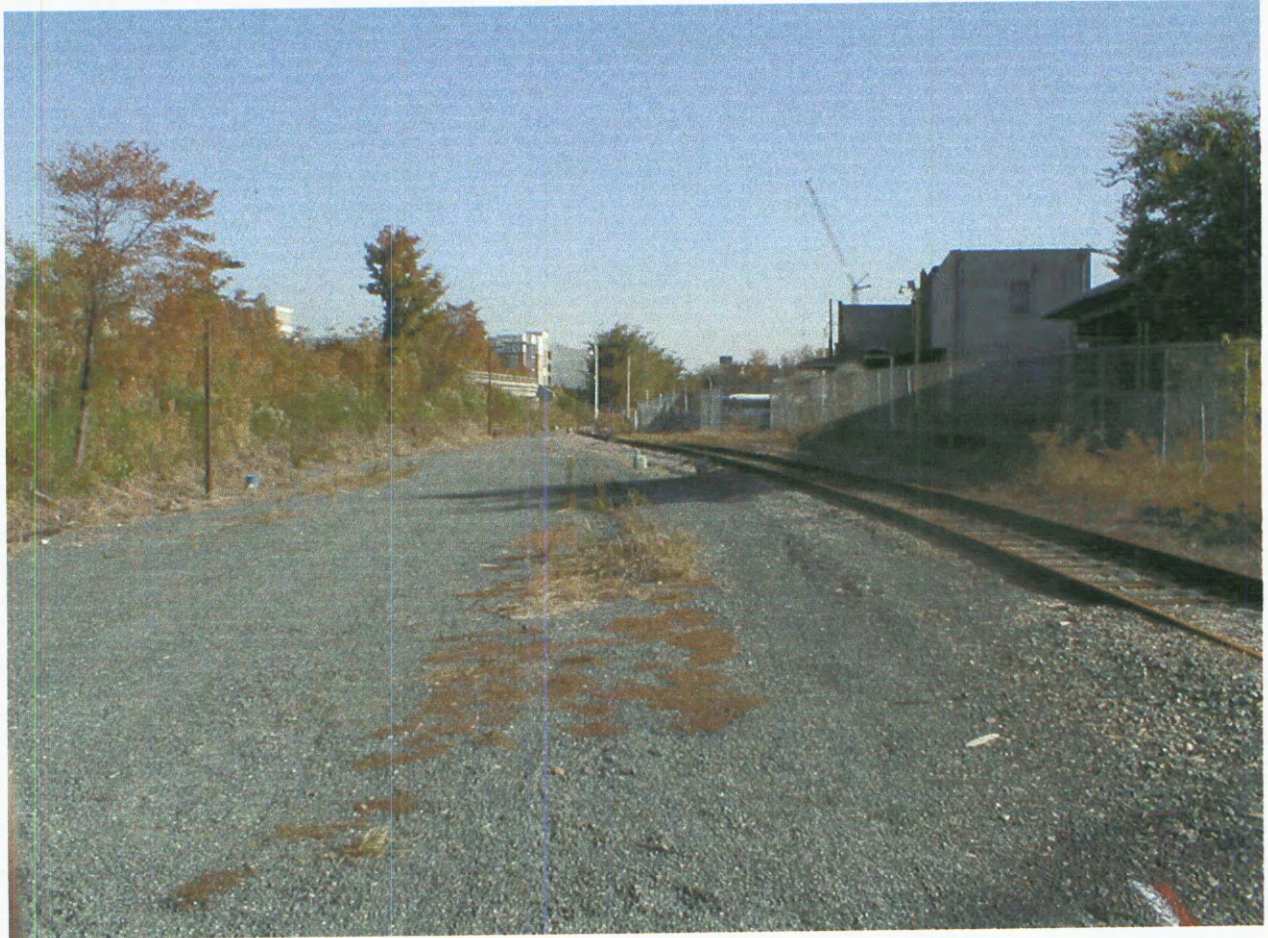
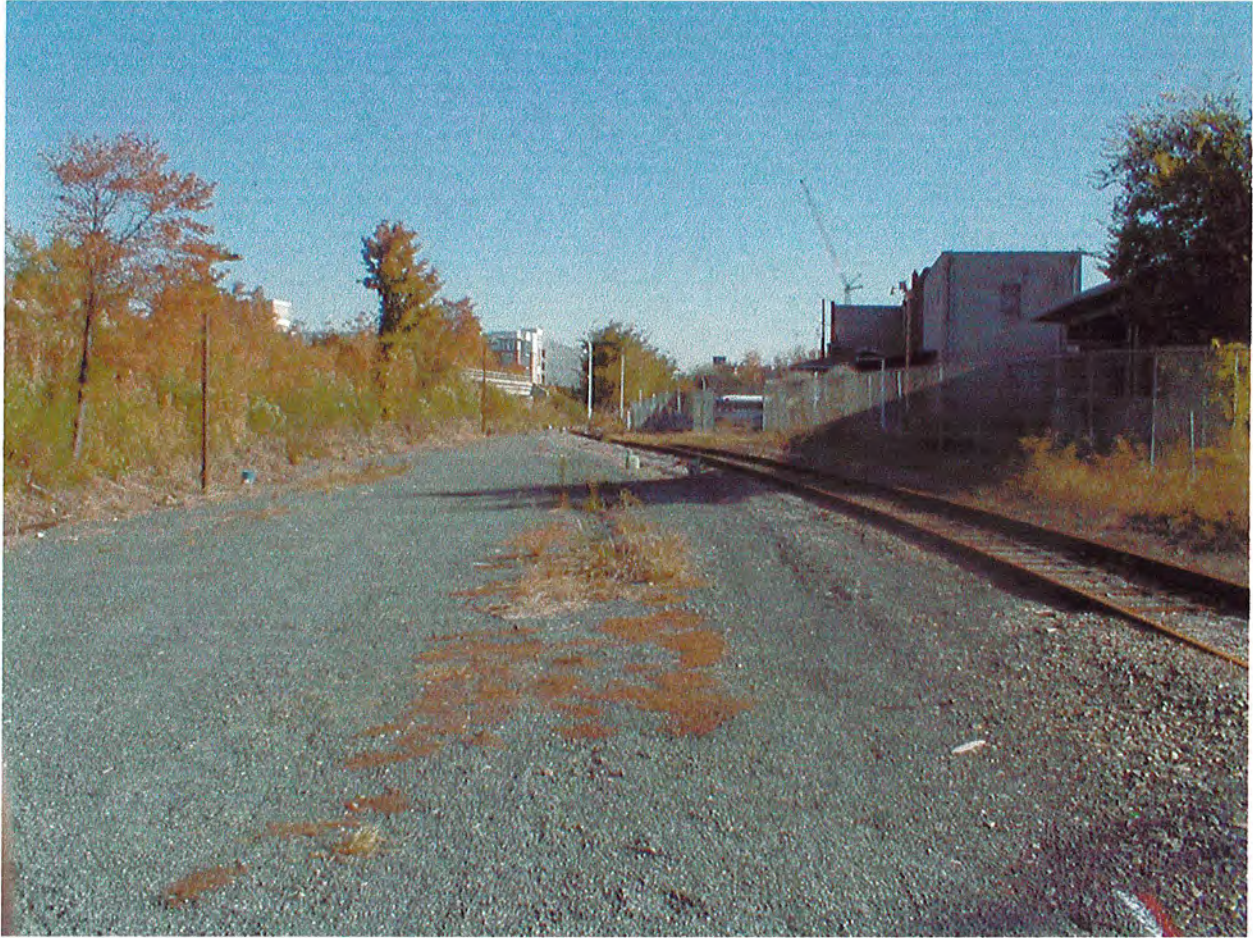
**Photograph 3 Parcel #2 facing northeast.**

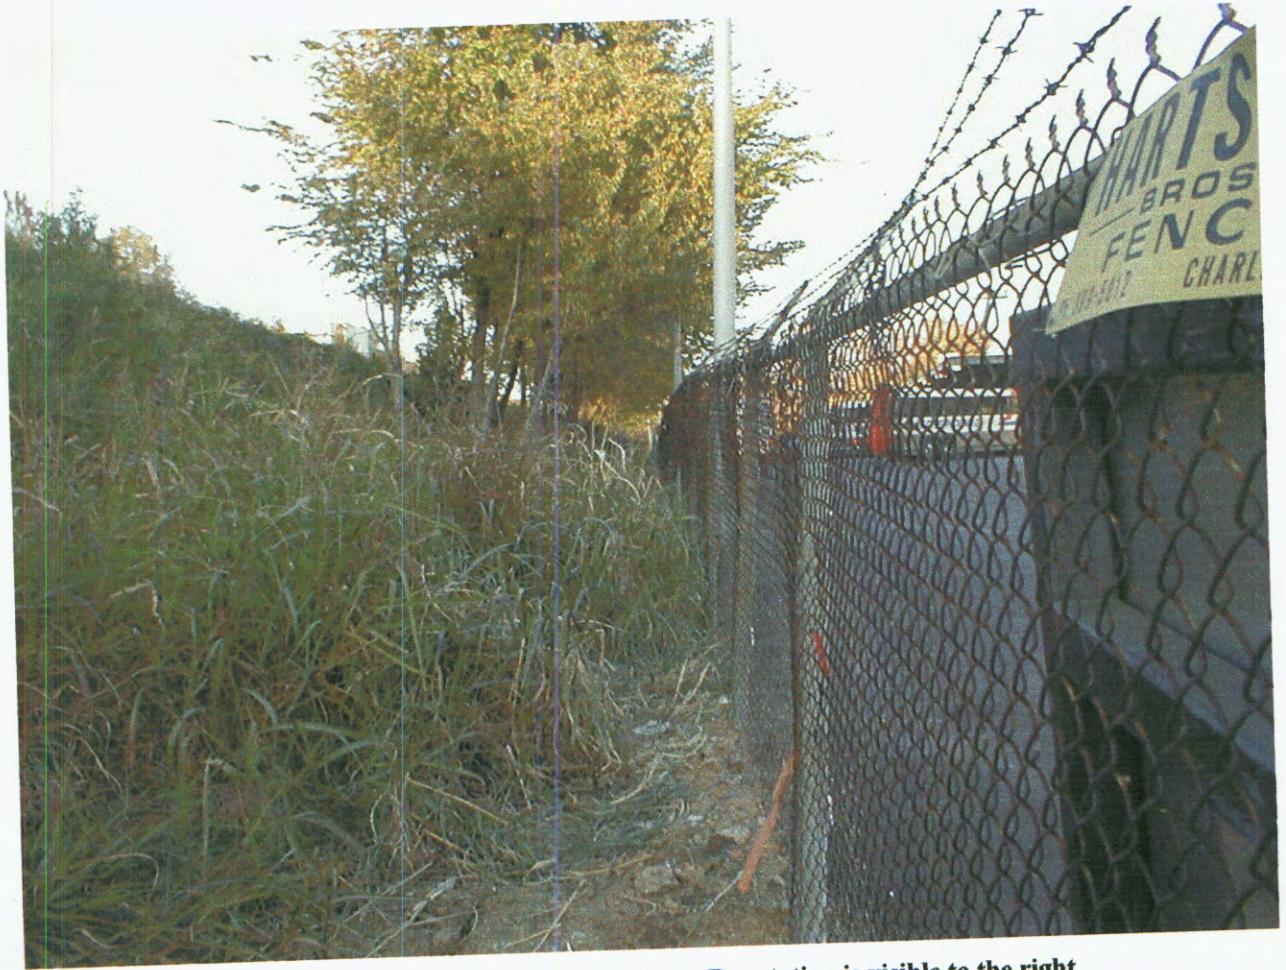
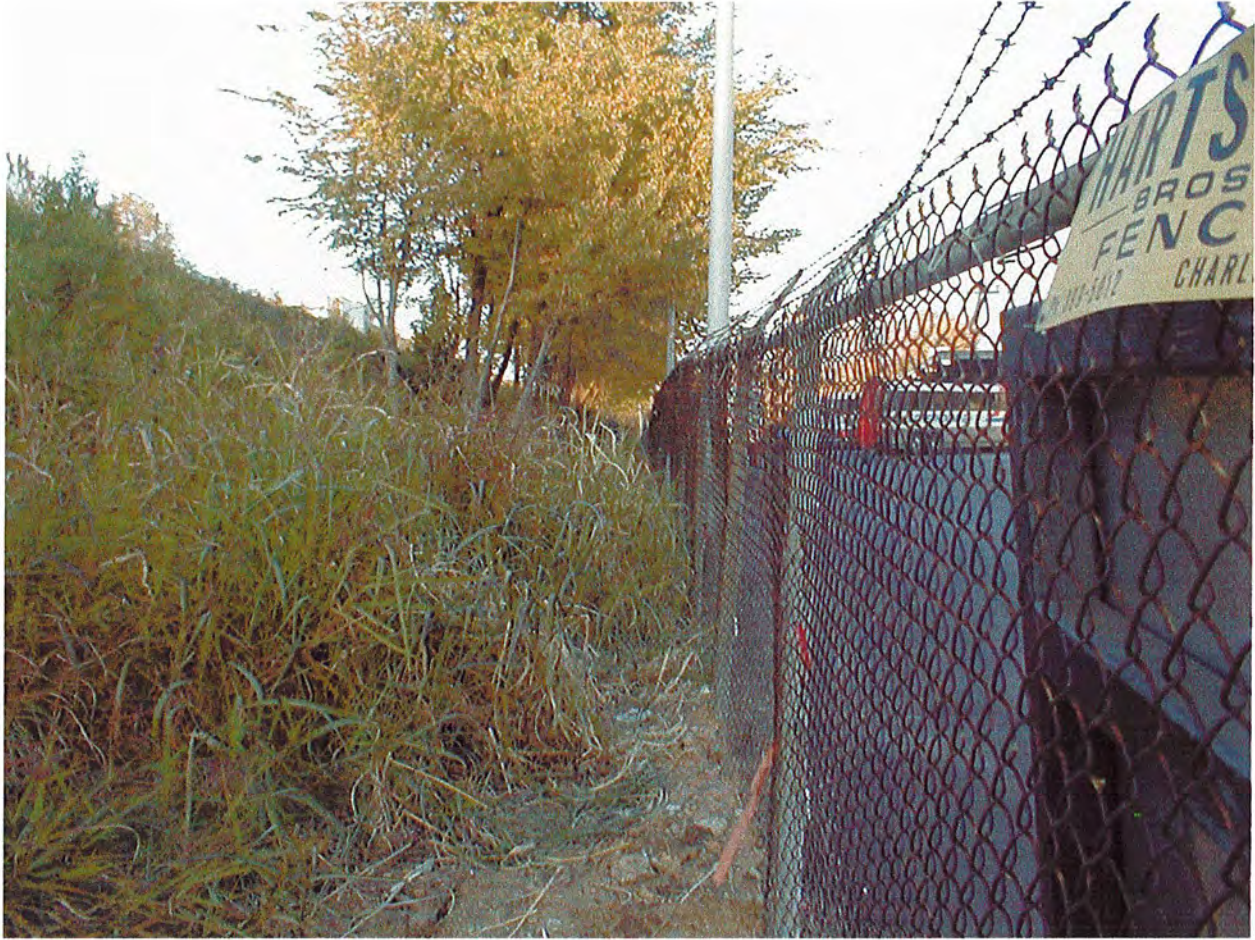
Parcel 4 encompasses approximately 0.21 acre, extending from West 4<sup>th</sup> Street and West Trade Street. The area near the perimeter fence is at street grade. The land slopes upward along the embankment slope to the main line tracks and is covered in overgrown scrub vegetation. The Greyhound bus station is located (southeast) of the perimeter fence (Photographs 4 and 5). We noted during our reconnaissance that the existing bus station has three diesel pumps and three vehicle-washing stations located on the

**Photograph 4 Parcel #4 facing northeast. Bus station is visible to the right.**

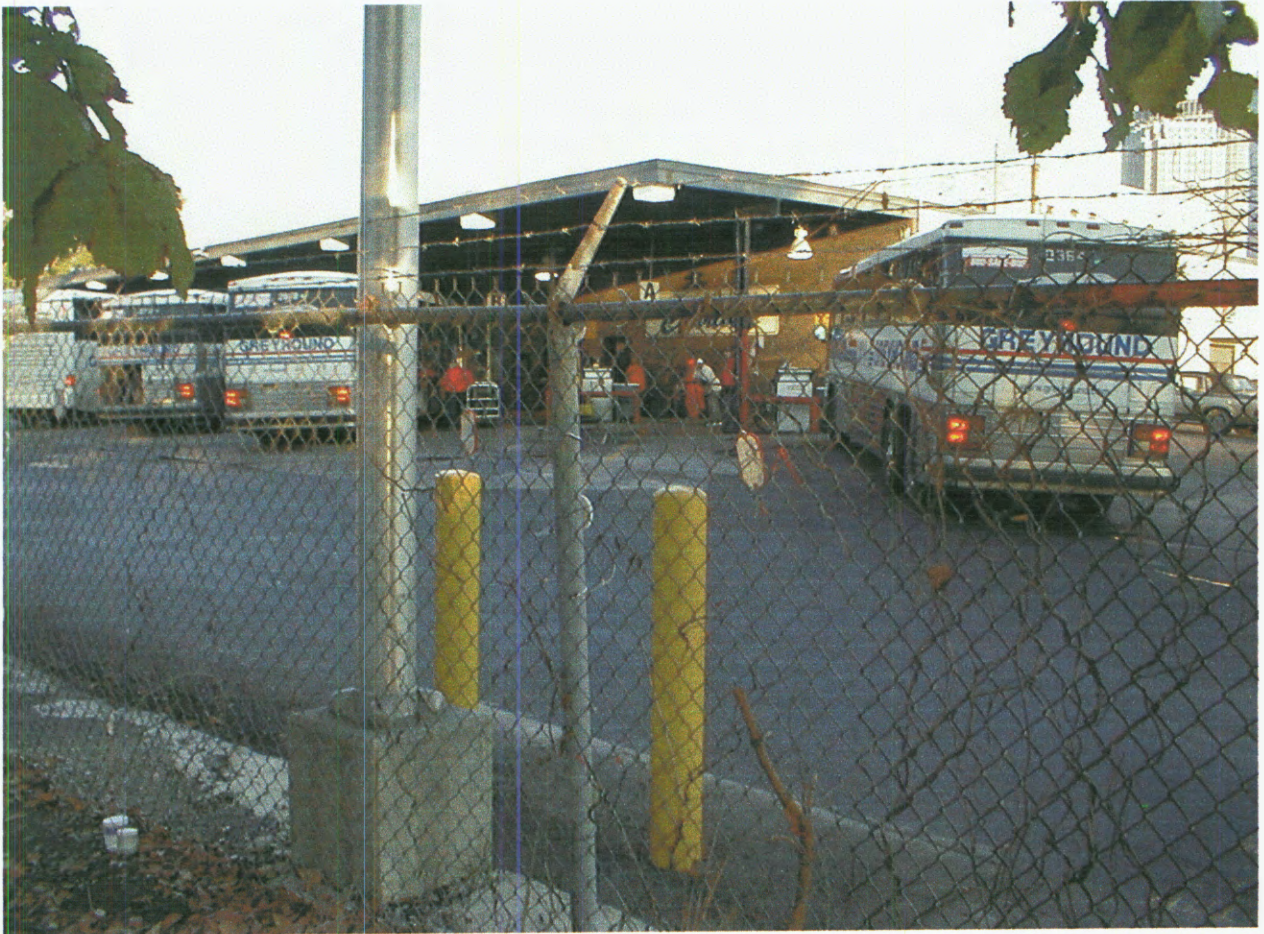
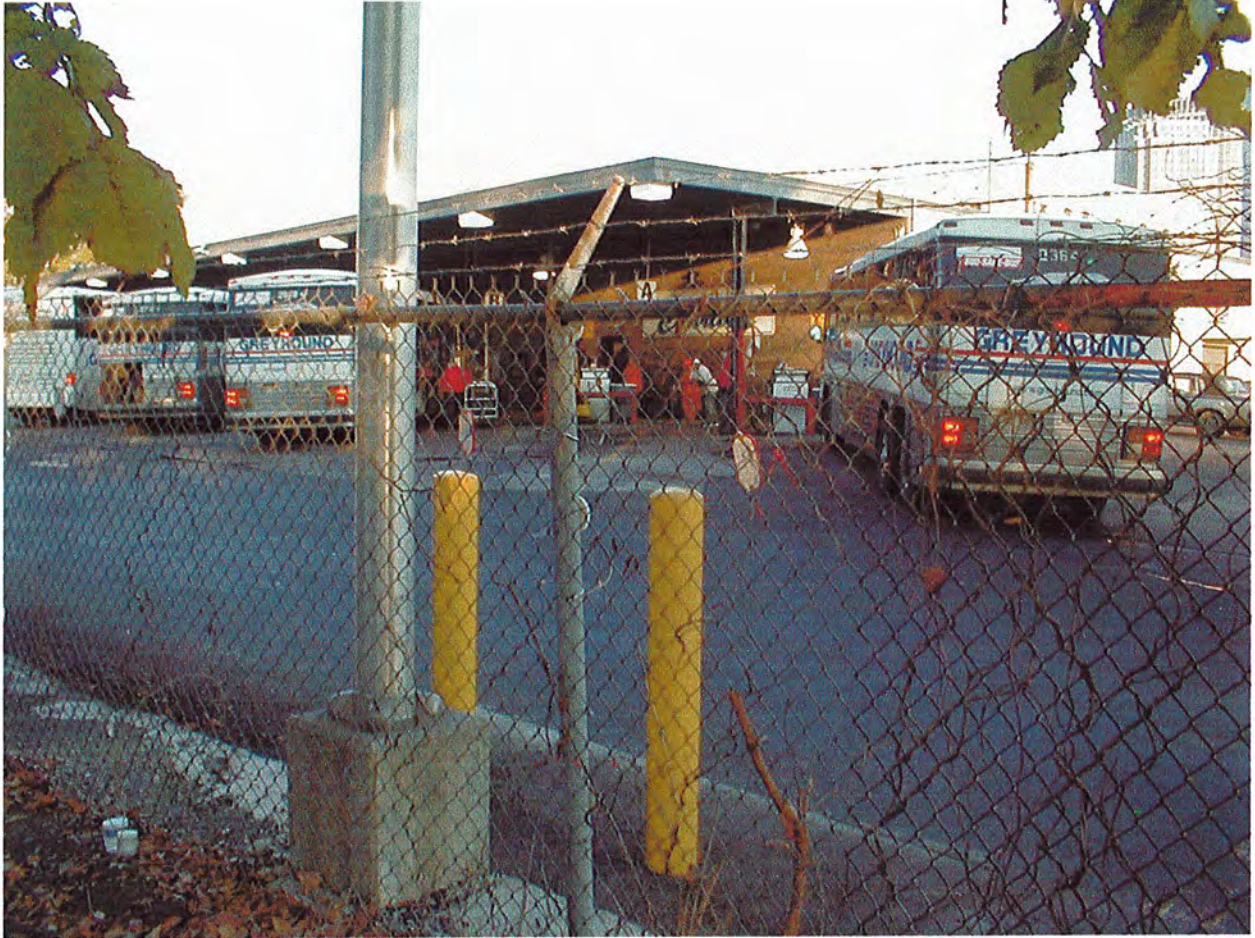
northwest side of the building (closest to Parcel 4). An existing 15,000-gallon underground storage tank (UST) is currently used for fueling busses.

**Photograph 5 Greyhound bus station viewed from Parcel #4. Diesel pumps are visible in background.**

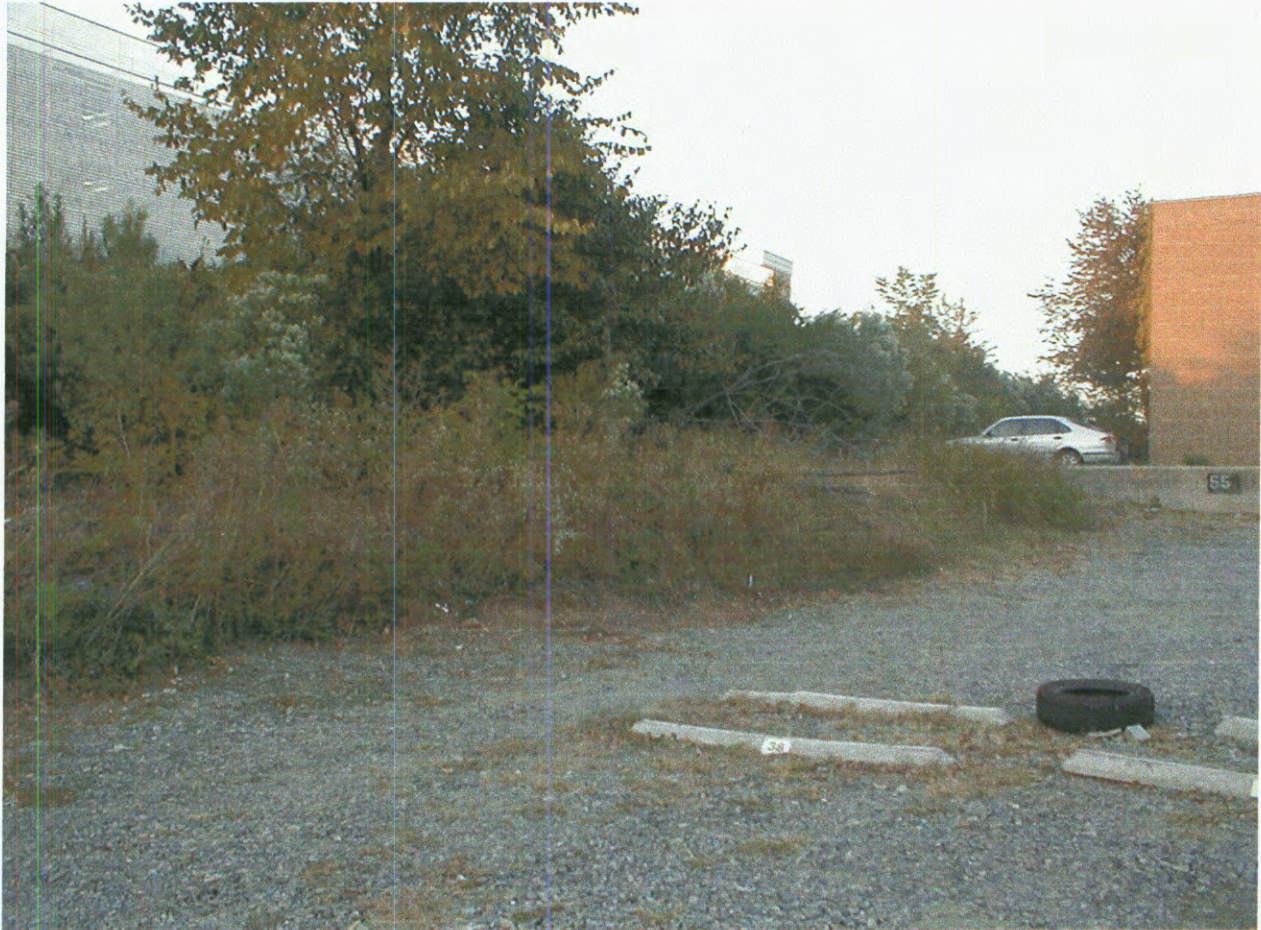
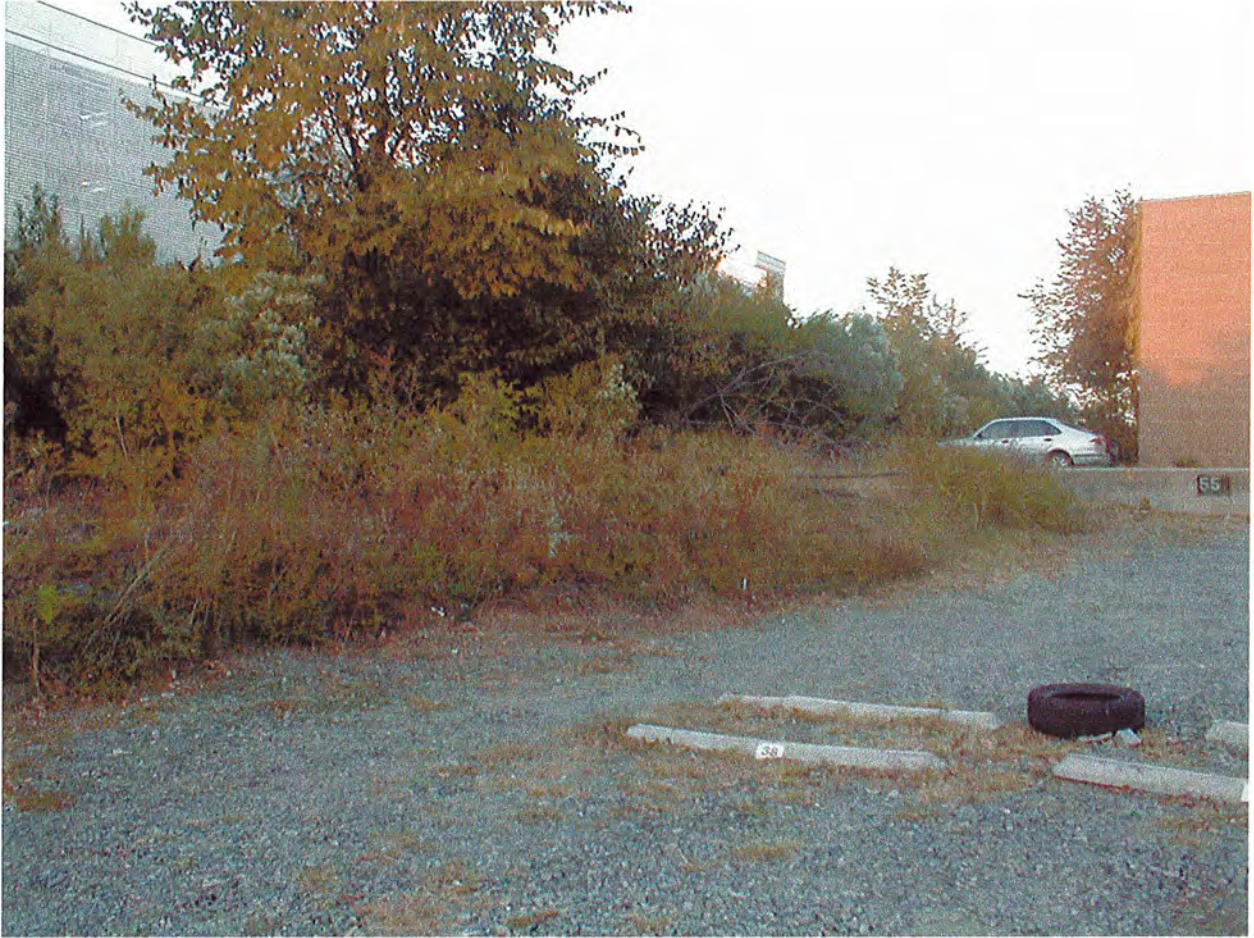
**Photograph 6 Gravel parking lots adjacent to Parcel #5.  
Business Storage Inc. warehouse is visible in background.**

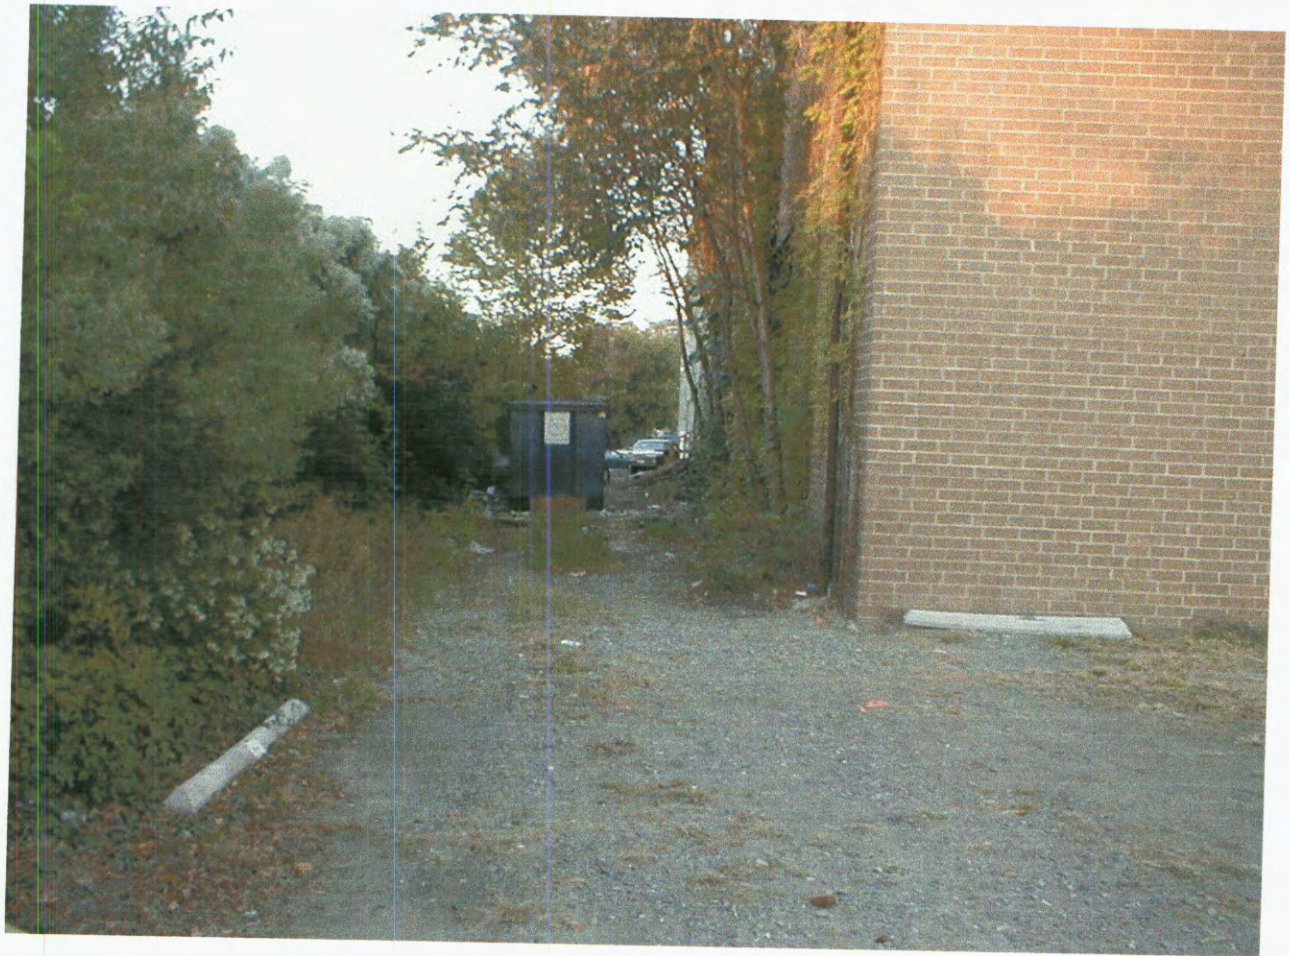
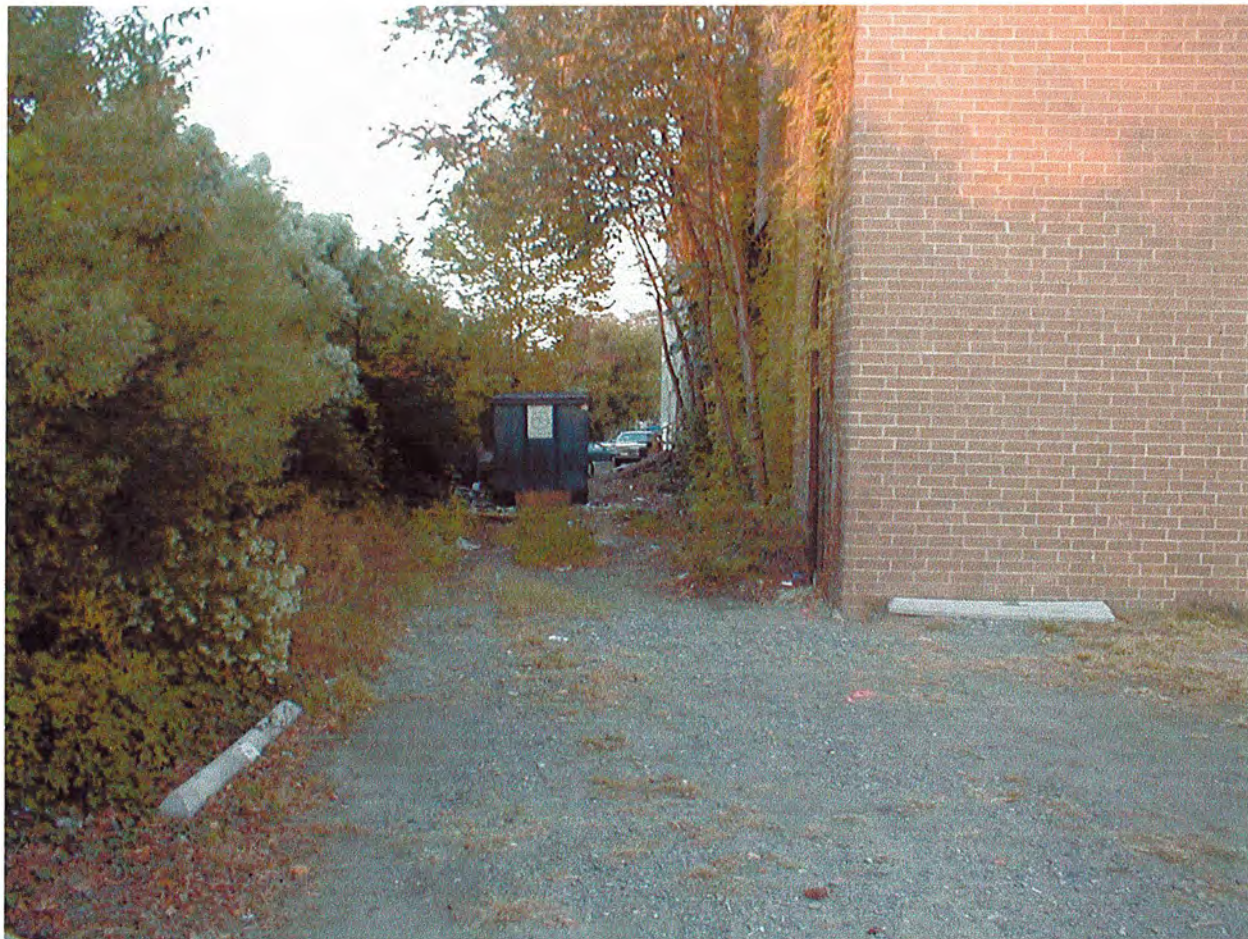
Parcel 5 comprises approximately 0.28 acres and extends along the east side of the main line rails from West Trade Street to West 5<sup>th</sup> Street. Most of the area east of the embankment fill is paved and is used as an alley way (Photograph 6) for the adjacent properties which include Witzens Art Gallery, Business Records Storage, Inc. warehouses, and two gravel parking lots. A solid waste container (dumpster) was observed in the alley behind the Business Records Storage, Inc. property (Photograph 7). Old, partially buried railroad tracks were observed in the alley.

**Photograph 7 Parcel #5.**

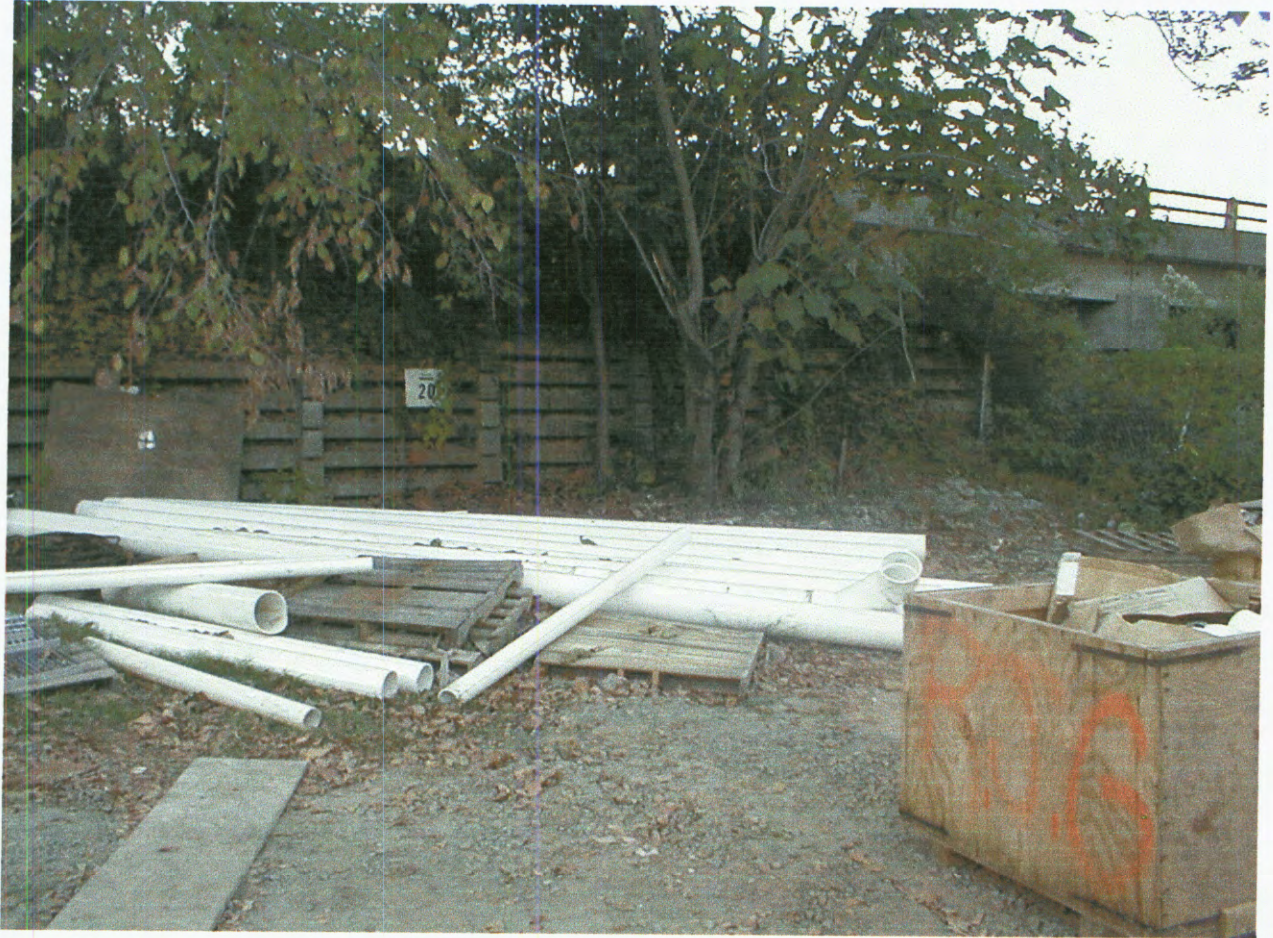
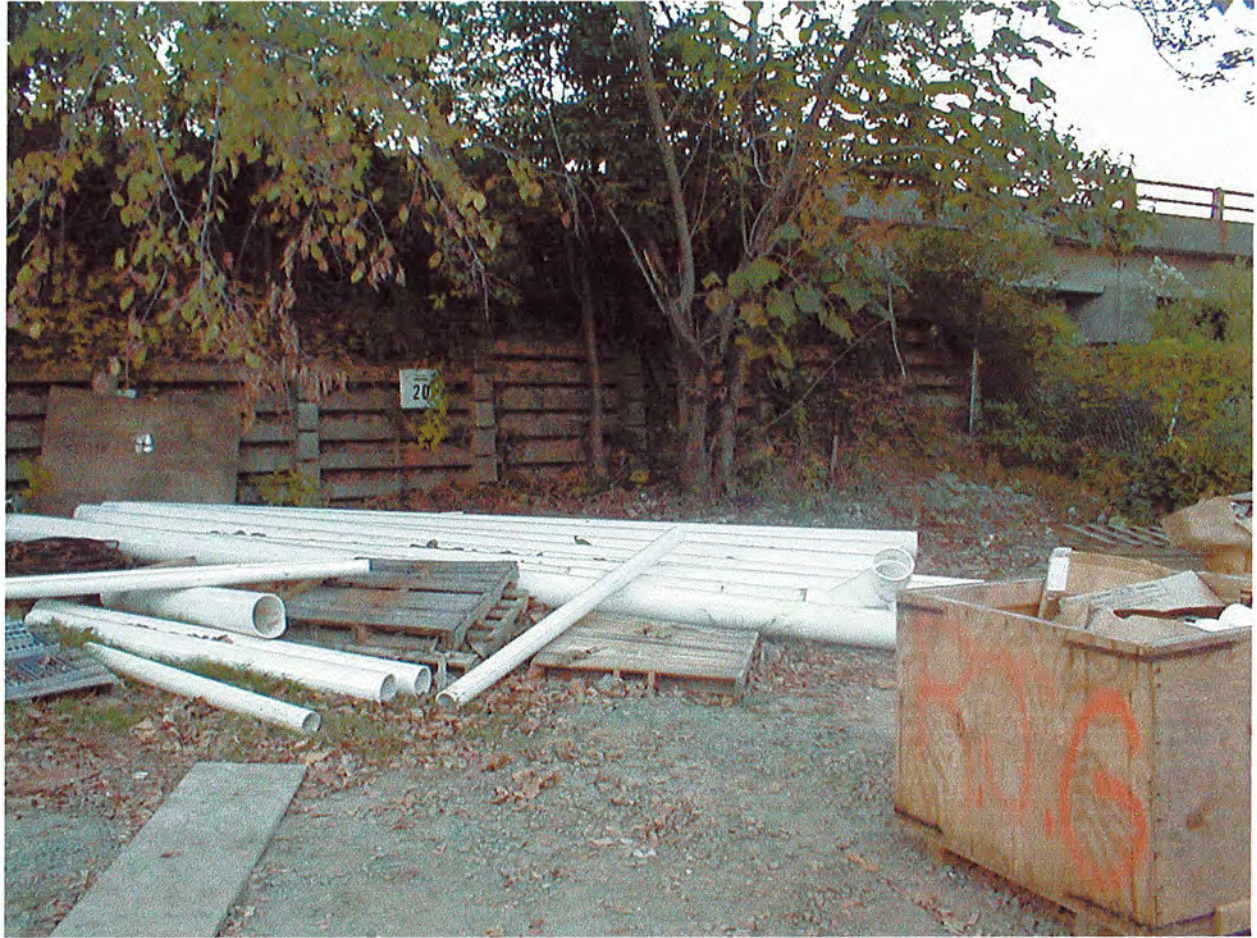
**Photograph 8 Location of SB-19.**

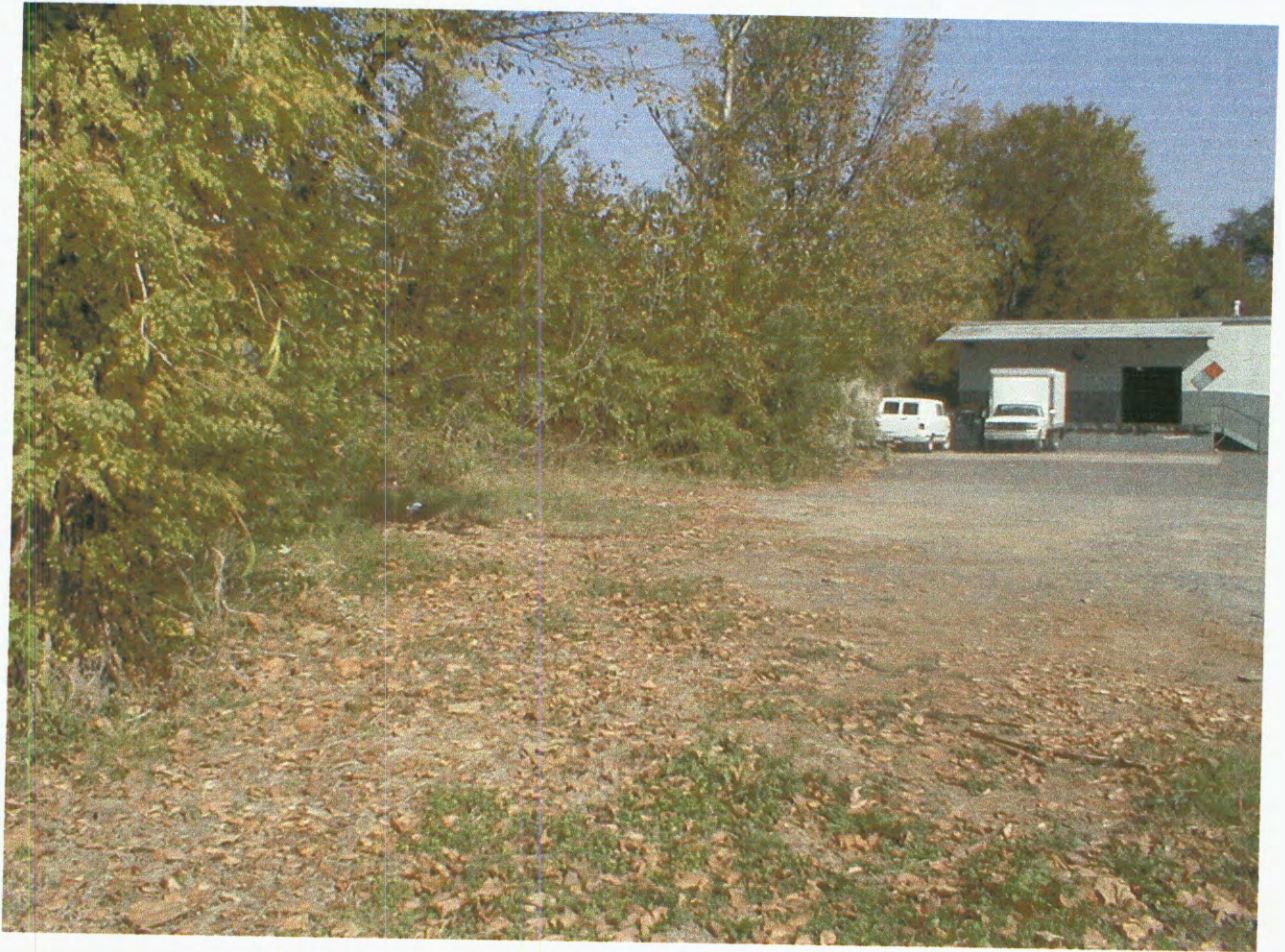
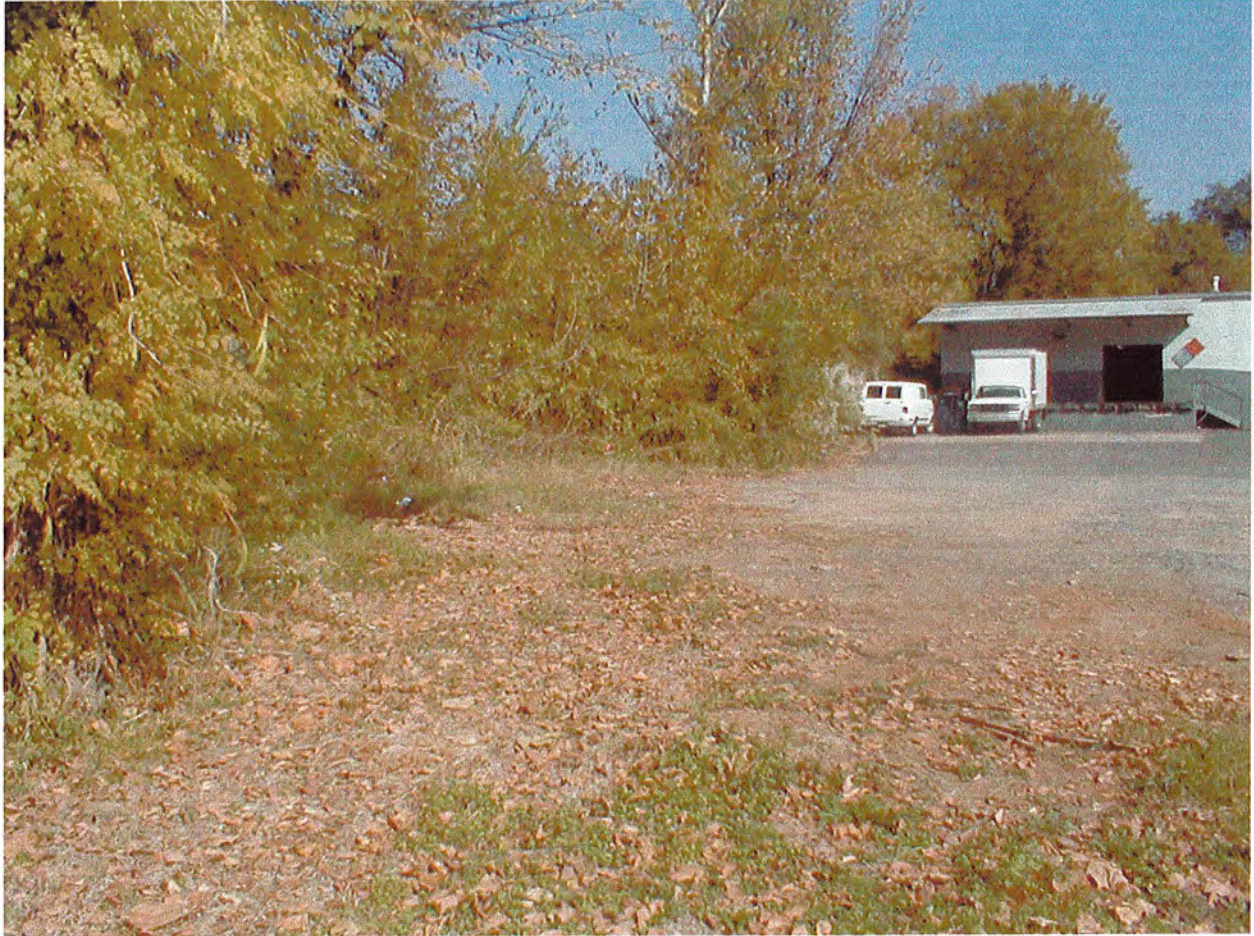
**Photograph 9 Parcel #7, Carolina Rim and Wheel property.**
