GEOTECHNICAL DEC 06 2001

PRELIMINARY SITE ASSESSMENT  
APPROXIMATELY 4.29 ACRES ALONG  
NORFOLK SOUTHERN RAILROAD  
MECKLENBURG COUNTY, NORTH CAROLINA  
STATE PROJECT NO. 9.9081000 (P-3800)

Prepared for:  
NCDOT Geotechnical Unit  
1589 Mail Service Center  
Raleigh, North Carolina 27699-1589

Prepared by:  
Solutions Industrial & Environmental Services, Inc.  
3722 Benson Drive  
Raleigh, North Carolina 27609

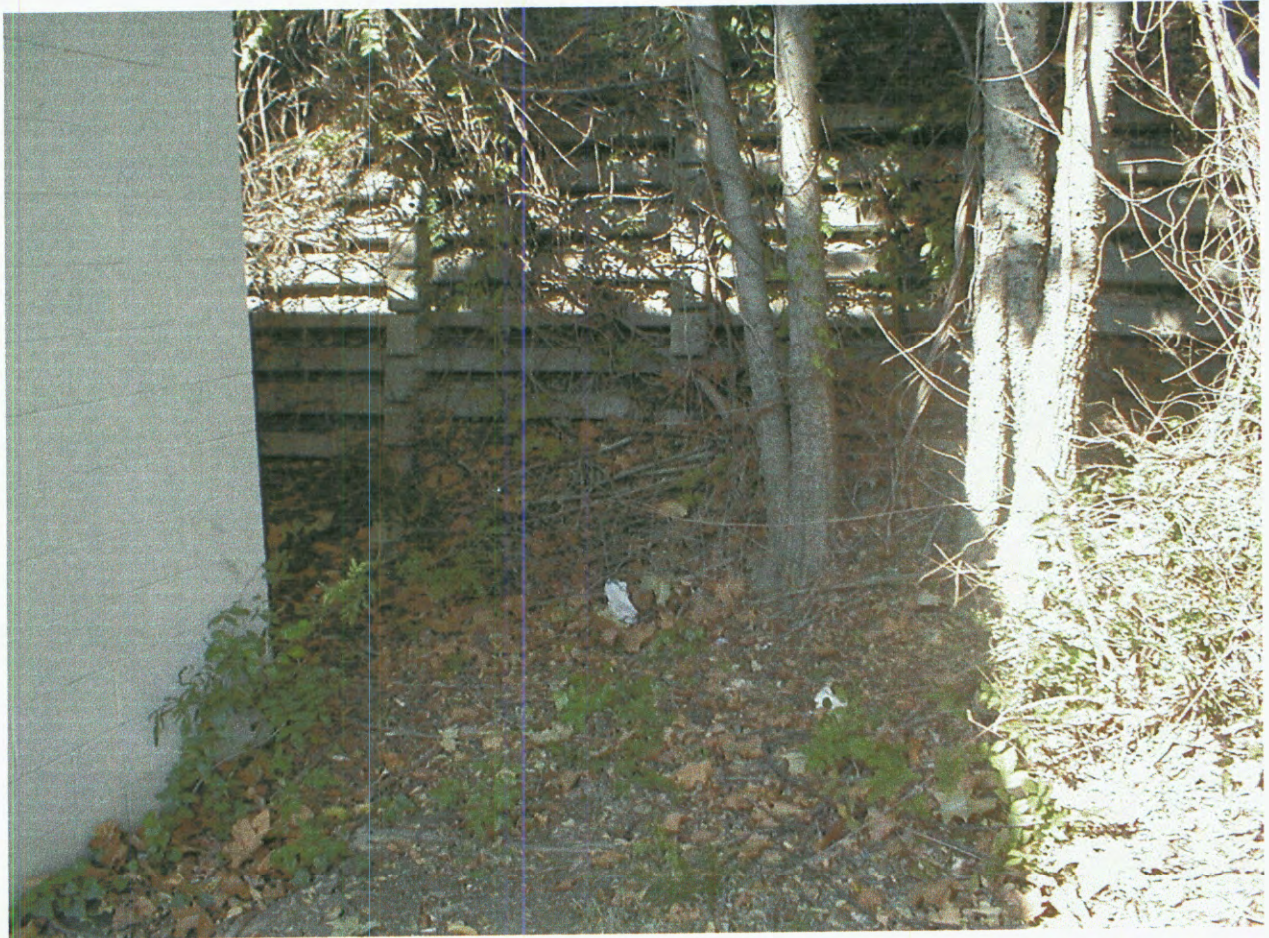
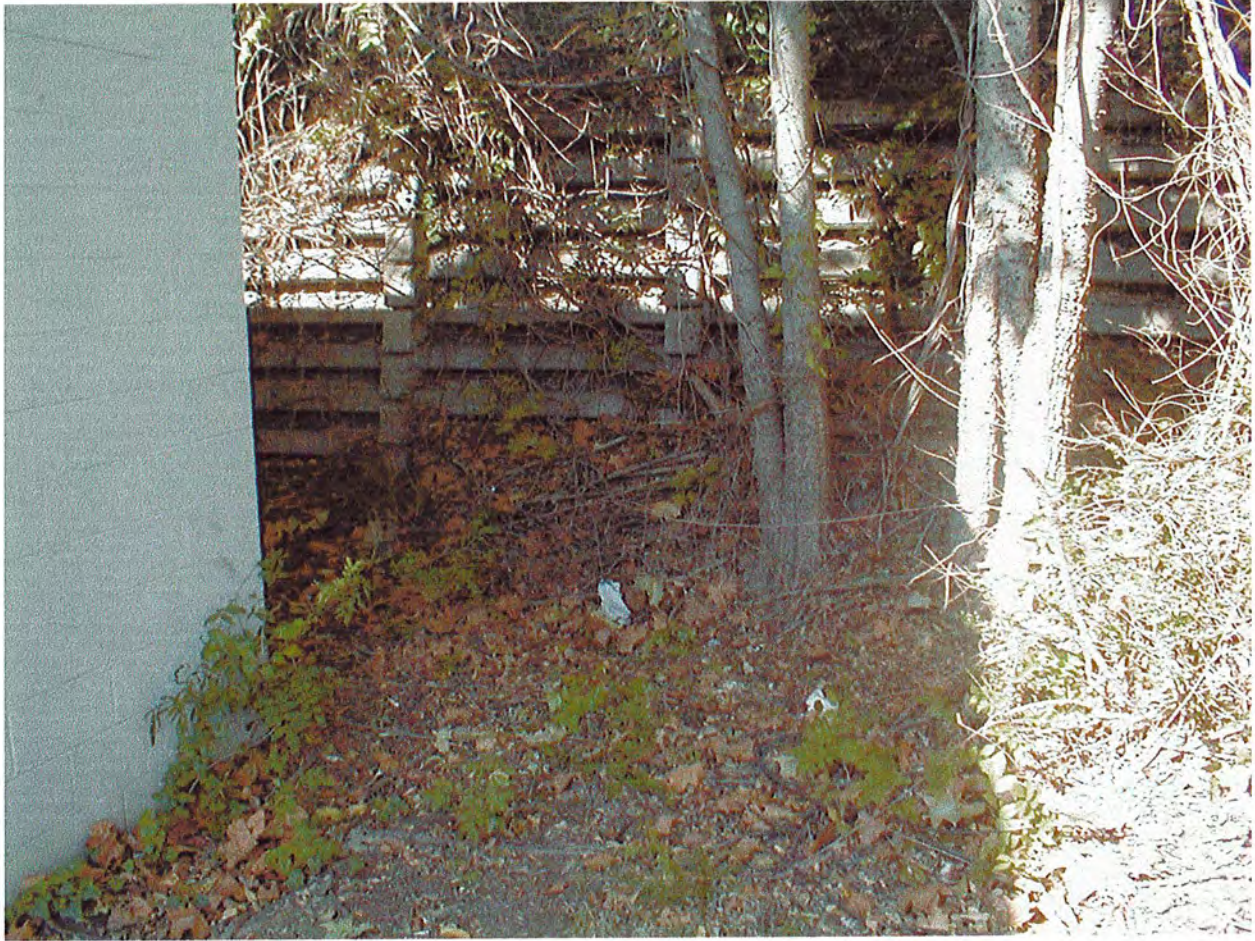
**Photograph 10 Location of SB-21, located on northeastern corner of Carolina Rim and Wheel building.**

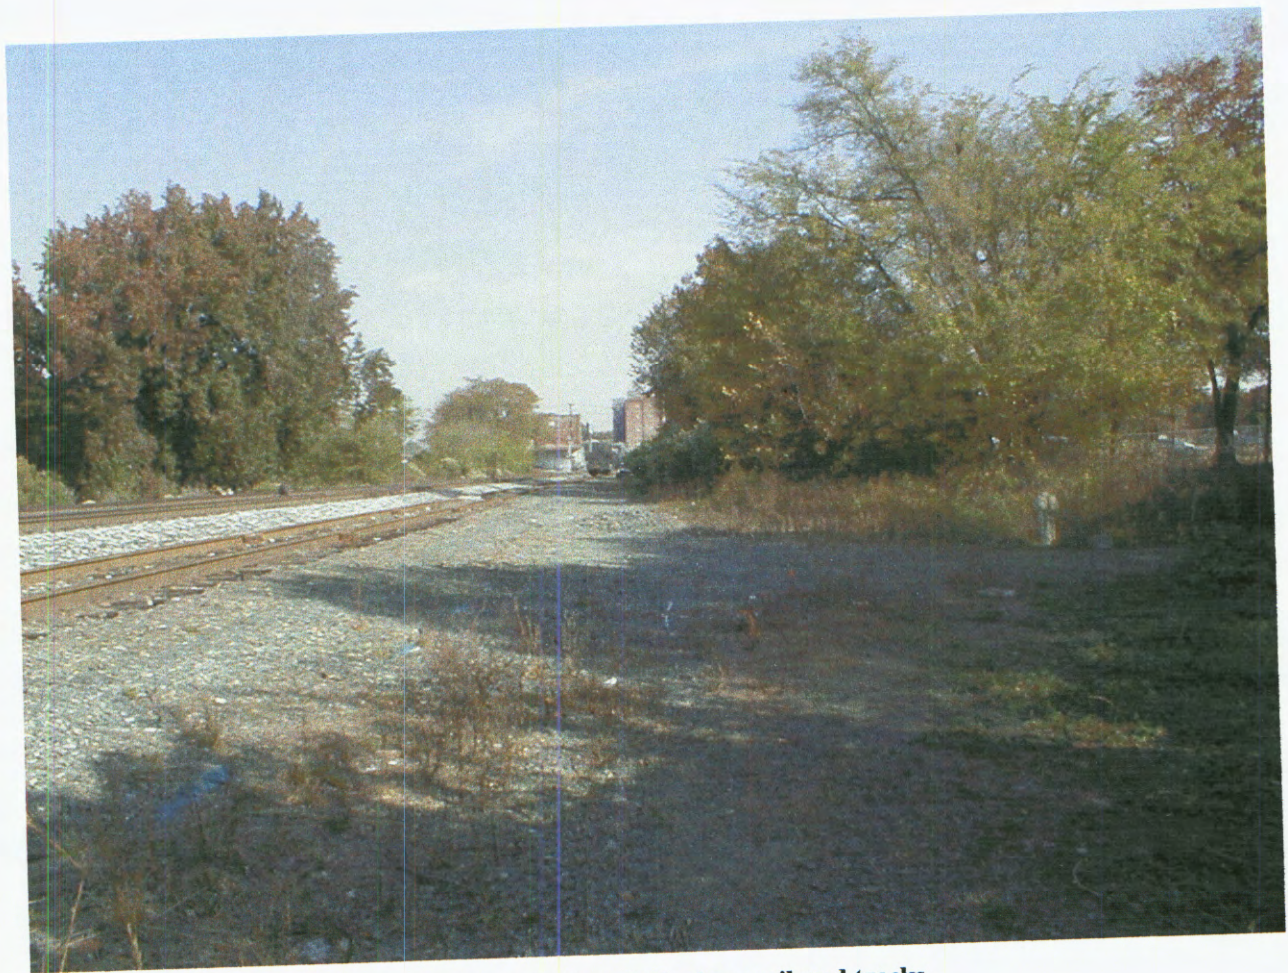
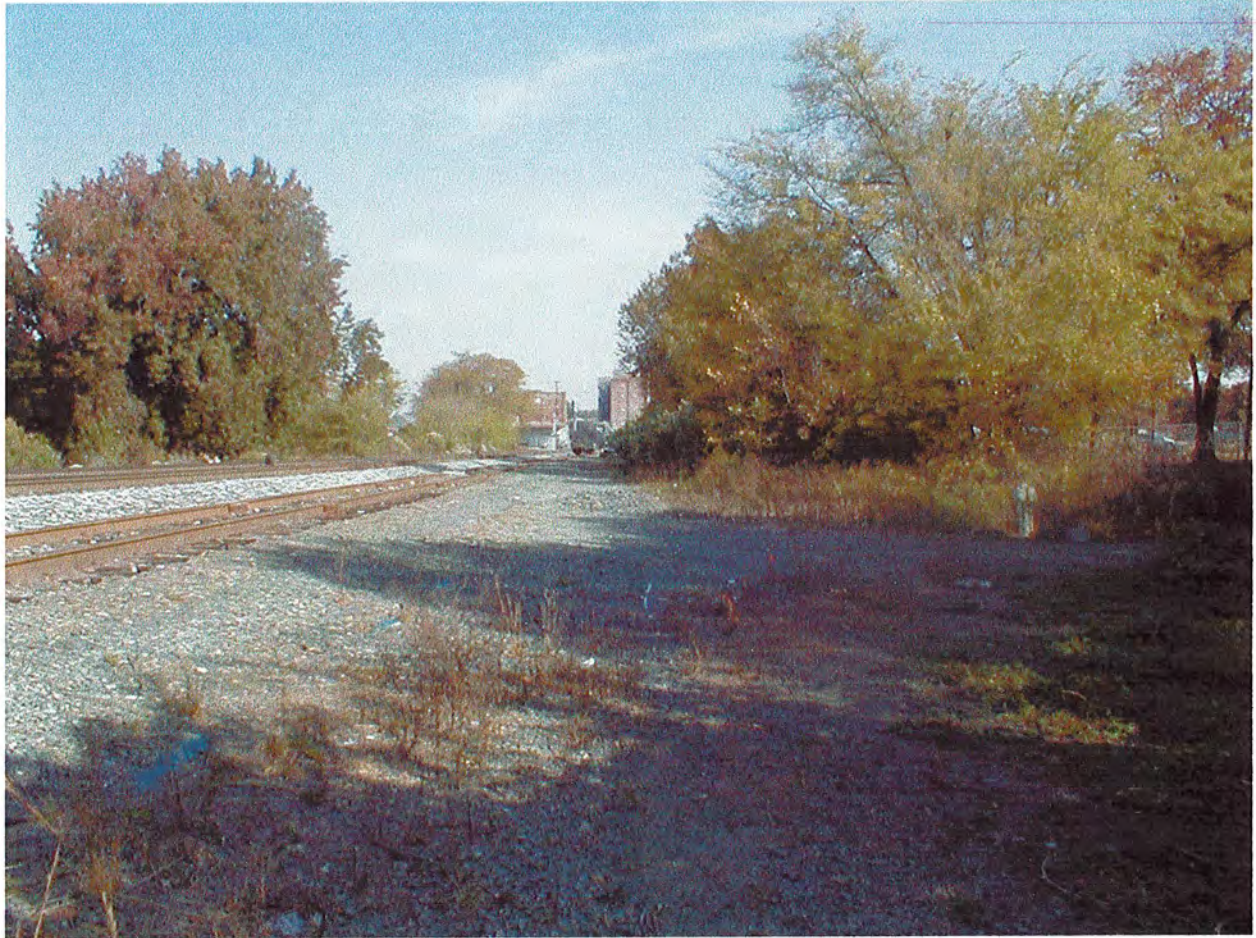
Parcel 7 (0.8 acres) is located along the southeast side of the main line rails between 5<sup>th</sup> and 9<sup>th</sup> Streets. Most of the city block adjacent to this parcel between 5<sup>th</sup> and 6<sup>th</sup> Streets has been cleared and is currently undergoing construction. Photograph 8, taken near the south end of Parcel 7 shows some construction material stored in the NS right-of-way. The railroad embankment, visible in the photograph, is partially retained by concrete cribbing. The city block between 6<sup>th</sup> and 7<sup>th</sup> street is occupied by Carolina Rim & Wheel, an auto supply store (Photographs 9 and 10). A gravel parking lot is present between 7<sup>th</sup> and 8<sup>th</sup> Streets, and a grass field is located between 8<sup>th</sup> and 9<sup>th</sup> Streets where the NS main line rail alignment drops downward to street level (Photograph 11).

**Photograph 11 Parcel #7, along railroad tracks.**
